ANALYSIS OF VALVE AND VALVE SEAT INSERT DAMAGE MORPHOLOGY OBSERVED AFTER DIFFERENT ENGINE TEST

A. Zuleta Durango^{1(*)}, F. Mazuco¹, A. Sinatora¹, D.K. Tanaka¹

¹ Surface Phenomena Laboratory, Mechanical Engineering Department, University of Sao Paulo, Sao Paulo, SP, Brazil

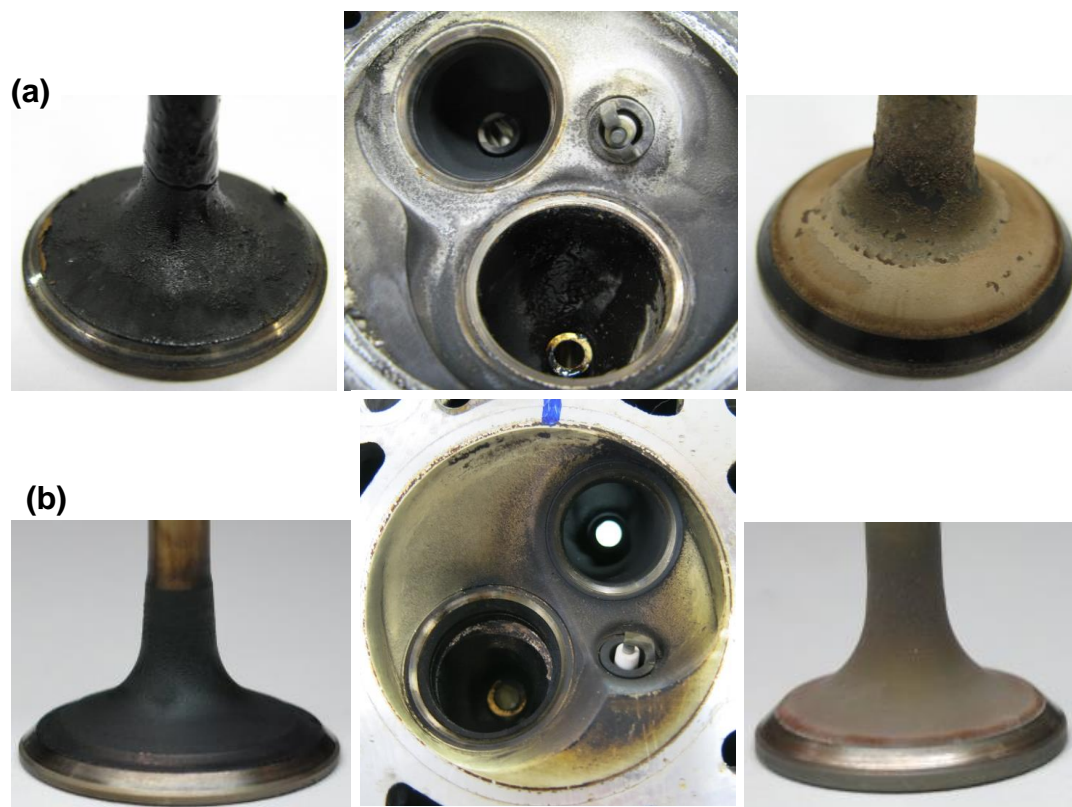
Figure 3 present the intake/exhaust valves and valve seats of cylinder one of both engines. The intake valves of both engines were covered by black sticky deposit, typical of high temperature thermal decomposition of lubricant, while the exhaust valves were covered by gray deposit of material probably consisting of ash from the combustion residue of the lubricant.

Figure 3. First cylinder with intake and exhaust valves of engine (a) MT-1 (b) MT-2.

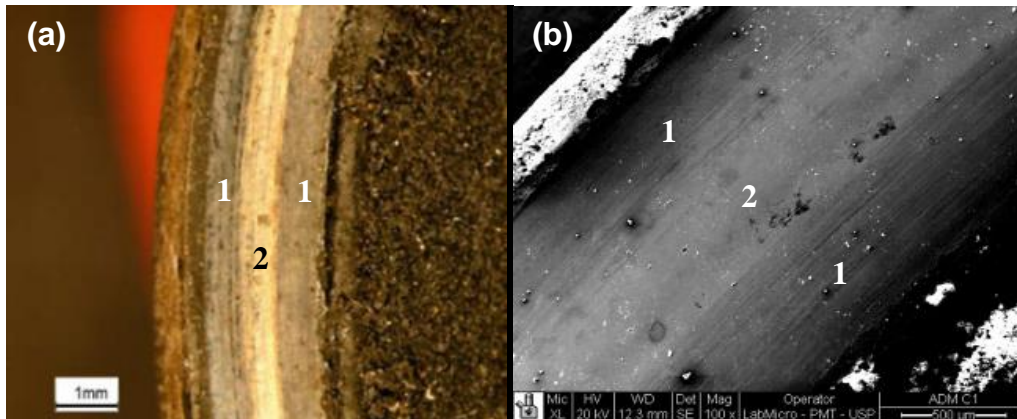
The Figure 4 shows the surface contact of the intake valve of the engine MT-1 by MO and SEM. It is possible to separate the area (surface) into two regions with different characteristics denoted by 1 and 2. The region 1 appears in both edges of contact and is characterized by having circumferential scratches (machining) and deposits. Region 2 is defined by a clear central band and smooth polished surface.

Figure 4. OM (a) and SEM (b) images of the surface of intake valve (MT-1).

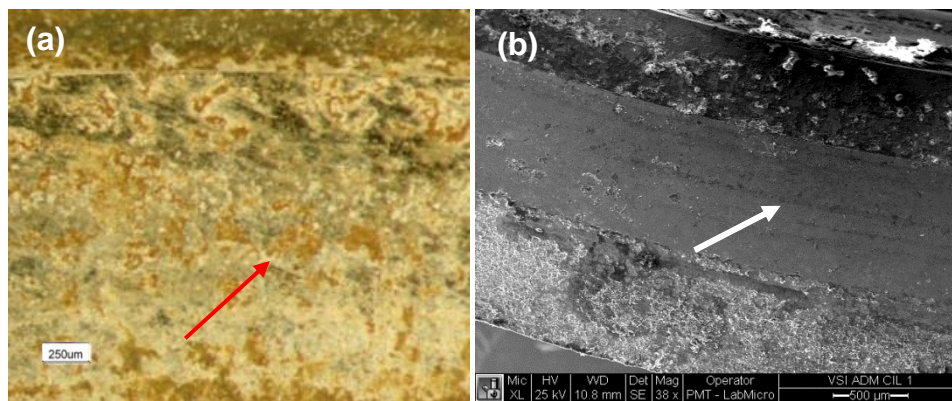
In Figure 5 it can be noticed material deposition on the contact surface, indicated by orange color in Figure 5a. This can be derived from the interaction between the valve seat material with the compounds of the air-fuel mixture. It also can be seen grooves as shown in Figure 5b. The grooves were caused by small particles that also left a deposit material as seen in the image of SEM.

Figure 5. OM (a) and SEM (b) images of the surface of intake valve seat (MT-1).

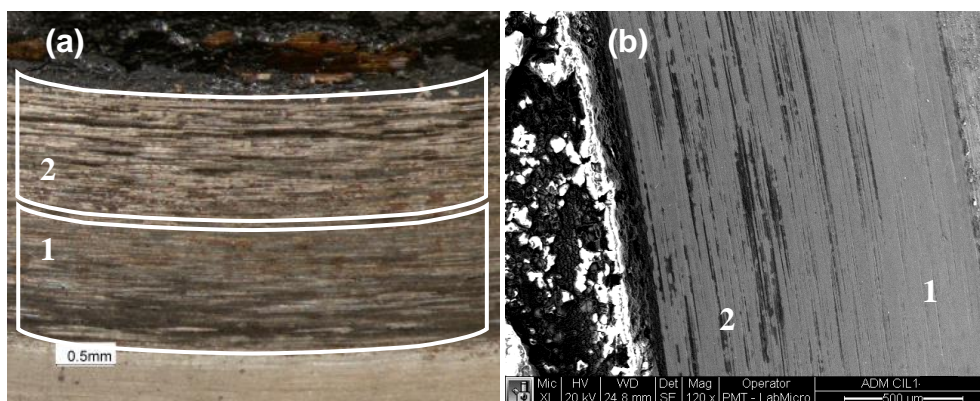
The surface of the intake valve is presented in Figure 6 of the engine MT-2. The contact surface is divided into two regions with different characteristics, denoted by 1 and 2. The region 1 has more homogeneous grayish appearance and region 2 has a surface with more evident circumferential scratches.

Figure 6. OM (a) and SEM (b) images of the surface of intake valve (MT-2).

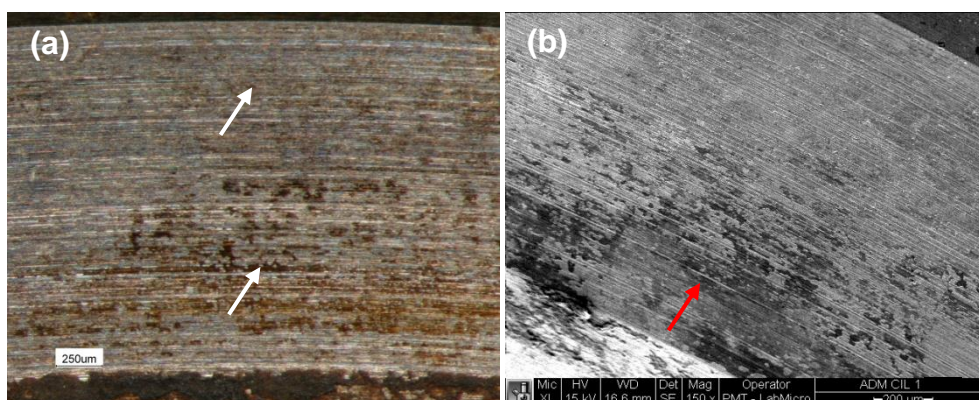
In another region of the valve seat, presented in Figure 7, it can be observed a different coloring. However, this does not represent a change in surface wear, but a deposition of material, as seen in the image obtained by SEM.

Figure 7. OM (a) and SEM (b) images of the surface of intake valve seat (MT-2).

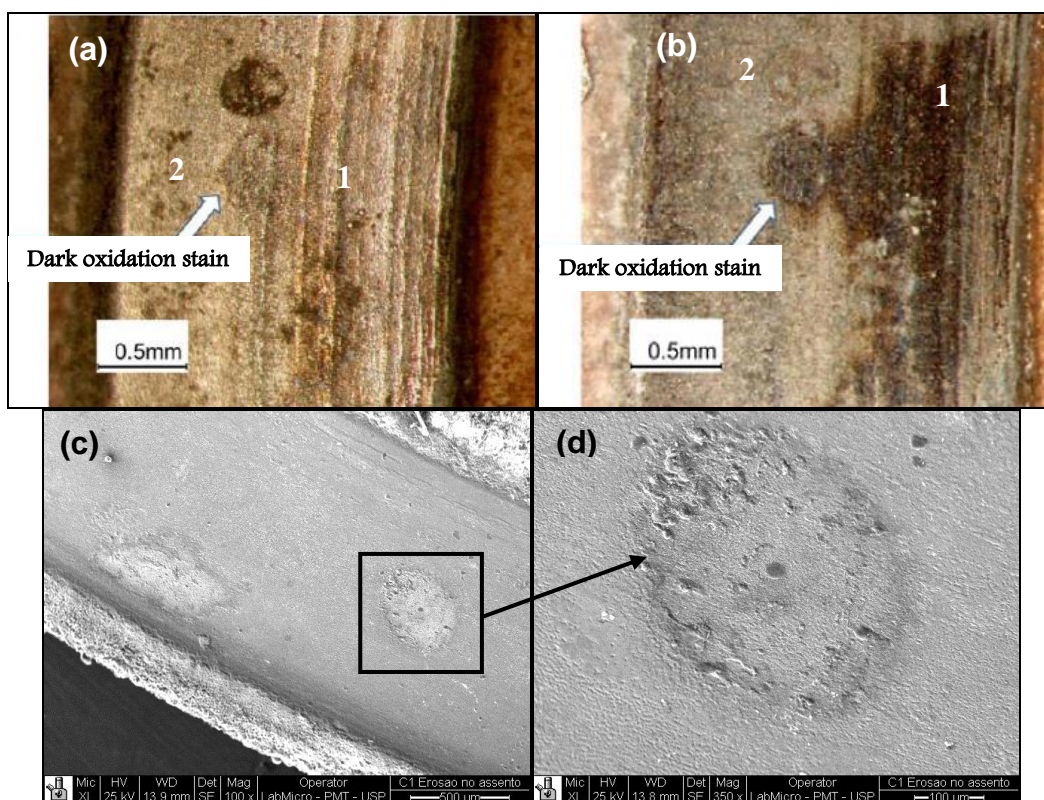
The surface of the MT-1 engine exhaust valve shown in Figure 8 is divided into two regions. Region 1 has marks of circumferential scratching and grooves due to detachment of material caused by small particles or surface with protuberances. Region 2 (Figure 8b) has a smooth surface. It can be also observed a spot, possibly a result of oxidation caused by the high temperatures of the exhaust gases. The oxidation can be better seen with angled illumination of 45°. In the images obtained by SEM, Figures 8c and 8d, it can be noted that there is deposition of material at the edges of the stain.

Figure 8. OM image with normal illumination (a) and angled illumination (b) of an oxidation stain. SEM images of the same region (c) and (d) of the surface of exhaust valve (MT-1).

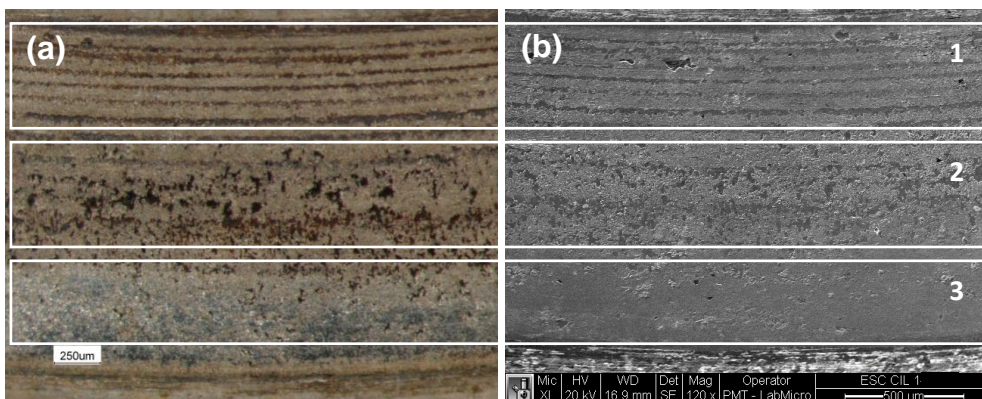
The contact surface of the exhaust valve of the engine MT- 2 shown in Figure 9 can be divided into three regions, which have different coloring and aspects indicating that wear occurred in different ways.

Figure 9. OM (a) e SEM (b) images of the surface width of exhaust valve (MT-2).

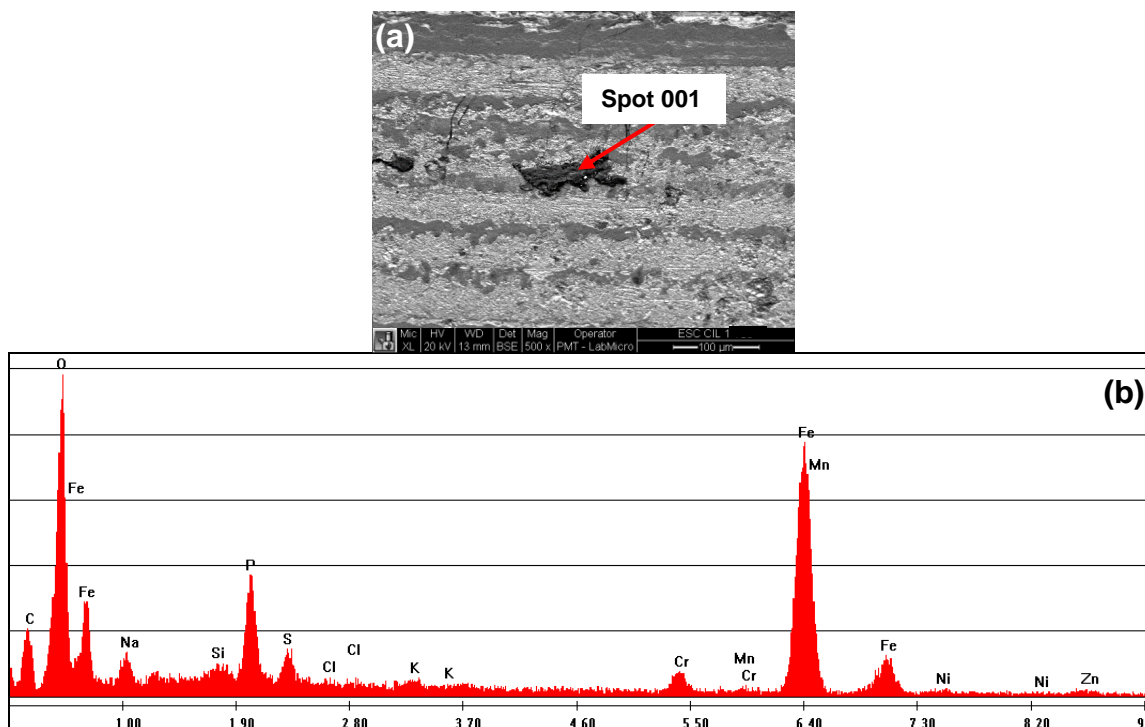
The region 1 show deposits, dark spots and circumferential machining scratches, which can be seen in Figure 10a. Region 2 has a transition characteristic between regions 1 and 3. The region 3 exhibits a smooth surface with disorganized deposition of material, which indicates, as mentioned above, increased wear in this region.

Figure 10 – SEM image (a) of region 1 in the surface of exhaust valve (MT-2). EDS analysis of spot 001 (b).

An energy-dispersive X-ray spectrometry (EDS) analysis was performed in the dark spot. In Figure 10b can be observed the presence of elements such as Fe, C, Si, K, S, Mn, Ni and Cr, constituent elements of the valves and valve seats, but it was observed a peak of oxygen which indicates oxidation at this location. The presence of Na, P and Zn, may indicate that occurred a deposit of material from the lubricating oil.

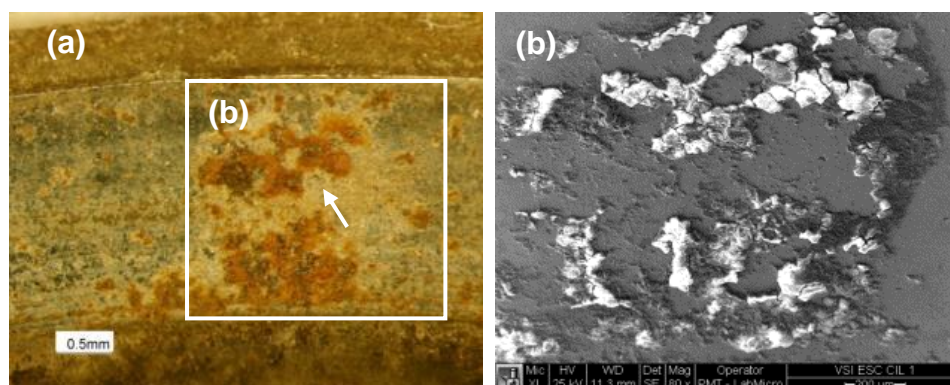
In Figure 11, it can be observed deposition of material, which occupied the whole contact surface. In the image obtained by OM it is noticed that the deposit has orange coloring with early stage of oxidation in the region indicated by the arrow. In the image obtained by SEM can be observed that the deposition has no defined distribution pattern, showing that this deposit is not related to the wear caused by contact between the valve and the valve seat, but by the interaction with the hot combustion gases.

Figure 11. OM (a) and SEM (b) images of the surface of the exhaust valve seat (MT-1).

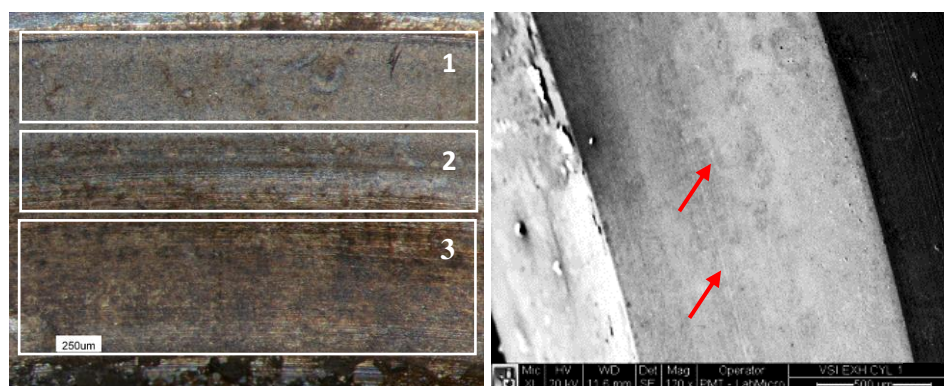
The surface of the exhaust valve seat of the engine MT-2 shown in Figure 12 was divided into three regions with different aspects and coloring. Region 1 is characterized by having surface with less roughness than the others regions closer to the inner edge (region 3), characterized by the circumferential machining scratches and deposits. Region 2 has a transition characteristic between regions 1 and 3. This fact indicates that the region 1 suffered more severe wear (as explained in Figure 13).

Figure 12. OM (a) and SEM (b) images of the surface width of exhaust valve seat (MT-2).

Some regions of the valve seat surface had different appearance as can be seen in Figure 12a. In the central region there are circumferential scratches, as shown in Figure 12b obtained by SEM. Despite different coloring obtained by optical microscopy, the wear mechanism occurred in both regions was not different from that described for the reference section, as seen in the SEM image.

The wear was more severe possibly due to the higher contact pressure that occurs at the outer edge, indicating that wear increases from the inner edge to the outer edge of contact surface. This may occur due to the project recommendation between valve
