Corrosion failure of titanium tubes of a heat exchanger for the heating of dissolving lye

Corrosion Failure of Titanium Tubes of a Heat Exchanger for the Heating of Dissolving Lye

Running title: Titanium corrosion during sylvinitic ore processing

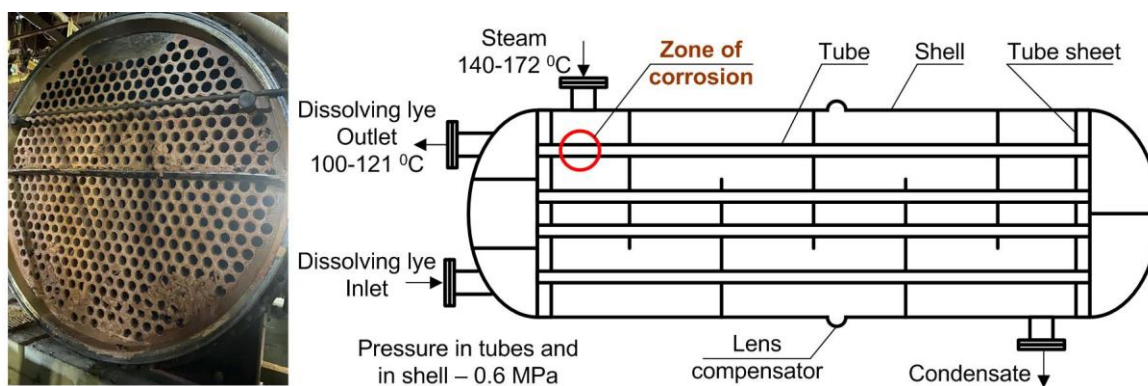
The heat exchanger (material: titanium VT-1-0 according to GOST 19807, in Germany 3.7034 or Ti2, Grade 2, in England IMI125) is intended for operation in existing heating schemes for dissolving lye (tube space) using saturated water vapor or superheated condensate as a heat carrier. As a result, the lye is heated up to 120 °C under a pressure of 0.6 MPa. The heat exchanger is schematically depicted in Fig. 1. Its total surface area was 179 m². The orientation of the heat exchanger was horizontal. The shell of the heat exchanger had a temperature disc lens compensator. The pipes were sized 38 mm × 2.0 mm (inner diameter is hence 34 mm) according to VT-1-0 GOST 22897-86. The location of the investigated corrosion is shown in Fig. 1. The location of the corrosion failure was where the

lye reached its maximum temperature before exiting the heat exchanger.

Fig. 1. Picture of outlet showing lye deposits (left) and schematic of shell and tube type titanium heat exchanger (right)

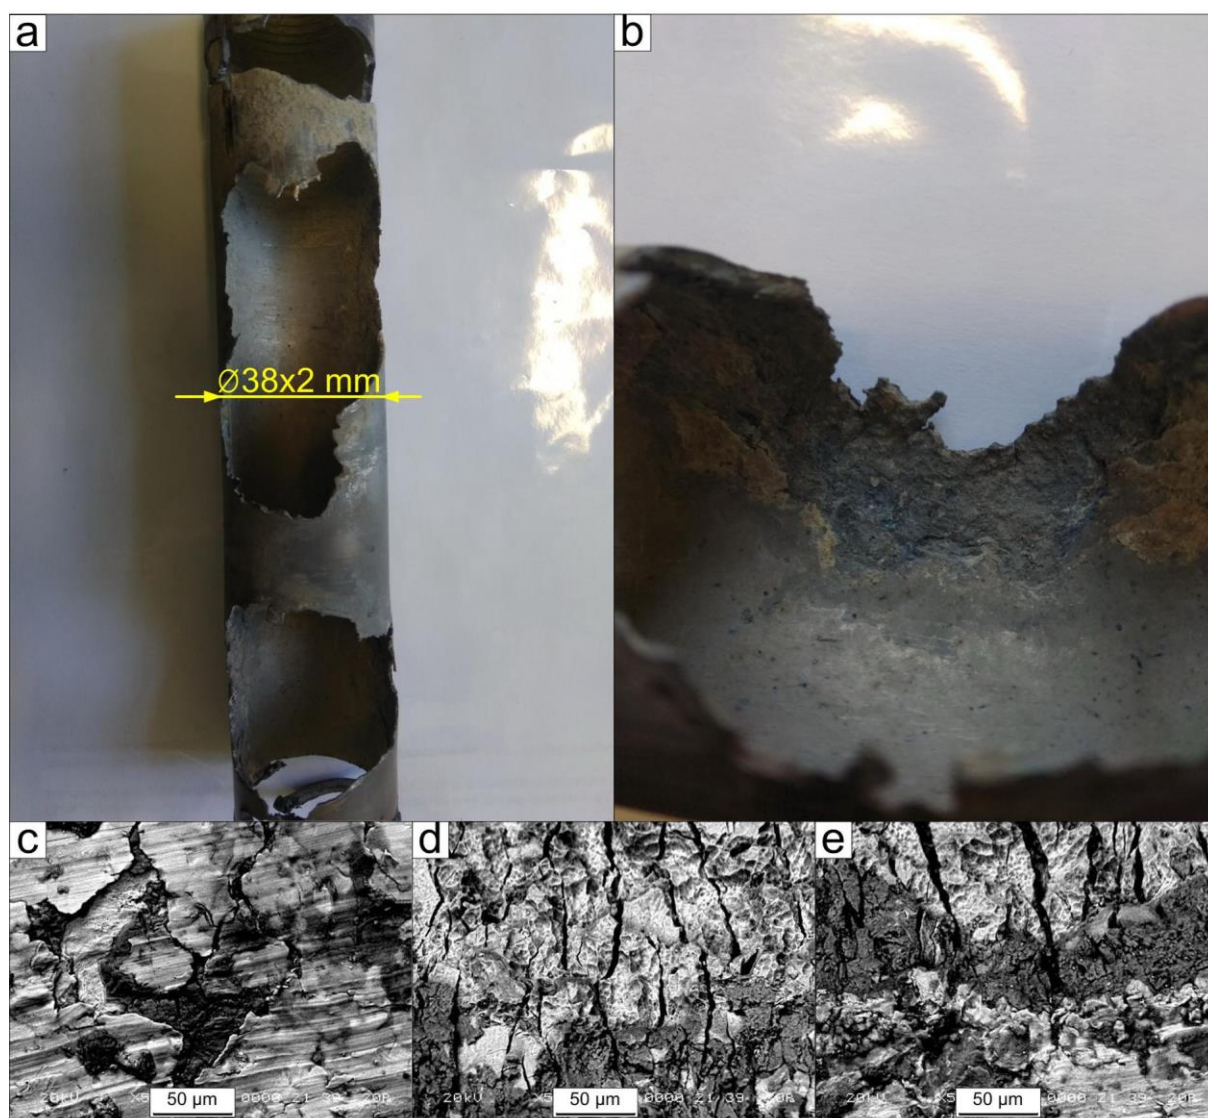
Fig. 2 shows photographs and SEM images of corroded titanium tubes of the heat exchanger used to heat dissolving lye. The photographs (upper two rows in Fig. 2) show millimeter to centimeter-sized holes. The corrosion started from the inside of the tube.

Fig. 2. Photographs (upper row) and SEM images (lower row) showing millimeter and micrometer-sized cracks and visible corrosion and failure

During the maintenance once in three months, the condition of the pipes was checked only visually. In the problem area, this visual inspection should be complemented by non-destructive methods such as ultrasound (to measure the thickness of the pipe), acoustic testing (to distinguish brittle from ductile metal and detect cracking), and electrochemical measurements (to detect the onset of active corrosion by a lower than usual potential). Further, frequent removal of corrosion products from process streams is essential to avoid the formation of crevices and thick deposits that cause overheating. Such Fe-containing deposits may lead to a greater hydrogen evolution and a greater extent of cathodic reactions [4], resulting in greater hydrogen-induced cracking. Surface modification of titanium tubes by pickling, passivation and thermal oxidation can be considered to minimize corrosion attack and hydrogen-induced cracking [7, 14].

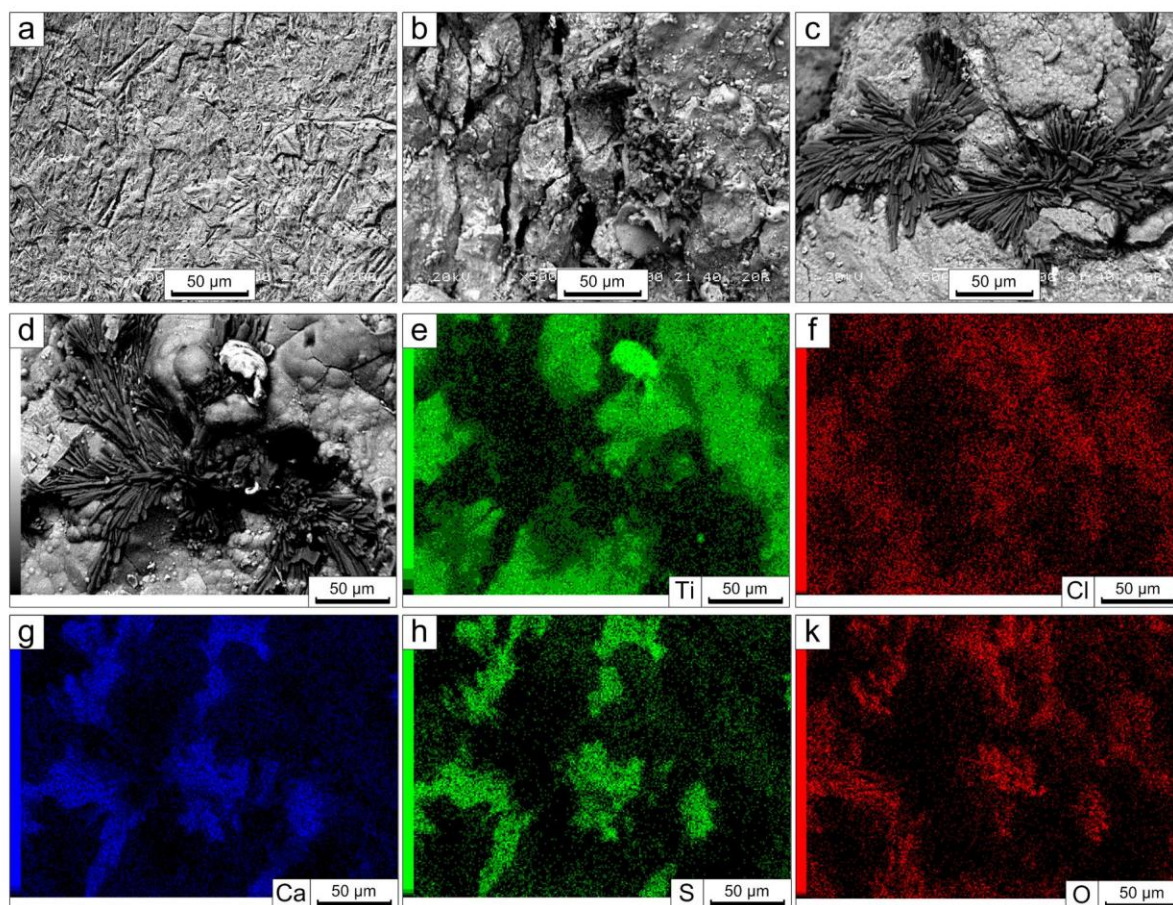
In order to investigate which substances took part in the extensive corrosion of the titanium tubes, the corrosion products were analyzed. SEM images are presented in Fig. 3 and corresponding EDS results are shown in Table 2.

Fig. 3. SEM images of an unaffected titanium tube (a), corroded area (b), and sediments (c-d) with corresponding (to d) EDS mapping results (e-k)

The composition of corrosion products, by means of EDS analysis, is shown in Fig. 3 and in Table 2. EDS analysis showed a higher value of Fe for the titanium metal of an unaffected area than did the chemical analysis provided by the supplier (Table 1), suggesting some preferential deposition of Fe impurities from the dissolving lye. Fe, as well as copper (Cu) and zinc (Zn) can catalyze cathodic reactions on titanium metal [18]. Fe, Cu, and Zn are even more enriched in the corroded area (Fig. 3b, Table 2). Deposits (Fig. 3c, Table 2) contain small amounts of these and other impurities, and mainly the dissolving lye main insoluble components (Ca, S, O).

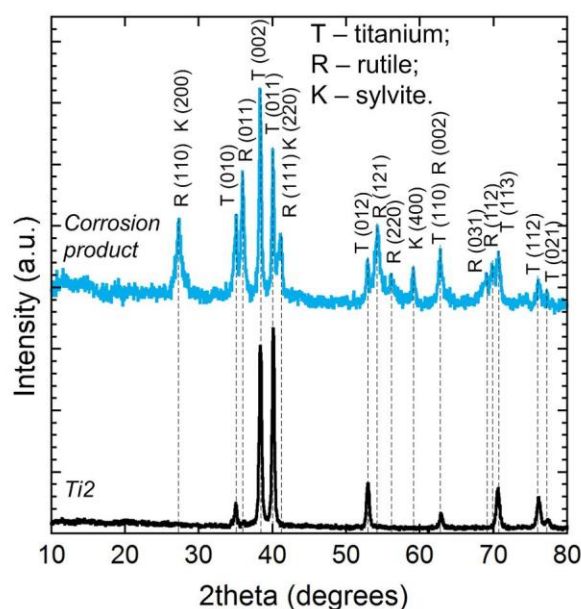
Fig. 4. XRD diffractograms of corrosion products and bulk titanium (for comparison)

XRD patterns of the corrosion products showed peaks of titanium metal (hexagonal crystal system and $P63/mmc$ space group), rutile (tetragonal crystal system and $P42/mnm$ space group) and sylvite (cubic crystal system and $Fm3m$ space group), Fig. 4. The main content of the corrosion products was titanium dioxide (rutile). Sylvite was found in the corrosion product samples in a minor concentration and some deposited crystals of calcium sulphate were also found.

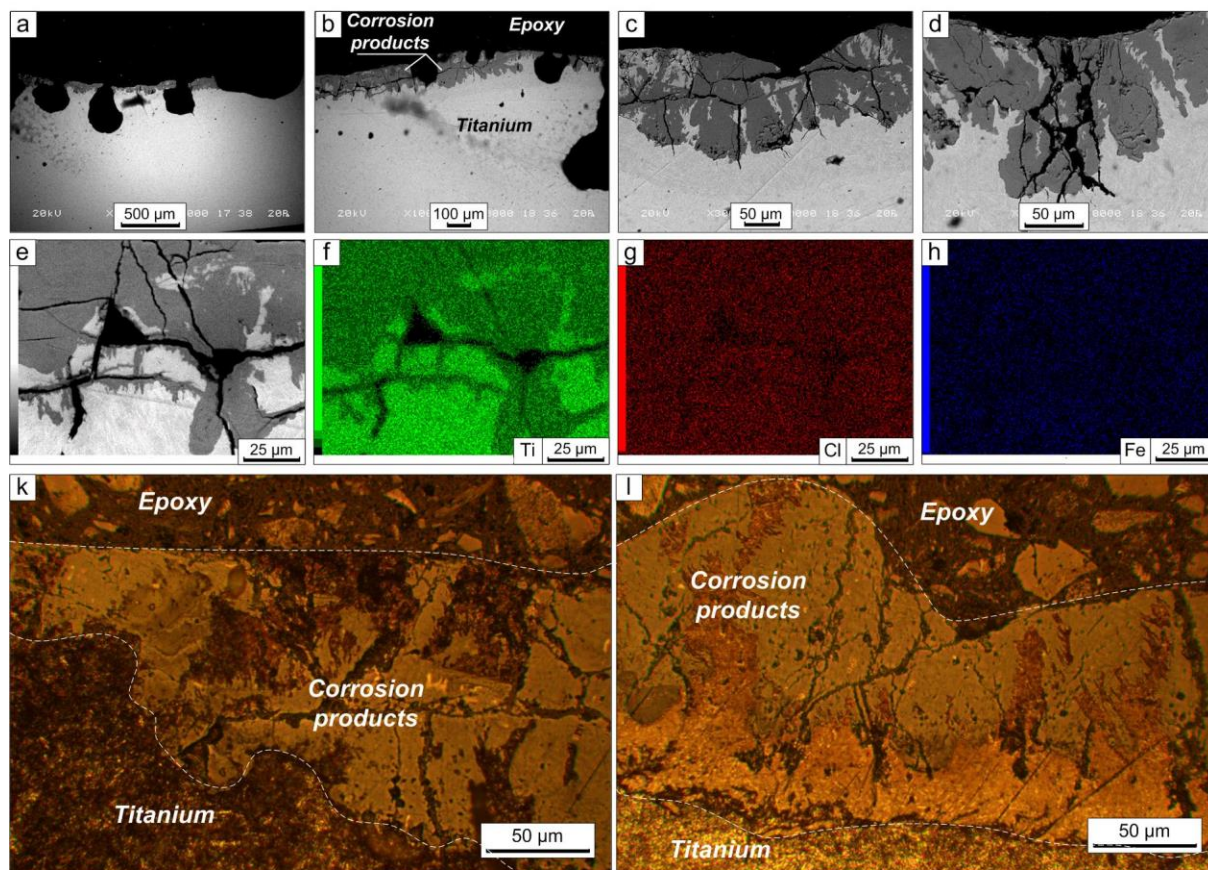
To determine whether intergranular corrosion and stress corrosion cracking could have played a role, the cross-section of the corroded specimen was mapped by EDS (Fig. 5). Cracks passed through the titanium oxide and continued into the metal, which is unusual for a corrosion-induced cracking type. Likewise, chlorine was not concentrated at the crack tips or along the cracks. This suggests that the titanium metal could have been embrittled by hydrogen and/or that there were large stresses, facilitating a rapid propagation of the cracks. The distribution of Fe did not imply the participation of Fe (itself) in the corrosion process,

but it could have been a catalyst for the evolution of hydrogen and, therefore, increased hydrogen embrittlement. To conclude, neither intergranular corrosion nor stress corrosion cracking or oxide-induced stress corrosion cracking seemed to be the dominant corrosion propagation mechanism, and a rapid cracking propagation was found. It should be noted that there were no vibrations or other loads during operation of the heat exchanger. There were also no frequent or large temperature variations. When disrupting the processing for maintenance (once every 3 months), only mechanical cleaning and further rinsing with water were used.

Fig. 5. Cross-section by SEM (a-d), cross-section and corresponding EDS mapping (e-h), and optical microscope images (k and l)

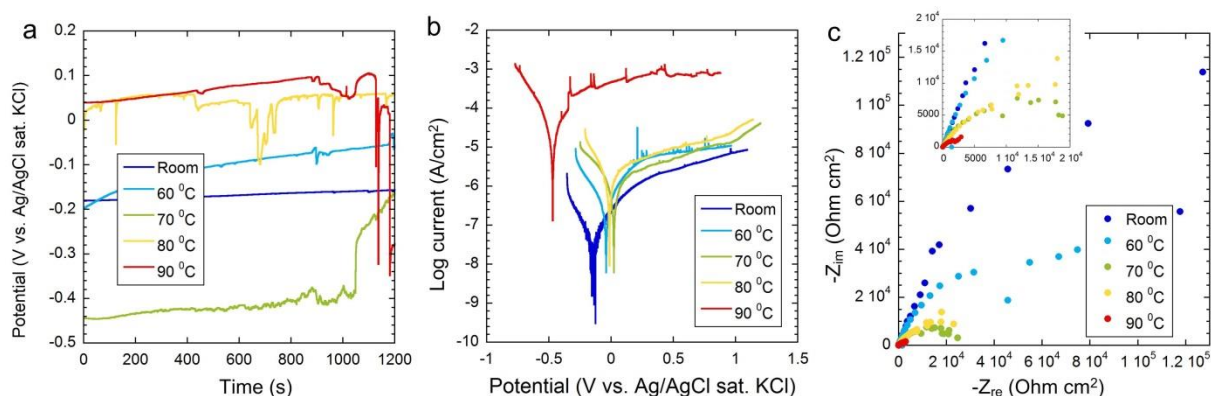
Fig. 6. Representative curves of OCP (a), potentiodynamic polarization (b) and EIS (c) at room temperature, 60, 70, 80, and 90 °C.

The corrosion potential (and OCP) first increased slightly with temperature (statistically significant for room temperature compared with 60 and 70 °C) and decreased then (above 80 °C). An increase is probably related to a more rapid oxide growth at higher temperature. The corrosion current was smallest at room temperature and increased with temperature. This was statistically significant for the difference between room temperature and 60 °C. The difference was largest between room temperature and 90 °C (380-fold), while it was a smaller difference for all lower temperatures – with a 20-fold increase between room temperature and 80 °C. Up to 60 °C, there was no pitting breakdown under the tested conditions, while this was the case for the higher temperatures. In order to compare passive and active conditions in this study, we defined an anodic branch current density as the current density 400 mV positive to the corrosion potential (we could not call this a passive current density, since the material was clearly not passivated). This current density increased with temperature, with relatively small differences (statistically significant between 60 and 70 °C) of 4-fold increase from room temperature to 80 °C, while it increased 150-fold from room temperature to 90 °C. The pitting potentials were high and consistent at 70 °C (955 and 991 mV) and at 60 °C (947 and 910 mV) for duplicate samples, while they sharply decreased to 293 and -344 mV at 90 °C.

All these corrosion parameters point towards a serious breakdown of passivity at 90 °C, while there are minor differences up to 80 °C.

The shape of the Nyquist curve (Fig. 6c) at 90 °C, as compared to the other temperatures, suggests a change from a protective surface oxide to an oxide with possible diffusion.

The strong influence of the temperature above 80 °C suggests that the temperature difference between the corrosion-affected outlet zone (maximum temperature of heat exchanger) and the rest of the titanium tubes of lower temperature might play a role in the rapid corrosion propagation. The relatively small area of higher temperature could have been activated and the relatively large area of lower temperature could have fueled the anodic part-cell corrosion process by providing the surface area necessary for the cathodic reactions. These data are in good agreement with paper [12], which noted crevice corrosion of titanium alloys of Grades 2 at 80 °C in seawater. Another study on titanium of Grade 2 in 0.27 M NaCl found a film breakdown and repassivation transients at a temperature threshold of around 65 °C, initiating crevice corrosion [13].
