SURVEY OF DAMAGE MECHANISMS ON PVD COATED HSS HOBS USED IN SWEDISH GEAR MANUFACTURING INDUSTRY

ABSTRACT

This work presents a survey of wear as observed on today's state of the art hobs used by Swedish gear manufactures. It aims to identify damage mechanisms and the common problems in order to enable future production of more reliable hobs. The tools were temporarily borrowed from the production and the analyses were made non-destructively using optical microscopes. This was complemented by destructive cross-sectional analysis on two of the hobs.

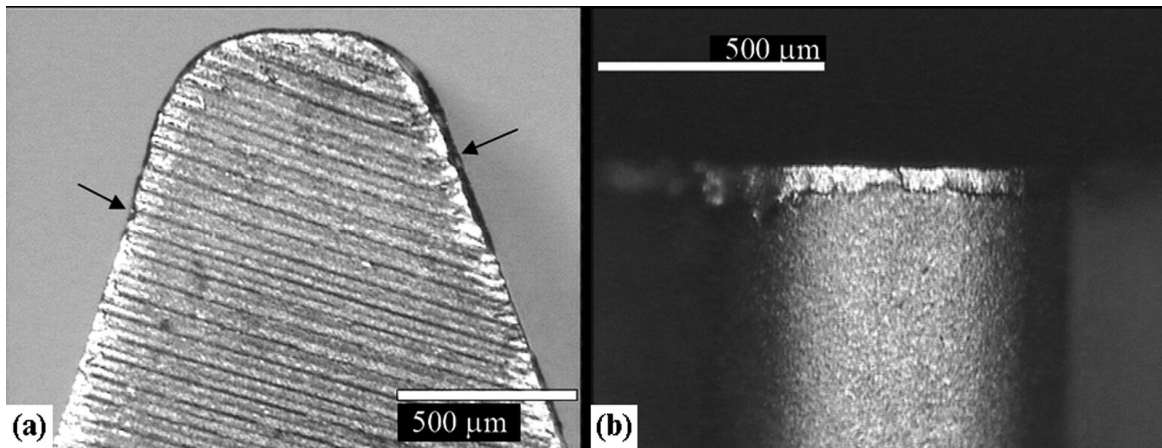
Wear dominated by flank wear was only observed on hob A. The wear on this hob is rather extensive and it is located at the cutting edge, see Fig. 6. The coating surrounding the worn area on the tooth flank, see Fig. 6b, appears to have a more or less full coating thickness without any discoloration. This

indicates that the flank wear has not been propagating by gradual removal of superficial material but rather by discrete failures. Another fact, supporting this, is that the cutting edge is not worn uniformly but instead it is full of notches. Furthermore, the rake face appears to consist of rather large ridges and grooves and the notches in the cutting

appear to be associated to these, which are indicated by arrows in fig 6a

The hob has, contrary to the others, been cutting by conventional hobbing that involves high mechanical loads on the cutting edge and sliding of the tooth flank against the work piece under high pressure.

Figure 6. Pictures of a worn tooth representative for hob A: Bright areas of exposed HSS are seen close to the cutting edge on the tooth rake face (a). Extensive wear of the coating as well as the HSS at the cutting edge seen from the tooth flank face (b).

The wear on hob A has been characterised as flank wear which might be a bit misleading. Flank wear is often described as mild abrasive and/or adhesive wear of the flank face when sliding against the surface of the work piece. On hob A, on the other hand, the edge seems to be worn down more drastically and on a larger scale as it has a more jagged appearance. This is supposedly a consequence of a large grinding marks at the cutting edge combined with high external stresses. The wear, however, is propagating on the flank face and thus referred to as flank wear.

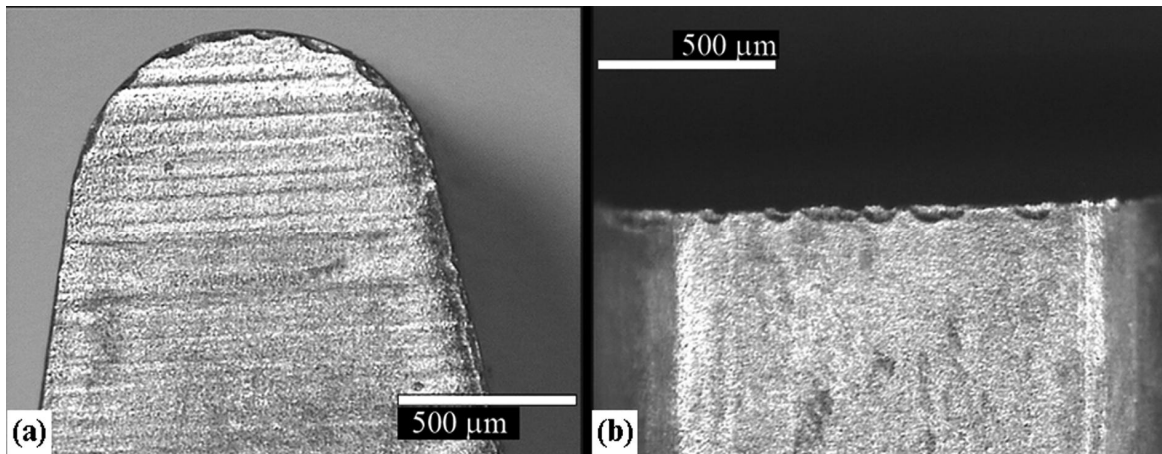
Figure 7. Pictures of a worn tooth representative for hob B: Secondary to edge chipping the coating is exposed to mild wear which appears as dark areas on the rake face (a). The jagged cutting edge is seen from the tooth flank face in (b).

The dominating wear of hob B and of hob C is edge chipping, see Fig. 7 and 8. Secondary to the edge chipping, a mild wear of the coating can be seen as a dark area on the tooth rake face. The edge chippings are most probably consequences of point defects in the cutting edge. The coating is removed by discrete failures exposing small areas of HSS that has a significantly lower wear resistance than the coating, resulting in a hollowed cutting edge. If the failures are initiated in the coating, the interface coating/HSS or in the HSS bulk is not possible to determine from this superficial analysis. On hob C however, the notches in the cutting edge seem to be connected to the ridges on the tooth flank face, see Fig. 8b.

The dominant damage mechanisms on the hobs, B and E, are characterised as edge chipping and crater wear respectively. The cross-sections, however, reveals that the underlying wear mechanisms are much the same for the two. Nevertheless, the location and extent of the damages differ. On hob B the weakest point, limiting tool life, is the sharp cutting edge in combination with a thick coating. This leads to flaking of the coating around the edge and accelerated wear of the exposed HSS resulting in a jagged cutting edge. On hob E, on the other hand, the weakest points are irregularities in the coating itself and in the interface between coating and substrate. Here, the cohesive coating failures are thus located at the rake face, although close to the cutting edge, resulting in craters where exposed HSS has been worn of.

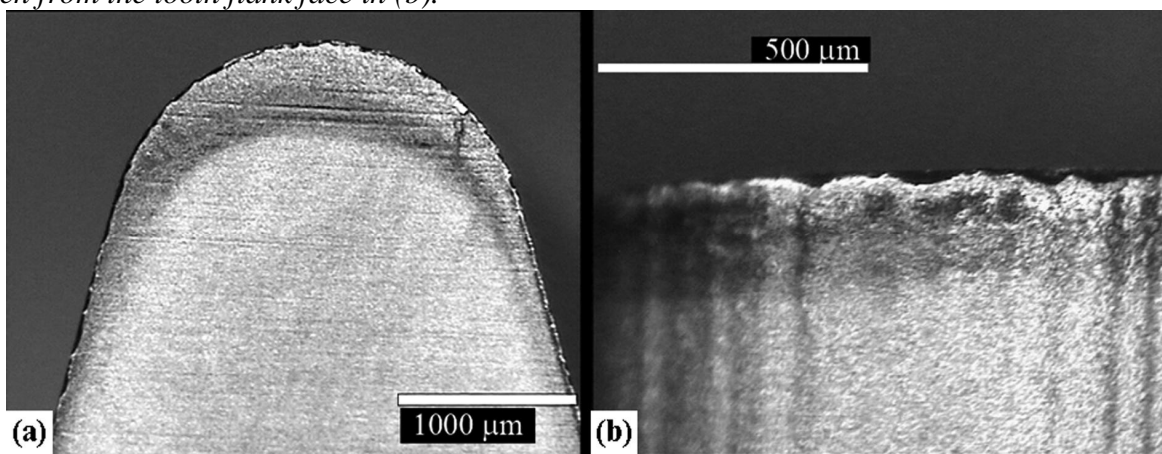
Figure 8. Pictures of a worn tooth representative for hob C. The edge is worn by discrete failures (edge chipping) while the coating on the rake face is exposed to mild wear, seen as dark areas (a). The jagged cutting edge is seen from the flank face in (b). Note how the edge chippings seem to correlate with the coarse ridges on the flank face.

On hob C the edge chippings seems to be connected to the ridges on the flank face of the tooth (*c.f.* Fig. 8b). These ridges are relatively high and therefore probably carries most of the load which may have resulted in local plastic deformation and chipping. The two hobs that are more or less free from edge chippings, hobs E and H, both have quite smooth flank faces. There is therefore reason

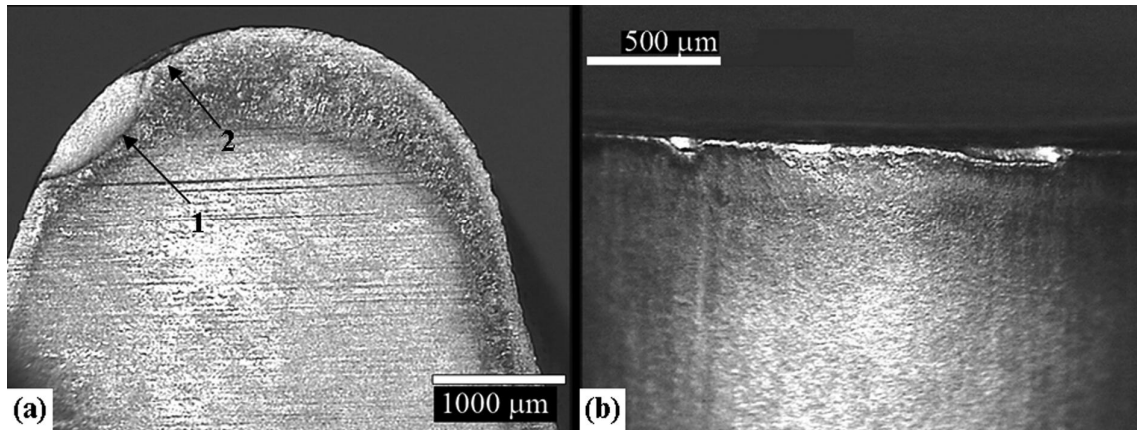
On hob D the wear is characterised by a crater that is formed on the rake face in close connection to the cutting edge, see Fig. 9a. Nearby, a large chip has been removed from the cutting edge. Chipping also occurs on other parts of the cutting edge, which is seen in Fig. 9b.

Figure 9. A worn tooth representative for hob D: A crater is formed in connection to the cutting edge on the rake face (a) indicated by arrow 1. Above the crater, a large chip has been removed from the cutting edge, indicated by arrow 2. The cutting edge seen from the tooth flank face reveals the presence of several discrete failures in the cutting edge (b).

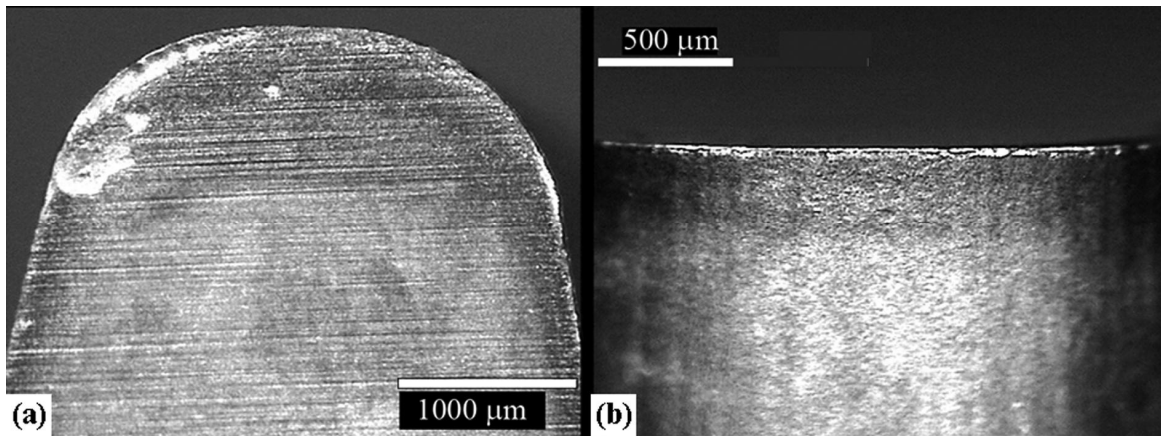
Hob E, shown in Fig. 10, has a crater that is formed in the same area of the rake face as the crater on hob D. Contrary to hob D, no significant edge chipping is seen on hob E, see Fig. 10b. Due to the fact that the edge of the crater is uneven it has likely been growing by discrete coating failures rather than a mild, continuous wear.

Figure 10. A worn tooth representative for hob E: An irregularly shaped crater is formed close to the cutting edge on the tooth rake face (a). No significant edge chipping can be seen at the cutting edge (b).

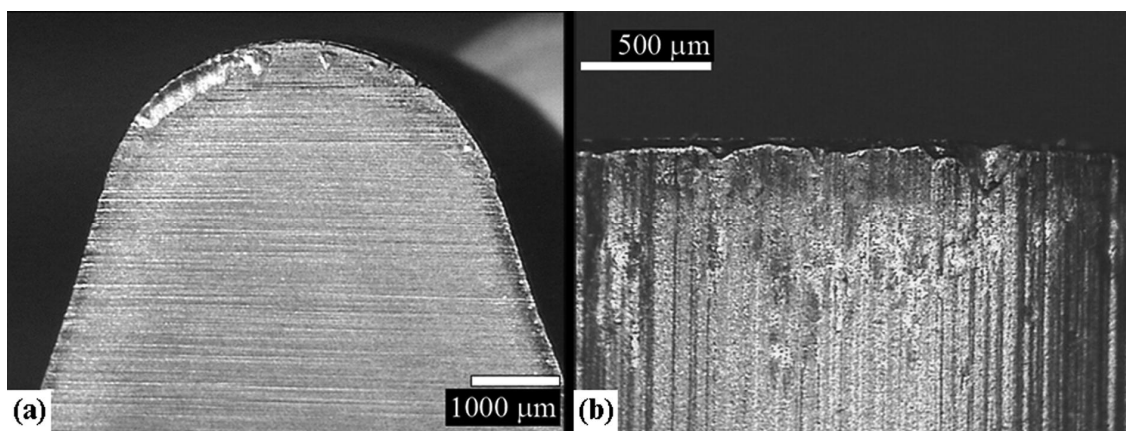
Hob F suffers from both severe edge chipping and crater wear as shown in fig 11. Discrete areas of exposed HSS result in grooves on the tooth rake face that accrete to a larger crater close to the cutting edge. The edge chipping is extensive and the cutting edge appears to be completely devoid of coating material, see Fig. 11b. A certain amount of flank wear, mainly located at the ridges present on the flank face, can also be seen.

Figure 11. A worn tooth representative for hob F: A large crater is seen close to the cutting edge along with smaller isolated craters on the rake face (a). The coating on the cutting edge is completely removed and extensive edge chipping is seen (b). A mild flank wear located primarily on the ridges of the flank face can also be seen.

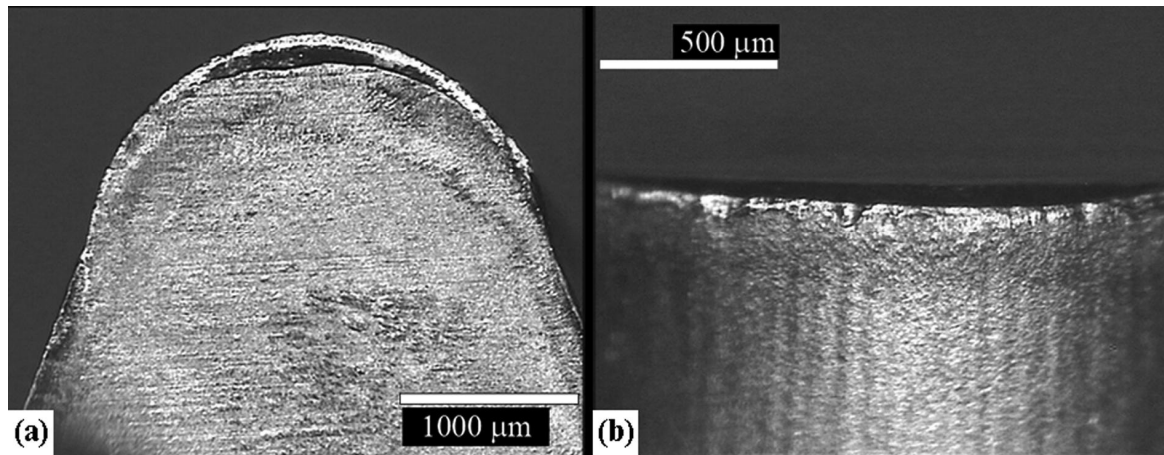
Hobs G and H have both been operating without presence of cutting fluid. For hob G, the crater is located close to, and extends along, the cutting edge as shown in Fig. 12a. Small edge chippings are seen in the edge. Furthermore, work material is welded onto the rake face giving its central part a rough appearance. The fact that work material is attached to the tool indicates adhesion and high friction between the tool rake face and the formed chip. On hob H, cracks and dimples are seen in the coating on the rake face close to the cutting edge, see Fig. 13. In connection to these cracks a crater is formed. This type of appearance indicates thermal softening of the HSS. As the HSS softens, the coating loses its support and collapses by brittle cracking when external load is peaking.

Figure 12. A worn tooth representative for hob G: A crater is located on the rake face in close connection to the cutting edge and follows the line of the edge (a). The area just beneath the crater appears to be polished which is seen as a smooth, dark area. The rough appearance of the surface further down on the rake face is due to work material welded on to the surface. The cutting edge, seen from the flank face, reveals small edge chippings in the edge (b).

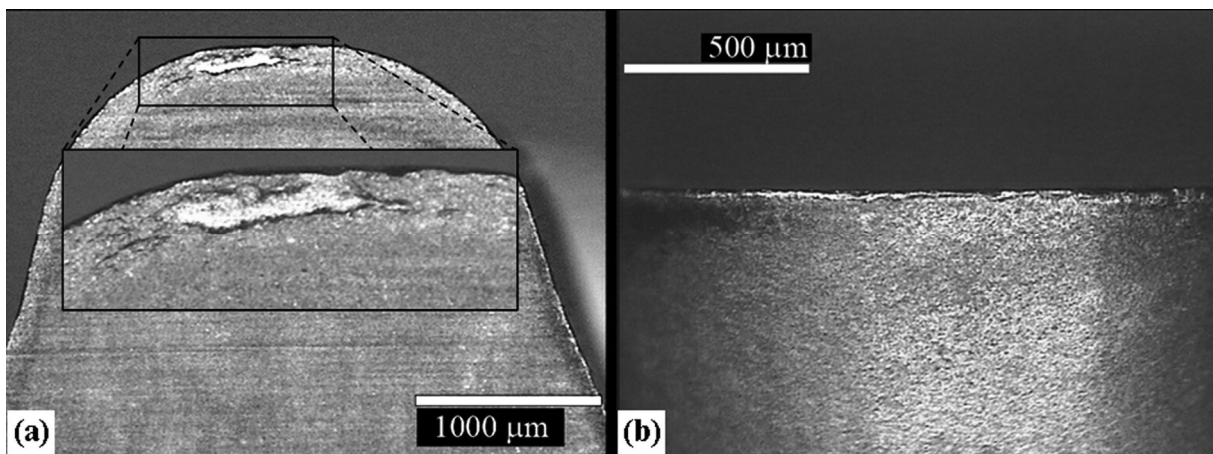
Figure 13. A worn tooth representative for hob H: Cracks parallel to the cutting edge are seen in the coating on the rake face (a). These cracks result in the formation of a crater and eventually the exposure of the HSS. No significant edge chipping can be seen in the cutting edge (b).

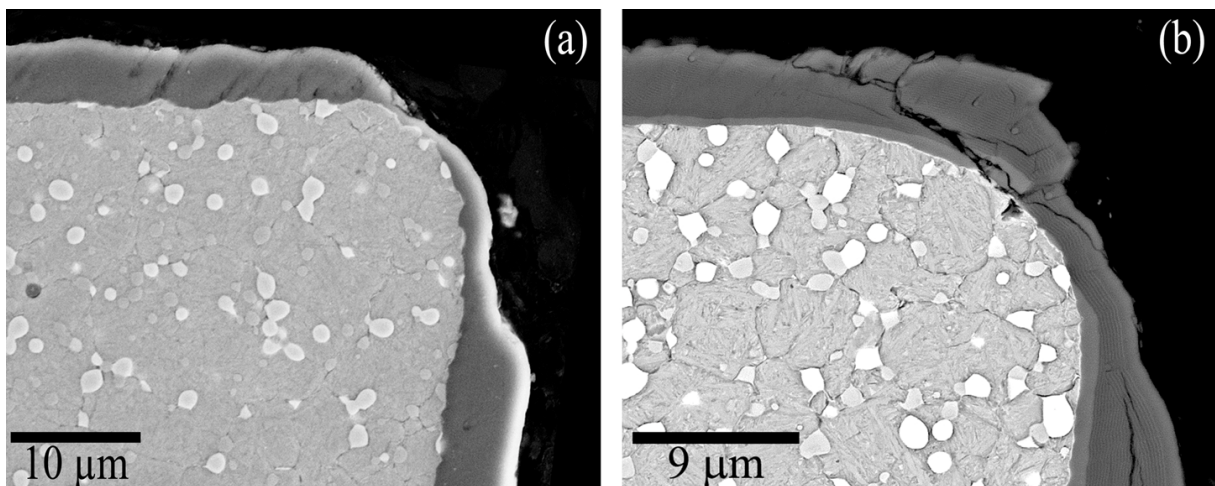
Cross-sections of unused or barely used teeth on both hob B and E show flaws in the coating around the cutting edge. On hob B, Fig 14 a, the coating is non-existing or very thin around the edge while it is rather thick on the rake- and flank face of the tooth. Steps where the coating thickness is reduced rather

abruptly can also be seen on both the flank- and the rake face. Similar, on hob E the coating is thinner close to the cutting edge than on the adjacent faces, cf fig 14 b. The interlayer, seen as a thin light band between the coating and the HSS substrate in fig 14 b, is also interrupted and missing on some parts around the edge indicating that the coating has spontaneously chipped during growth in the coating process. The extent of cracks found close to the edge support this observation.

Figure 14. Cross sections of the cutting edge on unused teeth taken from hob B (a) and hob E (b). The upper horizontal side is the rake face. The dark gray layer is the PVD-coating. the coating/HSS interface and at coating defects, see Fig. 16.

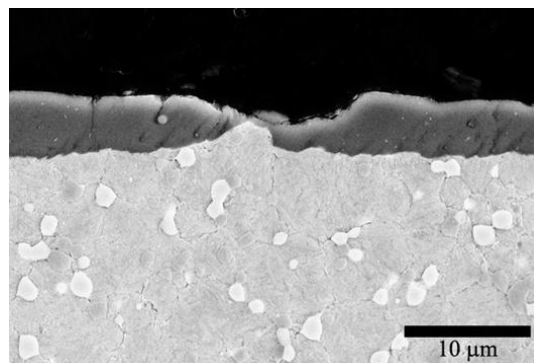
Moreover, cross-sections of worn teeth show that the coating is prone to crack at or adjacent to irregularities in the substrate/coating interface as well as at defects in the coating itself. A cohesive coating failure linked to a substrate surface irregularity on the rake face on a tooth from hob B can be seen in Fig. 15. A cross-section of a worn tooth on hob E reveals that chunks of coating material are removed from the rake face due to cracks initiated at pores in the coating/HSS interface and at coating defects, see Fig. 16.

Figure 15. Cross-section of the rake face on a cutting tooth from hob B. The coating (dark gray layer) has chipped close to a ridge in the HSS substrate (light gray) surface.

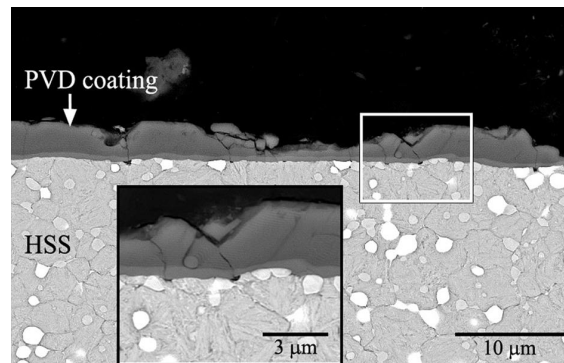
Figure 16. Cross-section of the rake face on a cutting tooth from hob E. The PVD coating is fractured and cracks can be seen originating at irregularities in the interface and in connection to droplets in the coating.
