TRAFFIC ENGINEERING
DEMONSTRATION PROJECT ON
U.S. 52 BYPASS
INVENTORY, ANALYSIS AND RECOMMENDATIONS

by
G.A. SHUNK
AND
H.L. MICHAEL

PURDUE UNIVERSITY
LAFAYETTE INDIANA

Progress Report

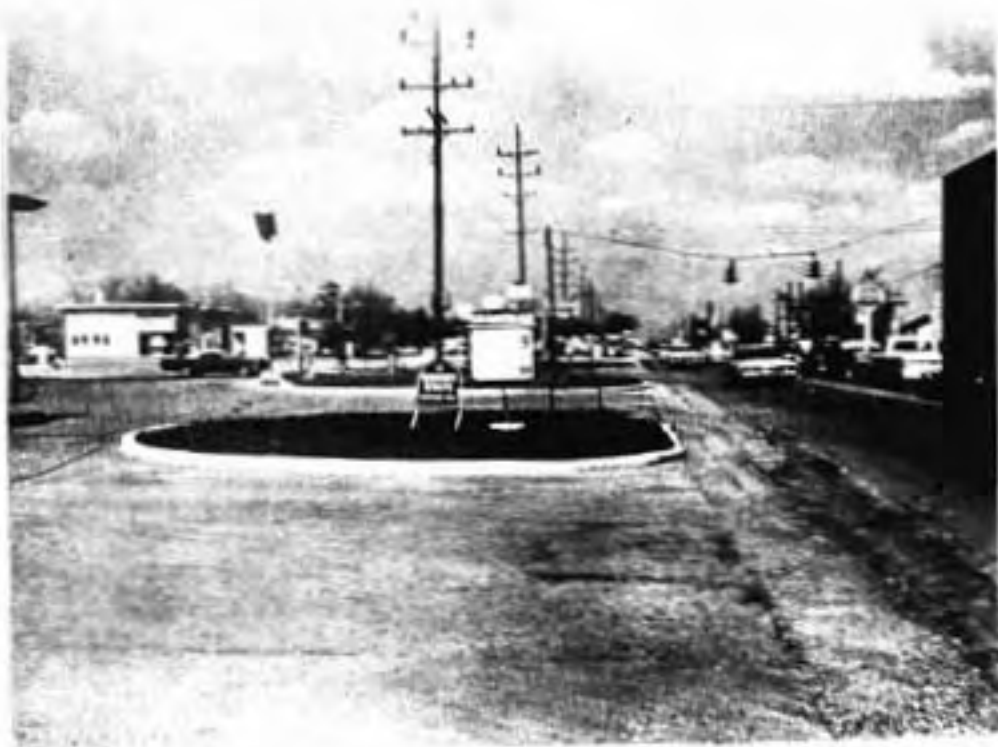
9. Remove all redundant and unnecessary informational signing within the right-of-way. These signs are subconsciously distracting to drivers and cause sight distance restrictions. Many are useless either because they are too small, too far from the roadway, or are obstructed in some manner (Figure 11).

FIGURE 11 SIGNS PLACED IN RIGHT OF WAY

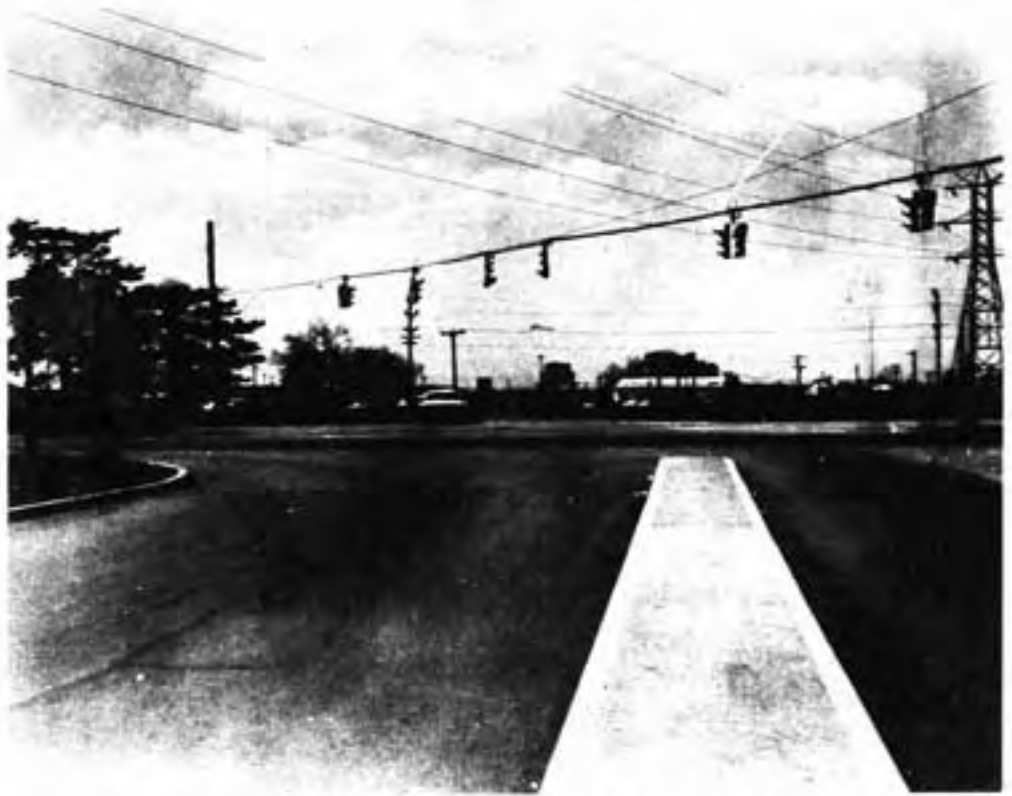
Since the east approach does not align with that from the west (Figure 14), through traffic on Teal must jog slightly. Vehicles turning from Teal must zig-zag to complete their maneuver without blocking opposing through and left-turning movements. Another anomaly of orientation concerns the location of entrances to the shopping center parking lot. The signals at the Indiana 38 intersection can be bypassed by short-cutting across the parking area between the Teal intersection and a point on the east approach

FIGURE 14 TEAL ROAD - POOR APPROACH ALIGNMENT

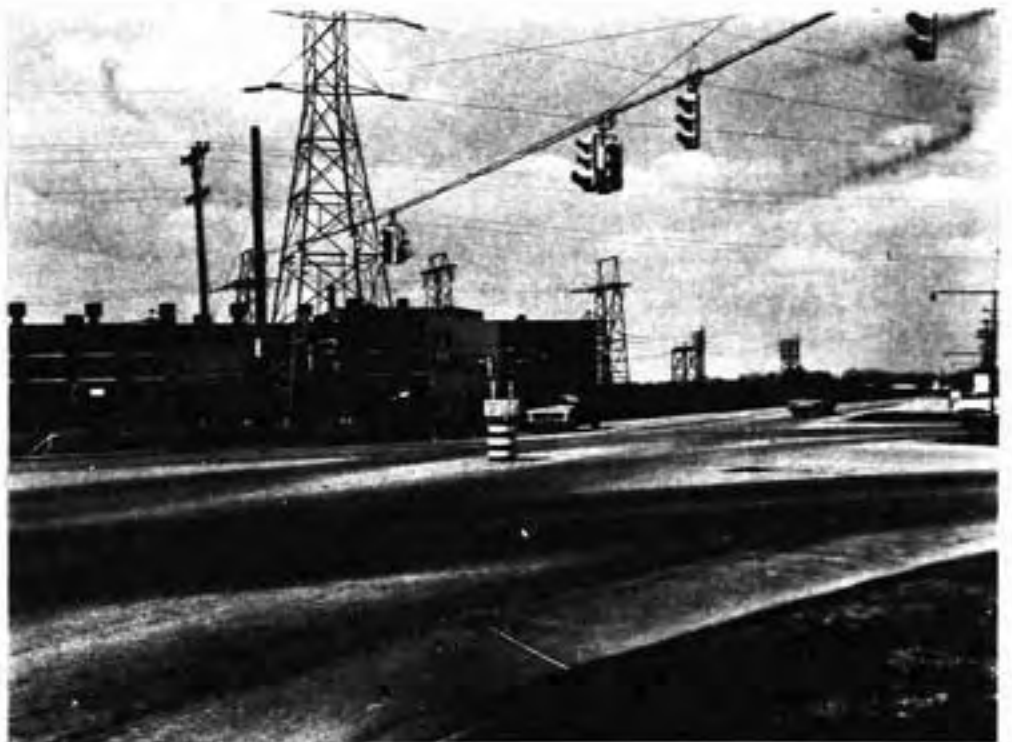
FIGURE 15 MAIN STREET - BARREL TO CONTROL LEFT TURNING VEHICLES

Heavy left-turn movements from both Bypass approaches are the problem at this location. The barrel currently employed to remedy the situation should have been only a temporary expedient (Figure 15). Accidents here

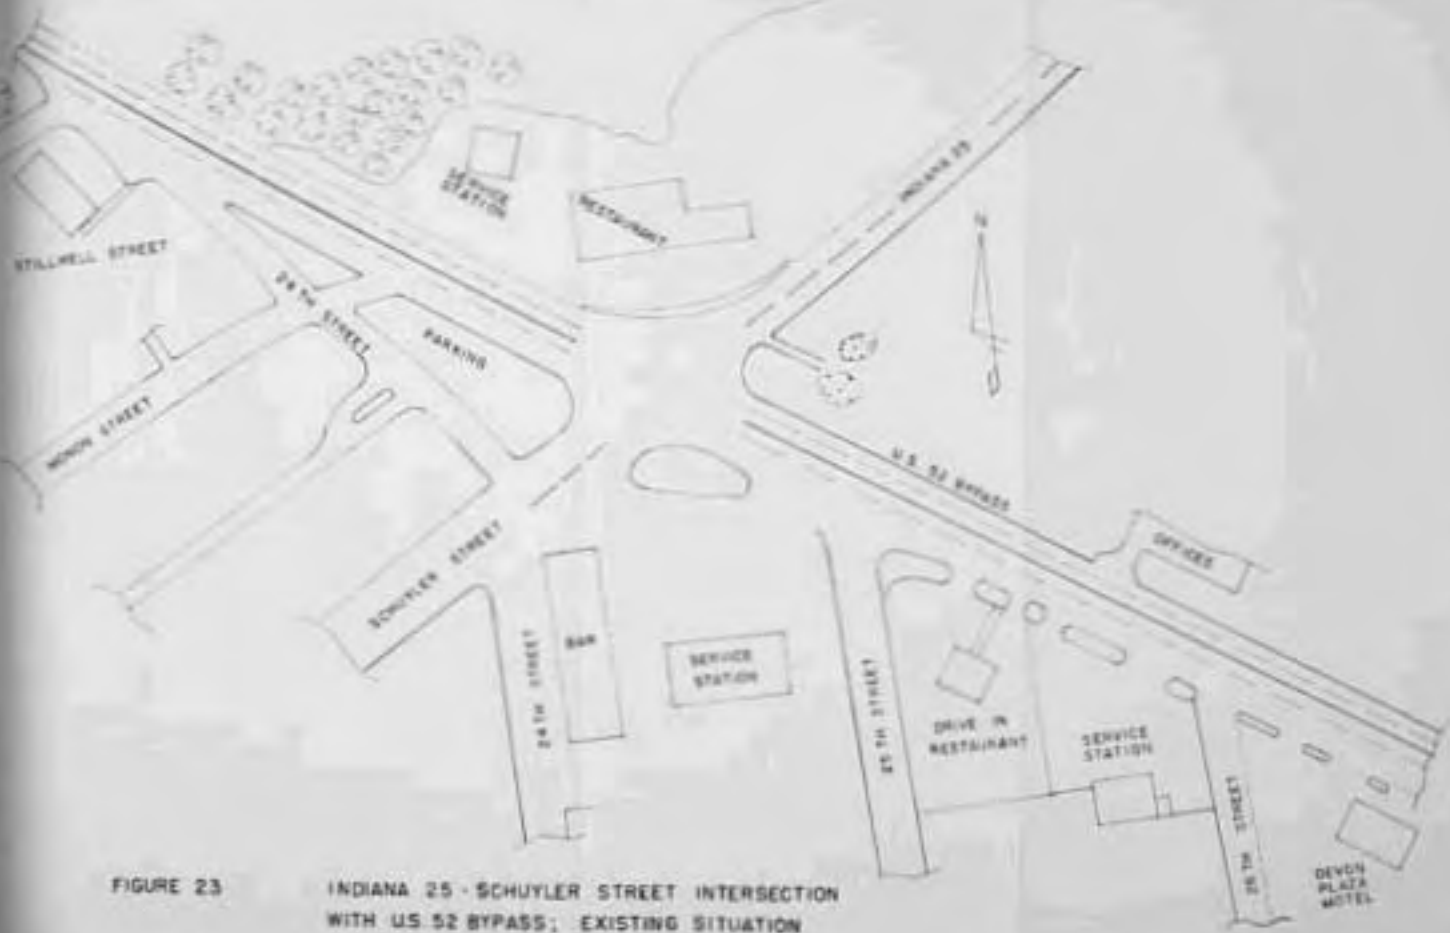
FIGURE 23 INDIANA 25 - SCHUYLER STREET INTERSECTION WITH US 52 BYPASS; EXISTING SITUATION

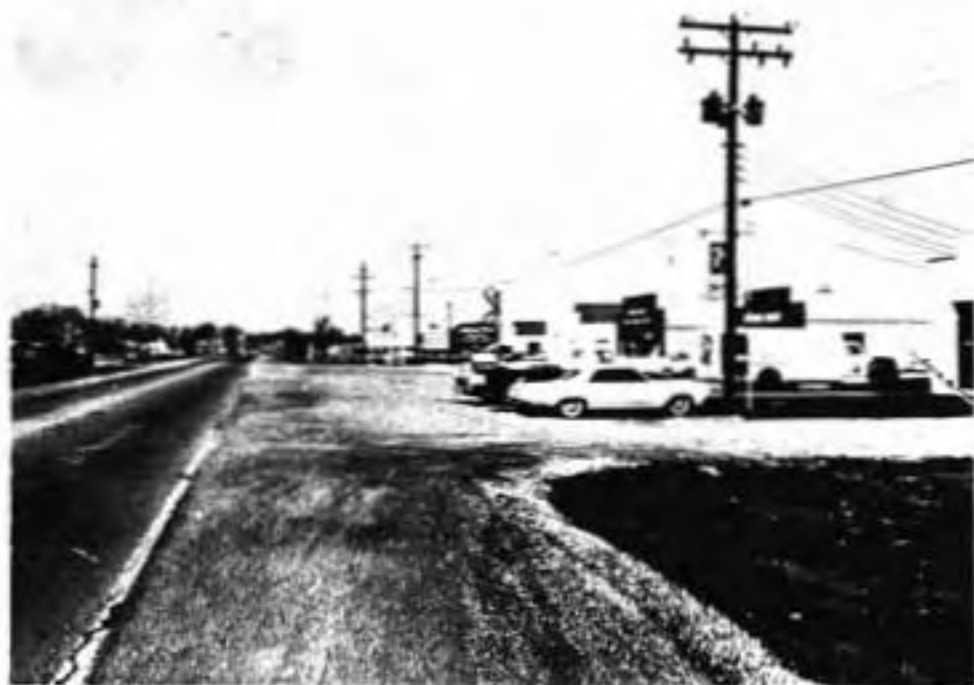
FIGURE 29 EXAMPLE OF POOR DRIVEWAY DELIMITATION

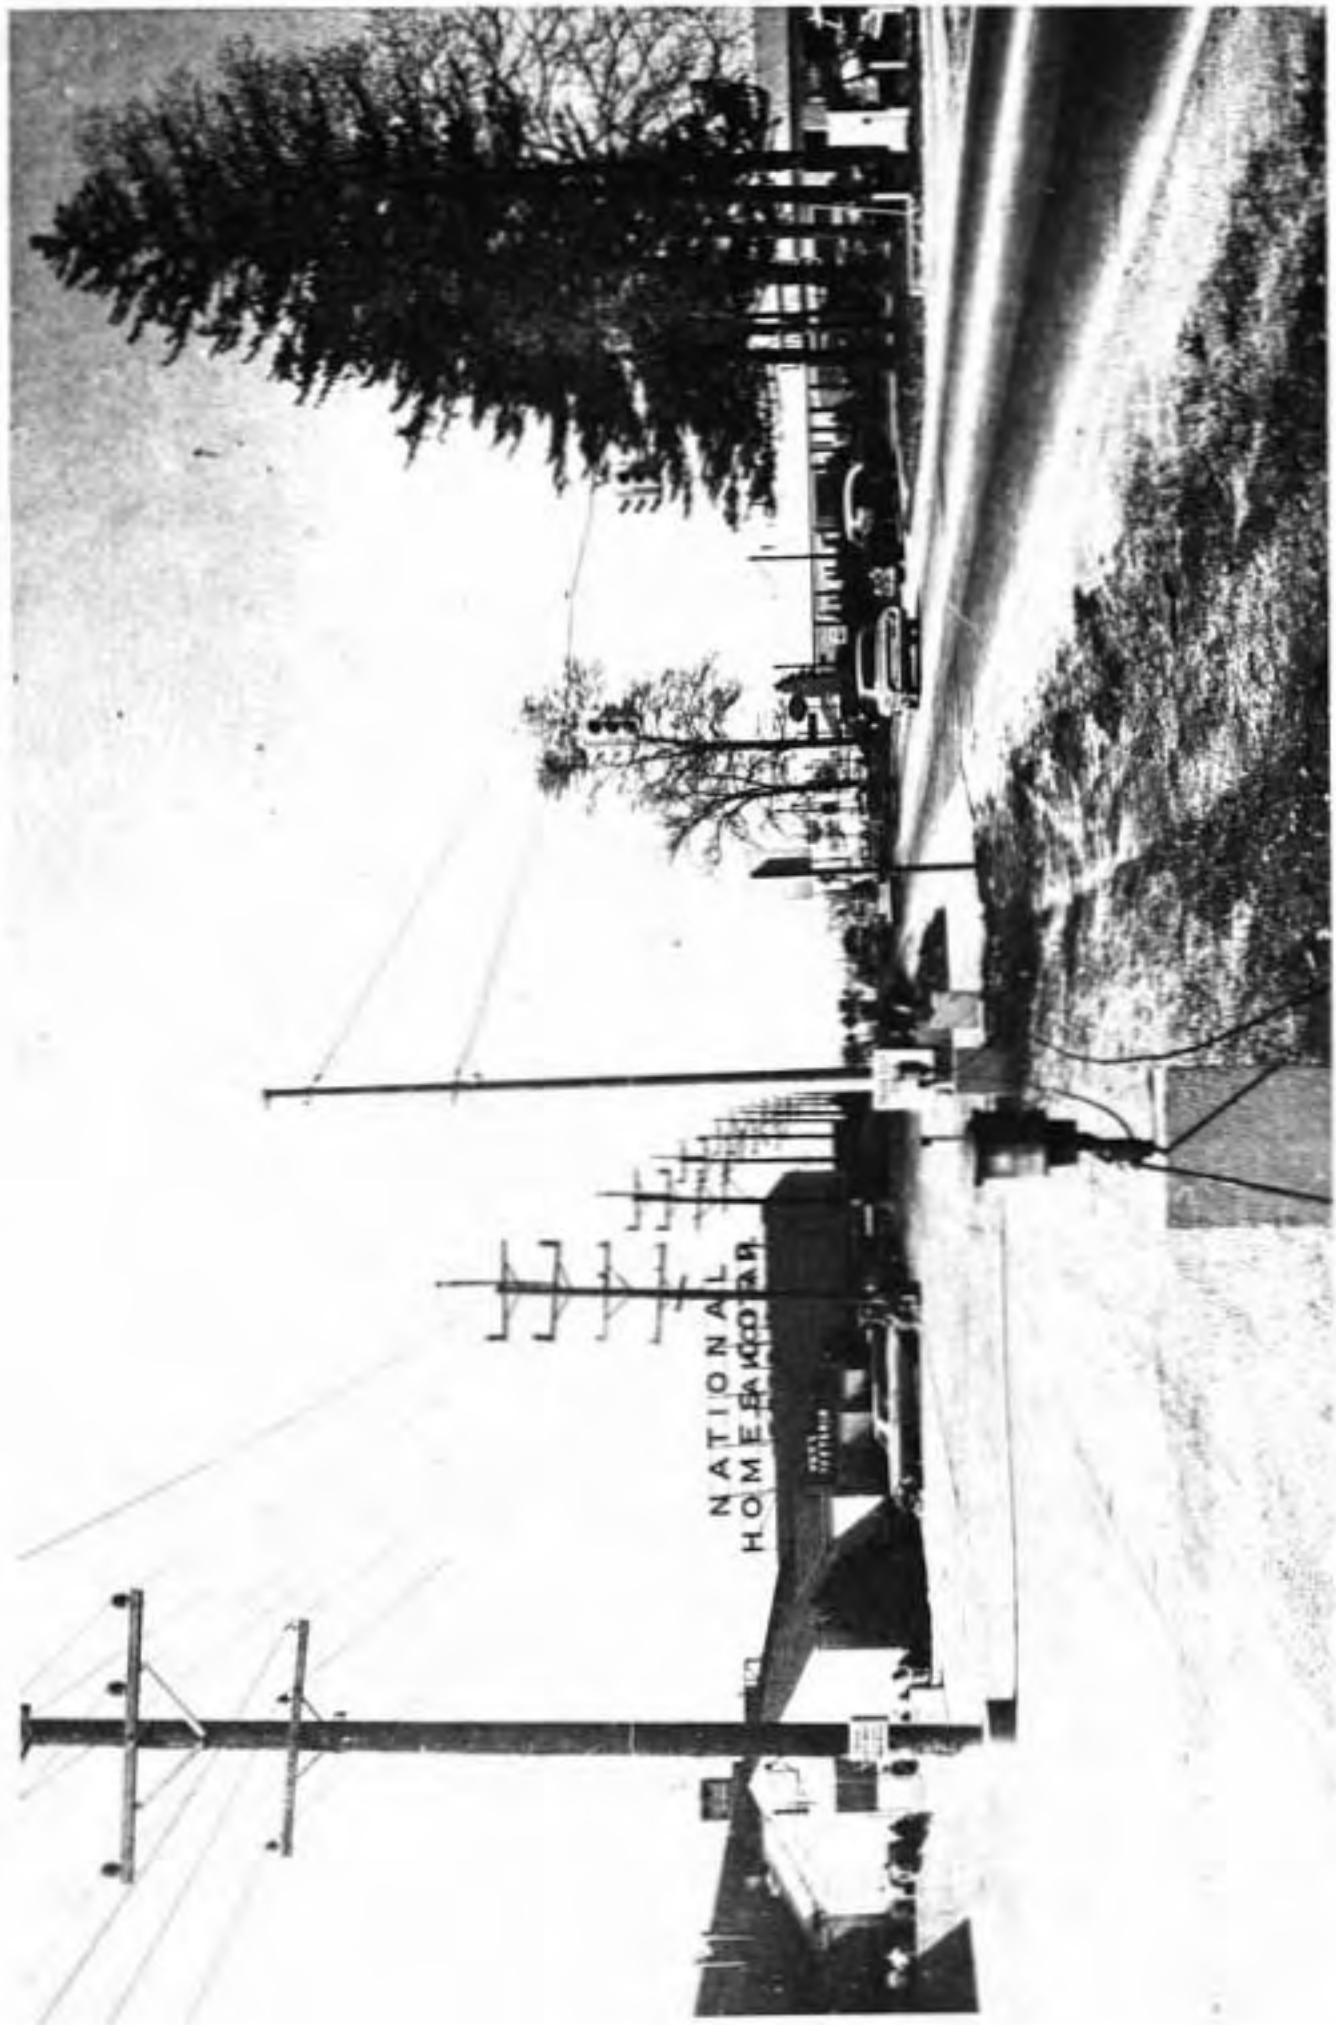
The closeness of the operations at this facility to the Bypass is extremely bad. The company is using all but a few feet of shoulder in a densely developed high volume section. The effect of this constriction on traffic operation is enormous. Lights on the posts (see Figure 31) holding cables at the edge of the roadway are very distracting at night.

FIGURE 31 EXCESSIVE ROADWAY FRINGE IMPIIEMENT AT NATIONAL HOMES
