Increased Lift for Feather Valves by Elimination of Failures Caused by Impact

INCREASED LIFT FOR FEATHER VALVES BY ELIMINATION OF
FAILURES CAUSED BY IMPACT

D. Woollatt
Process and Gas Compressor Operations
McGraw Edison Corporation

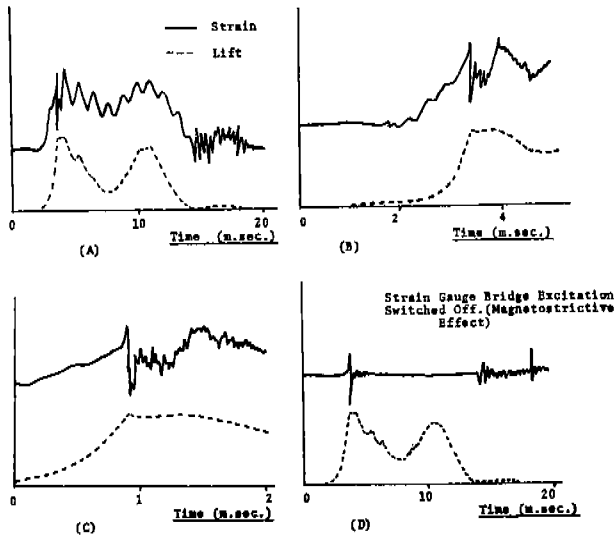
Fig. 2

It seemed probably that the actual stress in the strip would be higher than the basic stress given above due to the excitation of higher order vibrations. The effect of these was determined by strain gauge tests on operating valves. A typical strain gauge diagram is given in Fig. 2. The peak stress in the strip is 40 to 45% higher than that predicted by simple vibration or deflection under a uniform load. As shown in Fig. 2, the higher stress level is caused by a third order vibration excited in the strip during contact with the guard.

With a circular guard profile, the strip initially contacts the guard at the center and it was initially thought that the third order vibration was caused by the strip rebounding from the guard at the center while still moving towards the guard elsewhere. However, a detailed examination of stress and lift diagram (Fig. 2) suggests the following hypothesis (Figs. 3, 4).

LIFT AND STRAIN GAUGE DIAGRAMS DURING VALVE LIFT AND IMPACT

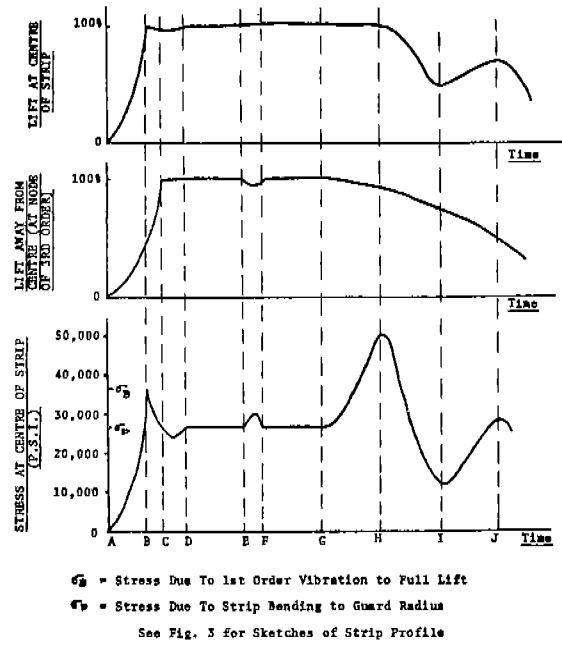
Fig. 4

this. The diagram shows only the 1st and 3rd modes as it is these that most strongly influences the stress in the strip. A small magnitude stress due to the 5th order is also discernable on the measured diagrams. The peak stress occurs at time H.

LIFT AND STRAIN DIAGRAMS TO ILLUSTRATE HYPOTHESIS ON INTERACTION OF STRIP AND GUARD

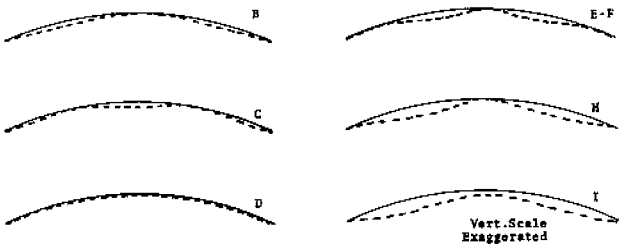
Fig. 3

DIAGRAMS TO ILLUSTRATE STRIP PROFILES FOR EVENTS SHOWN IN FIG. 4

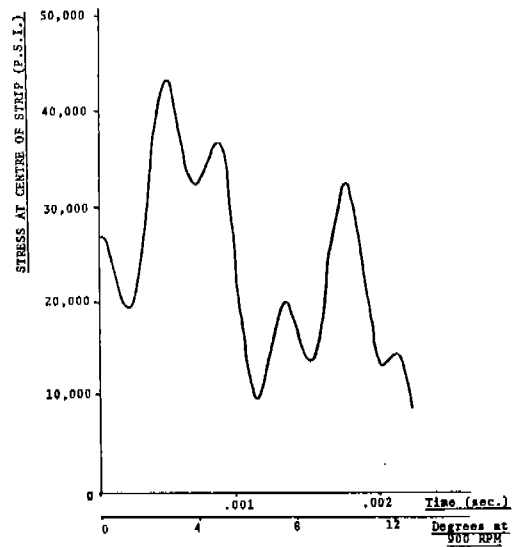
Fig. 5

A qualitative investigation of the vibration induced in the strip as it leaves the guard can be made by neglecting pressure forces and assuming that the strip is held in a circular arc and suddenly released. A Fourier analysis of the circular profile gives the amplitude of each order of vibration and the stress caused by each can then be evaluated as a function of time and summed. The results of the analysis considering just the first three odd orders is given in Fig. 5. The magnitude and form of the calculated stress diagram agree fairly well with those of the measured diagram, thus confirming that the above hypothesis is a possible explanation of the cause of the third order vibration.

CALCULATED STRESS IN STRIP FOLLOWING RELEASE FROM CIRCULAR PROFILE

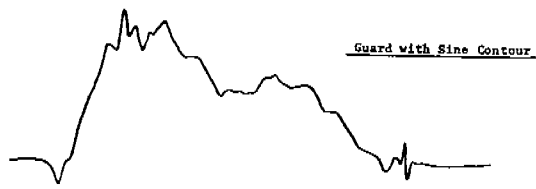
The higher order vibrations can in theory be eliminated, whichever of the above two explanations of their cause is correct by shaping the guard so that the strip reaches the guard at all points simultaneously. The "sine contour" guard is an attempt to accomplish this and as shown in Fig. 6 it substantially reduces the stress due to the third order vibration.

STRAIN GAUGE DIAGRAMS - .032" STRIP THICKNESS

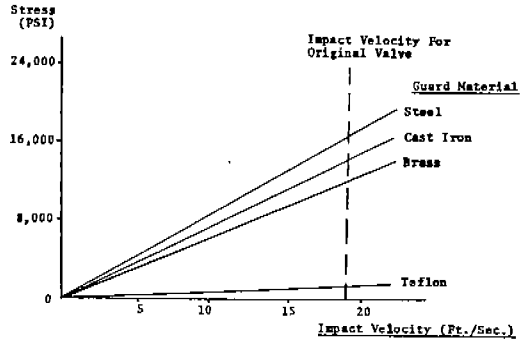
Fig. 8A

The magnitude of the compressive stress caused directly by the deceleration during impact can readily be calculated by conventional wave propagation methods. The stress wave diagram is shown in Fig. 7 and the results in Fig. 8. A more detailed analysis along the same lines has been published by Soedel (1).

It is evident that the transverse compressive stress is not sufficient to cause trouble even when combined with the longitudinal bending stress.

STRESS CAUSED IN STEEL STRIPS
BY IMPACT ON GUARDS OF DIFFERENT MATERIALS

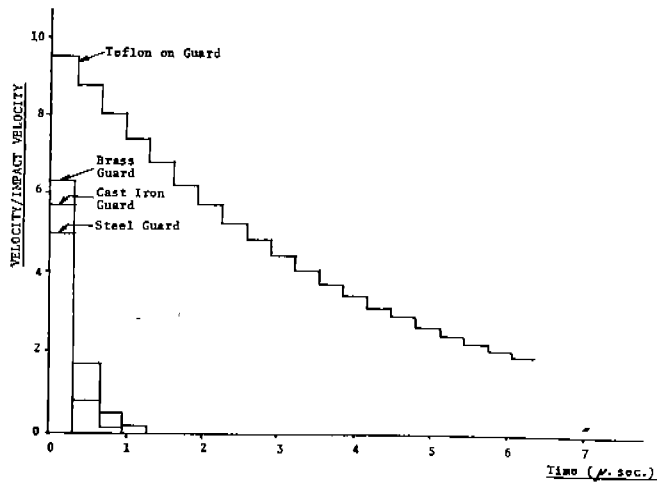
Fig. 8B

VELOCITY OF CONTACT POINT AFTER STRIP
HITS GUARD

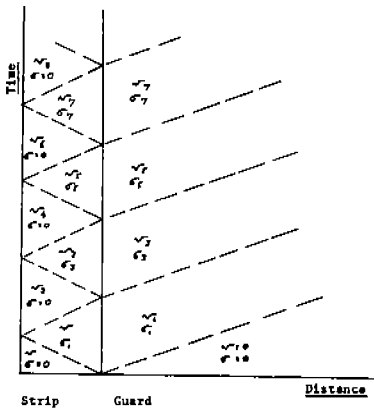
Fig. 7

WAVE DIAGRAM

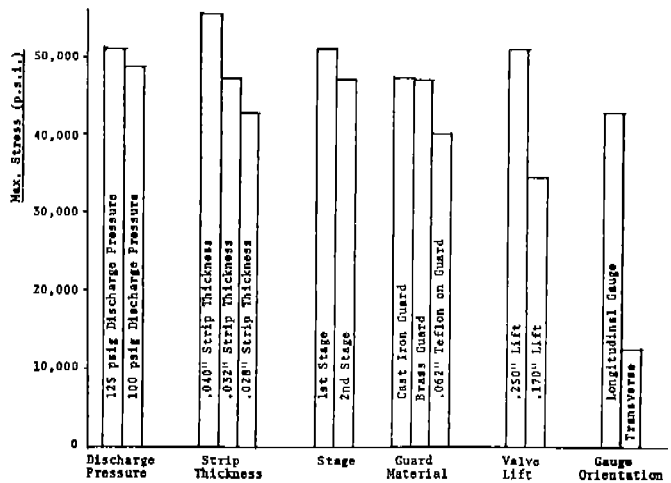
- 1) The maximum stress in the strip is about 40% higher than that calculated assuming simple bending in the first mode but is still far below the endurance limit of the strip material. See Fig. 9 for effect of valve design on peak stress.

SUMMARY OF STRAIN GAUGE TEST RESULTS
