Impact Fatigue Behaviour of Flapper Valve Steel

IMPACT FATIGUE BEHAVIOUR OF FLAPPER VALVE STEEL

Akemi Futakawa, Dr. Eng., Manager and Koji Namura, Engineer
Central Research Laboratory, Mitsubishi Electric Corporation,
Amagasaki, Hyogo, Japan

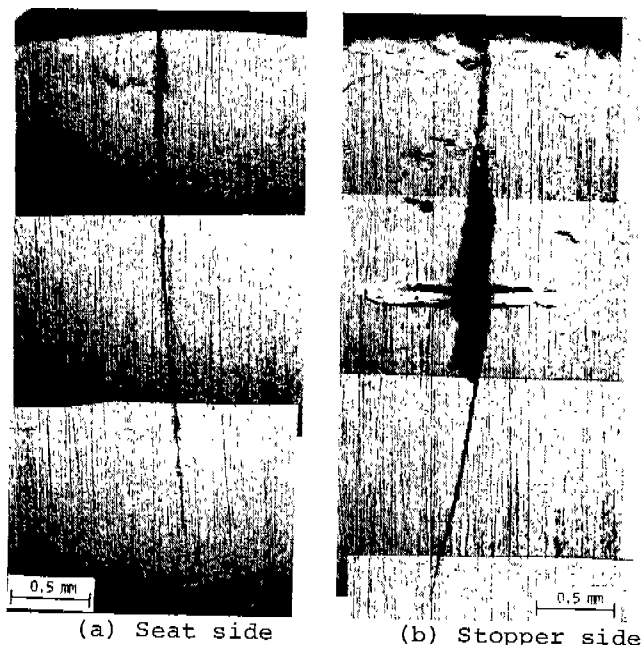
Fig. 5 Typical example of macroscopic shapes of impact fatigue crack ($V = 4.8$ m/s, $N = 5.2 \times 10^5$)

Comparing Fig. 5 with Fig. 6, appreciable difference is found in the nature of fracture initiation. When the test specimen is operated at an impact velocity of 4.8 m/s, the origin of failure is at the center of semicircular edge and then the crack propagates to the radial direction of the semicircular, followed by chipping-off failures. On the contrary, when the test specimen is operated at an impact velocity of 7.5 m/s, a lot of origins of impact failure are found along the circumference of the semicircular edge. Some of

Impact Fatigue Crack Origin: In order to clarifying the nature of fracture initiation and to get the hypothesis of impact fatigue crack initiation prior to failure, the origin of failure was examined by comparing Fig. 5(a) with Fig. 5(b) and Fig. 6(a) with Fig. 6(b). Particularly noticeable in Figs. 5(a) and (b) is comparatively long crack expanding to the longitudinal direction, accompanying with large chipping-off failures on the surface of the stopper side. From this result, the origin of the primary crack is at the center of the circumferential edge and directional characteristics in the crack growth is attributed to the strip rolling processing, when the test specimen is operated at low impact velocity. On the contrary, when the test specimen is operated at higher impact velocity, a large number of cracks are found around the circumferential edge on the seat and stopper sides as shown in Figs. 6(a) and (b). This observation leads to the hypothesis of impact fatigue crack initiation that the failure origin is at the multi-points of the circumferential edge, when the test specimen is operated at higher impact velocity.

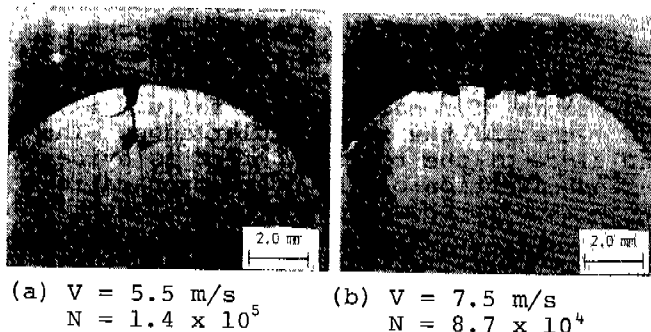
Impact Fatigue Damages: Figs. 4(a) and (b) show typical examples of impact fatigue damages produced in this test. Fig. 4(a) was obtained at 1.4×10^5 cycles under an impact velocity of 5.5 m/s. Fig. 4(b) was obtained at 8.7×10^4 cycles under an impact velocity of 7.5 m/s.

As can be seen in Figs. 4(a) and (b), impact fatigue damages are divided into two types of features in accordance with the impact velocity. The first one is the impact damage caused under the impact velocity below 6.0 to 7.0 m/s. Within this region of impact velocity, the failure origin and chipping-off failure seem to concentrate around the center portion of the semicircular edge of the test specimen. The initial propagation of the main crack seems to be always in the radial direction of the semicircular. The second one is that caused under the impact

velocity beyond 7.0 m/s. In this region, the failure origin and chipping-off fractures are scattered along the circumference of the semicircular edge of the test specimen and the propagation of the main crack orients to the longitudinal direction of the test specimen, coinciding with the rolling direction.

Fig. 4 Typical example of impact fatigue damages on stopper side surface

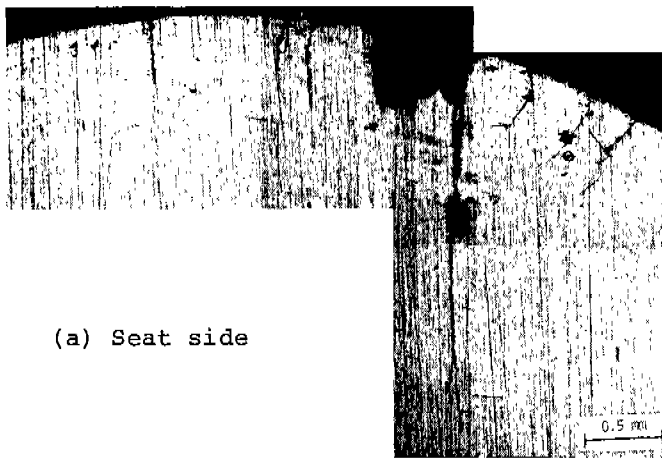
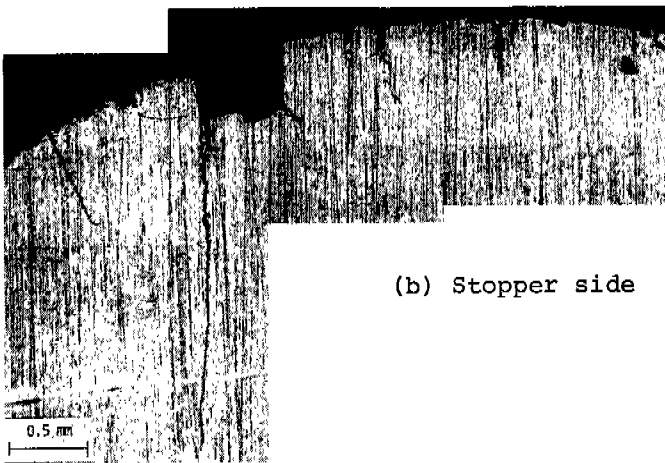
Fig. 6 Typical example of macroscopic shape of impact fatigue crack
($V = 7.5 \text{ m/s}$, $N = 5.1 \times 10^5$)

these cracks propagate to the longitudinal direction of the test specimen, coinciding with the rolling direction, and some of them orient to the radial direction of the semicircular.

On the crack growth history at an impact velocity beyond 7.0 m/s, the multi-crack origins along the circumferential edge are found as distinct type of the impact fatigue failure as shown in Fig. 6. Determining minutely the shape of the fracture crack leading edge from Fig. 6, the front shape of a few cracks is slightly curving to the tangential direction. These observations lead to the hypothesis that the lost of comparatively large

fragments from the circumferential edge as can be seen in Fig. 6 is caused by the linkage of individual cracks in the radial, or longitudinal direction, with the cracks in the tangential direction.

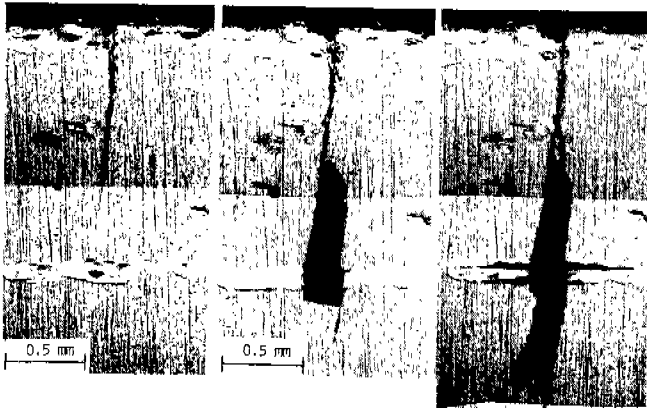
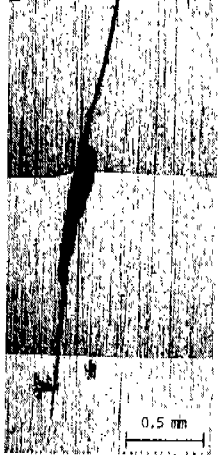
Let's attack the crack growth history of the test specimen at an impact velocity below 6.0 to 7.0 m/s. Figs. 7(a) to (c) show the crack features at 2.9×10^5 , 4.5×10^5 , and 5.8×10^5 cycles, respectively. On the fatigue side of the crack fronts, several distinct types of crack features are found. As described above, the origin of impact fatigue failure is at the center of the semicircular edge. The influence of the rolling defect is evident on the direction of the crack propagation. The fatigue process forms long straight line with a length of about 1.5 mm on the surface approximately parallel with the rolling defect. At 4.5×10^5 cycles in Fig. 7(b), comparatively large chipping-off failure appears at the crack front site on the surface. This photograph gives the impression of spreading into two

Fig. 7 Crack features on stopper side at low impact velocity ($V = 4.8$ m/s)

branches toward the crack front from a distance of about 1.0 mm apart the circumferential edge, leading to the linkage of two branched cracks. Fig. 8 shows the cross sectional view of the chipping-off failure zone. The cross section with vee shape means that a small fragment has torn off from the surface on the stopper side. The almost same crack growth history is observed at 5.8×10^5 cycles in Fig. 7(c). These observations lead to the conclusion that within an impact velocity of 6.0 to 7.0 m/s, a single crack is generated at the center of the circumferential edge and then the main crack which propagates to the radial direction spreads into branches, followed by chipping-off failures due to the linkage of these branched cracks.

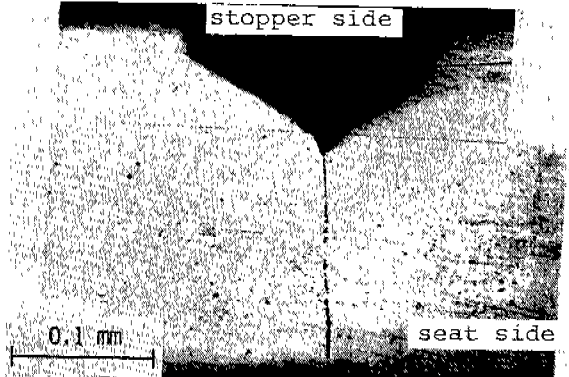
Fig. 8 Cross sectional view of chipping-off failure zone

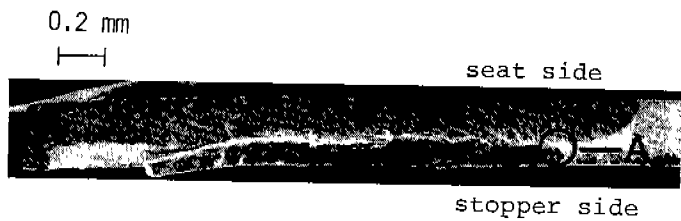
In order to establish the identification and analysis of impact fatigue failures whose macroscopic failures are ambiguous, the failure origin was more precisely examined on the failure surface at higher magnification. This was done for the partially cracked specimens obtained from the tests at an impact velocity of 5.5 m/s. Fig. 9 shows an allover view of the impact fatigue failure surface. A half-moon-shaped line is clearly observed on the fracture surface at the crack front on the seat side. This gives substance to evidence that the crack origin is at the corner of the circumferential edge on the seat side and propagates to the stopper side direction in addition to the radial direction.

Fig. 9 Allover view of impact fatigue failure surface

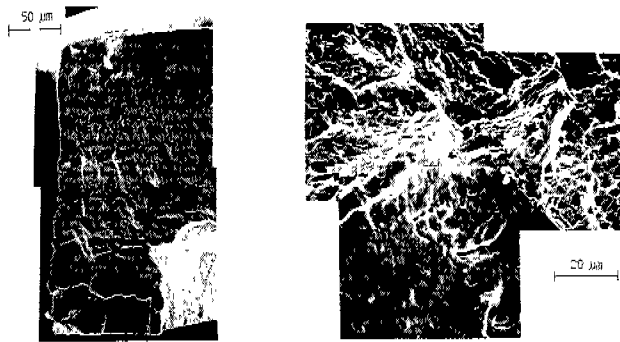
Fig. 10 shows the magnified fracture surface at the circumferential edge. Although very severe rub marks are found on the fracture surface, the ridge pattern seems to spread from the corner on the seat side to the stopper side. This result suggests that the crack origin is at the corner of the circumferential edge on the seat side and that the crack propagates to both radial and stopper side directions.

Fig. 10 Magnified fracture surface at circumferential edge

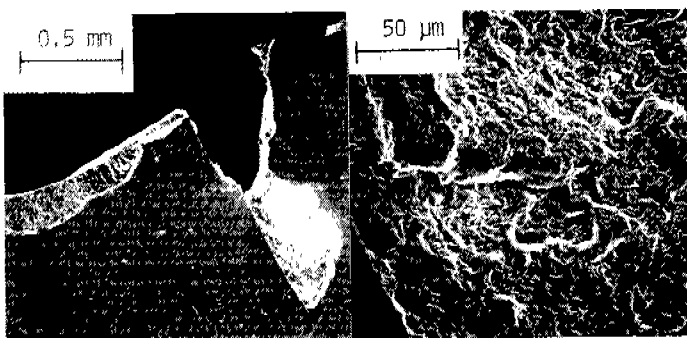
Fig. 12(a) shows a crack in the circumferential direction stretching from the radial crack and Fig. 12(b) shows the magnified aspect at the chipping-off failure portion. This fracture surface is a typical fatigue surface containing a lot of rub marks. From this result, it is clear that the crack in this area is also

Fig. 12 Crack in circumferential direction stretching from radial crack

gradually expanded by applying to cyclic stresses.

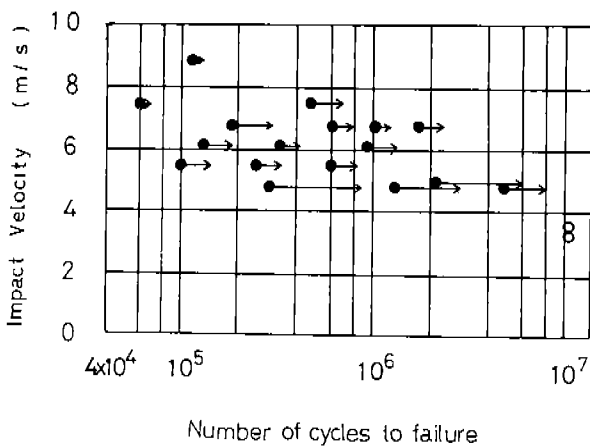
Fig. 14 shows the relationship between the impact velocity and number of cycles to failure. The black marks shown in Fig. 14 denote the moment where a small crack was initiated and the arrows denote the duration from the crack initiation to the lost of fragments from the edge or surface.

Fig. 14 Relationship between impact velocity and number of cycles to failure

As can be seen in Fig. 14, the impact fatigue mode is divided into three regions with respect to the impact velocity. In the first region above 6.0 to 7.0 m/s, the chipping-off failure, or the lost of fragments from the edge or surface, is produced at a short period after cracks are initiated. This phenomenon is caused by the linkage of the multi-cracks induced along the circumferential edge. In the

secondary region between 6.0 to 7.0 m/s and 4.0 to 4.5 m/s, crack propagates to the radial direction for a little while after the crack is initiated and then the chipping-off failure is induced. This phenomenon is caused by the linkage of cracks spreading into branches from the main cracks on the way to propagation in the radial direction. In the tertiary region below 4.0 m/s, no impact fatigue failure is induced into the test specimen.

From those results, an allowable impact velocity of about 4.0 m/s is recommended in the design of the tested suction valve. In this study, the test specimens of which edges were not ground and polished were used to induce the impact fatigue easily. Higher allowable impact velocity, therefore, seems to be acceptable. However, the value obtained from this study is considered to be an allowable impact velocity in safety design. In order to establish the general concept on the allowable impact velocity, further investigations are needed to conduct with respect to the various surface and edge finishment and the dimensions and shape of the suction valve.
