FHWA/IN/JTRP-2005/30

Vendor Comparison of Video Detection Systems

Joint Transportation Research Program
Project Number: C-36-17QQQ
File Number: 8-4-69
SPR-2869

Purdue University
West Lafayette, IN 47907
May 2006

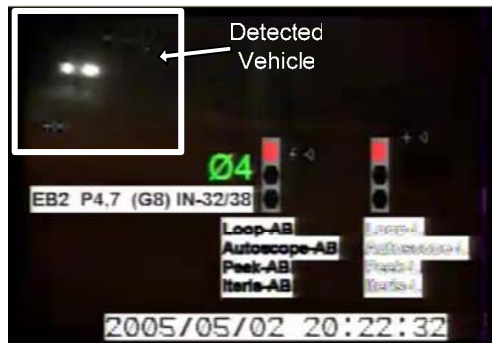
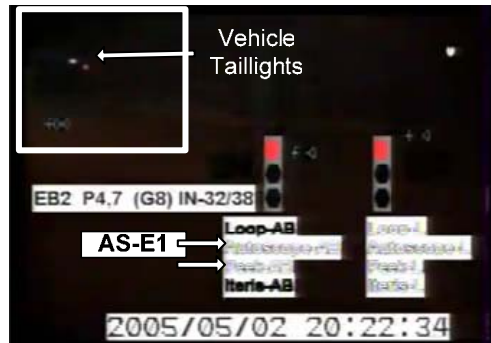
a) AS-E1: Vehicle in right turn lane is correctly detected.

b) AS-E1: Vehicle in right turn lane is dropped when headlights are no longer visible.

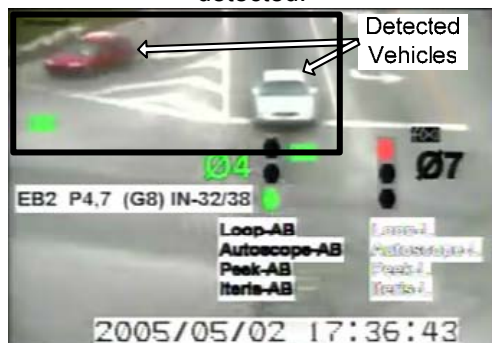
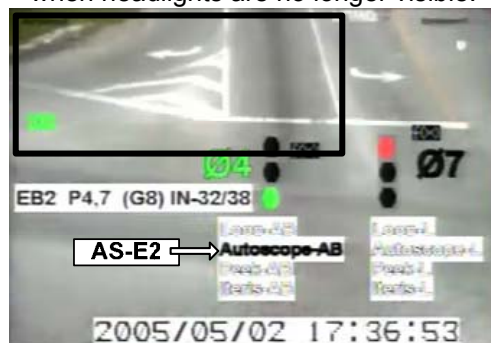
c) AS-E2: Vehicles are correctly detected in through-right lanes.

d) AS-E2: Vehicles depart through-right lanes but video detector maintains a call.

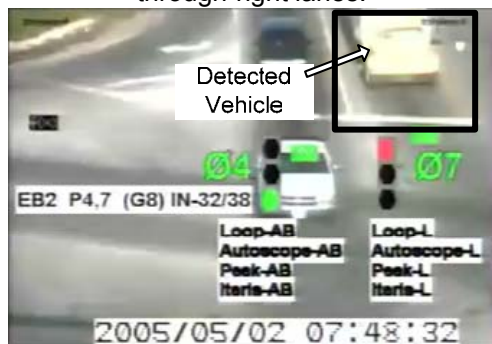
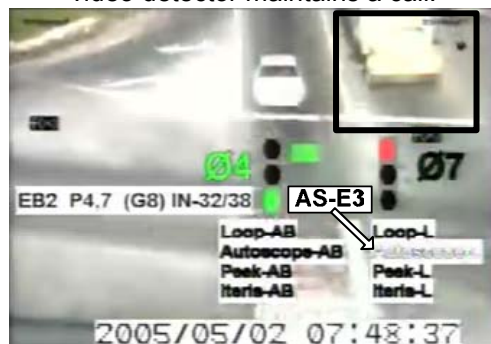
d) AS-E3: Vehicle in left-turn lane is correctly detected.

e) AS-E3: Vehicle call in left-turn lane is dropped by video detector.

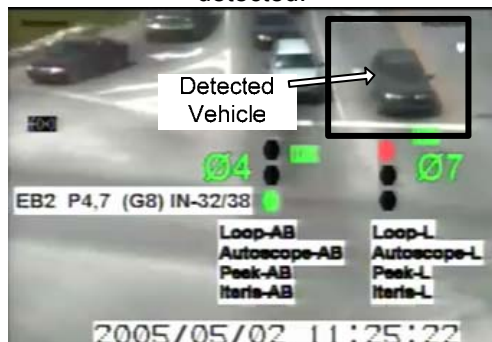
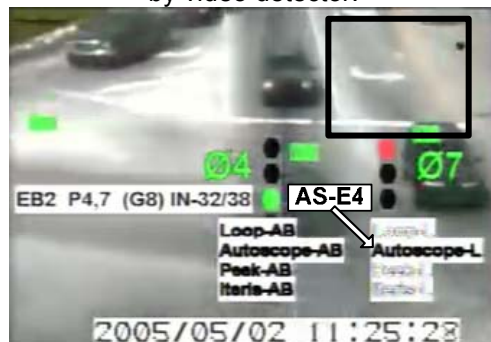
f) AS-E4: Vehicle in left-turn lane is correctly detected.

g) AS-E4: As vehicle creeps beyond stop-bar call is maintained.

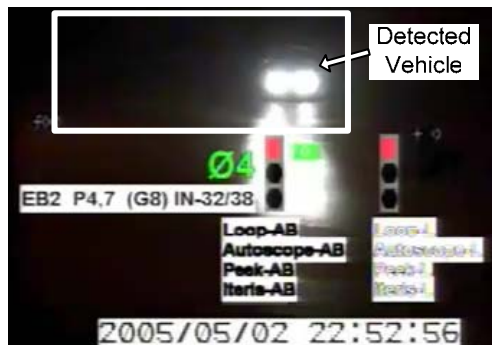
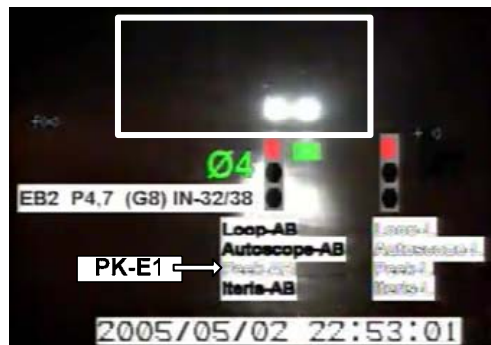
a) PK-E1: Vehicle in through lane is correctly detected.

b) PK-E1: Vehicle in detection zone is dropped because headlights are past stop bar.

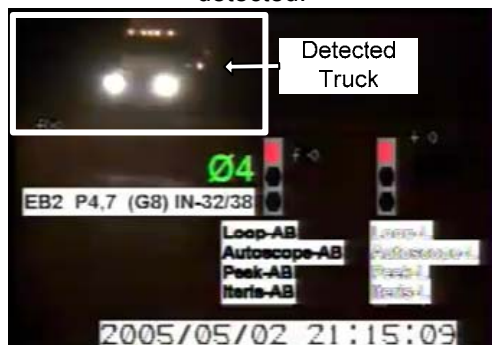
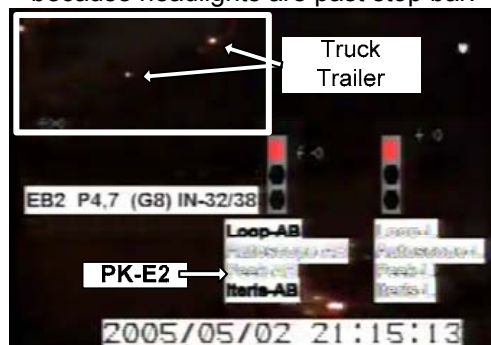
c) PK-E2: Truck is correctly detected in right-turn lane.

d) PK-E2: Truck is still in right turn lane but is not detected because headlights are not visible.

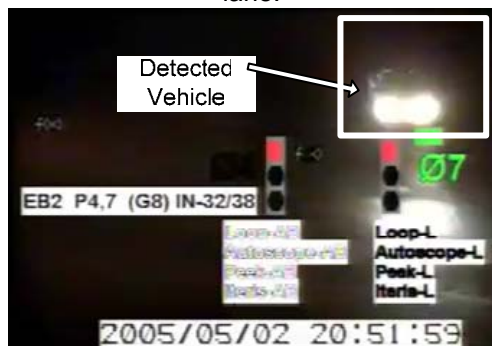
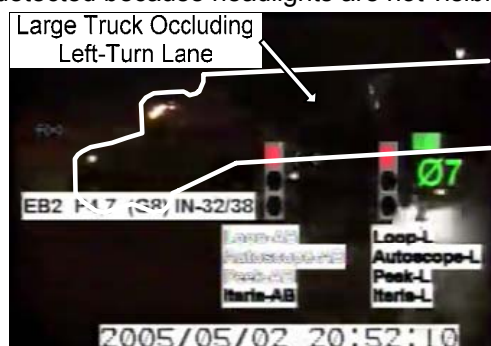
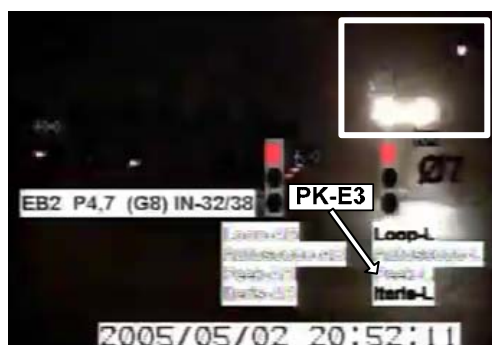
e) PK-E3: Vehicle in left-turn lane is correctly detected.

f) PK-E3: Truck traveling on cross street temporarily obscures left-turn lane.

g) PK-E3: Call by vehicle in left-turn lane is dropped.

video detection to drop the vehicle call. The other two missed calls were caused by a “Truck Wipe” as described under the Autoscope system. In fact, one of the errors occurred at exactly the same time as the error on the Autoscope system. During the September test, the Peek system missed 20 calls. Four of the twenty missed calls were due to a vehicle stopping with its headlights in front of the stop bar at night. The remaining 16 errors were not attributable to any obvious cause on the video. Thirteen of the sixteen errors were complete misses. The remaining three errors were dropped calls after detection.

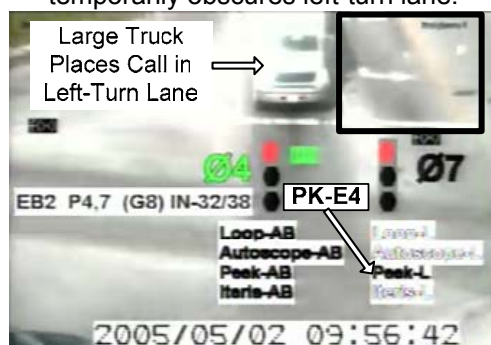
h) PK-E4: False call in left-turn lane, potentially because of large truck in through lane.

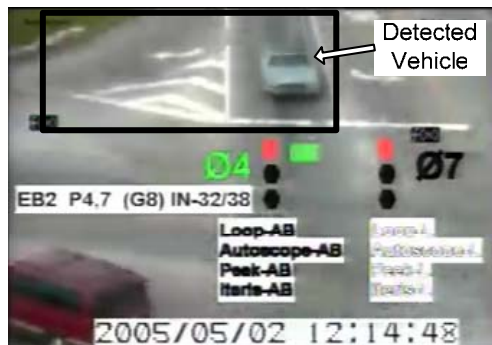
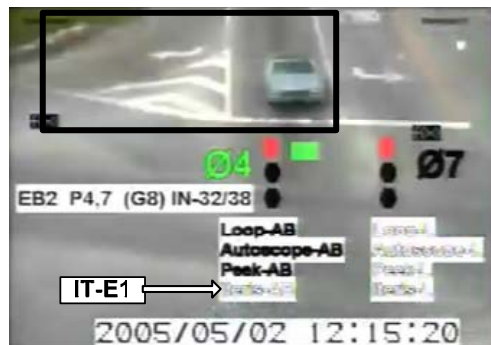
a) IT-E1: Vehicle in through lane is correctly detected.

b) IT-E1: Vehicle call in through lane is dropped. No obvious reason for drop is observed.

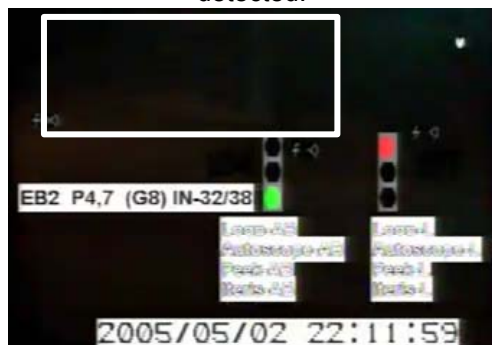
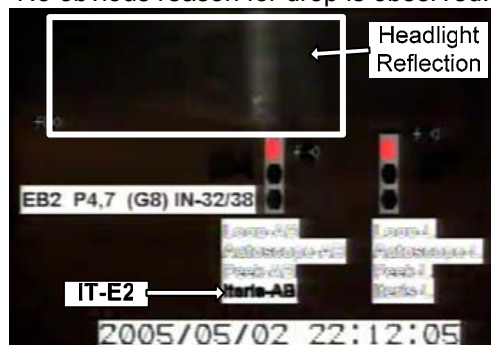
c) IT-E2: There is no calls in the through right lane.

d) IT-E2: Headlight reflection on the pavement causes Iteris to activate early.

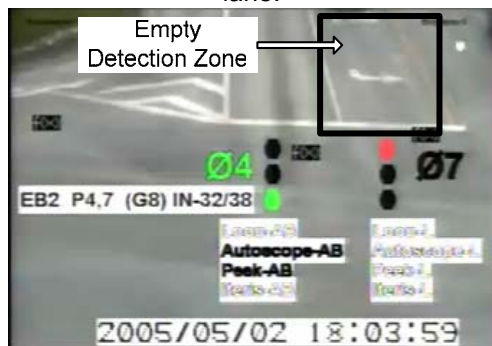
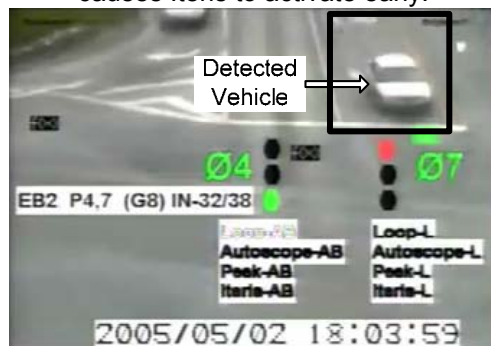
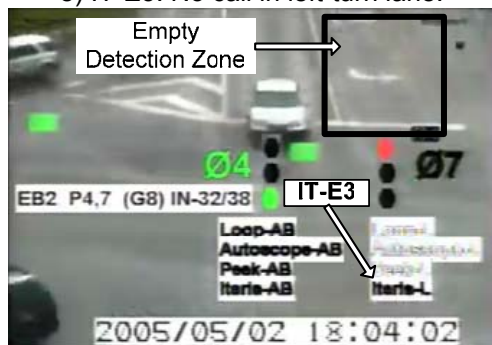
e) IT-E3: No call in left-turn lane.

f) IT-E3: Vehicle places call in left-turn lane.

g) IT-E3: Video detection incorrectly maintains call in left-turn lane.

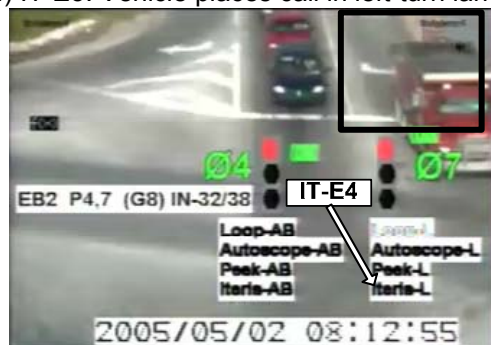
h) IT-E4: Large vehicle in Left-turn lane is beyond stop bar but still in video detection zones due to its' height.
