**EROSION MITIGATION AT FORT HASE BEACH
AND AT PYRAMID ROCK RECREATIONAL AREAS**

**U.S. MARINE CORPS BASE HAWAII, KANEOHE BAY
KANEOHE, OAHU, HAWAII**

FINAL REPORT
May 31, 2000

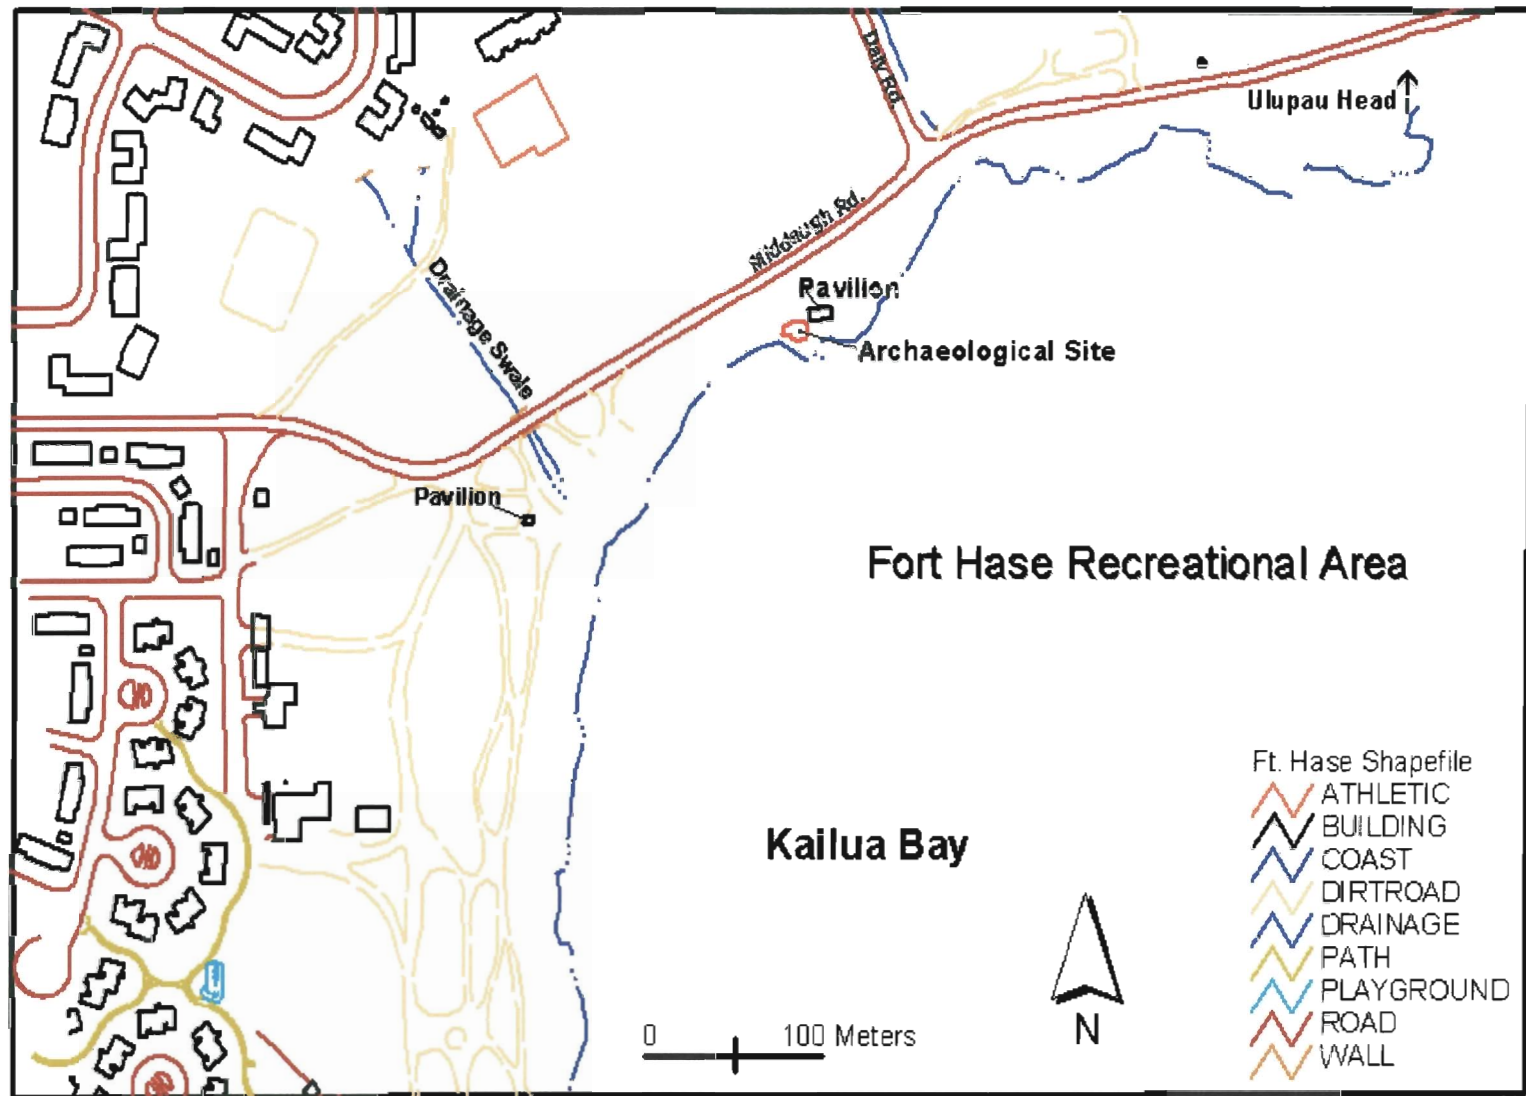
Figure 8. Fort Hase Beach Recreational Area. Note drainage swale and proximity of archaeological site to picnic pavilion.

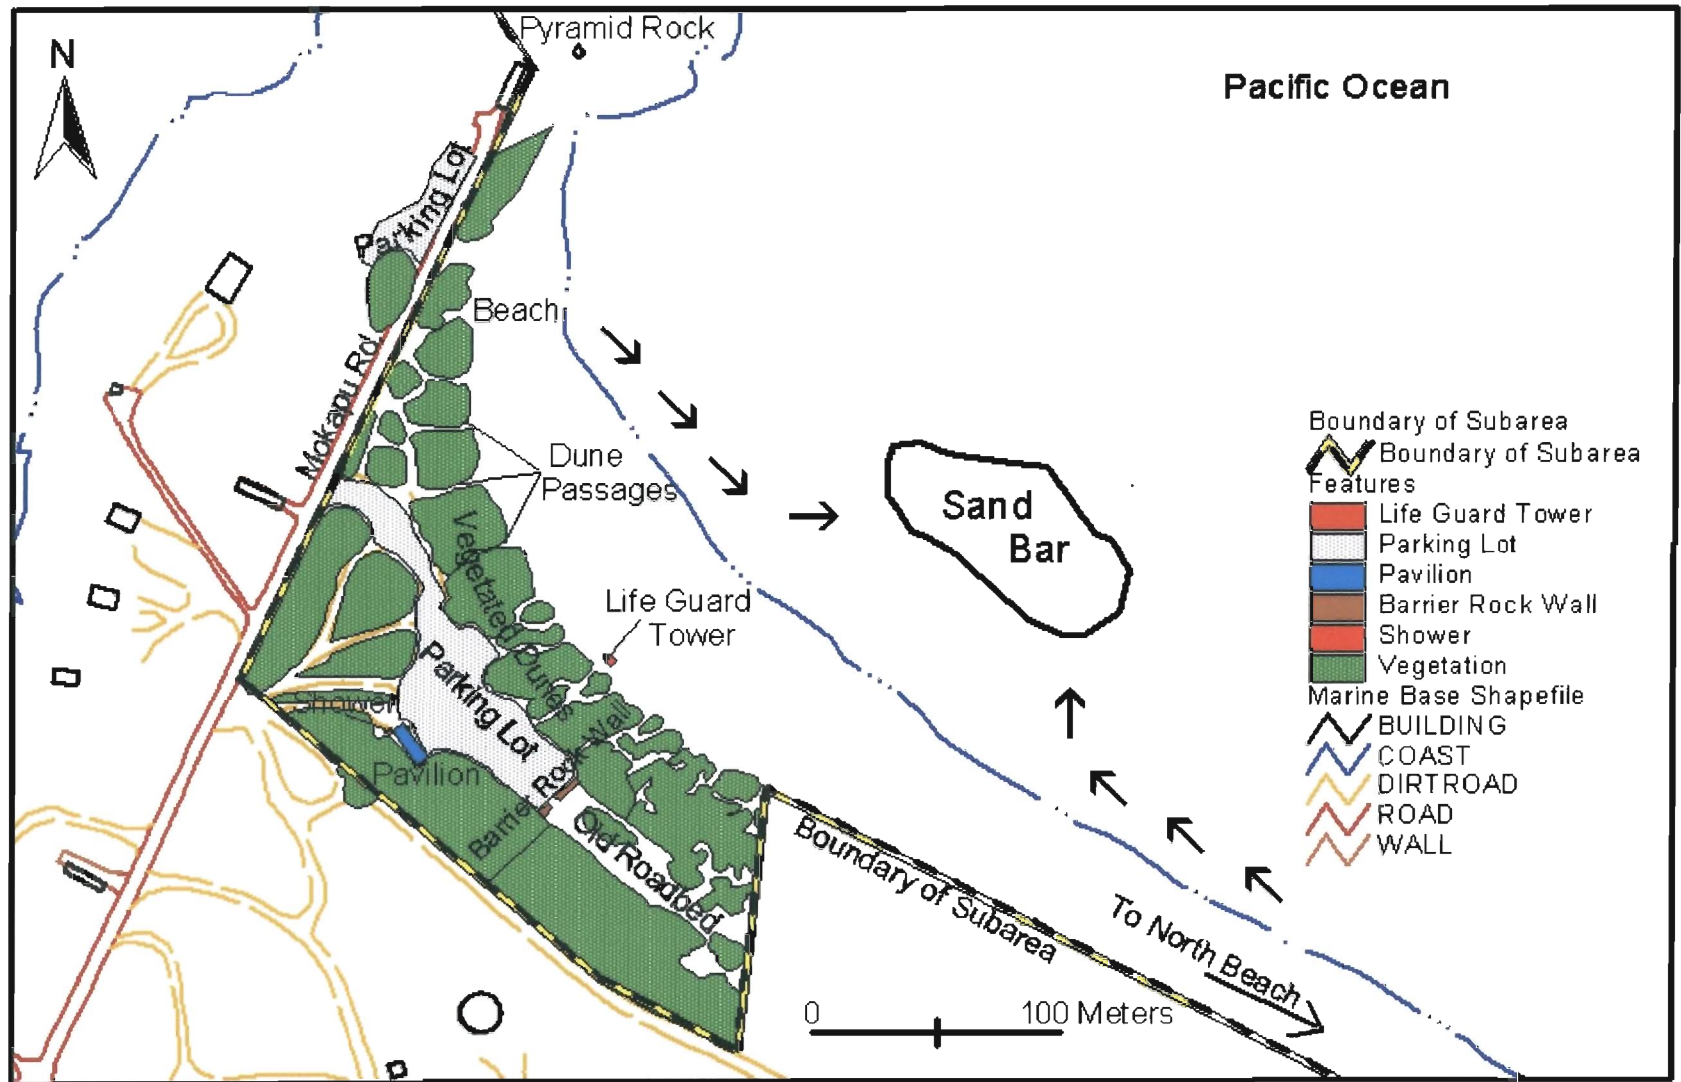
Wave and aerial photograph analysis was supplemented with interviews with lifeguards working at Pyramid Rock Beach. There is a pattern of seasonal beach loss and gain that is a function of the seasonal wave conditions. Pyramid Rock Beach is at its widest in early fall, before the winter swell begins to arrive. The winter surf generates longshore currents from the outer reaches of the beach, transporting sediment laterally toward the center of the beach. These currents converge opposite the present location of the lifeguard stand and create a cross-shore current away from the beach (Figure 15). The sediment is moved offshore and deposited in the form of a sand bar in the nearshore waters. This pattern was observed during a site visit on November 30, 1999, and confirmed by lifeguard observations.

The movement of the sand from the beach to the sand bar results in a retreat of the shoreline. Each winter the waterline is observed to move as far landward as the lifeguard stand and during high wave events the uprush of water can extend into the beach vegetation (naupaka). One such event occurred in November of 1996, when large surf generated by a storm east of Hawaii caused the waterline to move as much as 100 feet landward. The beach widened to its previous condition over the following summer.

Figure 15. Pyramid Rock Recreational Subarea. Figure illustrates direction of coastal sediment transport under winter wave conditions. Note location of seasonal sand bar.

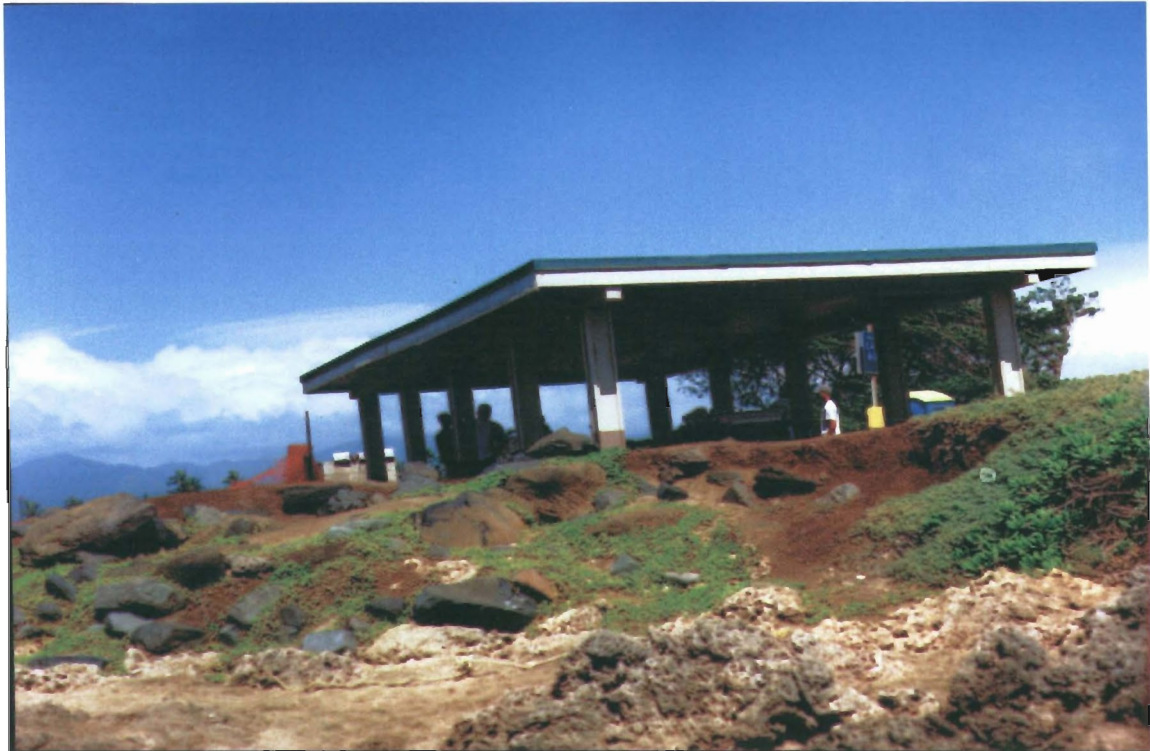
Photo 1. Picnic Pavillion at Fort Hase Beach Recreational Area. Note archaeological excavation in eroded dune bank in center of photo. Exposed volcanics and coral rubble are shown in foreground.

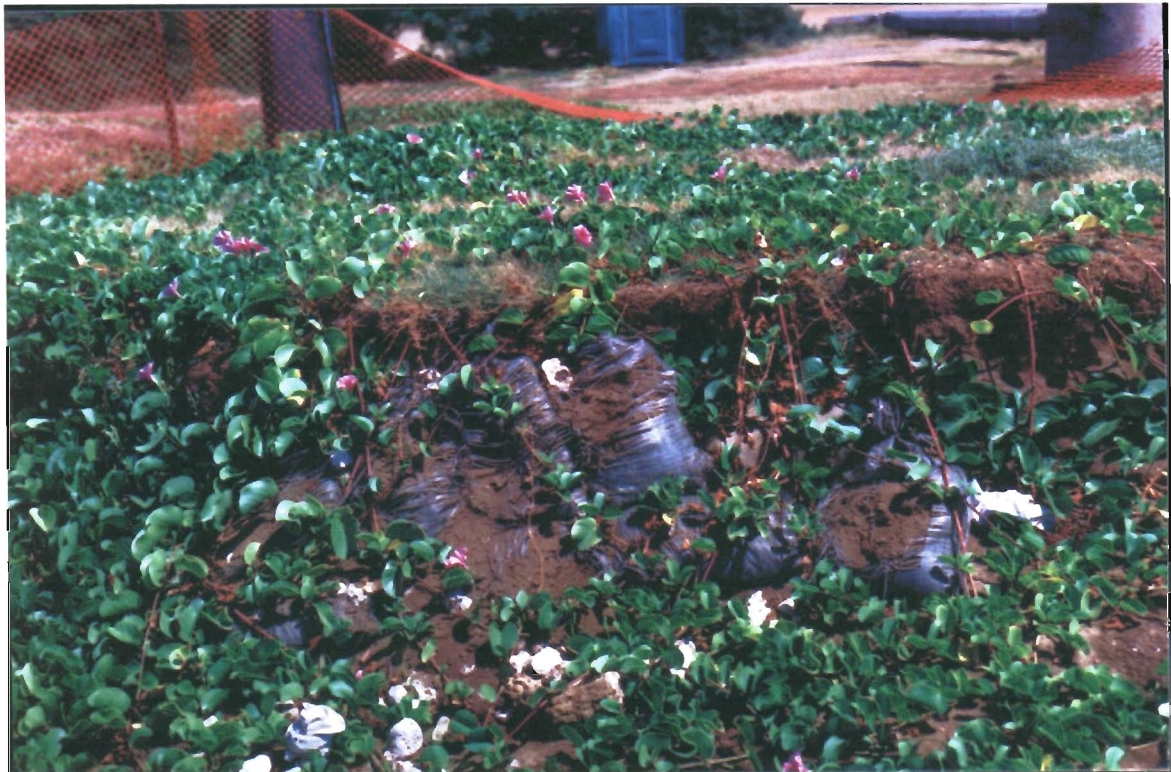
Photo 5. Fort Hase Beach Recreational Subarea. Dune erosional escarpment near picnic pavilion showing proliferation of beach morning glory *Ipomoea pes-caprae*.

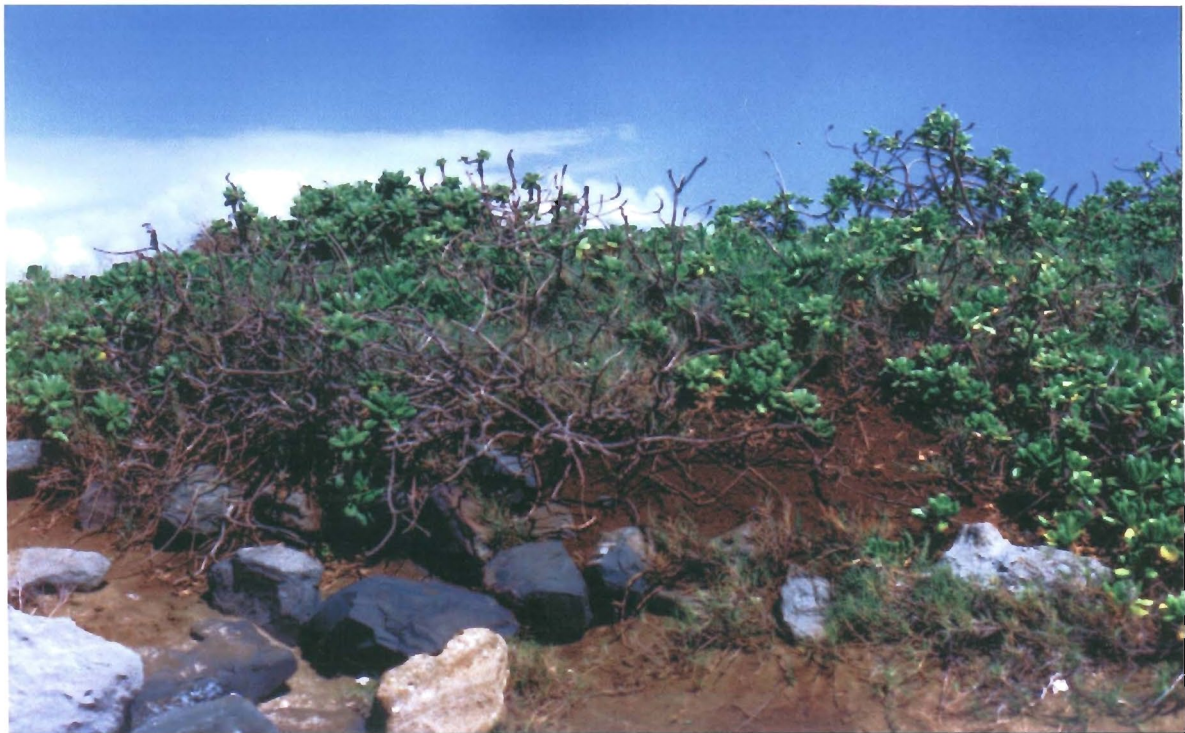
Photo 6. Fort Hase Beach Recreational Subarea. Dune erosion in the vicinity of the exposed archaeological site. Area is subject to foot traffic from beach park visitors as they walk from the parking area to the shoreline.

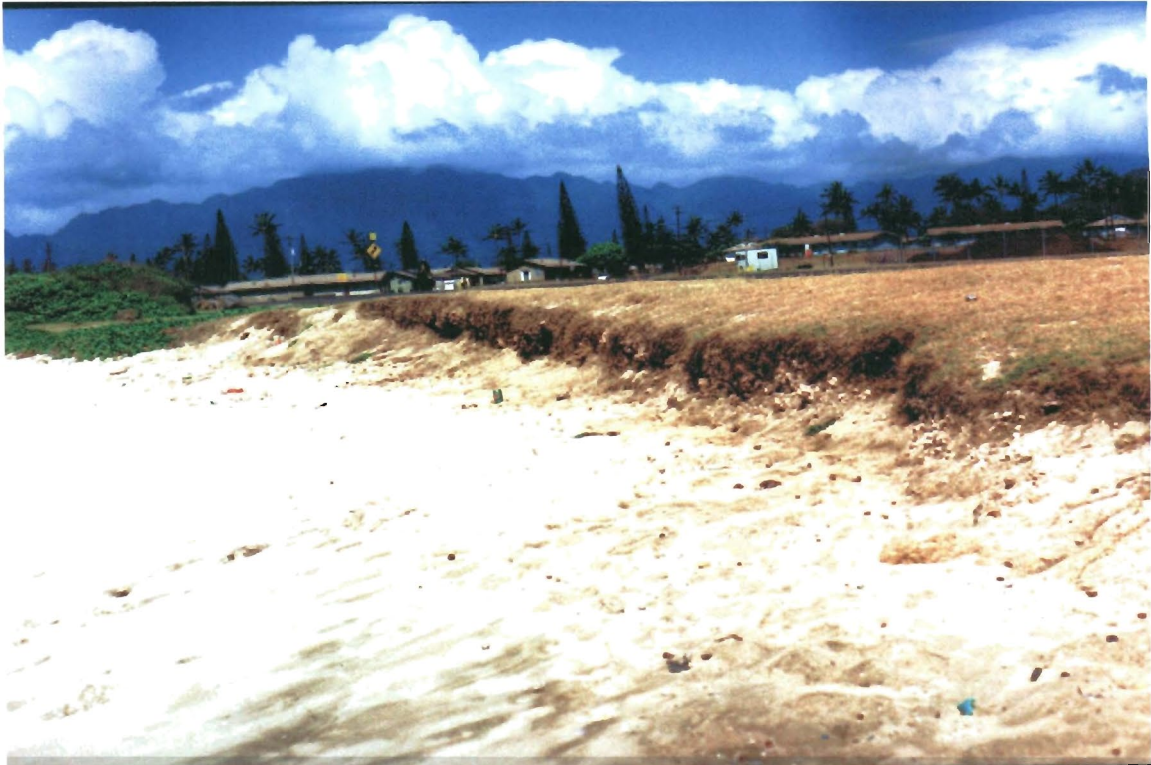
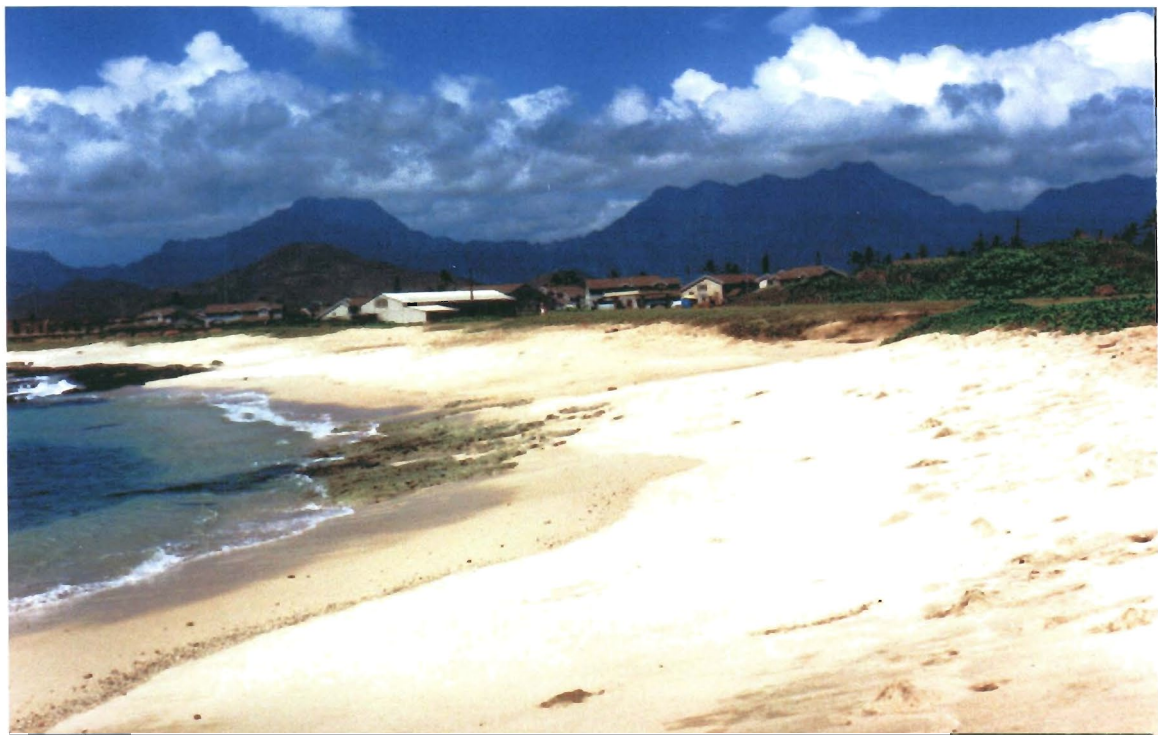
Photos 7. Fort Hase Beach Recreational Subarea. Wide sand beach lying south of the rocky headlands to the north. Note steep beach scarp somewhat protected by coastal vegetation. Scarp likely reflects the upper reach of storm waves. Note also the buildings on the previous dune reservoir area.

Photo 8. Fort Hase Beach Recreational Subarea. See above caption.

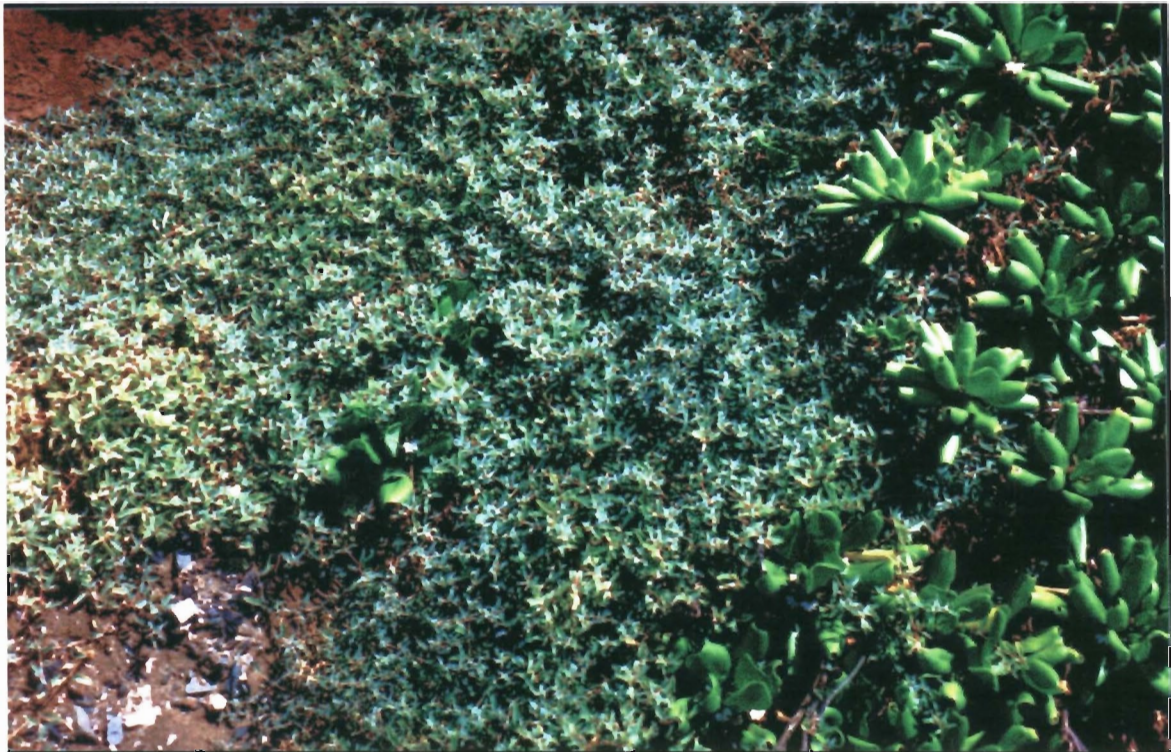
Photo 9. Fort Hase Beach Recreational Subarea. Beach Naupaka (right) and Australian Saltbush (middle and left). Demonstration of healthy revegetation of backshore dune area when foot and car traffic is controlled.

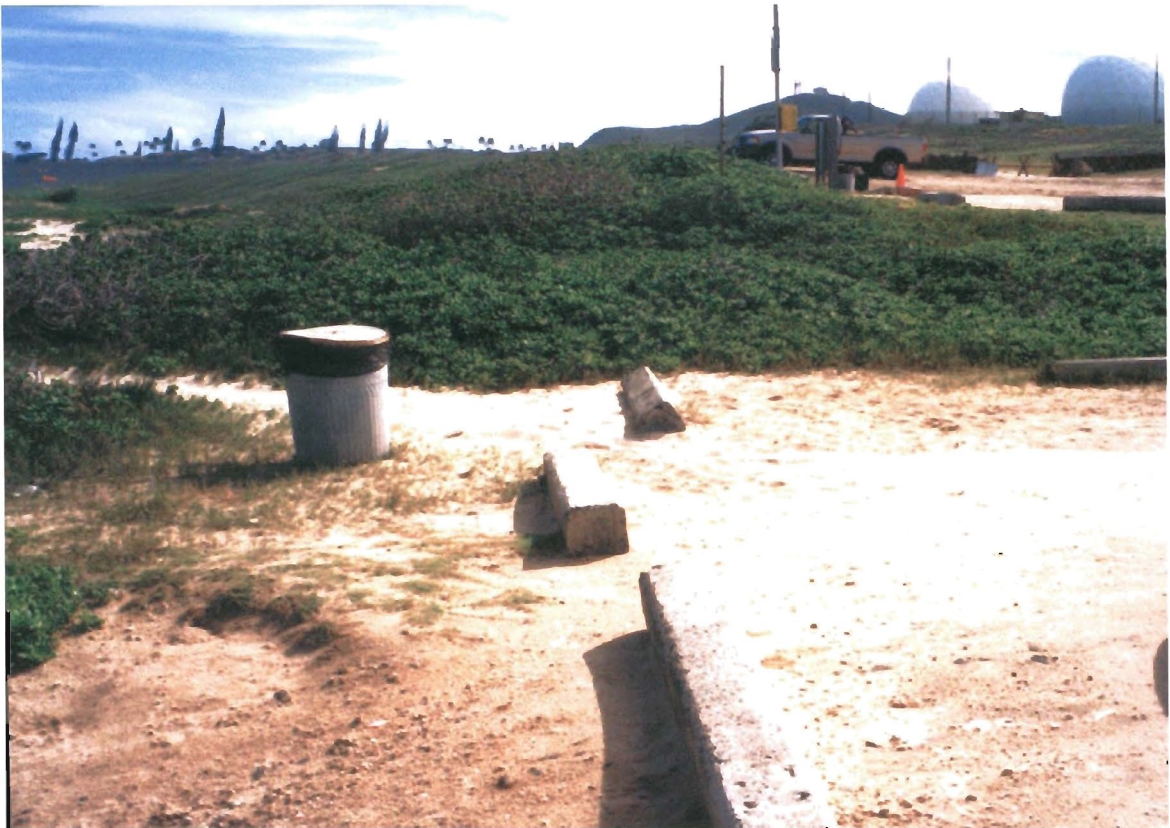
Photo 12. Concrete barricades to minimize (prevent) vehicle access to the beach at Pyramid Rock Recreational Subarea. Note movement of barrier toward beach and presence of sand blown into the parking area from the beach path.

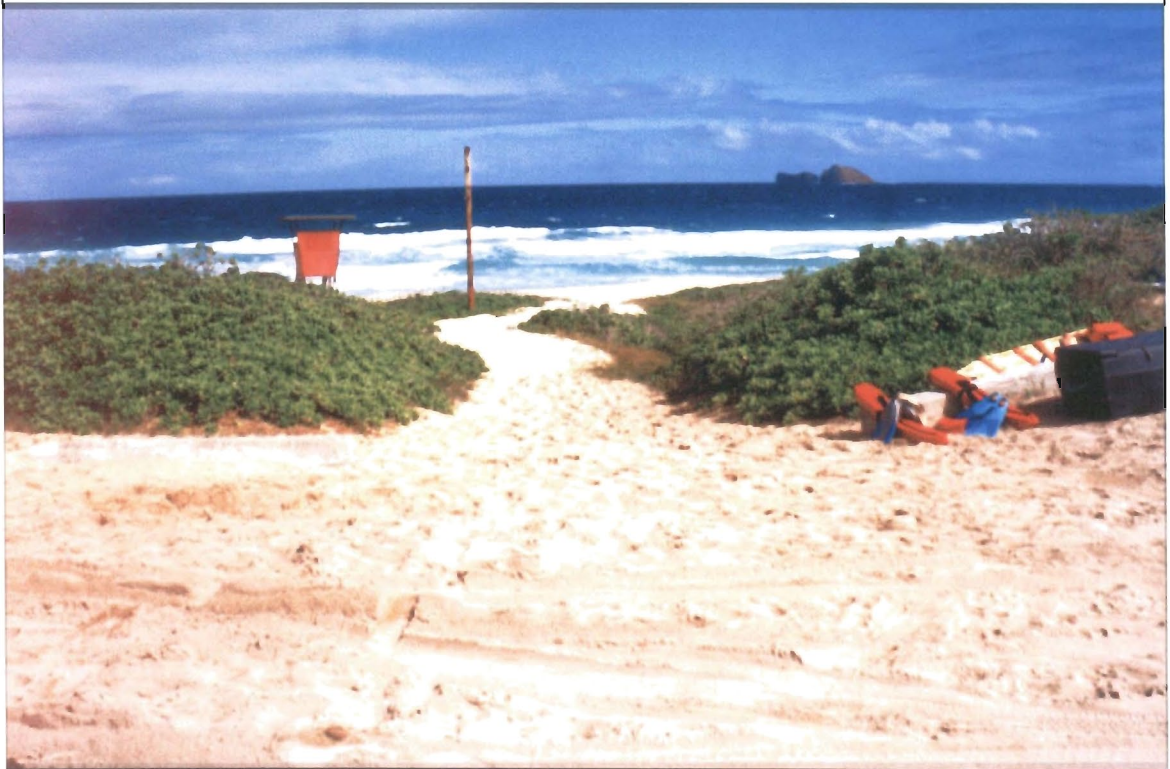
Photo 13. View of parking lot and path to beach through Naupaka at the Pyramid Rock Recreational Subarea. Note barely visible concrete barrier on the left that defines the seaward edge of the parking lot. Note also the quantity and depth of sand blown onto the parking lot. Vehicles are frequently stuck in this sand.

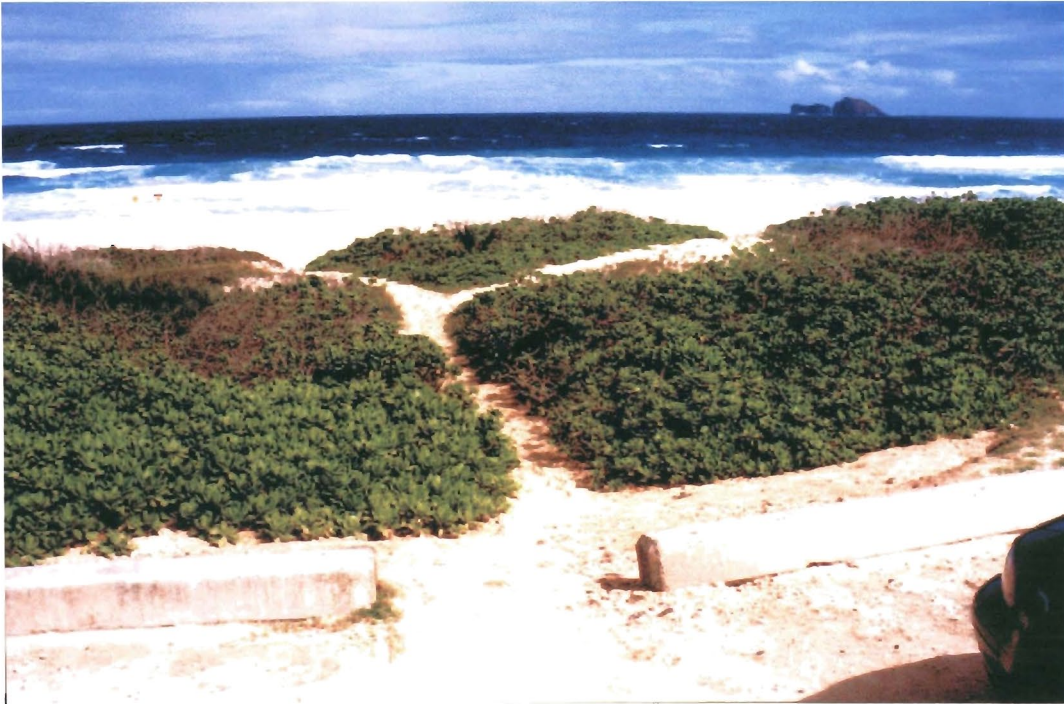
The dunes fronting the parking lot have at least eight passageways to the beach. The passages are generally straight and parallel to each other. Near the eastern end of the parking lot there are a series of three passageways to the beach that are connected by lateral trails. Past the end of the parking lot and on the other side of the low wall are a dozen trails, many with perpendicular branching connections (Figure 6). The vegetative cover has been worn away in these areas by pedestrian traffic to the beach.

Photo 14. One of many pathways to the beach at Pyramid Rock Recreational Subarea. Note the split to two paths in the center of the photo. The presence of wind blown sand at the edge of the parking area is also visible in the foreground.

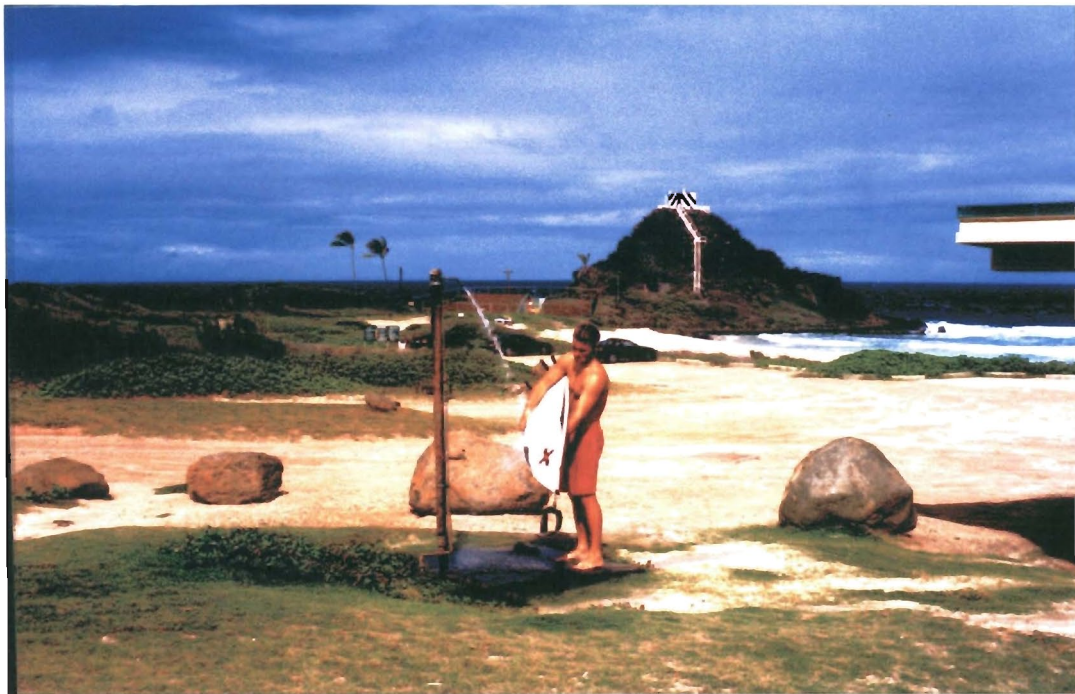
Erosion from the shower pad and natural run-off from rain have generated a drainage swale that impacts the road into the parking area, the parking area itself, and the nearshore strand vegetation. Furthermore, because of the lack of directional access to the beach, foot traffic has created numerous paths across the strand vegetation to the adjacent beach. This foot traffic has severely damaged the coastal vegetation, has encouraged the introduction of alien species, and has resulted in additional erosion of the underlying friable soil and sand. The paths to the beach have also served to funnel sand blown from the beach by the prevailing tradewinds on to the parking area in several places. Where this “blowback” has occurred, the depth of sand makes it difficult to use this area for parking.

Photo 15. The shower at Pyramid Rock Recreational Subarea. Note the lack of a designated drainage channel. Water flows from the concrete shower pad across the coral limestone parking lot causing the development of eroded drainage swales across the parking area and through the upper beach dunes.

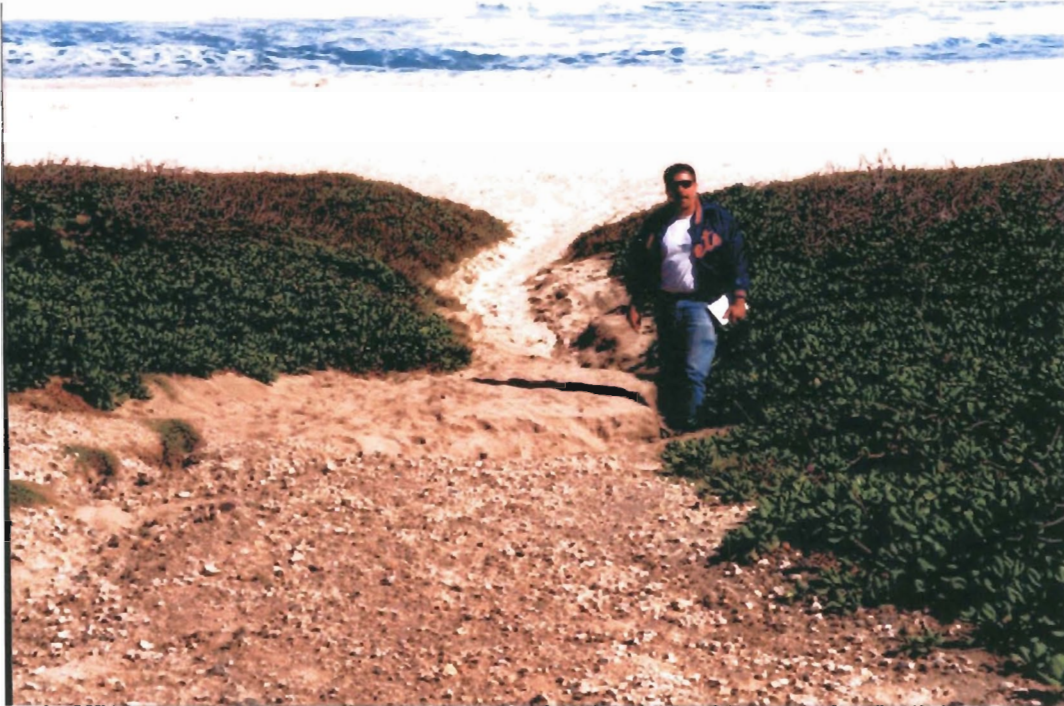
Photo 16. Erosion of pathway to the beach from the parking lot at Pyramid Rock Recreational Subarea. Note depth of gully.

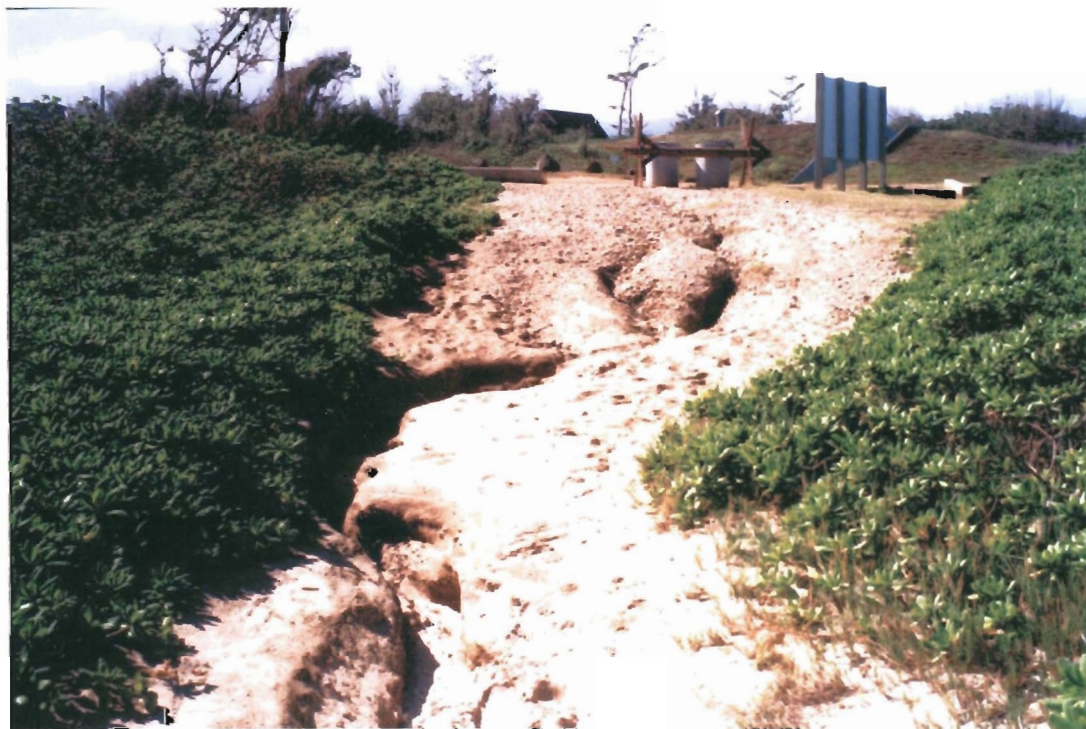
1. **Parking Lot Erosion.** As parts of the parking lot erode, it becomes more difficult to use the lot.
2. **Passageway Erosion.** Drainage from the parking lot, from rainfall or the shower, has widened and deepened parts of two passageways through the dunes.
3. **Degradation of the Sand Dunes.** With so many passageways through the sand dunes, the vegetative cover is being pushed back.
4. **Off-Road Vehicles.** Off-road vehicles destroy the substrate and eventually kill the sensitive vegetation, exposing the underlying sand.

Photo 17. Pyramid Rock Recreation Subarea. Note severe erosion along beach access path from parking lot. Path is subject to runoff from the parking lot during heavy rains as well as chronic flows from the shower.
