Review

Analysis of Renovation Works in Cappuccinelli Social Housing District in Trapani

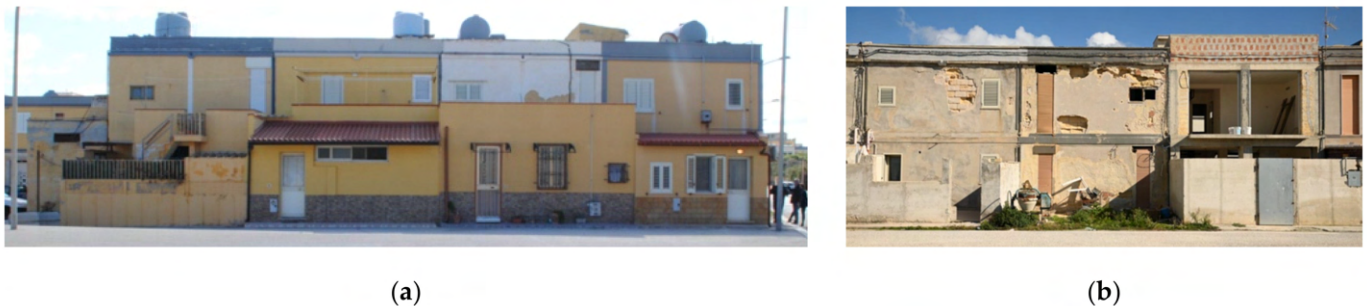
The phenomena of social decay impacted Cappuccinelli from the beginning. Many houses were illegally occupied even during the construction work, thus impeding the completion of the district according to the original project plan. Furthermore, unauthorized additions have proliferated: The small courtyards of paired duplexes were frequently closed and many private gardens in the large courtyard were changed to indoor spaces (Figure 2).

Figure 2. Unauthorized additions in the Cappuccinelli district: private gardens occupied by new rooms (a) and other chaotic modifications (b) in the terraced block named “L”.

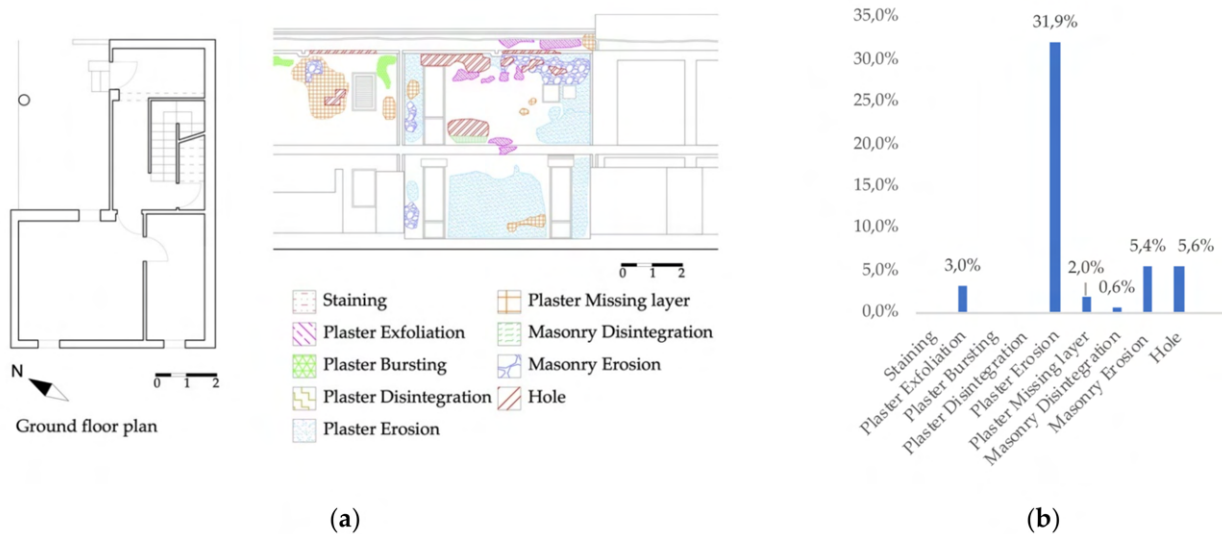
Figure 5a represents portion A (Figure 4) of the original plan (the project by Valori) and the southwest elevation of the “L” block and identifies its degradations: plaster exfoliation, plaster erosion, lack of plaster portions, masonry disintegration, masonry erosion, and lack of masonry blocks. In Figure 5b, the extent of each degradation phenomenon is estimated as a percentage of the analyzed surface. Plaster erosion is prevalent (31.9%), while other degradations range from 0.6 to 5.6%.

Figure 5. Ground floor plan from Valori project and representation of external visible damages on the façade (a), their extent estimated as a percentage of the analyzed façade surface (b) in the portion A (Figure 4) of the SW elevation of the “L” block. Authors: Erica La Placa, Calogero Vinci.

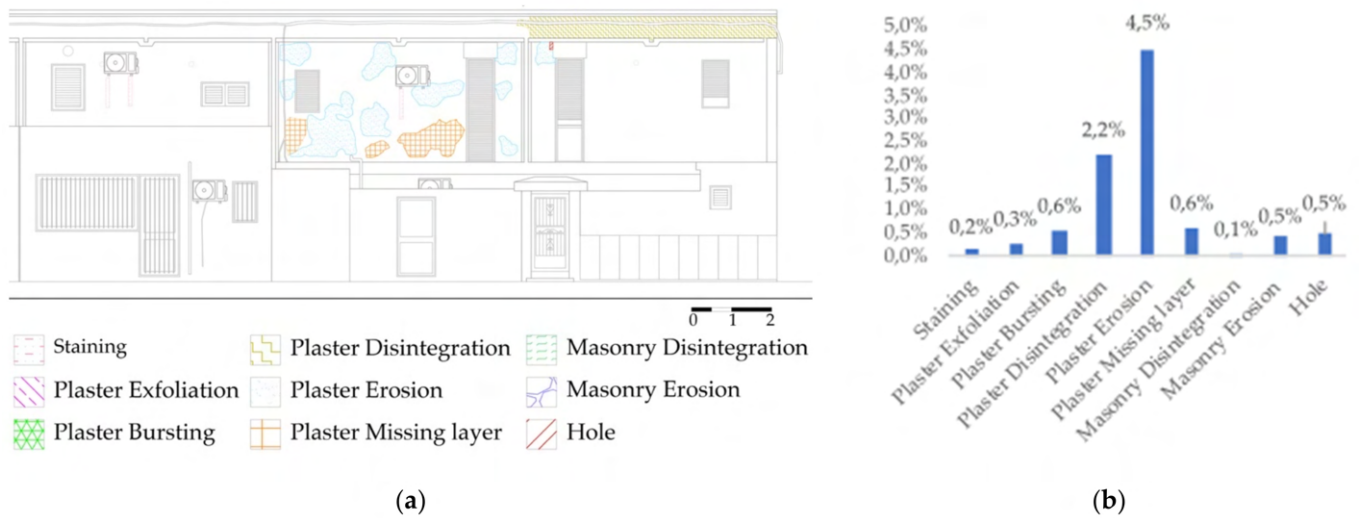
By extending this analysis to the entire “L” block (Figure 6a), erosion is confirmed as the most frequent degradation (4.5%) in all dwellings whose ownership passed from the public subject (IACP) to the private (original renters) (Figure 6b).

Figure 6. (a) Degradations of the portion B of the S-W elevation of “L” block in private dwellings. (b) Estimation of degradations as percentage of the analyzed surface. Authors: Erica La Placa, Calogero Vinci.

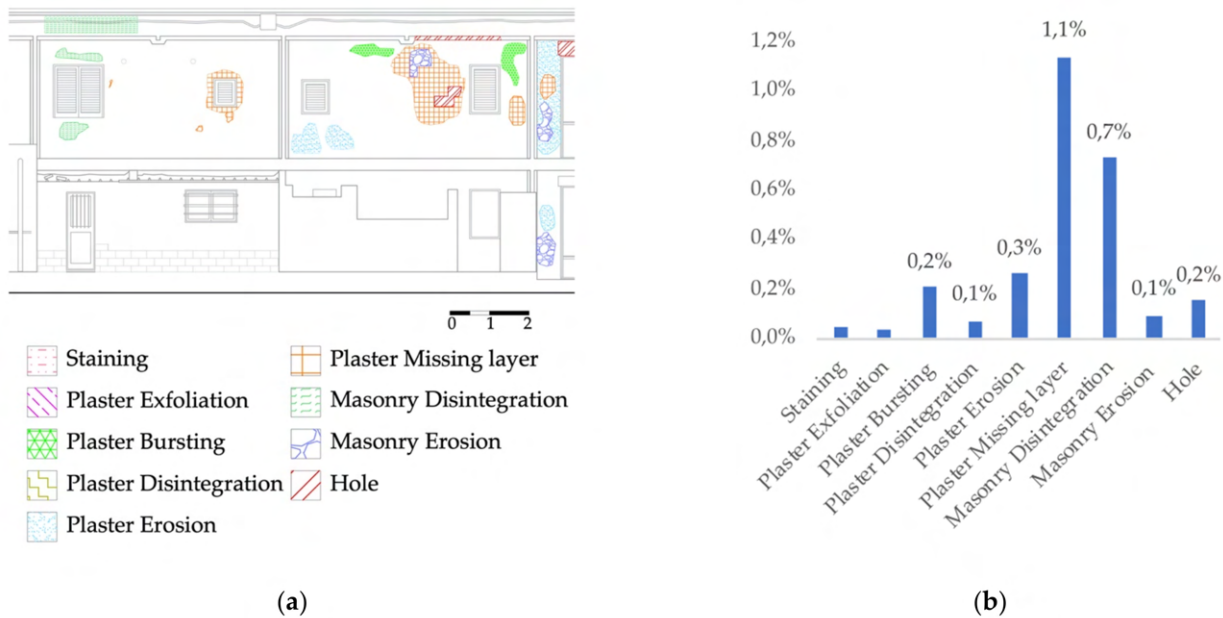
If the part still owned by IACP is considered (Figure 7a), the most recurrent deterioration is the lack of plaster portions (1.1%) (Figure 7b). More generally, the most frequent degradations on the façades of “L” block involve plasters. Indeed, the materials used for this functional layer were not suitable to calcarenite. Being very porous, this stone easily absorbs marine moisture and its content of salts, accelerating the mechanisms of the observed degradations.

Figure 7. (a) Degradations of the portion C in the SW elevation of “L” block in dwellings still owned by IACP. (b) Estimation of degradations as a percentage of the analyzed surface. Authors: Erica La Placa, Calogero Vinci.

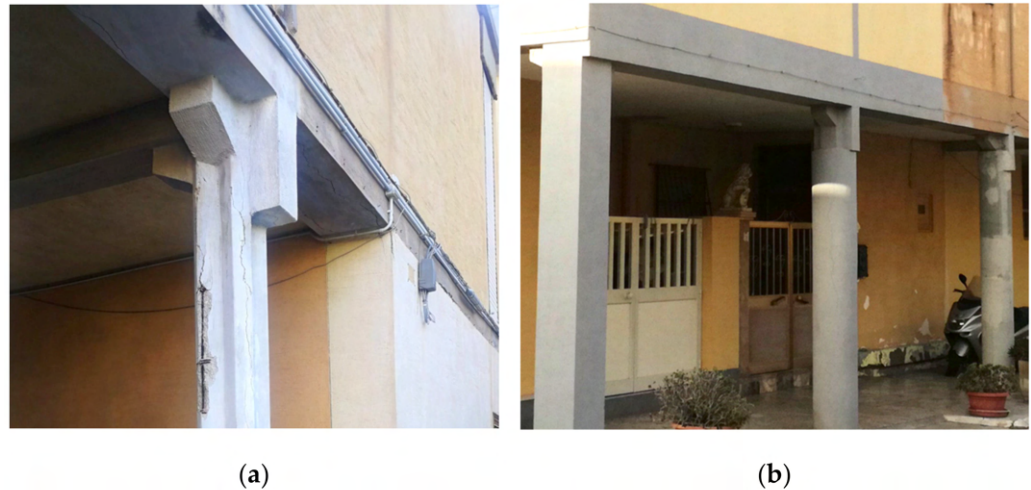
Buildings in the Cappuccinelli district, being close to the sea (about 150 m) and exposed to strong mistral winds, should be equipped with protection systems for reinforced concrete structures in order to significantly reduce the risk of corrosion of the steel reinforcements. However, repairs by the IACP modified the original shape of these building components. As a relevant example, the original shape of the pillars in the porticos (Figure 8a)—a significant architectural detail in the project by Valori—was heavily modified in the renovation works, but their alteration did not make them more effective (Figure 8b).

Figure 8. (a) Original shape of pillars designed by Valori. (b) Consolidation of pillars in the portico of court “B”, executed in 2012. Author: Rossella Corrao.

The design of structural strengthening and rehabilitation works, aimed at overcoming the detected causes of damage (presence of rainwater and sea salts; lack of adequate protection for the reinforcement bars; inadequate structural dimensioning) and complying with current requirements for structural safety, also must consider the architectural concept on which the buildings are based. In this sense, archive research on project development and renovation works carried out in Cappuccinelli were essential to complement the in-situ inspection of the buildings in order to identify the original solutions worth being preserved and the inappropriate repairs.
