Low-voltage shock impedance measurements: A false sense of security

Background: Implantable cardioverter defibrillators use low-voltage shock impedance measurements to monitor the lead integrity. However, previous case reports suggest that low-voltage shock impedance measurements may fail to detect insulation breaches that can cause life-threatening electrical short circuits.

Methods and results: We report six cases of insulation breaches in transvenous defibrillation leads that were not obvious during standard interrogations and testing of the lead beforehand. In two cases, an electrical short circuit during commanded shock delivery for internal electrical cardioversion resulted in a total damage of the ICD generator. In one of these cases, commanded shock delivery induced ventricular fibrillation, which required external defibrillation. In two cases, a shock due to ventricular tachycardia was aborted as the shock impedance was less than 20 Ω . However, in both cases the tiny residual shock energy terminated the ventricular tachycardia. In contrast, in one case the residual energy of the aborted shock did not end ventricular fibrillation induced at defibrillator threshold testin

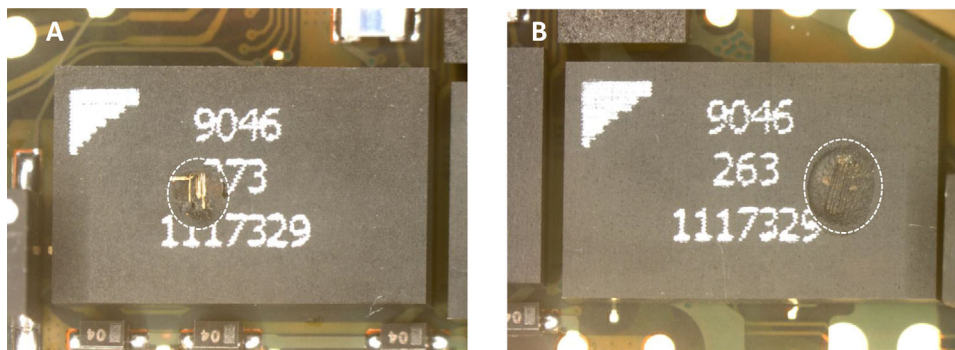
FIGURE 1 A and B, In an explanted Lumax 340 VR-T, both high-voltage circuits are damaged (white circles). The surface of the ICD was intact. The internal wiring and connections inside the circuitry have evaporated, and the integrated circuit housing has burst open [Color figure can be viewed at wileyonlinelibrary.com]

propriate shock delivery. The ICD was later replaced with a Lumax 340 VR-T (Biotronik) in July 2013 due to battery depletion. Defibrillation threshold testing (DFT) was not performed after the procedure. No electrical abnormalities of the system were observed during the follow-ups. In April 2016 the patient was referred to our hospital for electrical cardioversion of an atrial tachycardia. Device interrogation before internal electrical cardioversion showed stable interrogation values (RV sensing: 14.2 V; RV pacing threshold: 0.5 V / 0.4 ms; pacing impedance: 563 Ω ; shock impedance: 82 Ω). Internal electrical cardioversion with 40 J induced ventricular fibrillation which had to be terminated by external defibrillation (270 J) as communication with the ICD via the programmer was unsuccessful afterwards. The ICD was explanted and returned to the manufacturer for analysis. On manufacturer examination, no visual abnormalities were found on the device body. However, analysis revealed damaged HV circuits (Figure 1). We speculate that excessive currents by electrical short circuit due to lead insulation defects destroyed the device.

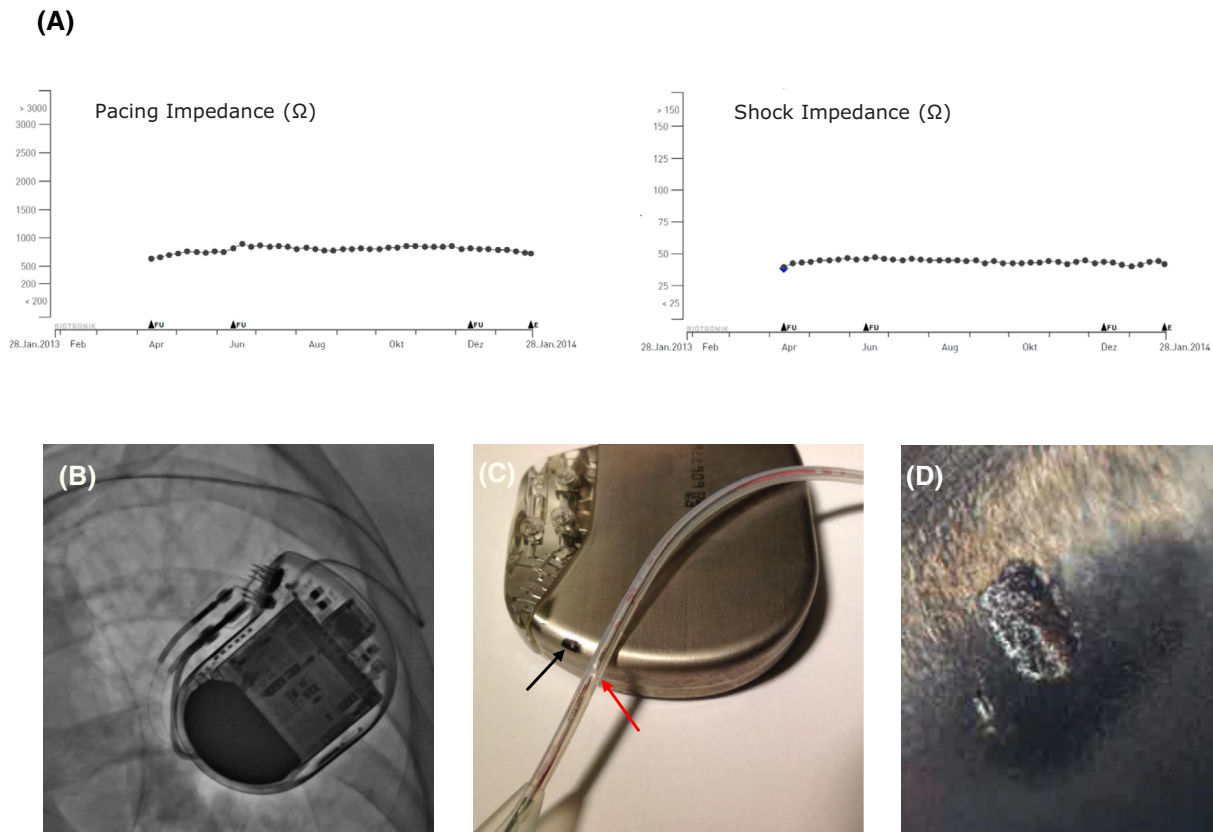
A 58-year old male with dilated cardiomyopathy was implanted with a single-chamber ICD (device: Lumax 340 VR-T; RV lead: Linux SD 65/18 lead; Biotronik) in April 2013 for primary prevention. Electrical parameters during in-office follow-ups had been stable (12/2013: RV sensing: 10.5 V; RV pacing threshold: 0.5 V / 0.4 ms; pacing impedance: 823 Ω ; shock impedance: 43 Ω). In addition, a remote monitoring system with daily transmissions (Biotronik Home Monitoring) was utilized. Data sent via the remote monitoring system on January 28th in 2014 exhibited no abnormalities with a pacing and shock impedance reading of 714 and 43 Ω , respectively (Figure 2A). The next day, the patient was referred to the hospital for electrical cardioversion of atrial fibrillation. After internal electrical cardioversion, communication with the device via the programmer was no longer possible. Thus, the ICD system was explanted and sent to the respective manufacturer for further analysis. An X-ray showed no lead abnormalities (Figure 2B). However, inspection of the lead showed an abrasion of the insulation 12-cm distal to the IS-1 connector pin (Figure 2C). In addition, a burn mark

FIGURE 2 A, Pacing and low-voltage shock impedance trends were unsuspecting before internal electrical cardioversion. B, A preoperative X-ray showed no lead abnormalities. C and D, Surface arc mark on the edge of the generator, which suggests an HV electrical short circuit. C, Partial isolation defect of the defibrillator lead [Color figure can be viewed at wileyonlinelibrary.com]

was found on the device surface (Figure 2C,D). Manufacturer's analysis report revealed a shock output into a low-impedance shock path with a damaged shock output stage and subsequent discharge of the battery.

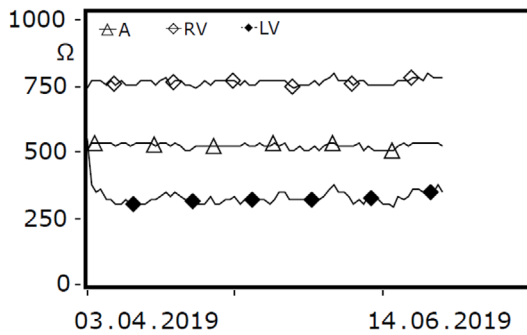
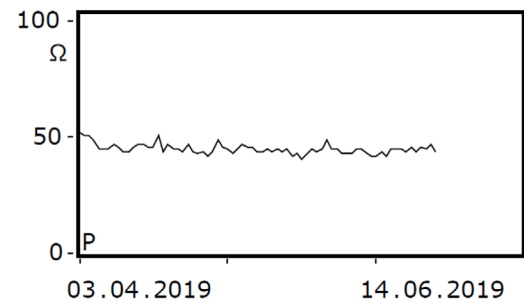
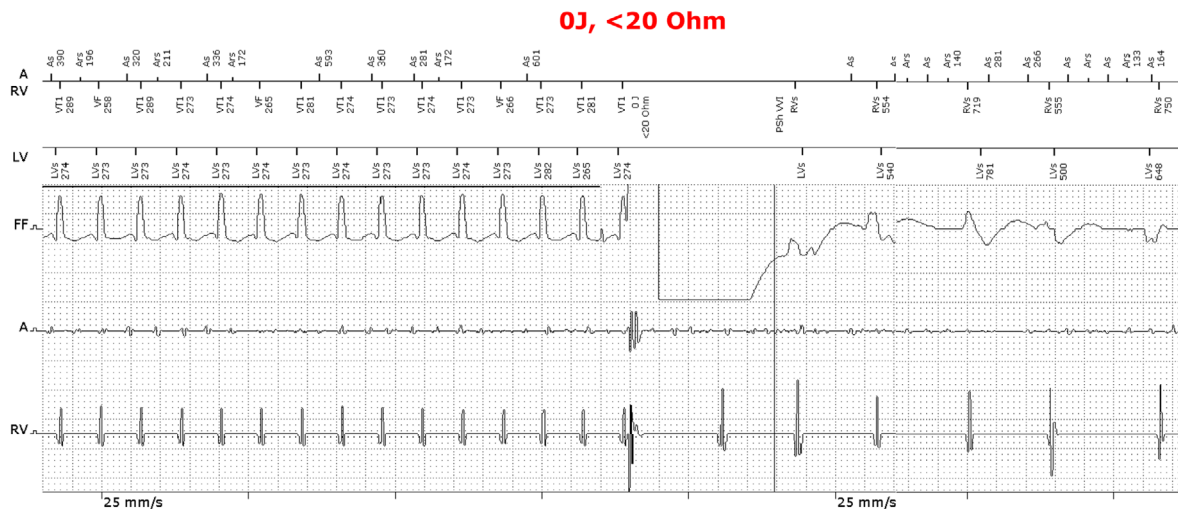
FIGURE 3 A, No abnormalities were detected in pacing impedance and low-voltage shock impedance values beforehand. B, Ventricular tachycardia detection with charging of the capacitors to 40 J. The shock was aborted (“O J”) as the shock impedance was $<20 \Omega$. The released tiny residual energy terminated the ventricular tachycardia [Color figure can be viewed at wileyonlinelibrary.com]

lead: Linux S65; Biotronik) in 2008 for secondary prevention after resuscitation due to ventricular fibrillation. At the time of implantation, no DFT testing was performed due to a left ventricular thrombus. In-office follow-ups revealed several ventricular tachycardia and ventricular fibrillation episodes, terminated by either ATP or shock delivery (last shock 07/2016). In 2012, the device was upgraded to a cardiac resynchronization therapy defibrillator (CRT-D; device: Lumax 540 HF-T; Biotronik). Due to battery depletion, the generator was replaced in April 2019 with an Inlexa 3 HF-T hardware (Biotronik) without DFT testing. During the follow-ups before and after the generator exchange, CRT-D interrogation parameters exhibited no abnormalities (Figure 3A). In June 2019, the patient experienced an ICD shock and was referred to the hospital for further management. CRT-D interrogation revealed a ventricular tachycardia (cycle length: 300 ms), which was treated adequately by shock delivery following two failed ATP attempts. However, the shock was aborted as the shock impedance was $<20 \Omega$, indicating a potential HV lead issue. Remarkably, the released tiny residual energy terminated the ventricular tachycardia (Figure 3B). All other device interrogation values were within the normal range (low-voltage shock impedance reading

40 Ω). In consultation with the manufacturer, a new RV-lead (Plexa Pro MRI S65; Biotronik) was implanted, and the old lead abandoned. Due to the excessive current protection system, the CRT-D generator could be reused and was not subjected to further examinations by the manufacturer.

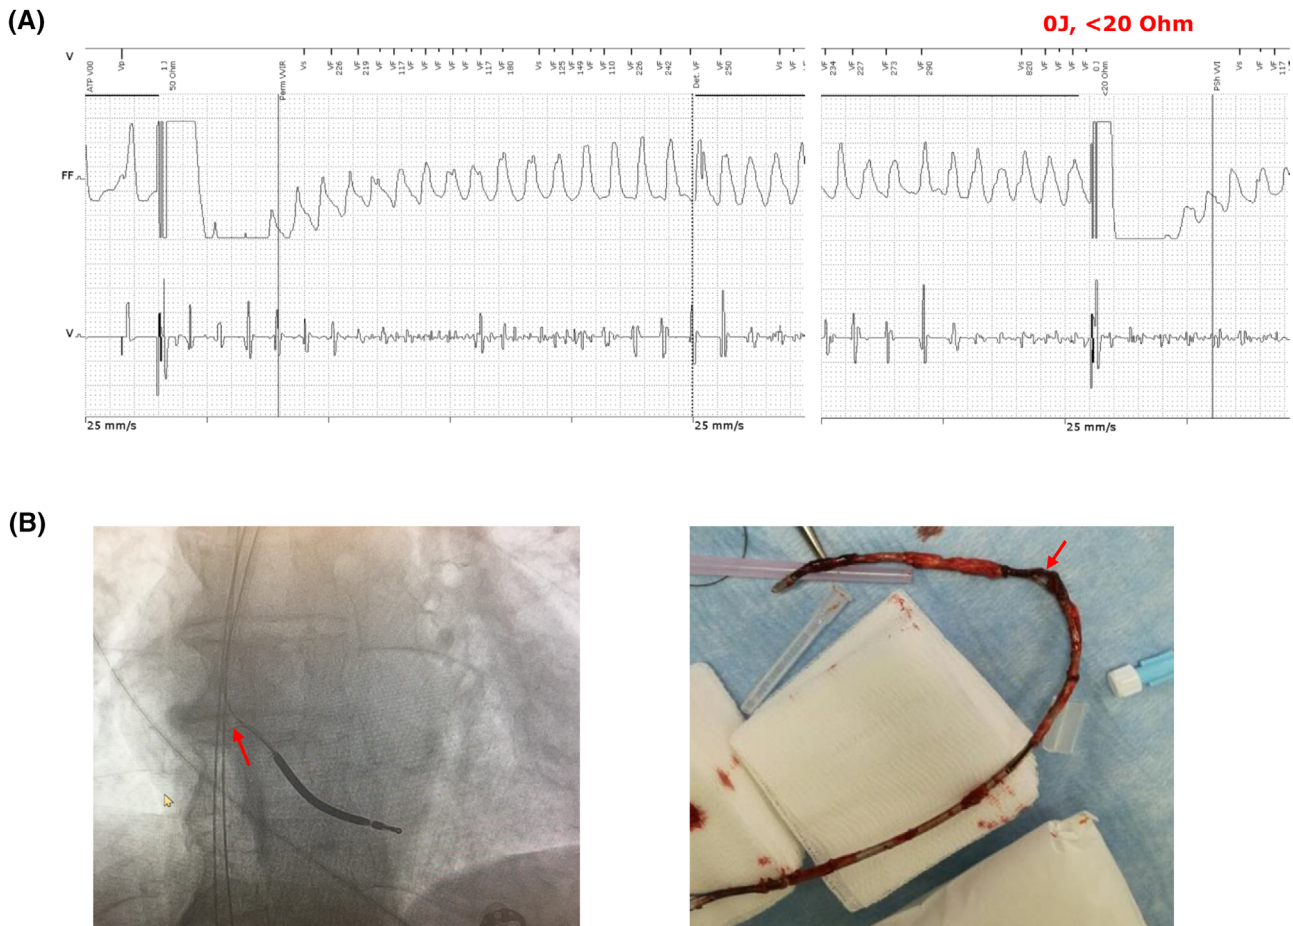
FIGURE 4 A, During DFT testing, ventricular fibrillation was induced by a 1 J shock on the T wave. Shock impedance measured by the 1 J shock was 50 Ω . After ventricular fibrillation detection and charging, the shock was aborted (“0 J”) by the excessive currents protection system. The released tiny residual energy did not terminate ventricular fibrillation. B, A cable externalization was revealed on a preoperative X-ray (left, red arrow) and after lead extraction (right, red arrow) [Color figure can be viewed at wileyonlinelibrary.com]

Lead-related electrical parameters after connection of the new generator were unsuspecting (RV sensing: 19.1 mV, RV pacing threshold: 0.8 V / 0.4 ms, pacing impedance: 607 Ω , and shock impedance: 62 Ω). During DFT testing, ventricular fibrillation was induced by a 1 Joule shock on the T wave. Shock impedance measured by the 1 J shock was in the normal range with an impedance reading of 50 Ω . After ventricular fibrillation detection, both the first shock and the following programmed two were aborted (0 J, <20 Ω ; Figure 4A). Ongoing ventricular fibrillation was successfully terminated by an external shock. DFT testing was repeated after reprogramming the shock path. At the second DFT testing, ventricular fibrillation was induced by a high frequency burst. Like during the first DFT testing, both the first shock and the following two (0 J and <20 Ω , respectively) were aborted. An external shock was administered, and the ongoing ventricular fibrillation terminated. As a chest X-ray showed evidence of a cable externalization (Figure 4B), the Riata 1580 lead was extracted, and a new ICD lead (Protego Pro MRI S 65; Biotronik) placed. Subsequent DFT testing went without complications.

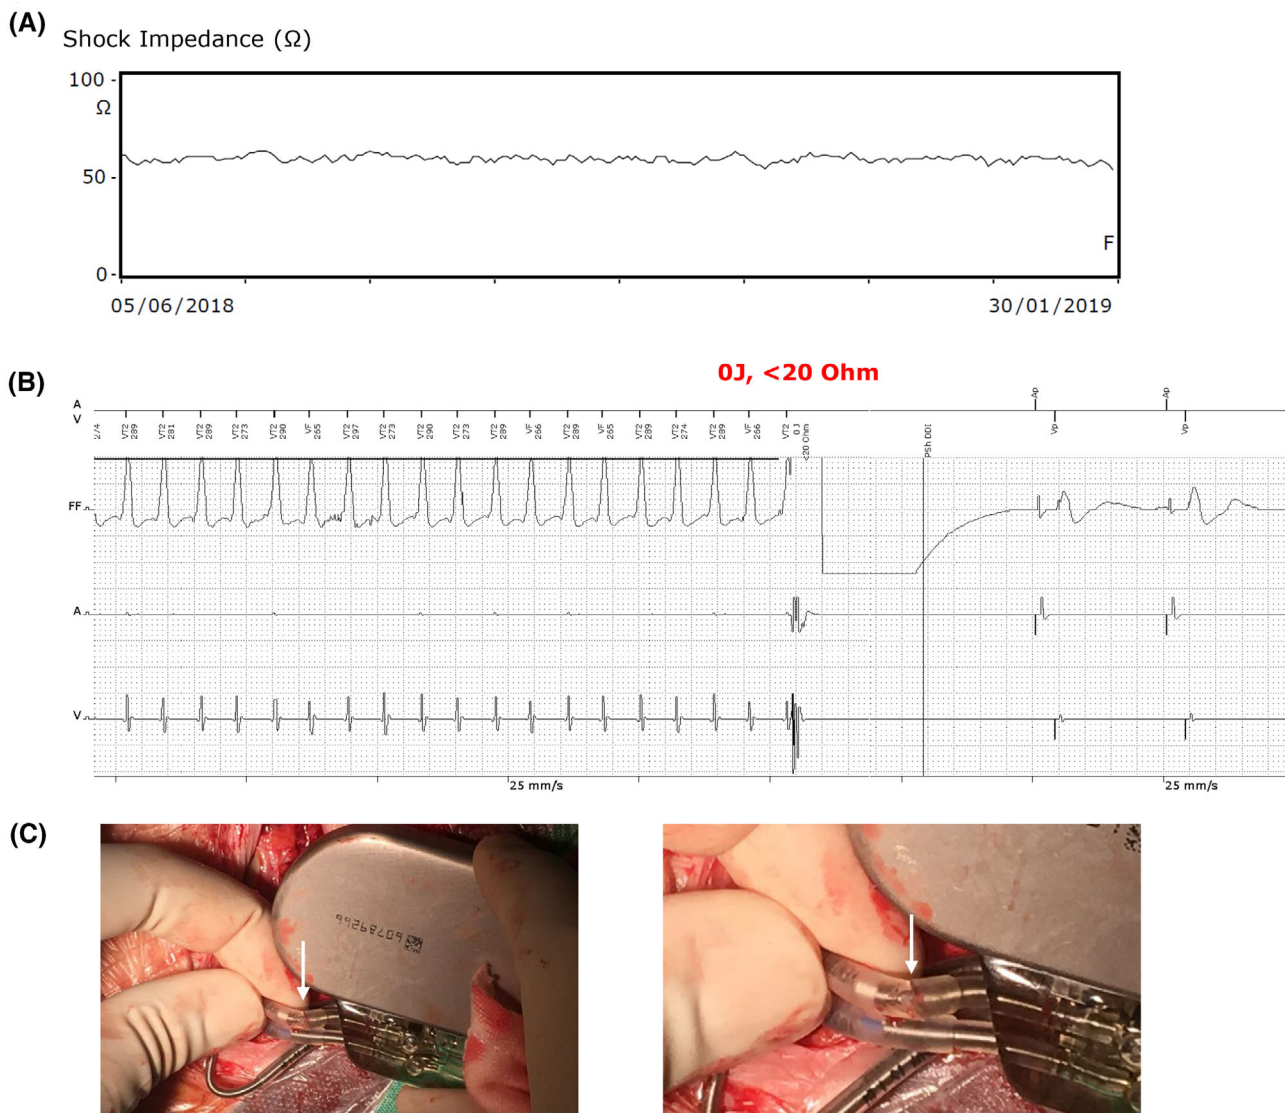
An 88-year-old male with ischemic cardiomyopathy with moderately impaired LVEF (40%) underwent implantation of a left-sided transvenous dual-chamber ICD (device: Lumax 300 HF-T, Biotronik; RA lead: Selox JT53, Biotronik; RV lead: Linx S65/18, Biotronik; LV port closed with a blind plug) in February 2009 for secondary prevention. In 2016, a device replacement with an Itrevia 7 DR-T (Biotronik) was performed due to battery depletion. After the generator exchange, no electrical abnormality of the system was observed during follow-up. Most important, low-voltage shock impedance measurements were stable and in the normal range (Figure 5A). In January 2019, the patient presented to the hospital due to an ICD shock delivery. Device interrogation showed a ventricular tachycardia (cycle length: 267 ms) with shock delivery. However, the shock was aborted as the shock impedance was less than 20 Ω . Even though the shock has been aborted, the released tiny residual energy terminated the ventricular tachycardia (Figure 5B). Thus, the indication for placement of a new RV-lead was made.

FIGURE 5 A, Low-voltage shock impedance values beforehand were in the normal range. B, Detection of a stable ventricular tachycardia (VT) in the ventricular fibrillation (VF) zone. After charging of the capacitor to 40 J, the shock was aborted (“0 J”) by the excessive current protection system. The released tiny residual energy terminated the ventricular tachycardia. C, The ICD lead shows partial insulation defect. The lead failure occurred not only on the silicone outer insulation, but also on the ethylene tetrafluoroethylene of the RV coil conductor [Color figure can be viewed at wileyonlinelibrary.com]

During the operation, a sharp cut on the RV defibrillator lead at the junction between the lead and the generator box was observed (Figure 5C). As the subclavian vein venography revealed a total occlusion of the left subclavian vein, the lead was abandoned and a dual-chamber ICD (Ilivia 7 DR-T; Biotronik) implanted from the right side.
