# Experimental procedure for studying the degradation and alteration of limestone slabs applied on exterior cladding

V. Pires<sup>1</sup> · P. M. Amaral<sup>2</sup> · J. A. R. Simão<sup>3</sup> · C. Galhano<sup>3</sup>

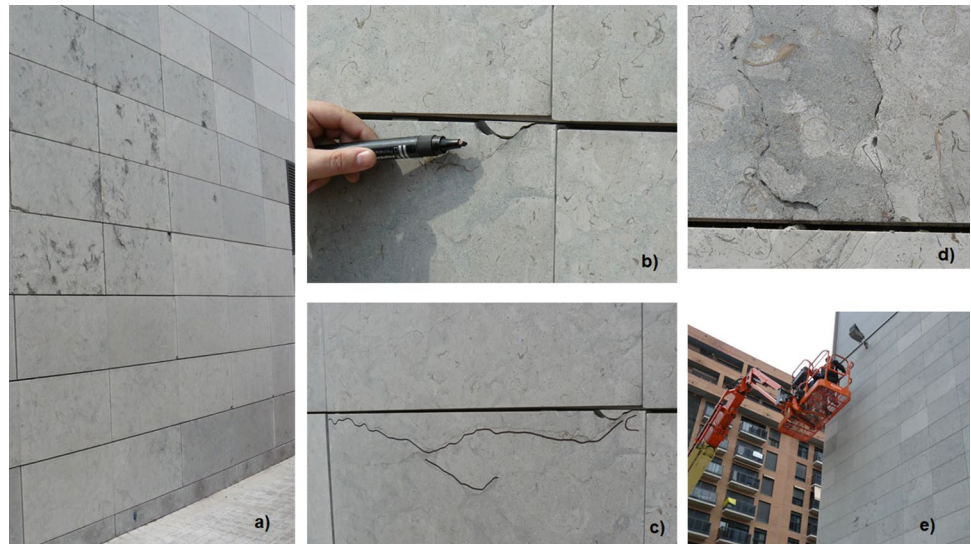
This case study refers to an experimental procedure to study the degradation of Portuguese limestone slabs with dimensions of 500 × 375 × 30 (mm) in a building facade in the city of Valencia (Spain) using a standard “Kerf” anchoring system. After approximately 4–5 years of installation signs of deterioration began to be detected in the external facade of the building that led to: (1) changes in color—detected through a change from the original color to a lighter hue; (2) enhancement of cracks and fissures parallel to the surface—developed along stratification plans and stylolites of the slabs; (3) expansion and loss of powdery material mainly on stylolites and at the slab edges. These phenomena have caused instability of the facade elements with consequent implications in users’ safety and aesthetics appearance of the building (Fig. 1).

**Fig. 1** Exterior views of the building façade: **a** Overview of AV limestone slabs at the façade showing slabs with different color; **b** Example of a crack with limestone fragment detachment; **c** Example of a fissure; **d** Example of cracks, fissures and swelling parallel to the surface—developed along stratification plans and stylolites of the slabs; **e** AV limestone façade inspection. Picture credits by Juan José Tejado Ramos

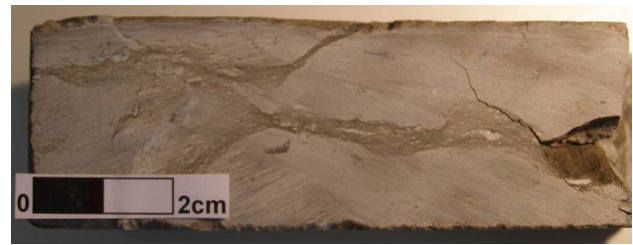
AV limestone has nonlinear, irregular cracks with widths between 1 and 5 mm; and layers sub parallel to the slabs surface (that can probably be related to clayed materials originating clayed veins) with variable thickness, between 2 and 10 mm, and showing darker color (see Fig. 3).

**Fig. 3** Visible cracks, fissures, and layers of on an example of a sound AV limestone slab

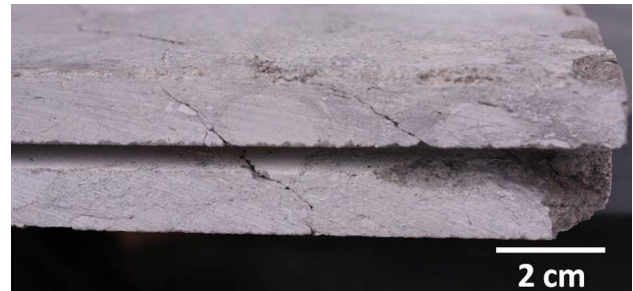
Damaged AV slabs were collected from the building façade and in these an increase in cracking, loss of material (see Fig. 4), swelling—shrinking and the appearance of powdery material was clearly detected (see Fig. 5).

**Fig. 4** Fractures and loss of material on AV slab in the kerf/slot region where the slab interacts with the anchoring system

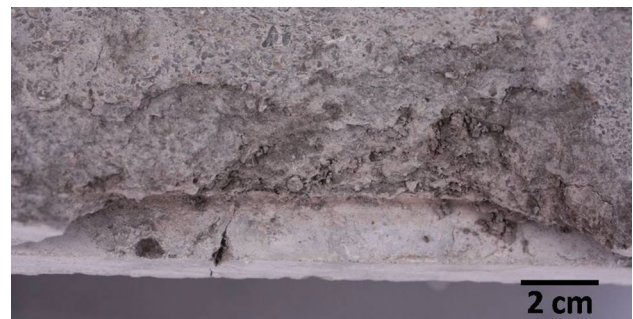
**Fig. 5** Powdery clay material on the AV slabs

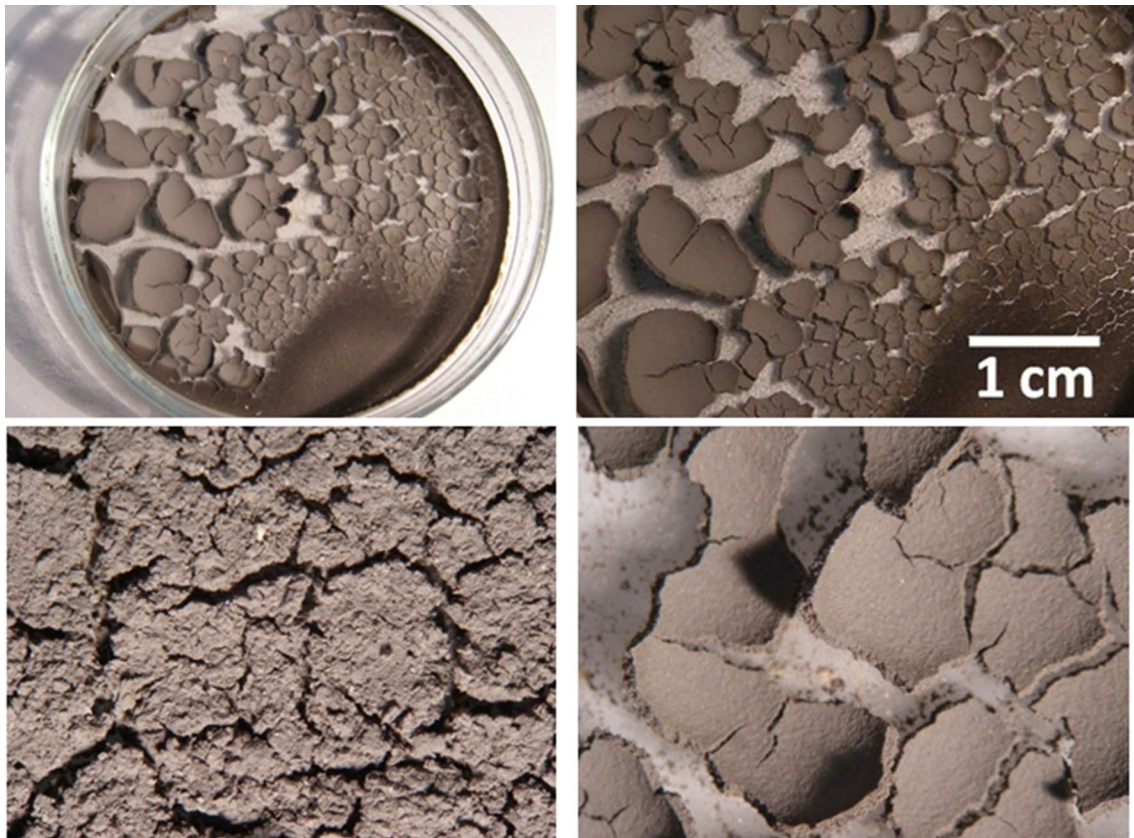
These results show that AV is not pure limestone but a marly limestone. After drying, this clay shows high retraction cracks, as it can be observed under the stereoscopic microscopic (Fig. 6).

**Fig. 6** Clay content of sound AV limestone with retraction cracks

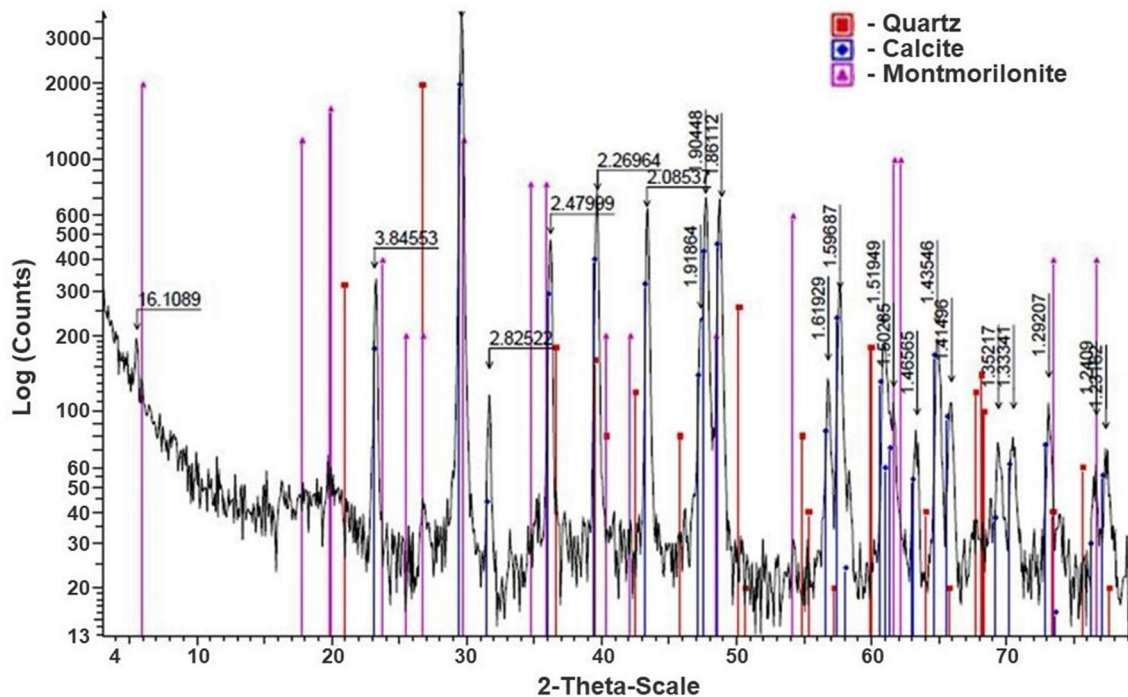
XRD mineralogical analysis on AV degraded specimens (Fig. 7) revealed the presence of calcite, a small amount of quartz and montmorillonite (expansive clay mineral from smectite group); no iron oxides were detected by this technique. As pointed by Gutiérrez et al. (2012), montmorillonite is a very harmful clay type. This specific clay type belongs to the expansive variety, and thus suffers intraparticle swelling. This clay type can intake considerable water volumes, increasing swelling and reducing the stone strength, therefore facilitating the stone disintegration even for moderate swelling pressures.

**Fig. 7** XRD analysis of sound AV limestone

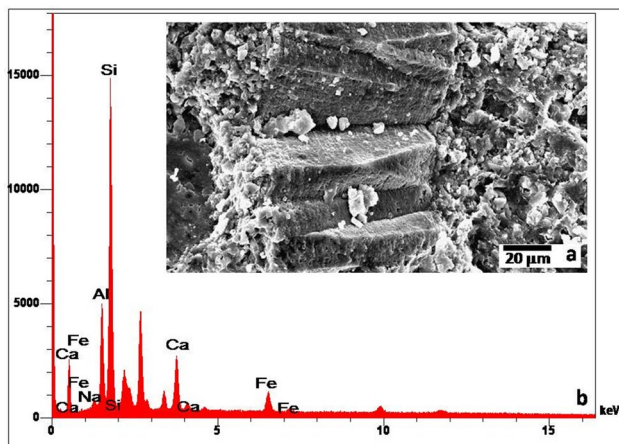
SEM observations allowed a detailed analysis of the layers sub parallel to the slabs surface and confirmed the presence of clayed veins previously mentioned on the petrographic description of AV degraded specimens (Fig. 8a). The microprobe analysis on the clay fraction (Fig. 8b) confirmed the presence of a Ca-montmorillonite, a very expansive clay of the smectite group.

**Fig. 8** SEM observation of a clay vein on AV limestone (a) and microprobe analysis of clay fraction (b)
