Nondestructive characterization of solar PV cells defects by means of electroluminescence, infrared thermography, I-V curves and visual tests: experimental study and comparison

Sara Gallardo-Saavedra ^{a*}, Luis Hernández-Callejo ^a, María del Carmen Alonso-García ^b, José Domingo Santos ^b, José Ignacio Morales-Aragón ^a, Víctor Alonso-Gómez ^a, Ángel Moretón-Fernández ^c, Miguel Ángel González-Rebollo ^c and Oscar Martínez-Sacristán ^c.

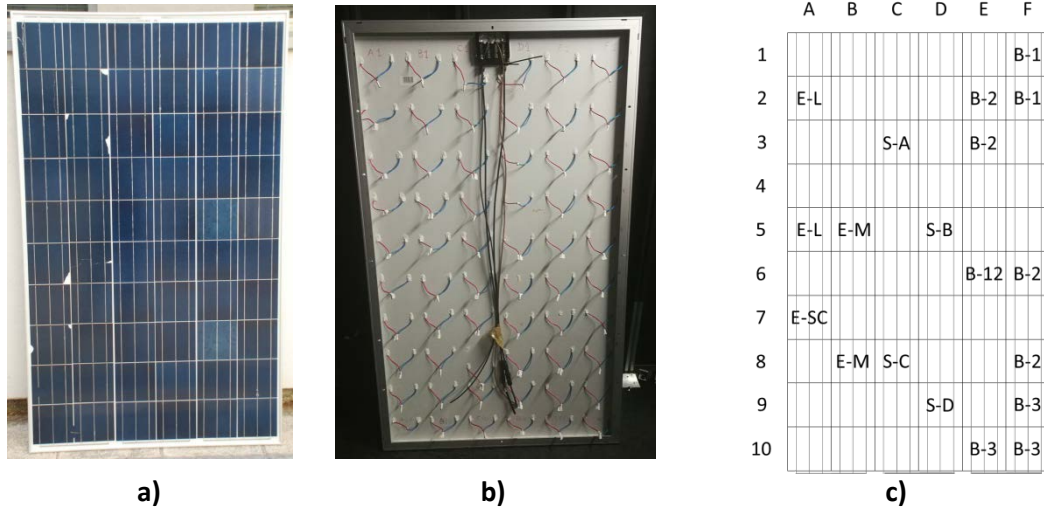
Fig. 1. a) Front view of the tested module. b) Back view of the tested module. c) Defective cells distribution showed in the back view of the tested module.

The module has been designed including similar kinds of defects in the same string. In this way, the string corresponding to columns A and B (string AB) contains manufacturing defects, the string CD contains soldering faults while the string EF contains breaking deficiencies. The defects of the three module strings are summarized in Table 1. The low efficiency defects (defect E-L, cells A2 and A5) are due to manufacturing problems, but they do not correspond with breaking or short-circuited cells. Short-circuit cell (defect E-SC, cell A7) has been generated by extending the cell connection tabs beyond the ordinary placement, short-circuiting the cell. In order to simulate the bad soldering defects, buses from the back of some cells have been left without soldering, either one bus (defect S-A, cell C3) or two buses (defect S-B, cell D5). Three buses have not been left without soldering in any case as it would have meant that this cell would not be series connected to the rest. The cell with only 1cm welded (defect S-C, cell C8) simulates a bad soldering, in which only 1 cm of the bus is welded instead of the typical 15 cm welded. When a piece of broken cell is placed on top of another cell (defect B-3, cells E10, F9 and F10), what it really generates is a partial shading. It could simulate an important permanent bird crap. These types of defects are analyzed as they ordinarily appear in commercial modules in operation, either in manufacturing, transport or operation. However, commercial modules are not accessible at the cell level. That is why an ad hoc module has been manufactured for the defects characterization.

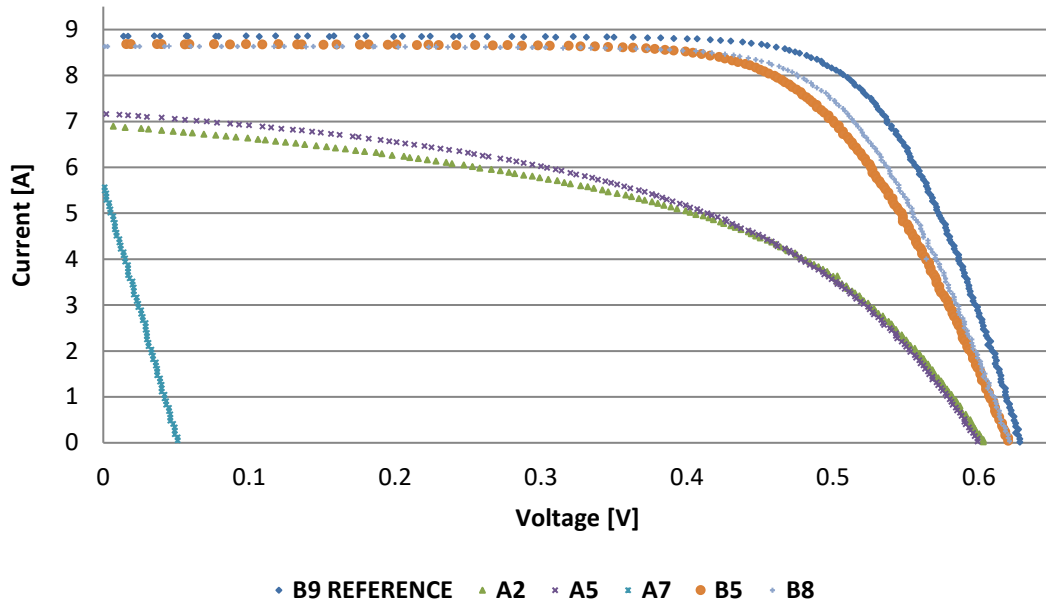
Fig. 4. I-V Curves of the manufacturing defective cells of the first string (string AB) at 1,000W/m², using B9 as the healthy reference cell of the string for comparison.

As it can be seen from Fig. 4 and Fig. 5, manufacturing defects are much more evident at higher irradiance levels, having a greater impact. Their Fill Factor (FF) is reduced at higher irradiance levels and therefore their maximum power output. The low efficiency cells (A2 and A5) and the medium efficiency cells (B5 and B8) have a mean FF of 48.19% and 69.54%, respectively, at 1,000 W/m², versus 73.36% of the reference cell of the string at the same irradiance level. Typical FF values of polycrystalline silicon cells at Standard Testing Conditions (STC), that is T=298.15 K, W=1000 W/m² and AM1.5 G spectrum, are 75% to 80% [18]. On the other hand, their FF at low irradiance level (100 W/m²) are 68.97%, 77.31% and 77.52%, respectively.

The medium efficiency defects present high values of series resistance (Rs) which can be seen in Fig. 4 as an increment in the curve slope at Voc and reduced FF. They also present low values of shunt resistance (Rsh), although not low enough to have a significant affection, as seen in the curve slope at Isc in Fig. 4. These facts are also appreciable in the modelled values in Table 3, in which Rs increases from 1.42 Ω/cm² in the reference cell B9 to 1.88 and 2.14 kΩ/cm² in B5 and B8, respectively, and Rsh decreases from 11.48 kΩ/cm² in the reference cell B9 to 4.21 and 4.97 kΩ/cm² in B5 and B8, respectively, using the single-diode model.

Otherwise, low efficiency cells have lower Rsh, which can be responsible of the decrement of Voc and the slope increment at Isc and higher Rs values, which additionally reduces the FF, as it increases the slope at Voc. Within the limitations of making a mathematical adjustment of these defective cells, which I-V curve is significantly different from the nominal one, they have also been modelled and their main parameters are in Table 3. At STC conditions it has been measured that the low efficiency defects can lead to an output power of 2.05 W, which compared with the reference cell of the string B9 that has an output of 4.08 W supposes a 49.76% of power loss. Within the limitations of modelling these curves, it is clearly observable uncommon ideality factor values n2 in cells A2 and A5.

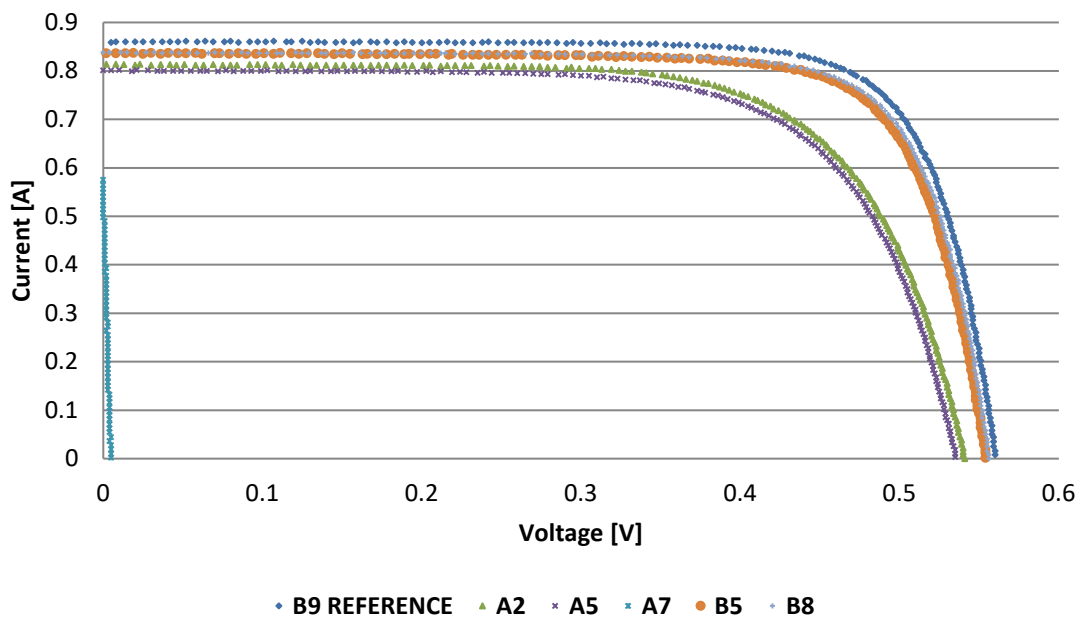
Fig. 5. I-V Curves of the manufacturing defective cells of the first string (string AB) at 100W/m², using B9 as the healthy reference cell of the string for comparison.

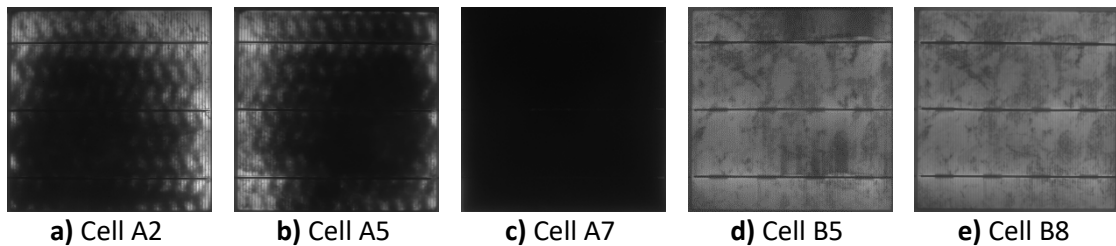
EL images of defective cells are showed in Fig. 6 and their indoor IRT in Fig. 7. IRT images have been taken with FLIR SC 640 IR camera. Their maximum and minimum temperatures in these conditions are (Fig. 7): a) $T_{max}=38.8^{\circ}\text{C}$ and $T_{min}=29.1^{\circ}\text{C}$. b) $T_{max}=40.6^{\circ}\text{C}$ and $T_{min}=30.8^{\circ}\text{C}$ and c) $T_{max}=33.0^{\circ}\text{C}$ and $T_{min}=27.6^{\circ}\text{C}$. Cells A2 and A5, which correspond with low efficiency cells, experiment a local overheating in the emitting area as it can be seen in the IR images presented in Fig. 7, a) and b), respectively. The short-circuited cell, A7, does not emit any light during EL as it can be seen in Fig. 6 c) and its whole area is seen colder in thermography, as seen in Fig. 7 c). Traditionally, when a cell or group of cells operates at abnormal temperature in a PV system it has been labelled as *hot spot* and this situation has been said to exist when a solar cell within a module generates less current than the string current of the module or of the PV generator [31]. This occurs when the cell is completely or partially shaded, damaged, or when cells are electrically mismatched. The shaded cell becomes reverse biased and dissipates power in the form of heat, which can be detected with IRT. Here, authors propose a new term, *cold spot*, defined as cell or group of cells at abnormal low temperature in a PV system. This effect is evident in the non-emitting areas during an EL test, in which these areas remain colder, as shown in Fig. 7 c). During outdoor operation, the three defective cells in Fig. 7 get hotter than the rest of cells, revealing as hot spots in outdoor IRT. This fact will be further analyzed in section 3.4.

Fig. 6. EL images of the manufacturing defective cells of the first string (string AB) with an injected current of 8.9A. Images taken with PCO 1300 camera, with a focal distance of 4 cm and exposure time 40s.

These low efficiency defects can be due to manufacturing imperfections. In Fig. 6 a) and b) it can be seen as a tire imprint in the cell EL images, which can be due to temperature inhomogeneity of the transport belt during the firing process of the cell producing [18]. Additionally, there is a central part in the cell that does not emit in these cells, which can be due to temperature inhomogeneity during firing process of the cell manufacturing that leads to center edge gradient

of contact resistance of the cell finger metallization [18]. Each of these two defects are classified separately as a failure that has no effect on safety with a power low below detection limit of 3% by the International Energy Agency (IEA) [18]. However, it has been seen that in this case there is a 49.76% of power loss.

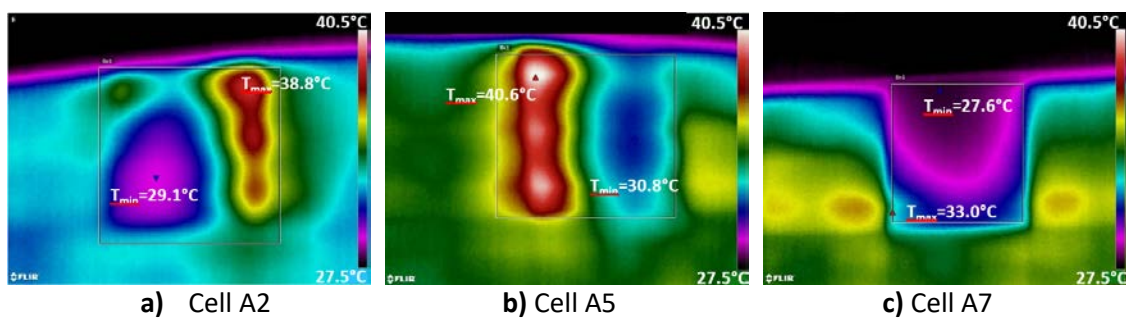
Fig. 7. Indoor IRT images of the low efficiency (a and b) and the short-circuited (c) defective cells of the first string (string AB) during EL tests, injecting current of 8.9A.

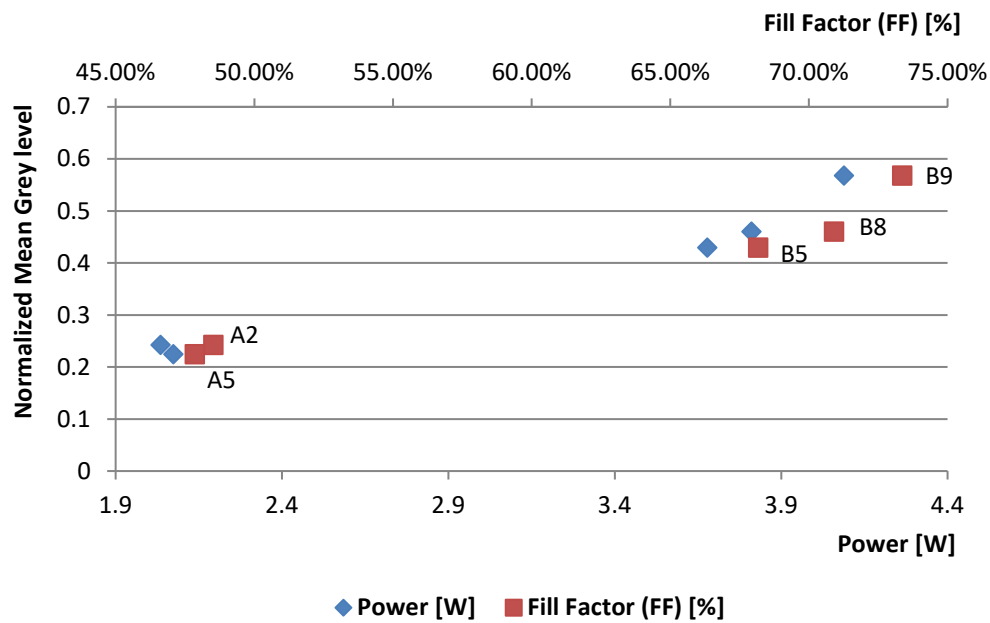
It has been observed a tendency to decrease the light emission during EL tests with the efficiency drop. An individual histogram of the luminescence intensity of each defective cells has been obtained. The mean value of the resulting histogram is presented in Fig. 8 versus their power and FF. Cells A2 and A5 have the lowest power, FF and light emission levels while the reference cell B9 has the highest values.

Fig. 8. Normalized Mean Grey level of the manufacturing defective cells of EL images captured with a PCO 1300 camera of 12 bits.

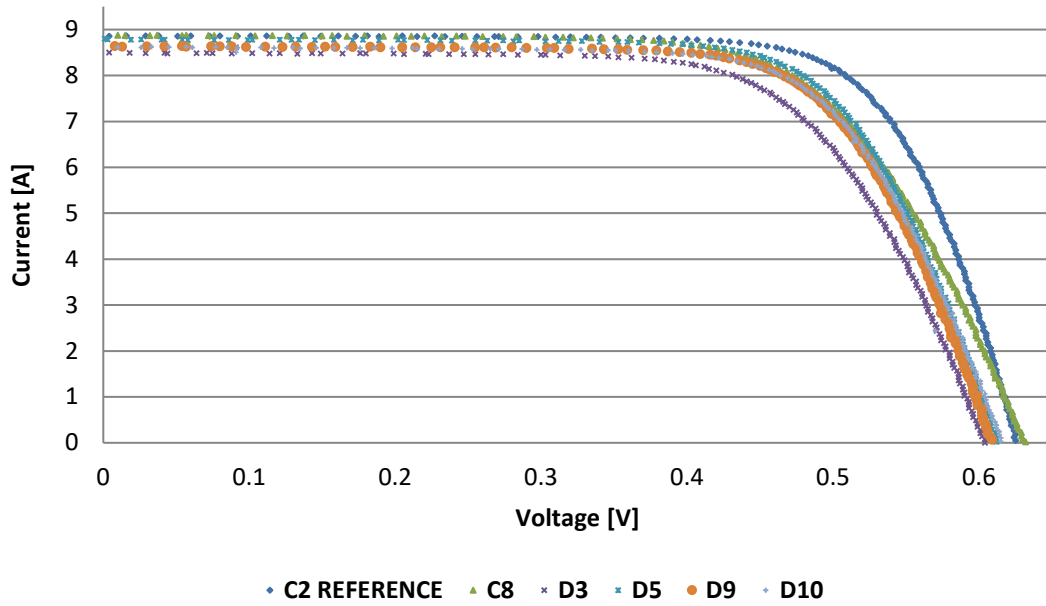
The electrical characteristic curves of the defective cells in the module string with soldering faults at 1,000 and 100 W/m² are presented in Fig. 9 and Fig. 10, respectively, and the statistical values of the main parameters of the I-V curve of the 20 cells of this string at 1,000 W/m² are presented in Table 4. It can be seen that these cells present smaller parameter deviations than the previous defects, appearing the maximum coefficient of variation in the power (3.69%).

Fig. 9. I-V Curves of the soldering defective cells of the second string (string CD) at 1,000W/m², using C2 as the healthy reference cell of the string for comparison.

The cell with only one centimeter welded (defect S-C. cell C8) simulates a bad soldering in which only one centimeter of the three buses is welded instead of the typical fifteen centimeters. In this case, all the current has to pass through a reduced surface, increasing the R_s of the cell (and of the module. consequently). This fact can be seen in Fig. 9 C8 cell I-V curve, in which the curve is strongly affected by the sR_s near the V_{oc} . Its R_s value could be estimated calculating the slope of the I-V curve at the V_{oc} . The V_{oc} is not affected by this R_s since the overall current flowing through the solar cell and through the resistance at this operation point is zero. The main impact of R_s is to reduce is nominal FF, although excessively high values may also reduce the short-circuit current [32].

The experimental FF values for C8 at 1,000 and 100 W/m² are 67.5% and 74.7%, respectively, versus 73.75% and 75.79% of the reference cell C2 at the same irradiance levels. As it can be seen, the current level has great impact on the losses due to R_s , having higher losses at higher current levels. The power loss in defective cells C3, D5, C8 and D9, described in Table 1, at STC conditions (Fig. 9) with respect the reference cell are 1.36%. 6.06%. 7.43% and 8.90%, respectively. However, at 100 W/m² (Fig. 10), this loss is just 0.28% in C8 and 0.83% in D9, while the fall in the rest of cells is negligible. It can be then concluded that the power loss at STC conditions when there is a bus not welded (with two buses collecting the electricity. as in C3) has just a 1.36% losses, which is less than the manufacturer tolerance of 2%. When there are two buses not welded (with just one bus out of three collecting the electricity, as in D5) it increases to 6.06%. However, there are more losses when there is a I, as the R_s is considerably increased, achieving the power loss 7.43% in C8. Additionally, it can be seen how having all tabs loose may not interrupt the current in a new manufactured module, as in cell D9 in the module used in this research, in which the power loss is 8.90% in spite of not having any tab welded. In this case, they can do electrical contact despite not being welded, and its influence is not disastrous. This fact could be altered after some years of operation of the module in which the encapsulation is exposed to thermal cycles (which can move from negative degrees at night to more than 40-50°C during the midday) and can begin to lose its compressive properties losing contact.

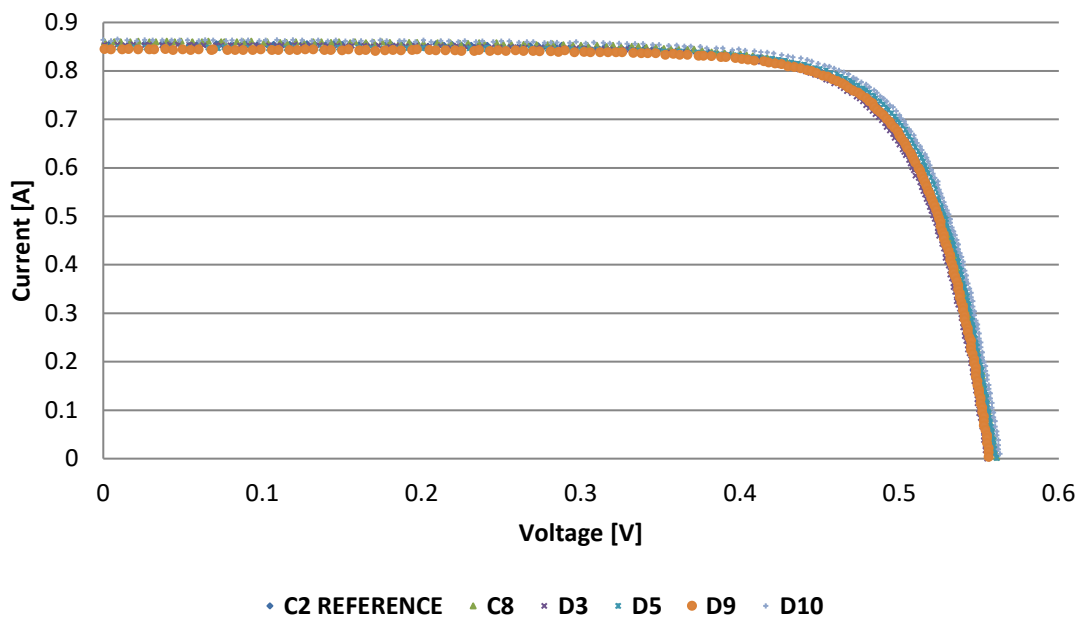
Fig. 10. I-V Curves of the soldering defective cells of the second string (string CD) at 100W/m², using C2 as the healthy reference cell of the string for comparison.

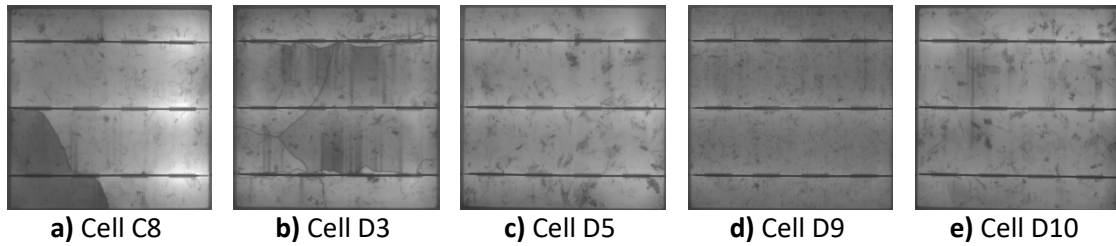
The EL images of the faulty cells with an injected current of 8.9A are shown in Fig. 11. Soldering defects are not visible in EL. It could be because they are made on the backside of the module. An additional analysis has been performed to check if these defects are visible with IRT performed from the backside of the module in short circuit current injection conditions. The IRT image of the backside of the whole module can be seen in Fig. 12 a). Images taken with FLIR SC 640 IR camera. The maximum and minimum temperatures in C8 cell in these conditions are: $T_{max}=38.2^{\circ}C$ and $T_{min}=29.6^{\circ}C$. In these conditions, it is seen in Fig. 12 a) that the only defect which certainly experiment an overheating is cell C8, corresponding the heating area with the centimeter of the three buses welded. This is clearly seen in Fig. 12 b), in which an IRT of the backside of cell C8 is presented. Therefore, defects with one or more buses not welded in the backside of the cell (cell C3 and D5) are apparently neither detectable using indoor IRT. It could be due to the metal sheet that covers the complete cell backside, which uniformly distributes the current that can be collected by the properly welded buses and the heat. Hence, hot spots

Fig. 11. EL images of the soldering defective cells of the second string (string CD) with an injected current of 8.9A. Images taken with PCO 1300 camera, with a focal distance of 4 cm and exposure time 40s.

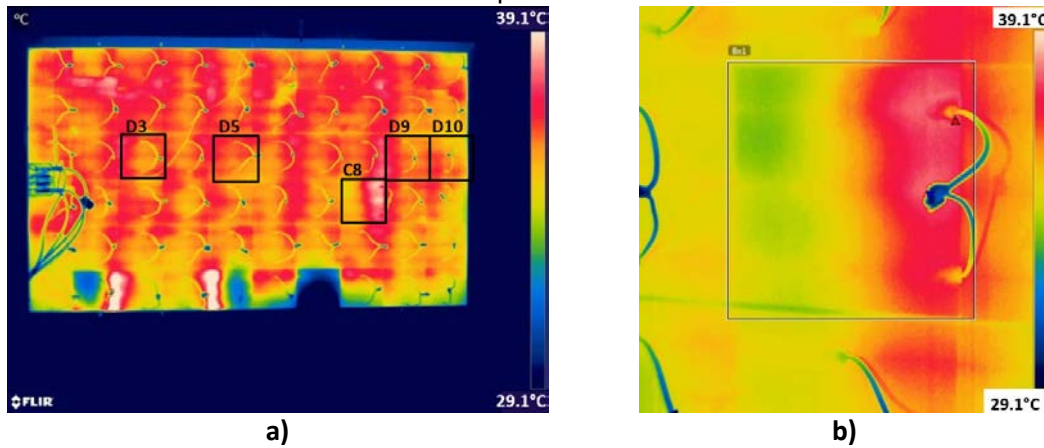
appear to be just detectable when there is a local soldering defect in just a part of the bus, as in this case the defect considerably increases the R_s , as it has been previously seen.

Fig. 12. Indoor IRT images of the backside of the module (a) and of the C8 cell (b) during EL tests, injecting current of 8.9A.

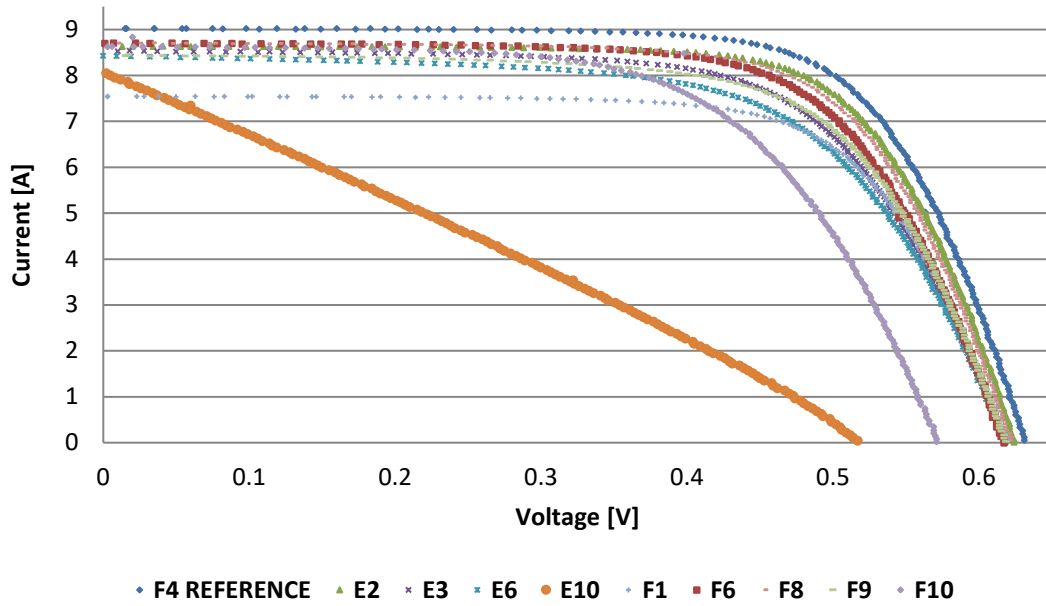
The electrical characteristic curves of the defective cells in the module string with breaking faults at 1,000 and 100 W/m² are presented in Fig. 13 and Fig. 14, respectively, and the statistical values of the main parameters of the I-V curve of the 20 cells of this string at 1,000 W/m² are presented in Table 5. It can be seen that the maximum coefficients of variation appears in the I_{mpp} (11.62%) and in the power (16.11%), similar to the manufacturing defective cells variations and higher than in the soldering defects string.

Fig. 13. I-V Curves of the broken defective cells of the third string (string EF) at 1,000W/m², using F4 as the healthy reference cell of the string for comparison.

The study of cracks in cells is similar to the shading case. In general, the shadow may be fully or partially according to the percentage of area that shades the PV module or PV cell. The amount of current that a healthy cell can produce is directly proportional to its unshaded area [30,33]. In case of a cracked cell in which the crack produces an electrical disconnection of a specific area from the rest of the cell, the current of the cell will be reduced proportionally to the disconnected area. The shape of the I-V curve of the affected cell will be very similar to the nominal equivalent cell but decreasing the current proportionally to the disconnected area. The Voc is also slightly decreased. This fact can be seen in Fig. 13 to Fig. 14, cell F1. The breakage in the cell electrically disconnect some part of it (one sixth, approximately). Therefore, the Isc current in this cell will be decreased in that same proportion, from 9 A in the reference cell (F4) to 7.5 A, as seen in the I-V curve. Similarly occurs in E2, E3, E6, F6, F8 and F9.

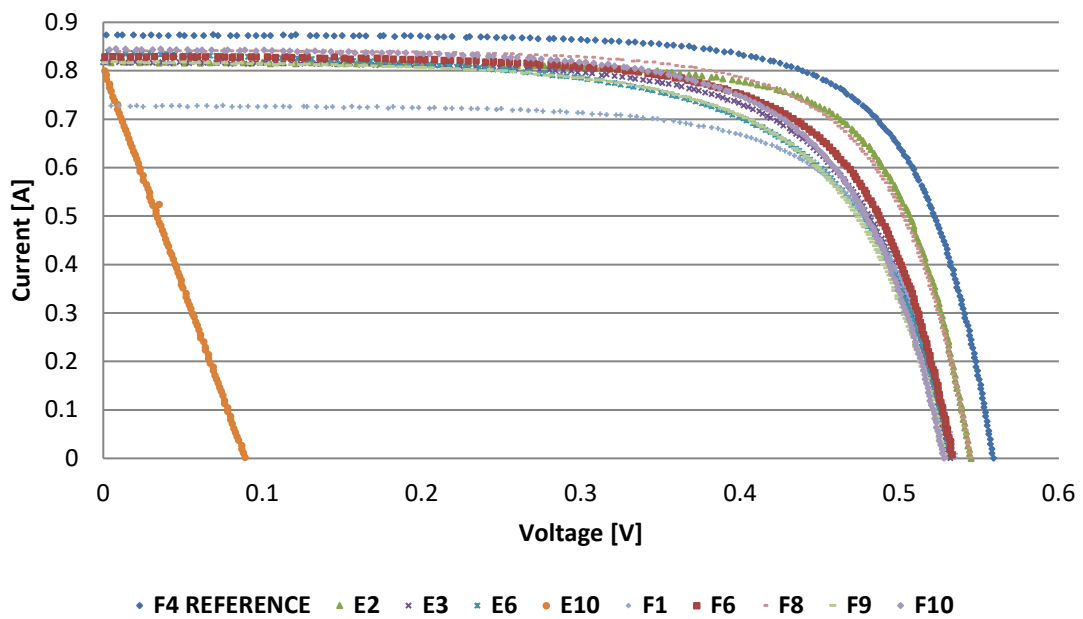
Fig. 14. I-V Curves of the broken defective cells of the third string (string EF) at 100W/m², using F4 as the healthy reference cell of the string for comparison.

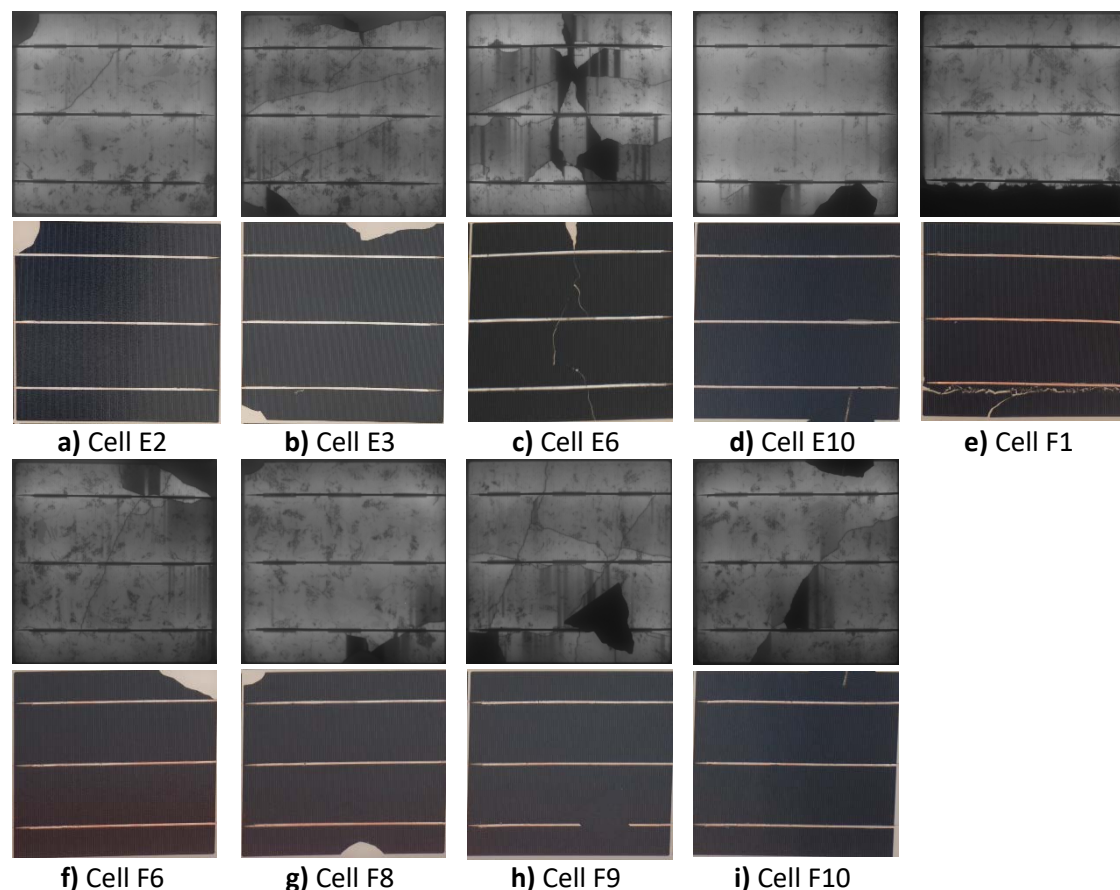
The EL images of defective cells, complemented in this case by their corresponding RGB images that allow seeing the breaking patterns, are shown in Fig. 15.

Fig. 15. EL and RGB images of the broken defective cells of the third string (string EF) with an injected current of 8.9A. EL images taken with PCO 1300 camera, with a focal distance of 4 cm and exposure time 40s.

As it can be clearly seen in Fig. 15 e), the breakage in F1 cell electrically disconnect some part of it, which corresponds with the one sixth previously cited. It is important to notice that not all

dark regions in EL corresponds with disconnected cell areas. Different is the case of cell E10, in which there is a piece of other cell over placed in the front part of the cell and it generates a parallel electrical path which is responsible of a small Rsh in the cell turning the I-V curve into a straight line, as seen in Fig. 13 cell E10.

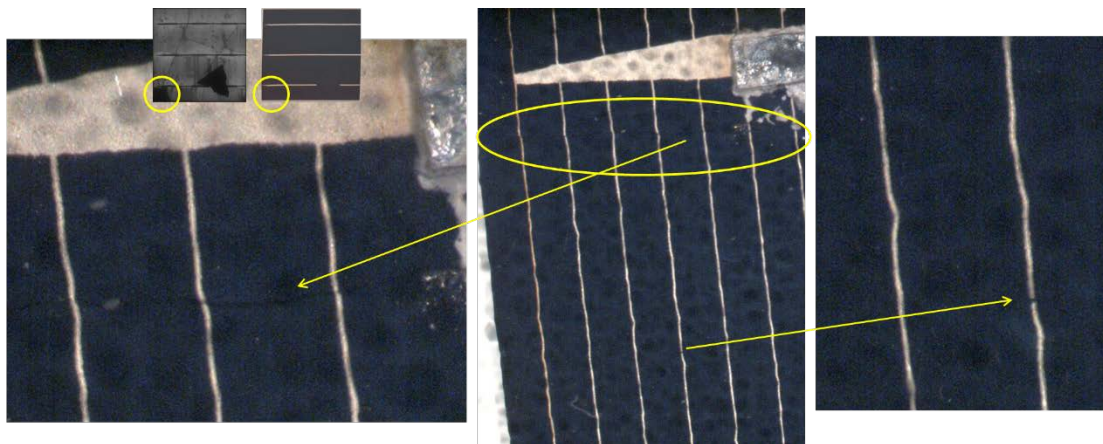
Failures like cell cracks, solder corrosion or broken cell interconnects have no limits in power loss and the PV module may become unusable [18]. Two distinct types of dark areas are observable in the EL images (Fig. 15), irregularly shaped regions and regular rectangular shaped areas. The irregular areas indicate the presence of cracks in the silicon wafers. However, the presence of regular rectangular dark areas can be due to broken front grid fingers, which are broken at the busbar [34,35] Finally, an optical microscope has been used for imaging a crack in cell F9 solar cell, which displayed a dark irregular area in the crack zone in the EL measurement (Fig. 16). It proves how a small crack, not visible for the human eye, can isolate a part of the cell.

Fig. 16. Optical micrographs of a crack in F9 solar cell which displayed a dark irregular area in the crack zone in the EL. Images captured with a Nikon SMZ 800 microscope.

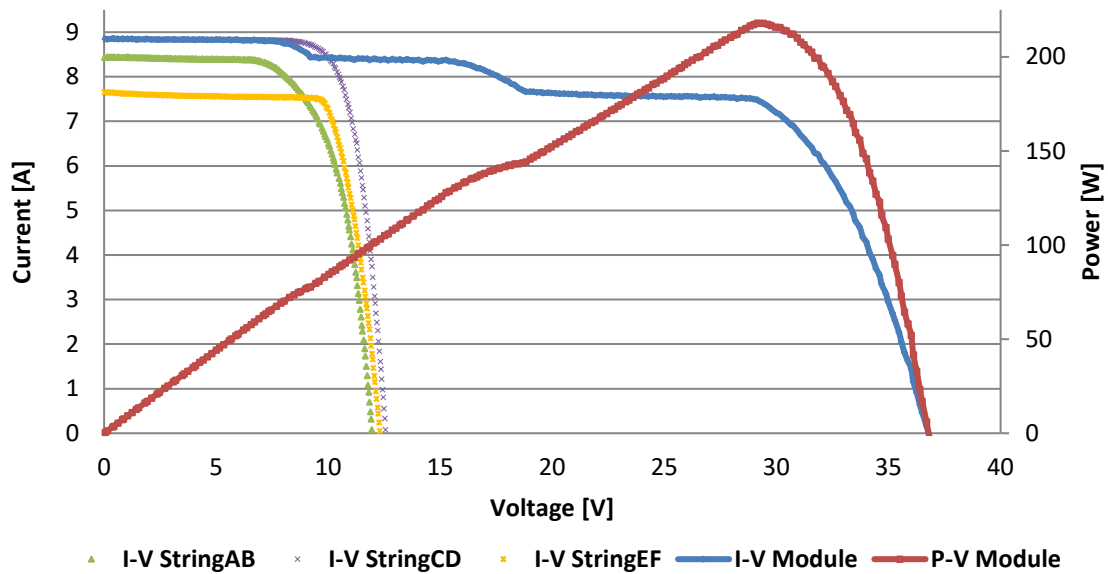
respectively. In Fig. 17, it can be seen that the most restrictive string is the breaking defects string (EF) with an I_{sc} of 7.65A, followed by the manufacturing defects string (AB), with 8.43A and the highest current and power is in the soldering defects string, with 8.84A.

Fig. 17. I-V Curves of the complete module and separate strings at $1,000\text{W}/\text{m}^2$. The secondary axis presents the P-V curves of the module at this irradiance.

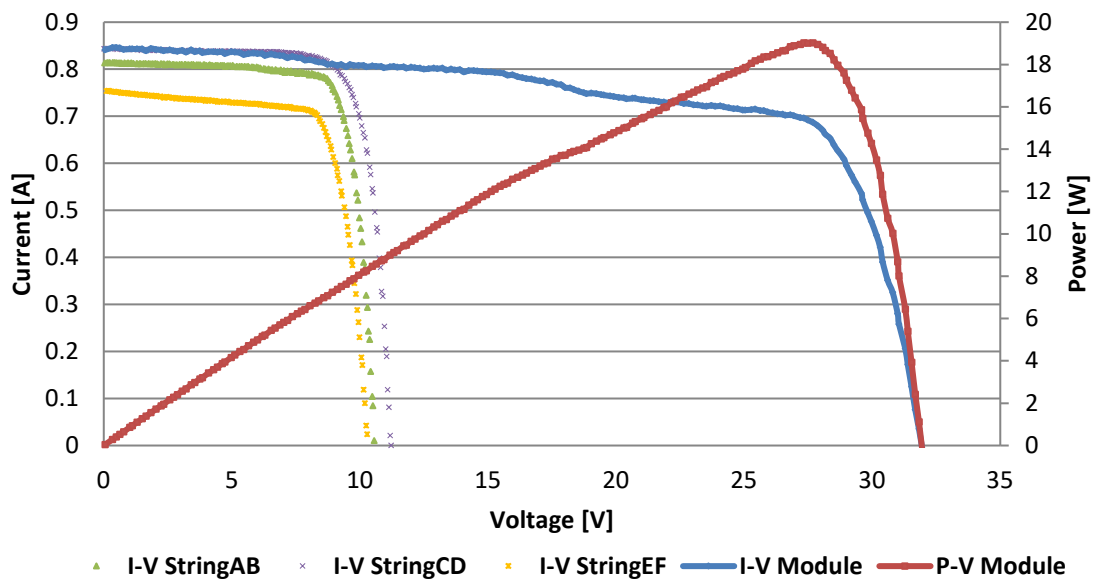
In this module, there is a total of three bypass diodes, one each 20 cells. As it has been seen, each bypass string contains different defects (of manufacturing, soldering and breaking cells) and each of them is able to produce a different current. Therefore, the electrical characteristic curve of the whole module, which is composed by the three bypass circuits in series, will contain three steps, each at the I_{sc} of each bypass circuit. The electrical characteristic curves of the three bypass strings and of the module at 1,000 and 100 W/m^2 are presented in Fig. 17 and Fig. 18,

Fig. 18. I-V Curves of the complete module and separate strings at $100\text{W}/\text{m}^2$. The secondary axis presents the P-V curves of the module at this irradiance.

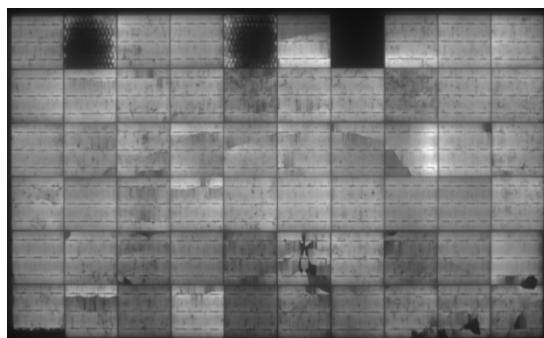
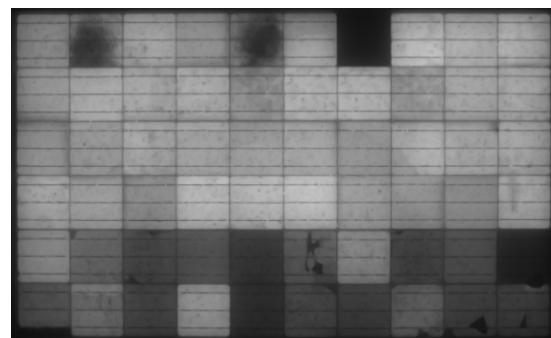
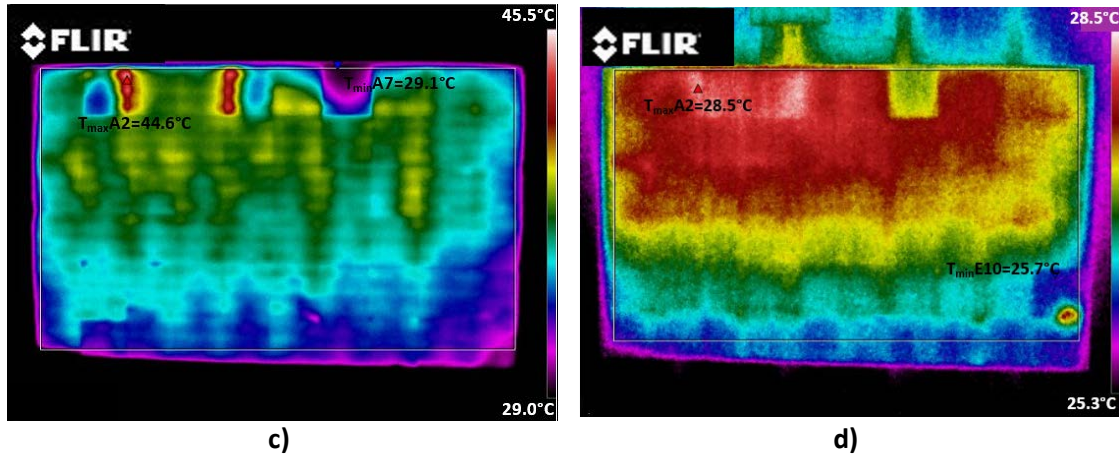
The effect of a shunt resistance is particularly severe at low light levels, since there will be less light-generated current. There is a clear tendency to increase the shunt resistance on lower irradiance levels in illumination tests [37]. This effect is observable also at low injected currents while performing EL test, as seen in Fig. 19 a) and b). Following with the discussion introduced in section 3.3, this effect is extremely evident in cell E10, in which the shunt resistance increment at low injected current is responsible of appearing almost black in this case. In Fig. 14 it has been seen the impact of this high R_{sh} at low irradiance levels in the I-V curve. Fig. 19 c) and d) presents the indoor IRT images during this EL test. In these IRT images, it can be seen that the temperature of the manufacturing defects (cells A2 and A5) significantly increases with the injected current, being the maximum temperature of cell A2 44.6°C and 28.5°C with 8.9A and 0.89A injected, respectively. The rest of defects (soldering and breaking cells) experiment negligible temperature gradients compared to manufacturing defects.

Fig. 19. EL (a and b) and indoor IRT (c and d) images of the tested module with an injected current of 8.9A (a and c) and 0.89A (b and d). EL images taken with PCO 1300 camera, with a focal distance of 4cm and exposure time 50 s (a) and 15 min (b).

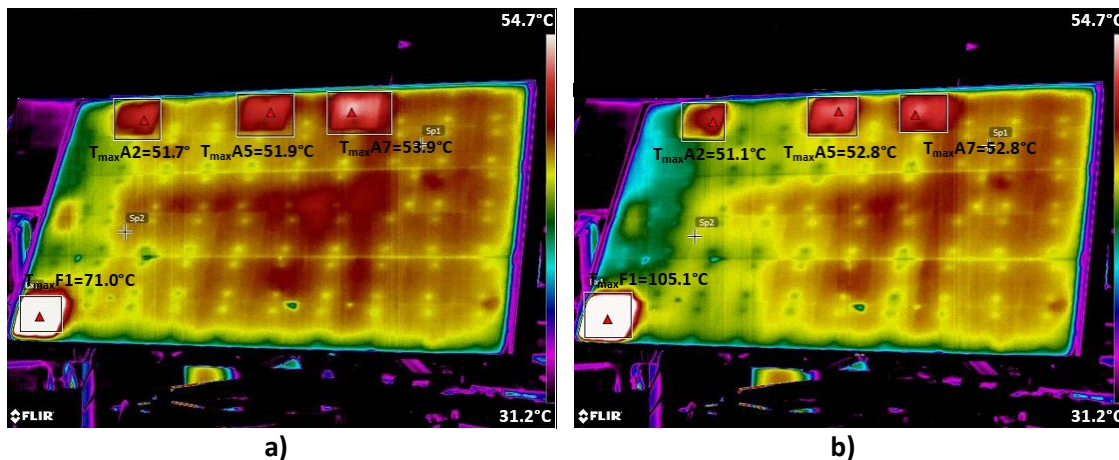
Two different operation points of the outdoor IRT at the irradiance of 933 W/m^2 are presented in Fig. 20, in the lower current step of the I-V curve at 7.3 A-24 V (a) and in the middle current step of the I-V curve at 7.8 A-15 V (b). These IRT images have been taken with a FLIR SC 640 IR camera. The maximum temperature values of the different hot spots are indicated in the figures. Emissivity and reflected temperature values, calculated experimentally are 0.8 and -3.5°C , respectively. In Table 7 the maximum temperatures of the main thermal defects presented in Fig. 20 and delta temperature between them and a module healthy area are presented. It is interesting to notice that delta temperature remains almost equal in A2, A5 and A7 from the first to the second operation point (from 7.3 A to 7.8 A). At the low current step, the diodes are not operating, as seen in the combiner box in Fig. 21, in which all diodes are at the same temperature (42.1°C). However, in the second current step, at 7.8 A, the temperature in F1 increases a lot, as string EF has the most restrictive current in the module and throughout the bypass diode of this string has to circulate the current that the string is not able to do.

Fig. 20. Outdoor IRT images of the module in the lower current step of the I-V curve at 7.3 A-24 V (a) and in the middle current step of the I-V curve at 7.8 A-15 V (b) at 933 W/m^2 .

Operation point	7.3A and 24V (Fig. 20 a)		7.8A and 15V (Fig. 20 b)	
	Healthy area temperature= 47.4°C		Healthy area temperature= 46.6°C	
Cell	T _{max} [°C]	ΔT [°C]	T _{max} [°C]	ΔT [°C]
A2	51.7	4.3	51.1	4.5
A5	51.9	4.5	52.8	6.2
A7	53.9	6.5	52.8	6.2
F1	71.0	23.6	105.1	58.5

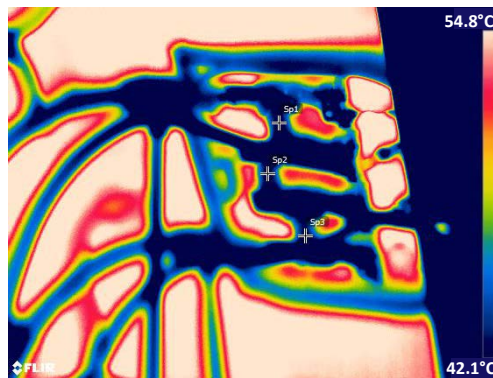
Fig. 21. Outdoor IRT images of the junction box of the module in the lower current step of the I-V curve at 7.3A and 24V. String diodes are at 42.1°C.

As it has been seen, the negative impact of faulty cells within a string is partly minimized by connecting bypass diodes parallel to a number of cells. The diode will conduct the current around the defective cell. It can be seen that in F1 hot spot heating occurs, as the rest of series connected cells (19 cells in this case) cause a reverse bias across the defective cell, that leads into a dissipation of power in this poor cell which has an area reduction of a sixth part.
