Observations from the March 2021 Thessaly Earthquakes: an earthquake engineering perspective for masonry structures

Abstract

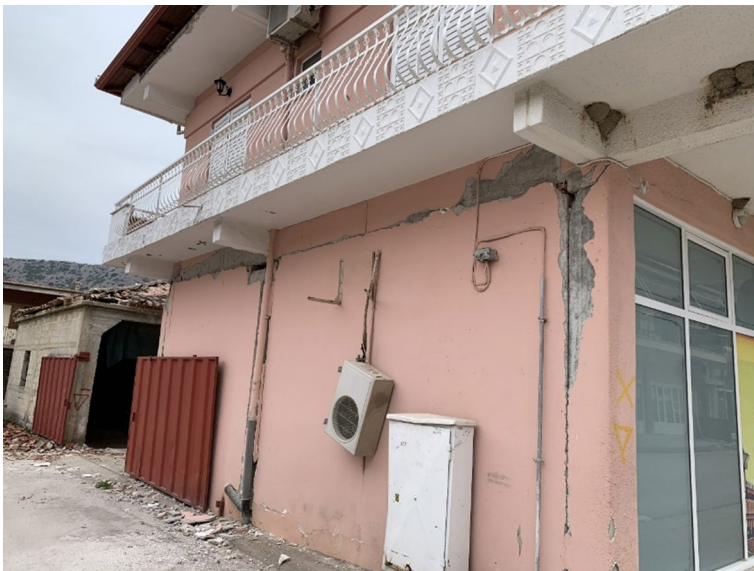
Fig. 8 Damage of infill walls in a RC building due to out of plane bending and shear damage in the column due to in plane infill behaviour in Damasi

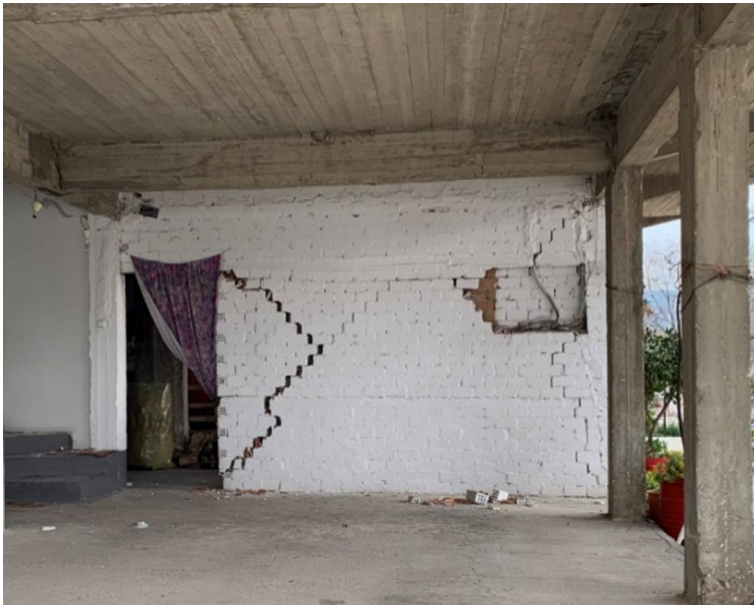
Figure 9 shows another example of in-plane shear failure of a poorly confined masonry wall in Mesochori. Cracking in masonry presents a diagonal shear crack formed in a zig-zag pattern.

Fig. 9 In plane shear failure of poorly confined masonry wall due to door opening in Mesochori

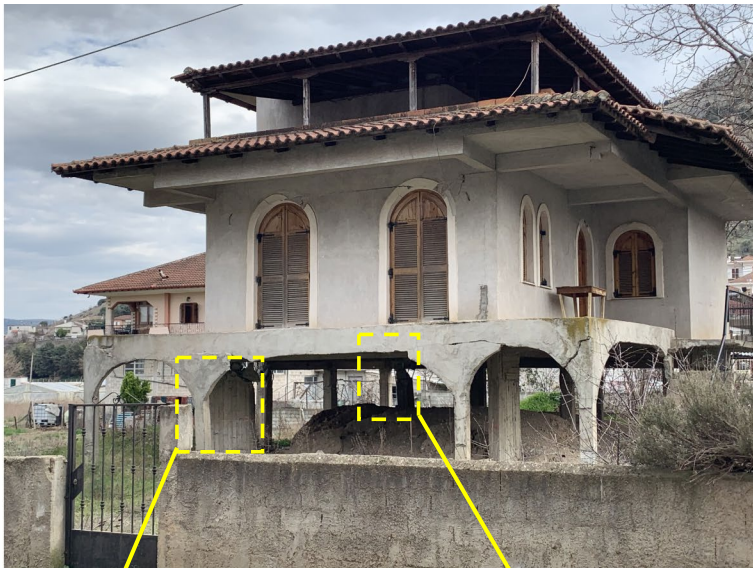
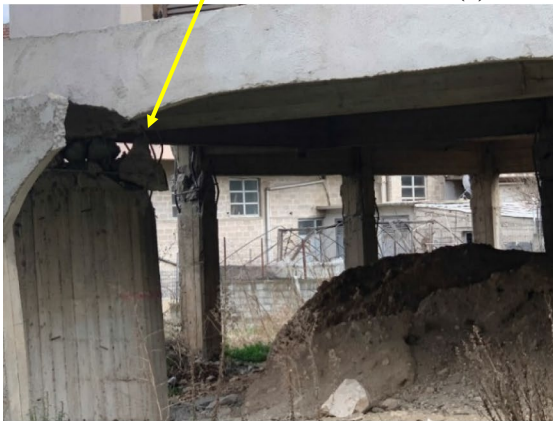
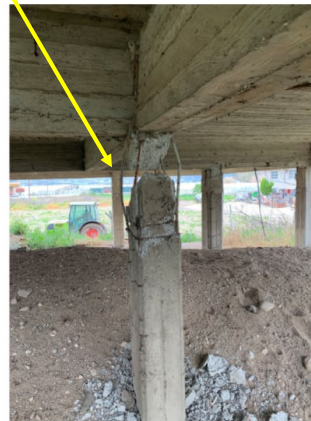
Severe damages to RC buildings were observed mainly in soft-storey ground floors (called pilotes in Greek, see Fig. 10a). These are buildings mainly designed and constructed before 1985. The lack of shear reinforcement accompanied with loss of stiffness due to open ground floors led to shear failures of columns and beam to column joints, see Fig. 10. Lack of appropriate horizontal reinforcement (stirrups) resulted in buckling of the longitudinal rebars of the columns (Fig. 10c). The strong beams remained undamaged, while severe damage and plastic hinges developed at the top of the columns. In other cases, where not enough reinforcement installed, diagonal shear cracking was observed in shear walls, see Fig. 11.

Fig. 10 Strong beam-weak column of a residential building in Damasi

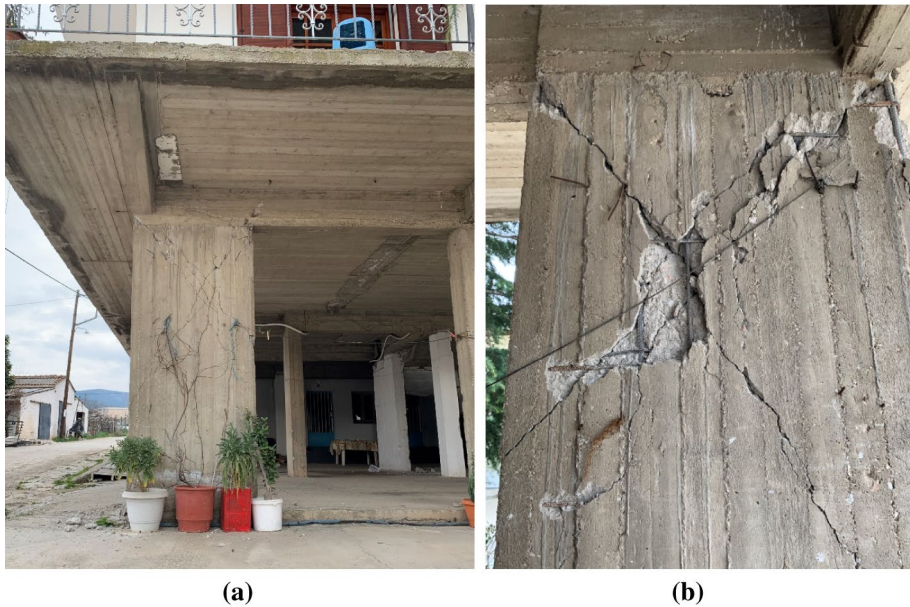
Fig. 11 “X” shaped failure of a shear wall located near the top in a RC building **a** face of the shear wall; **b** back of the shear wall at the corner of the building

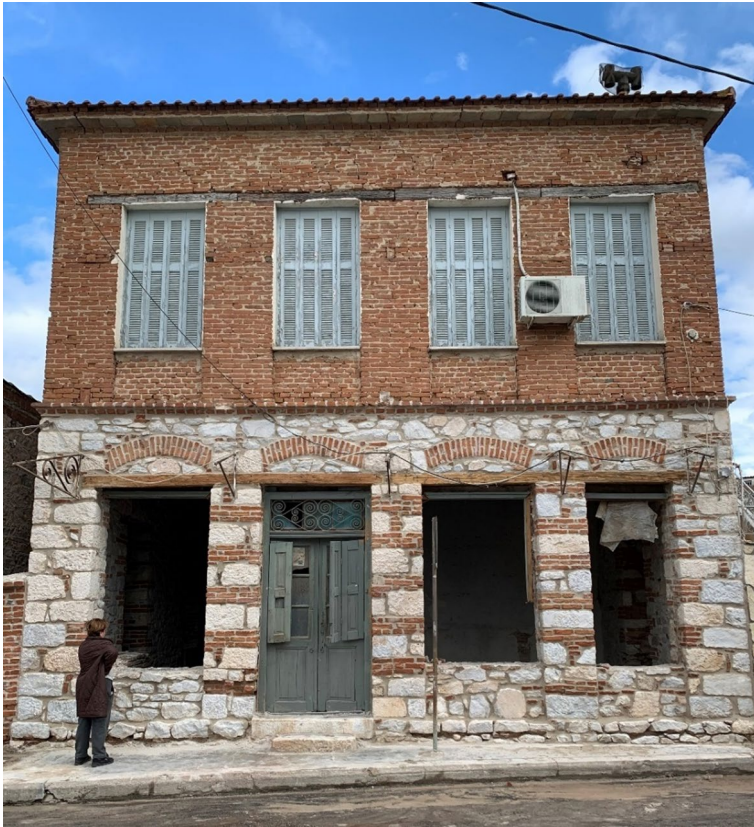
Fig. 12 Masonry house with large openings and wooden lintels above openings in Tyrnavos. The ground floor is made of stone masonry while the first floor is made of clay bricks

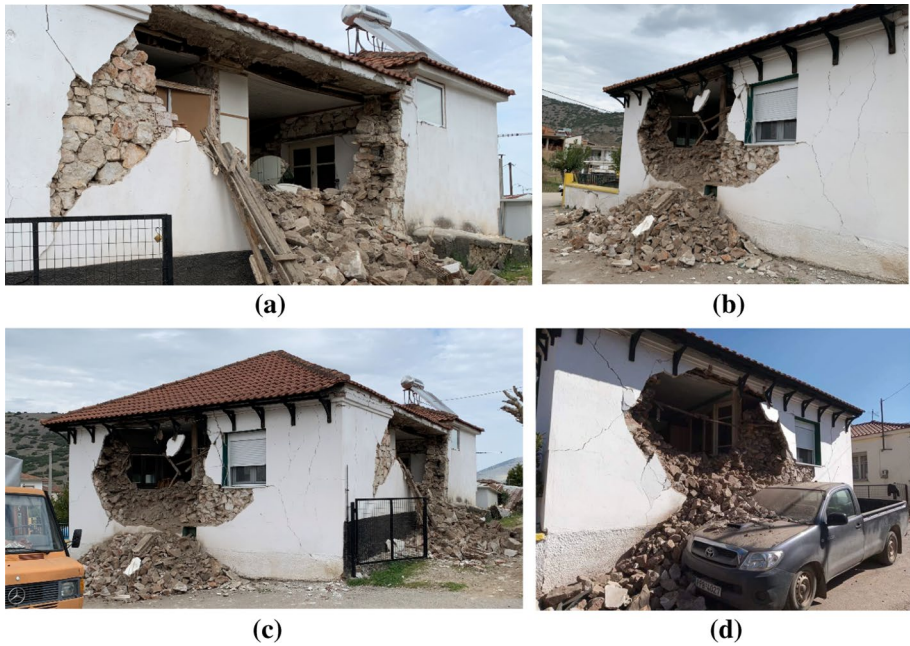
buildings in Damasi and Mesochori. Figure 13 shows some examples of out-of-plane failure of masonry walls. It is evident from Fig. 13 that, although the thickness of the walls is adequate, these were constructed using mud as mortar, which is of very low strength and thus vulnerable to earthquake shaking (Lourenço 1998). Despite the fact that Fig. 13 does not show a serious damage in the form of partial or total collapse, parts of the wall falling on the street causes many other secondary issues, such as blocking the passage of large rescue vehicles and damaging civilian cars.

Fig. 13 Out of plane collapse of masonry walls in Damasi, Greece

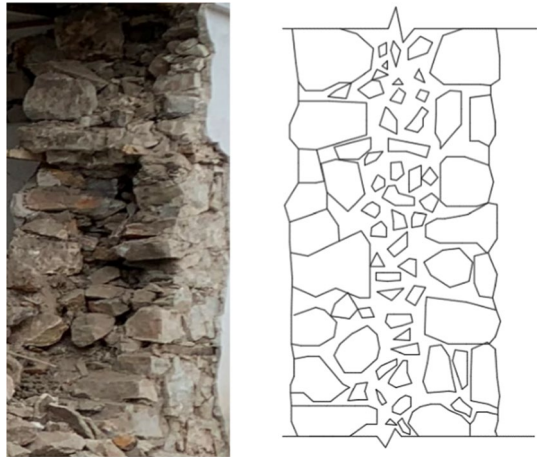
Fig. 14 Typical uncoursed random rubble stone masonry walls found in buildings in Thessaly region **a** view of the inner part of the thick wall; **b** cross-section of the wall (average thickness of walls is 0.5 m)

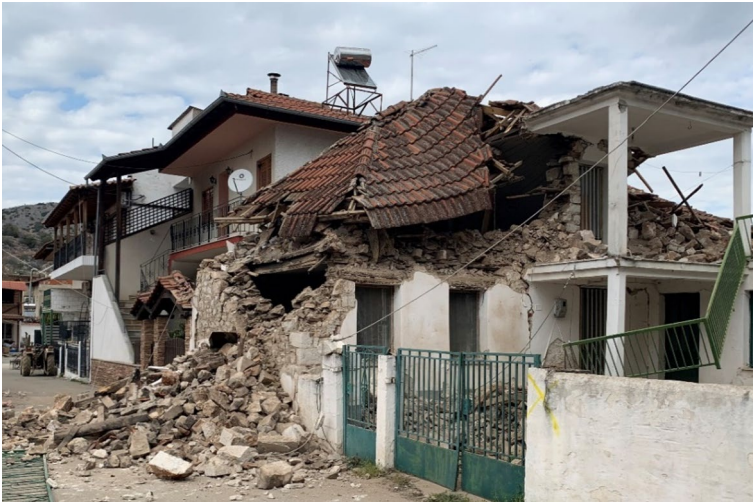
Fig. 15 Out of plane collapse due to poor connection between the roof and the underlying masonry and no rigid top floor, Damasi, Greece

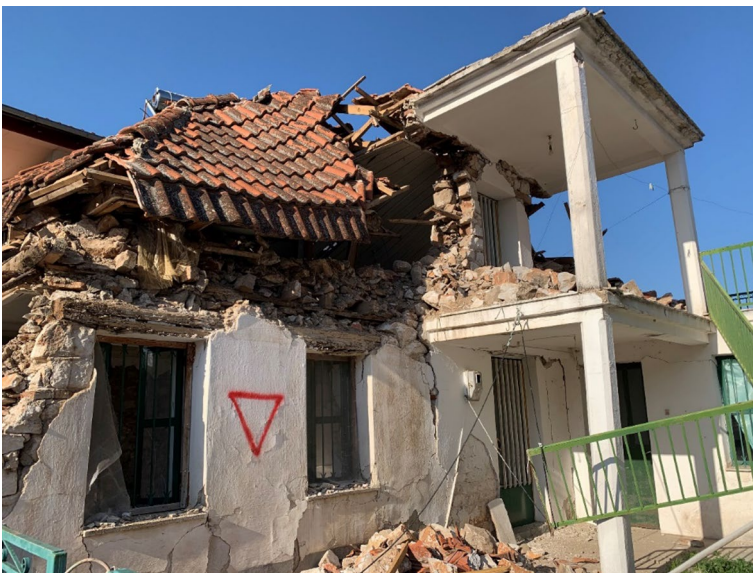
Fig. 16 Pounding failure due to different dynamic characteristics of structural components

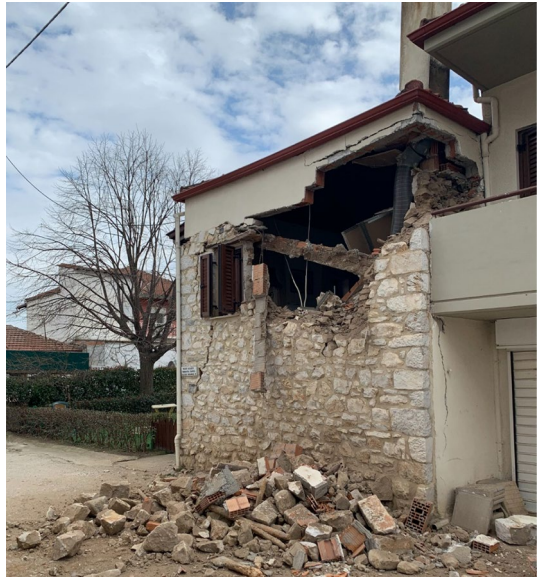
Fig. 17 Lack of an effective ring beam

layers of clay masonry units with a stronger mortar, which is a rather unfortunate design choice. The higher masonry ring beam may have caused redistribution of vertical compressive stresses and some parts of the masonry wall below, could result in becoming unloaded and prone to being unstable during the earthquake. In addition, the high stiffness of the masonry ring beam, which is able to carry large axial and bending forces has modified the natural vibration mode of the masonry walls and generated local high stresses in the masonry walls below the ring beam (Borri et al. 2016; Faella 2020). From Fig. 17, the lack of anchoring of the ring beam with the load bearing walls to resist loads from horizontal direction and the lack of strengthening of the wall are the main causes of the partial collapse.

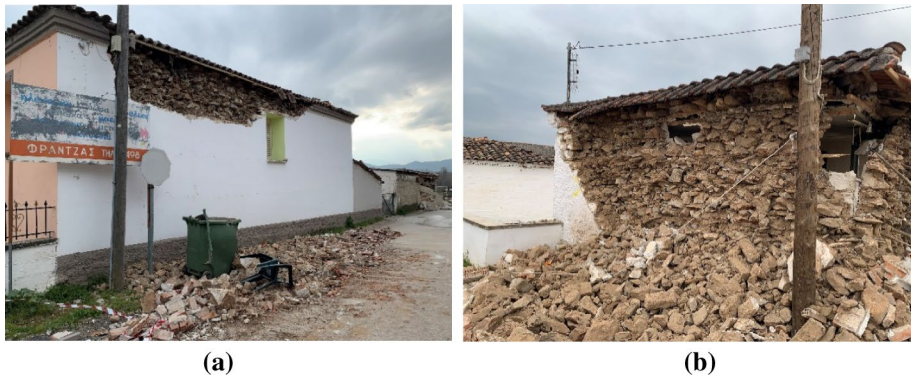
Another type of damage observed was that of bulging and delamination of the walls due to their outward buckling. The main reason for delamination was the absence of through stones or connection between the two-leaf walls as well as due to weak bonding between the outer wall and fill material. Delamination was mainly observed at the upper part of the walls. Since the space between the interior and exterior walls was filled with small stones and rubble bonded with mud mortar, connection between the two walls was inadequate. Figure 18 shows examples of delamination of masonry walls in buildings found in Meschiori. It is worth mentioning that delamination was formed in a trapezoidal shape. In some cases, delamination was observed only at the masonry walls (Fig. 18a), while in others it was a combination of the masonry walls and wall to wall intersections (Fig. 18b).

Fig. 18 Delamination of **a** the upper part; and **b** entire wall of a masonry buildings in Mesochori

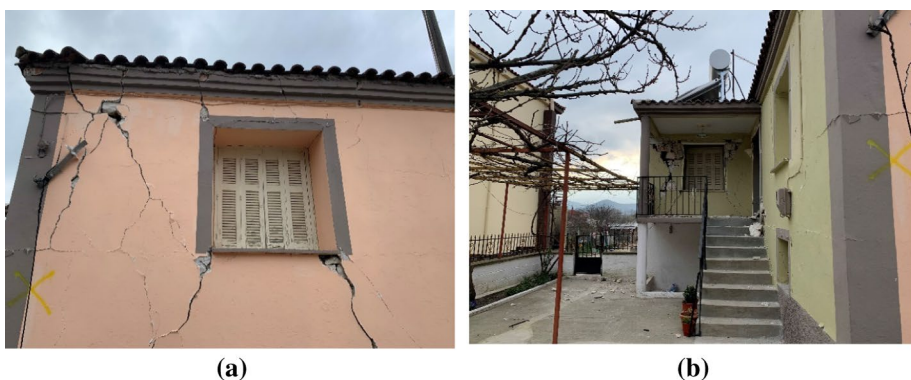
triangular sections of the cross-diagonal crack become unstable, and eventually it may lead to collapse with aftershocks. Typical, examples of diagonal shear cracks in load-bearing walls caused by the earthquake in Thessaly are shown in Fig. 19.

Fig. 19 Shear cracks due to diagonal tension in domestic masonry buildings in Mesochori

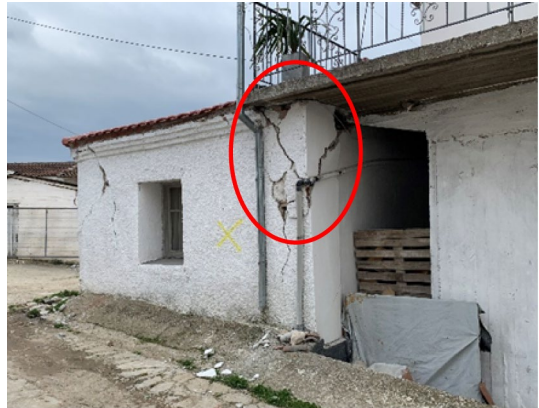
Figure 20 also shows pounding of the RC building slab into the masonry wall of the adjacent building. The RC slab of the reinforced concrete building penetrated in the corner of the masonry buildings at the wall to roof connection and created damage.

Fig. 20 Pounding between adjacent RC and masonry buildings

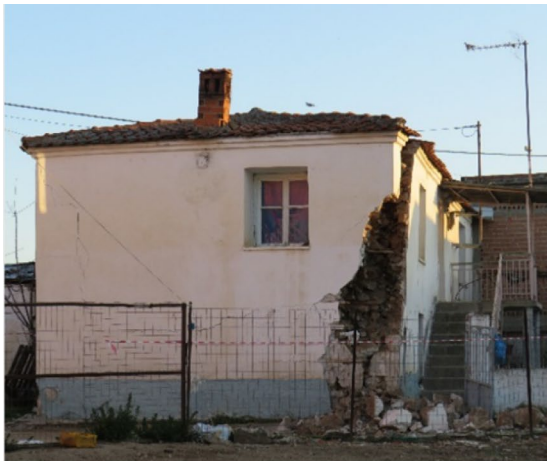
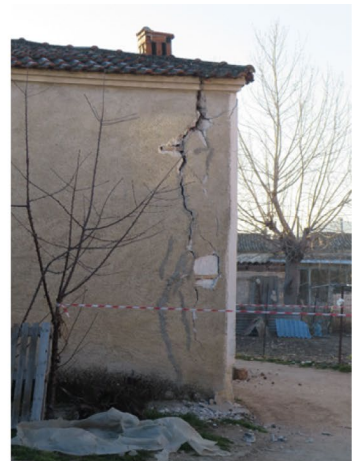
In addition, it was observed that severe vertical cracks and gaps formed and propagated along the height of bearing wall intersections, see Fig. 21a and b. Such damage was attributed to the lack of the horizontal diaphragms. Structural integrity formed due to the inadequate connections between the bearing walls at the wall intersections and between the bearing walls and the roof. From Fig. 21 the lack of diagonal shear cracks is evident which denotes that the walls acted independently along the in-plane and out-of-plane direction under the earthquake.

Fig. 21 Vertical cracks at corners of the buildings denotes the lack of diaphragmatic action of the roof and floor systems (Lekkas et al. 2021a, b)

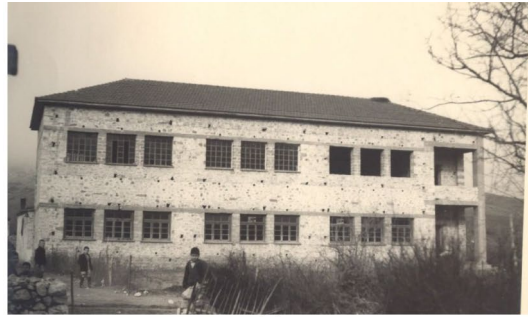
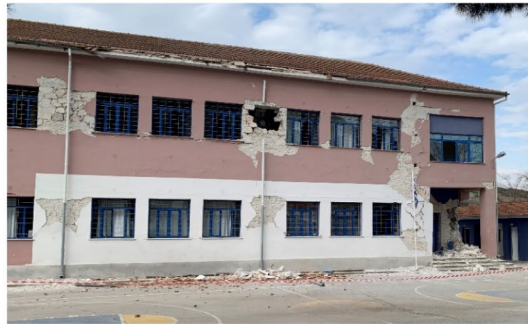
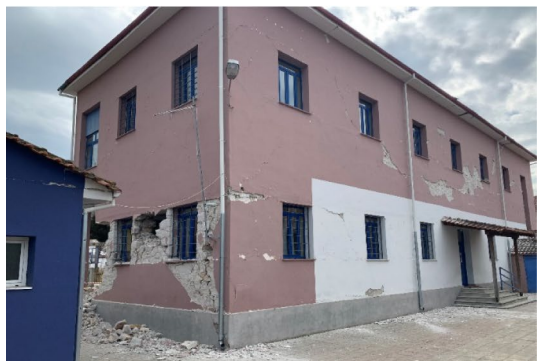
walls, lintels above window and door openings, beams, or bands at various heights etc. The failures observed in school buildings in Thessaly follow the typical damage typology of the masonry residential buildings. The extent of damage in the school of Damasi which was built in 1938 is shown in Fig. 22. Sixty-three students and their ten teachers were fortunately unharmed when some masonry walls locally collapsed. From Fig. 22, it can be observed that parts of the load bearing walls of the building failed in the out of plane direction while some diagonal shear cracks are evident between the window openings of the ground floor. Also, the front face of the school suffered more damage compared to the back side. This was due to the fact that more openings existed at the front of the school in which classes were located as opposed to the back side of the school in which there was the corridor to the classes. In the interior of the building, major diagonal shear failure at the masonry walls as well as separation of coating material from the masonry walls and overturning of chairs, desks and equipment occurred. The structure

Fig. 22 **a** Front view of the school from the 1940s; **b** front view of showing shear cracks and out of plane failure of the masonry walls; **c** rear view showing extensive shear failure of the piers between openings

was characterised as unsuitable and was demolished a couple of weeks after the first strong earthquake.

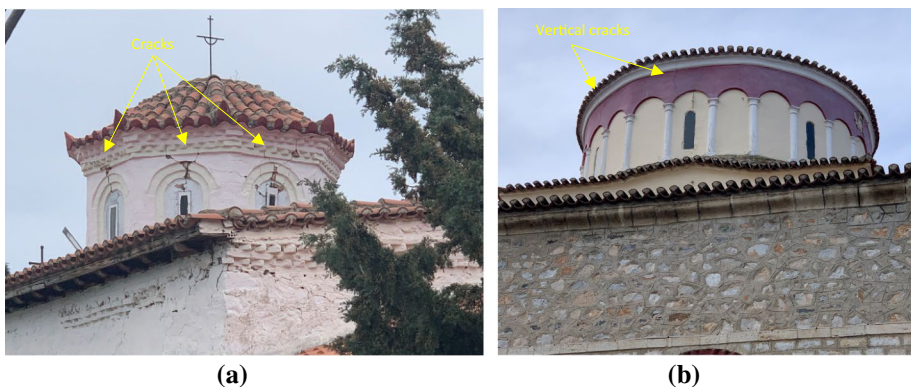
Fig. 23 Vertical cracks in arches and domes: **a** profitis Ilias in Tyrnavos; **b** Panagia Faneromeni in Tyrnavos

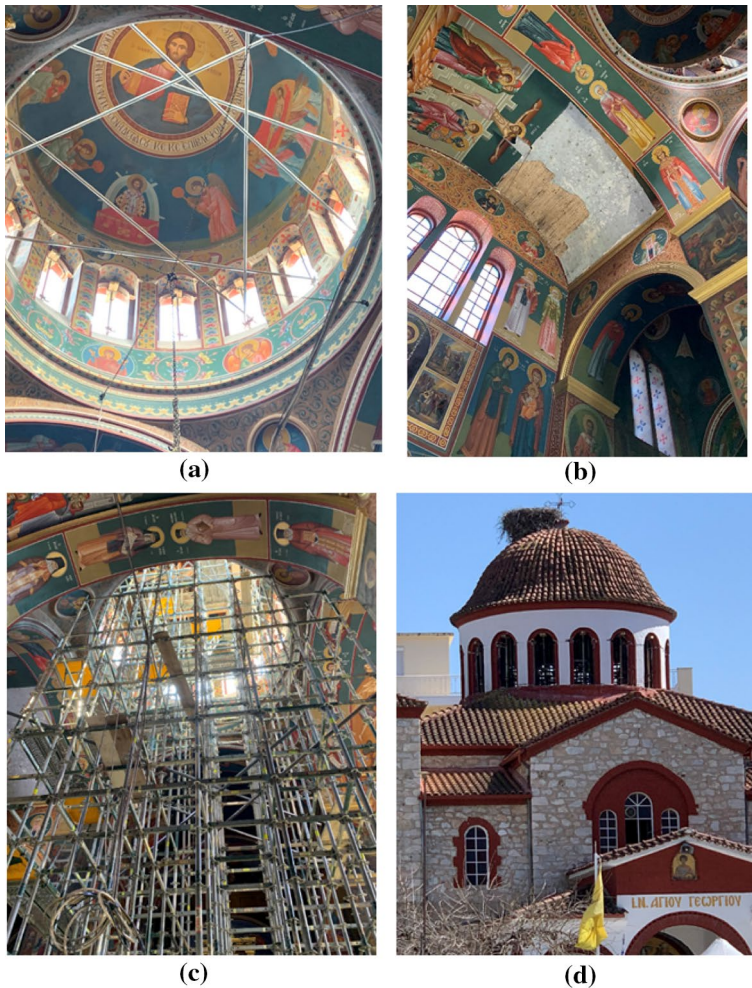
Fig. 24 Church of Agios Georgios in Tyrnavos: **a** Lateral springing thrust of the arches resulted in shear cracks in the slender piers supporting the wooden dome; **b** non-structural damages; **c** scaffolding for supporting of the arch dome; **d** external view

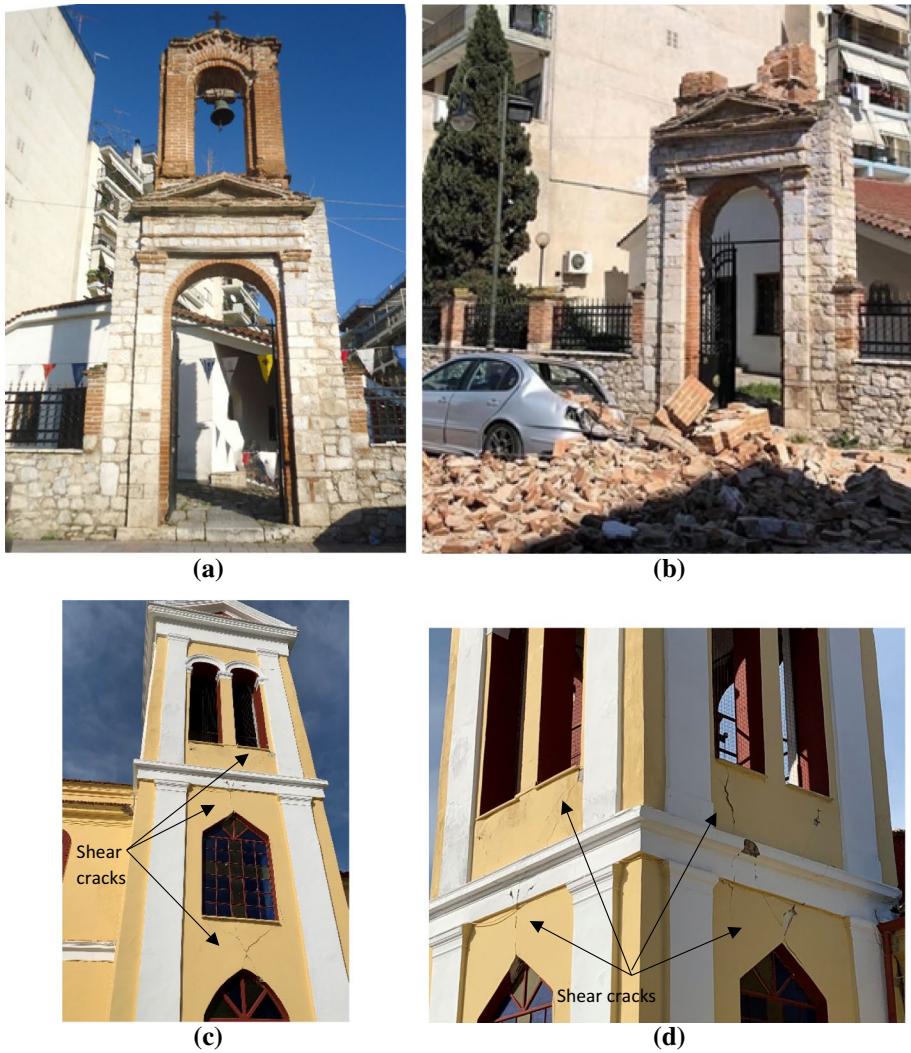
Fig. 25 **a** Bell tower of church of Agios Ioannis in Tynavos before the 3/3/2021 event (source: Tirnavospress.gr); **b** out of plane failure after the earthquake; **c** and **d** shear diagonal cracks between openings at the bell tower of the church of Agia Paraskevi in Tynavos

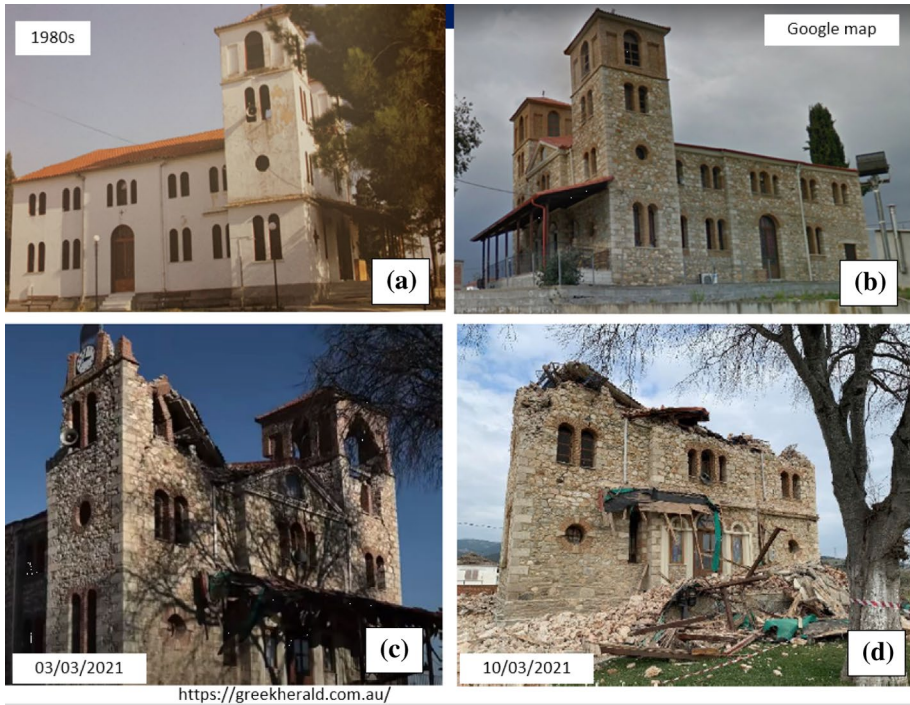
Fig. 26 Church of Agios Dimitrios at Mesochori **a** view from the 1980s; **b** before the earthquake; **c** after the main event of 3/3/21; **d** after the aftershocks on 10/03/21

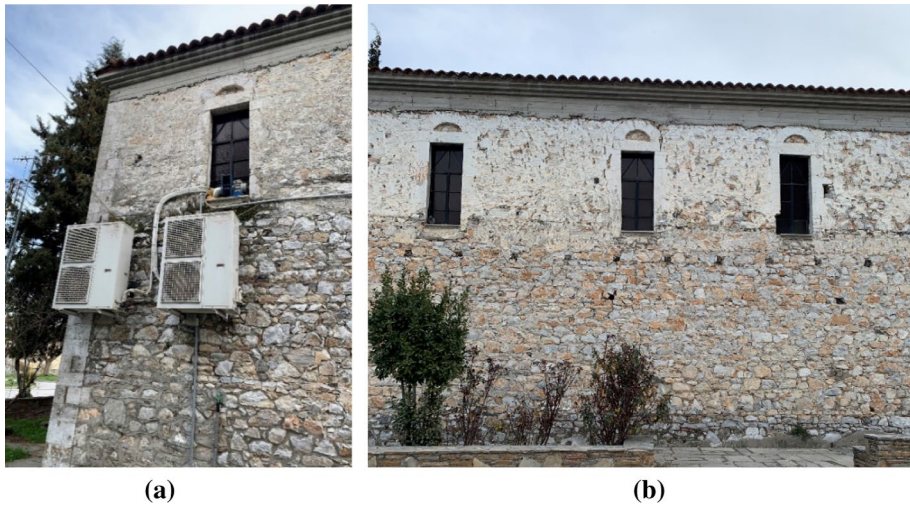
Figure 27 is an example of an effective retrofitting scheme to improve connection of the roof and the walls applied to a church in Tyrnavos. The reinforced concrete ring beam effectively kept the connectivity of the peripheral walls of the building and the roof together. In order for the retrofitting scheme to be effective, reinforced concrete ring beams should be introduced to avoid excessive increase in weight and stiffness

Fig. 27 Example of good quality RC ring beam which ensured connectivity of walls in a church in Tyrnavos

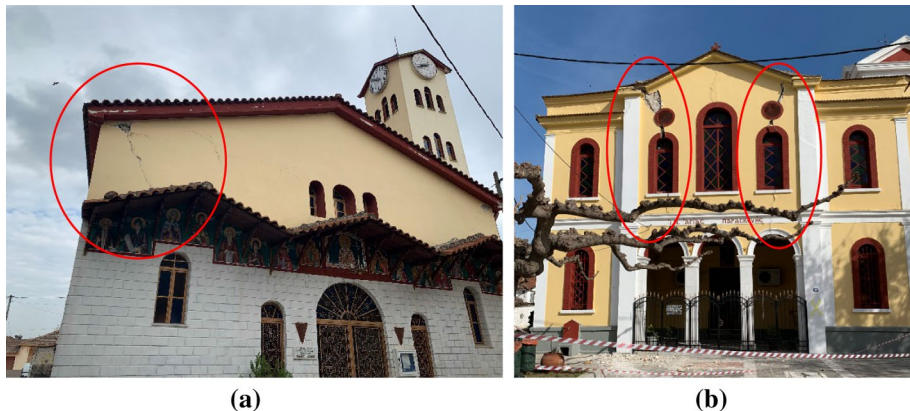
On the other hand, Fig. 28a shows a corner failure of the load bearing walls of a church due to out of plane movement which can lead to façade separation, while in Fig. 28b shear cracks occurred due to the large openings. Such cracks propagated from the window and door openings to the roof.

Fig. 28 Damages (within the red ellipses) in the corner and perimeter wall of churches at **a** Damasi (church of Agios Nikolaos); and **b** Tyrnavos (church of Agia Paraskevi)

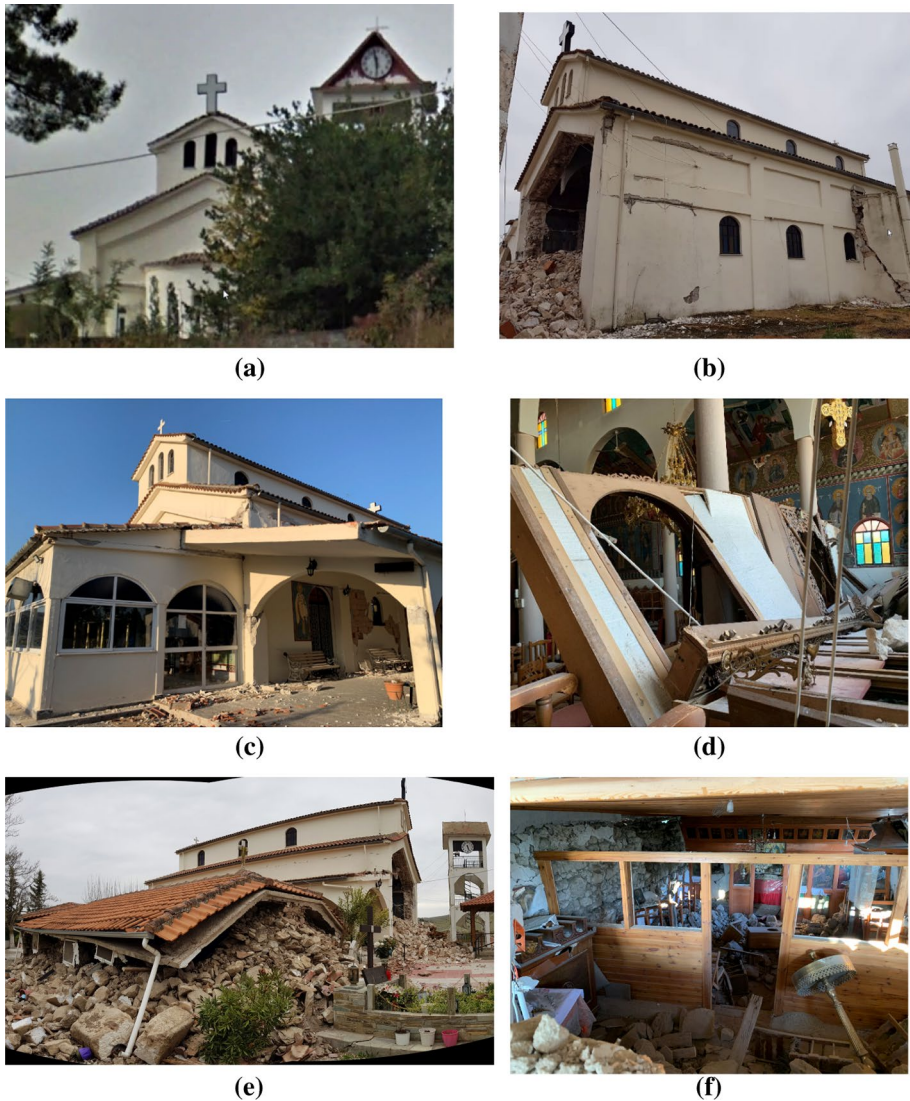
Figure 29 shows the Church of St Nicolas in Koutchocheron. As we can see from Fig. 29b the eastern wall of the church collapsed in an out of plane mode. This may be attributed, among others, to the existence of three large openings at the altar (Fig. 29a), a not so typical architectural feature (most Greek Churches have one opening at the altar only). Also, Fig. 29c shows an extension of the church with a RC covered walkway in contact with the southern wall of the church for operational reasons. Diagonal “X” shaped cracks of the infill walls of the walkway as well as separation of the newer walls with the existing ones of the church occurred during the earthquake. Several non-structural damages were also observed in Fig. 29d. Finally, Fig. 29e and f shows the total collapse of the older, Agios Nikolaos chapel (built in late 1700s), next to the newer church. The chapel was made of stone masonry connected with low in bond strength mud mortar. Also, the timber roof simply resting on top of the perimeter walls without any capacity of resisting any out of plane actions of the upper part of the walls but rather transfer horizontal forces which led to collapse of the walls.

Fig. 29 Church of Agios Nikolaos at Koutchochero: **a** before the earthquake (picture taken from Google maps-street view), **b** North side of the church after the earthquake of March 2021; **c** west side of the church; **d** non-structural damages inside the church; **e** older, Agios Nikolaos chapel; **f** interior of the chapel of Agios Nikolaos
