Traditional Structures in Turkey and Greece in 30 October 2020 Aegean Sea Earthquake: Field Observations and Empirical Fragility Assessment

Yasemin D Aktas^{1*}, Ioanna Ioannou¹, Fatma Sevil Malcioglu², Ahsana Parammal Vatteri¹, Maria Kontoe¹, Kokcan Donmez², Jacob Black³, Danaï Kazantzidou-Firtinidou⁴, Panagiotis Dermanis⁵ and Filiz Diri-Akyildiz^{1,6}

Aktas YD, Ioannou I, Malcioglu FS, Vatteri AP, Kontoe M, Donmez K, Black J, Kazantzidou-Firtinidou D, Dermanis P and Diri-Akyildiz F (2022) Traditional Structures in Turkey and Greece in 30 October 2020 Aegean Sea Earthquake: Field Observations and Empirical Fragility Assessment. *Front. Built Environ.* 8:840159. doi: 10.3389/fbuil.2022.840159

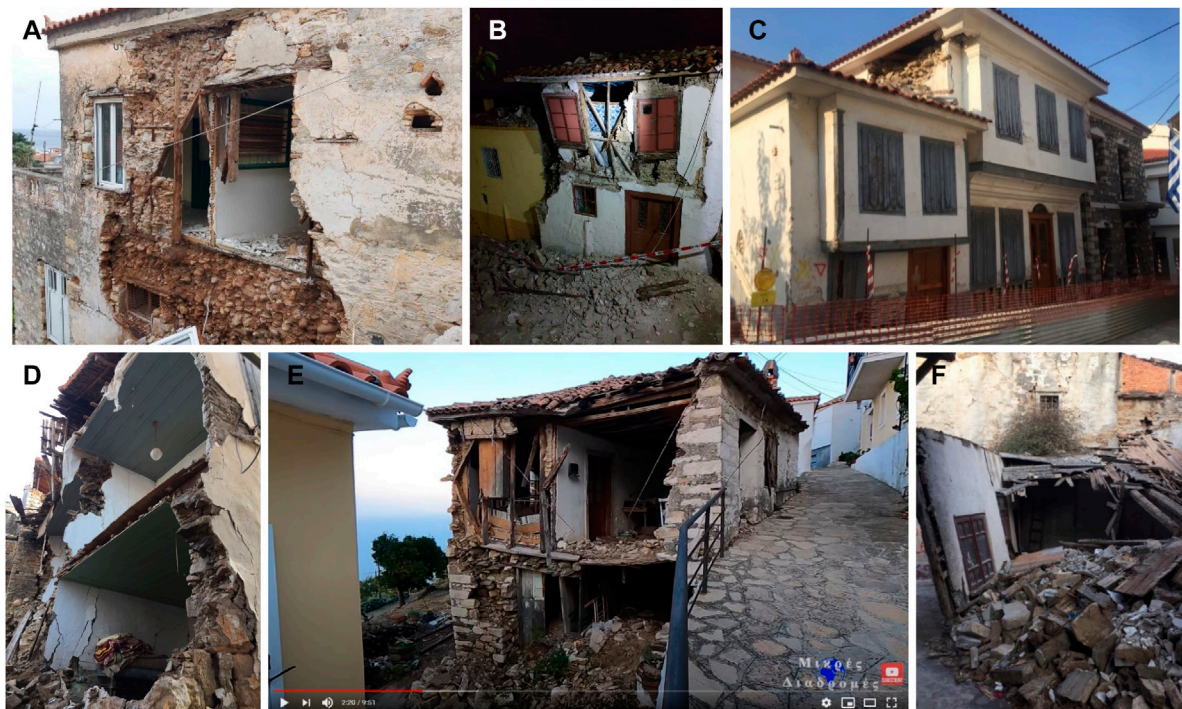
FIGURE 2 | Examples of timber-masonry structures which suffered from failure of masonry: **(A–C)** out of plane infill failure of masonry in the upper floors, **(D,E)** failure of masonry ground floor and timber frames above **(F)** total collapse induced by the failure of the masonry ground floor [(**B,E**) from Mikres Diadromes Samou, 2020] [DG3-DG5] (all in Samos, Greece).

shown in **Figure 2A**, where the colour suggests that a mud-based mortar was used. The failure of ground floor masonry material might trigger failure of an entire timber frame on top (**Figure 2D, E**) or may lead to progressive collapse (**Figure 2F**).

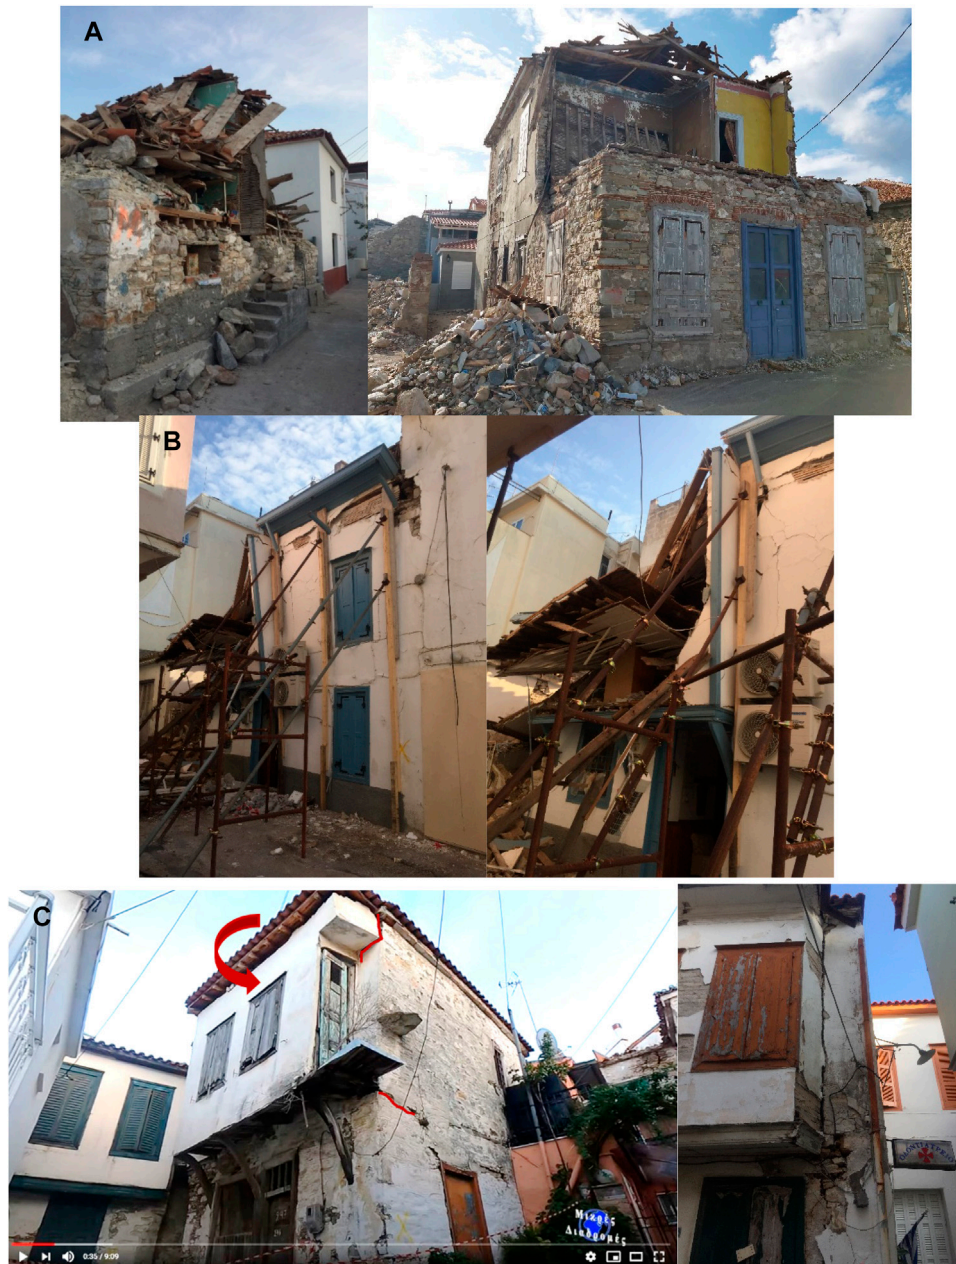
FIGURE 3 | Examples of damage to timber framing in timber-masonry structures. **(A and B)**: progressive failure of the upper floor timber framing and the roof [DG4-DG5]; **(C)** Overturning of the jetty in timber-masonry structures [picture on the left from Mikres Diadromes Samou, 2020] [DG3] (all in Samos, Greece).

Apart from the common cases of masonry failure discussed in the previous section, there are also those cases where the timber framing is damaged independently from the masonry failure, leading progressively to the roof collapse (**Figure 3A,B**). The

weakened connections within and between the individual timber frames, and between the masonry ground floor and the timber framed upper stories are the common triggers for this type of damage. Sometimes damage may be concentrated at the cantilevered sections, i.e. jetties (**Figure 3C**).

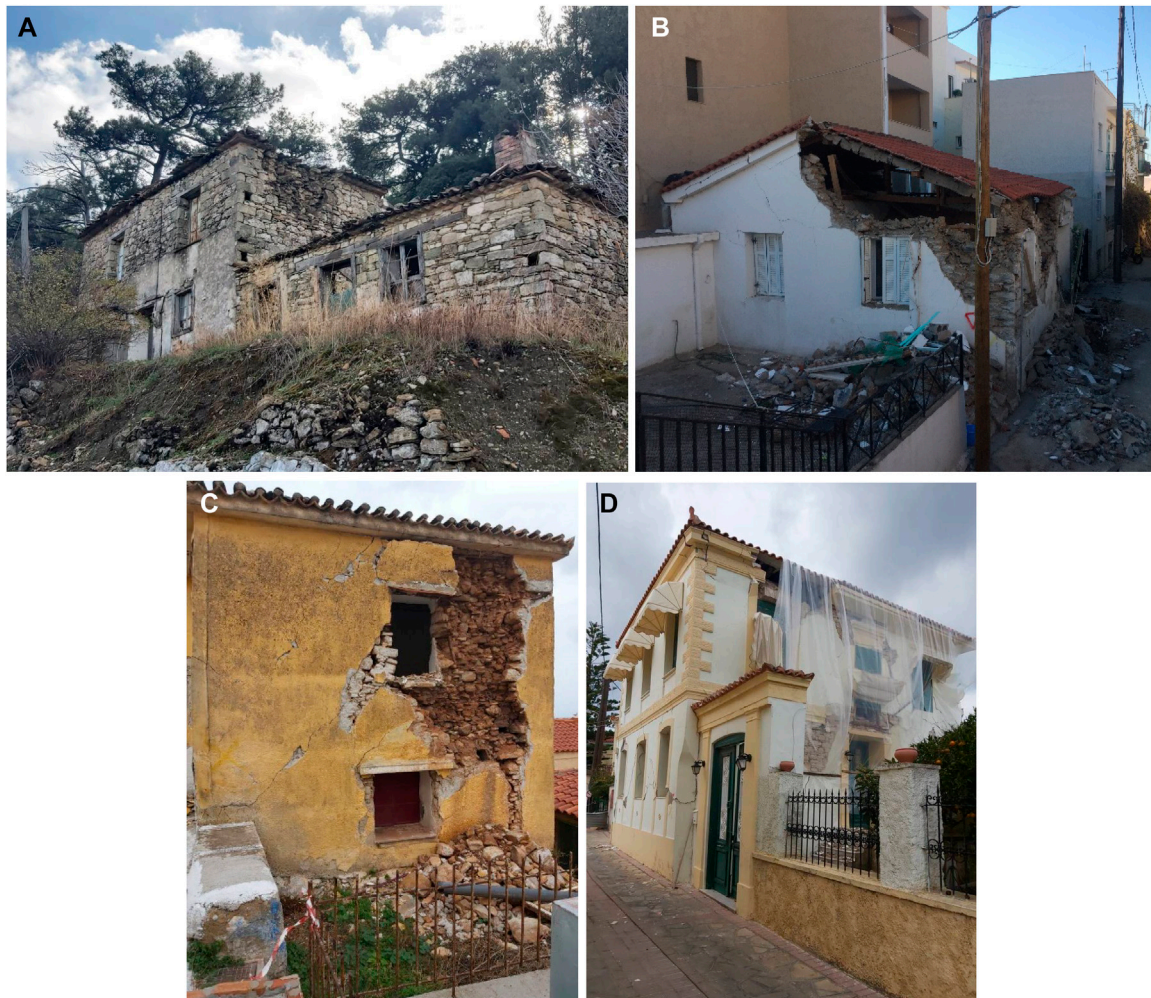
FIGURE 5 | Examples of out-of-plane failure in masonry structures: **(A)** Partial overturning of the external leaf; **(B)** Corner failure and partial overturning of gable; **(C)**: Out-of-plane failure of the external leaf of a multi-leaf masonry wall with mud mortar; **(D)** Out-of-plane failure of a brick wall [DG3-DG5](all in Samos, Greece).

ways: vertical or partial overturning, and corner failure are the most common types. Sometimes the overturning of the external leaf of the masonry walls is triggered by the in-plane failure of the façade (**Figure 5**). The extent of this type of failure is often limited to part of the façade however, and does not seem to be governed by its connection to the perpendicular walls. The interaction between the roof and the perimeter walls is a common cause of the out of plane failure at the higher elevations in a façade.

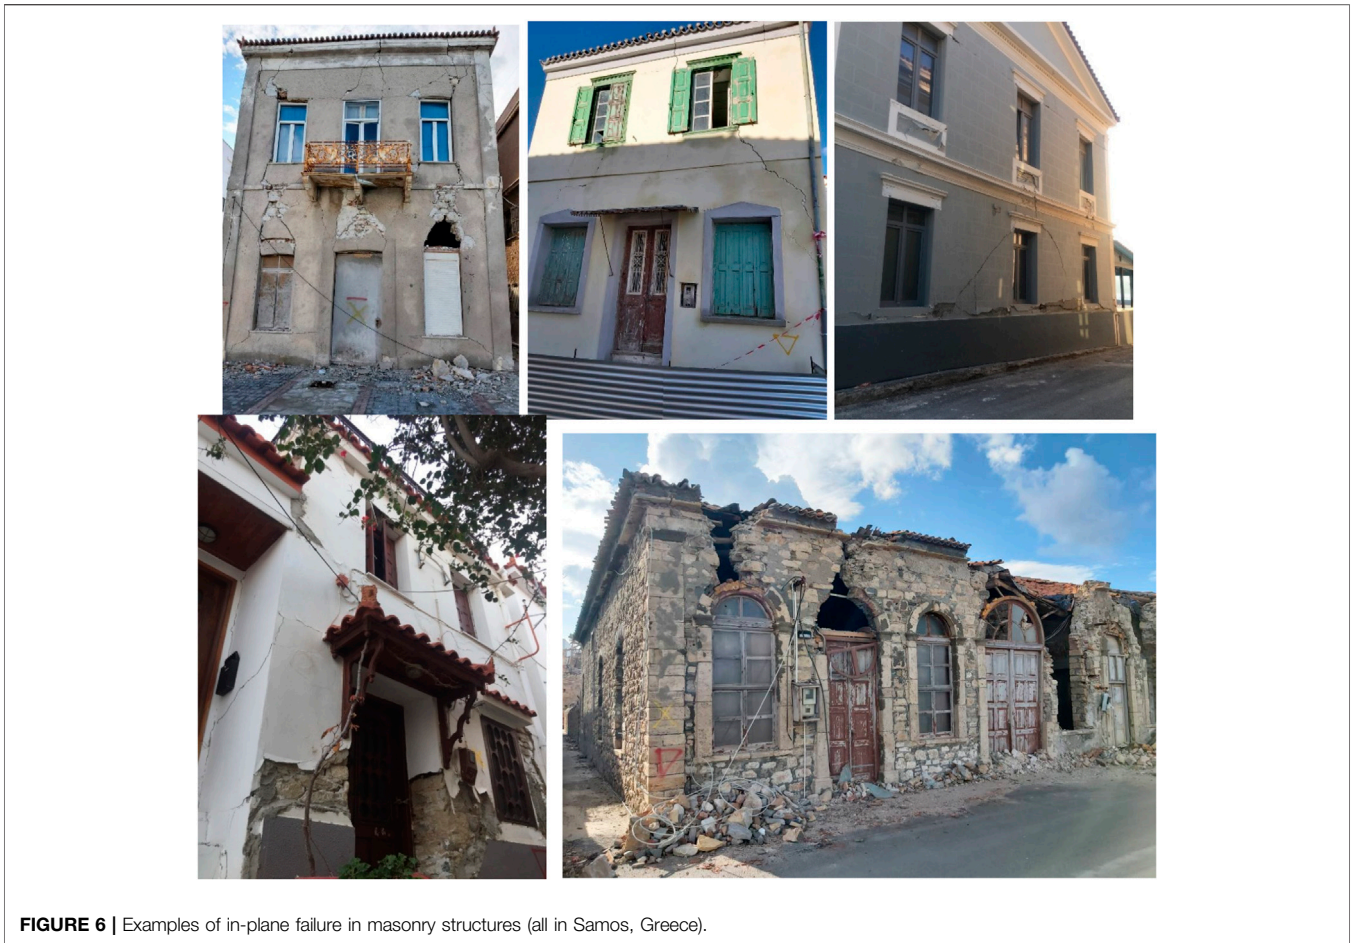
In-plane failure is often characterised by shear or flexural cracking, a common damage mechanism in the masonry structured surveyed in this study, which manifests as cracking in the spandrels and diagonal cracking in the piers are very common. The strength of the lintels over the façade openings is an important determinant of the failure patterns in spandrels. Shear failure is observed mainly in case of weaker lintels (such as shallow masonry lintels), while flexural mode is more common for spandrels supported by strong lintels (**Figure 6**). How

FIGURE 6 | Examples of in-plane failure in masonry structures (all in Samos, Greece).

widespread the failure over the rest of the façade might be seen as an indicator of the homogeneity of the wall morphology.

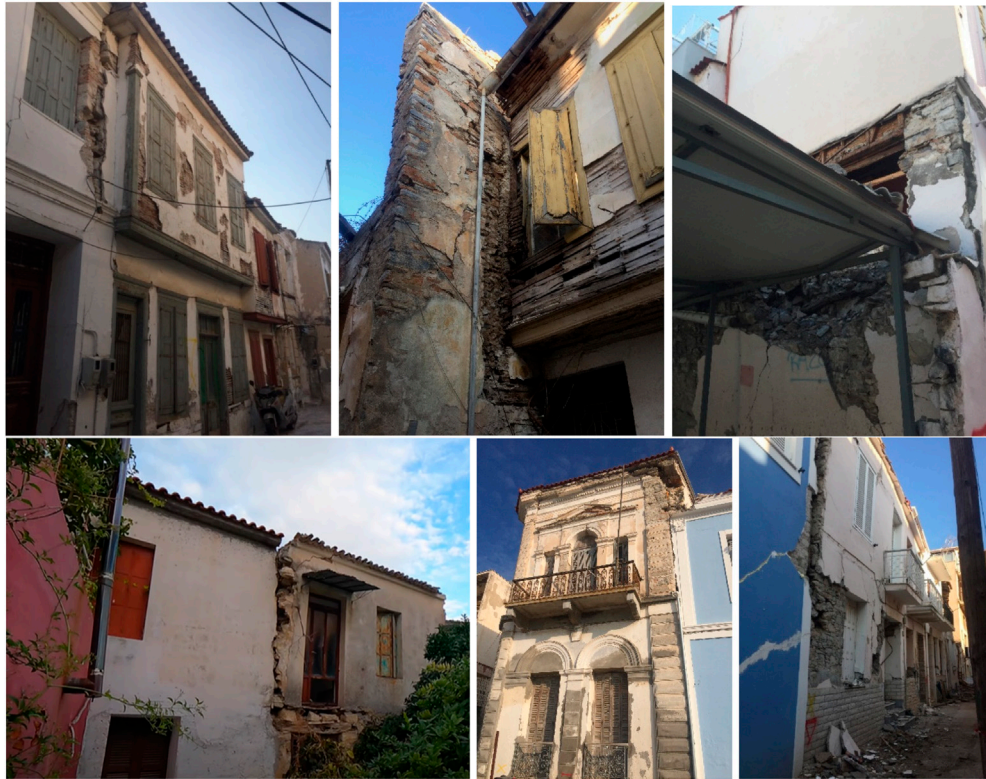
Pounding refers to the lateral collision of abutting buildings during earthquakes, and it is a common cause of damage for building terraces under earthquake loading. Pounding induced damage manifests in the form of cracks along the interface between the adjoining buildings, and is commonly observed in both the terraced timber-masonry (**Figure 7** top row) and masonry buildings (**Figure 7** bottom row) in the areas affected by the 30 October 2020 event.

FIGURE 7 | Examples of pounding induced damage in timber-masonry structures [DG2-DG3] (Samos, Greece) Examples of pounding induced damage in timber-masonry structures [left picture from Mikres Diadromes Samou, 2020] [DG2-DG4] (all in Samos, Greece).
