On the Excessive Porosity in the Welds of AMS 4975 Titanium Air Compressor Rotor Duct

CASE STUDY

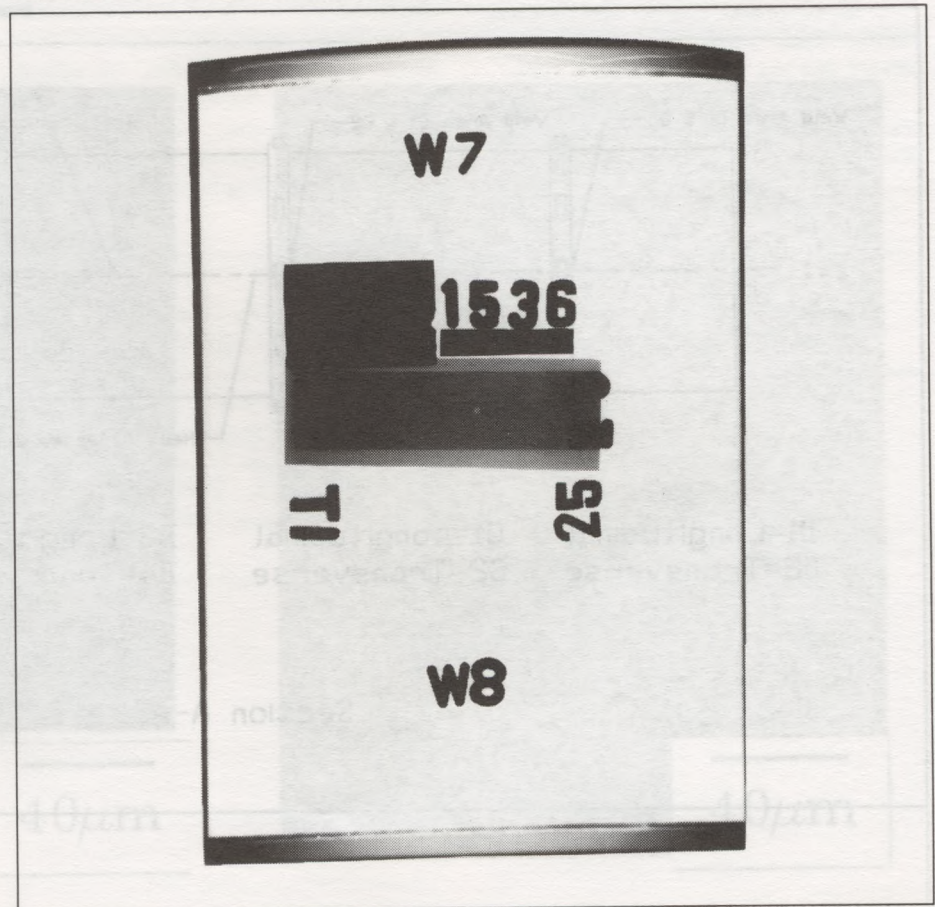
FIGURE 2 Radiograph Showing the Presence of Pores

The porosity is a subsurface problem in this case. The duct does not meet testing criteria because the diameters of the pores in the welds exceeded allowable specifications [1]. A weld pore diameter greater than 0.43 mm (0.017 inches) is cause for part rejection. According to the radiographic in-

spection report, ten of the eleven welds were rejected for excessive porosity. A radiograph is shown in Figure 2. The part was rejected at this stage because rewelding at this point to correct the porosity would create excessive shrinkage. The detection of 0.43-mm (0.017-inch) diameter pores was an ongoing problem in these air compressor rotor duct parts.

Thus, with the elimination of the previously stated probable causes, the next area to concentrate on was the welding technique itself. After a literature search, an article dealing with a similar situation and problem was found [5]. In this study, titanium alloys were welded in the annealed condition and tested. The findings relevant to this study are:

1. Attempts to produce high-voltage (150-kV) welds at moderate weld speeds (40–60 ipm) resulted in welds that contained a variable degree of porosity.
2. Attempts to link the presence of this porosity with the form and duration of the cleaning of the butting surfaces were unsuccessful. Note

3. *It was found that with the introduction of high-voltage (150-kV)/high-weld speed (120 ipm) technique, the porosity was no longer encountered.*

The aerospace company should employ the high-voltage/high-weld speed

techniques in the EBW process for the titanium air compressor rotor ducts. The beam voltage should be increased from 80 kV to around 150 kV, and the weld speed should be increased from 12 to 120 ipm. A high-vacuum system (10^{-3} – 10^{-6} TORR) should be maintained to reduce the likelihood of contamination by atmospheric gases.

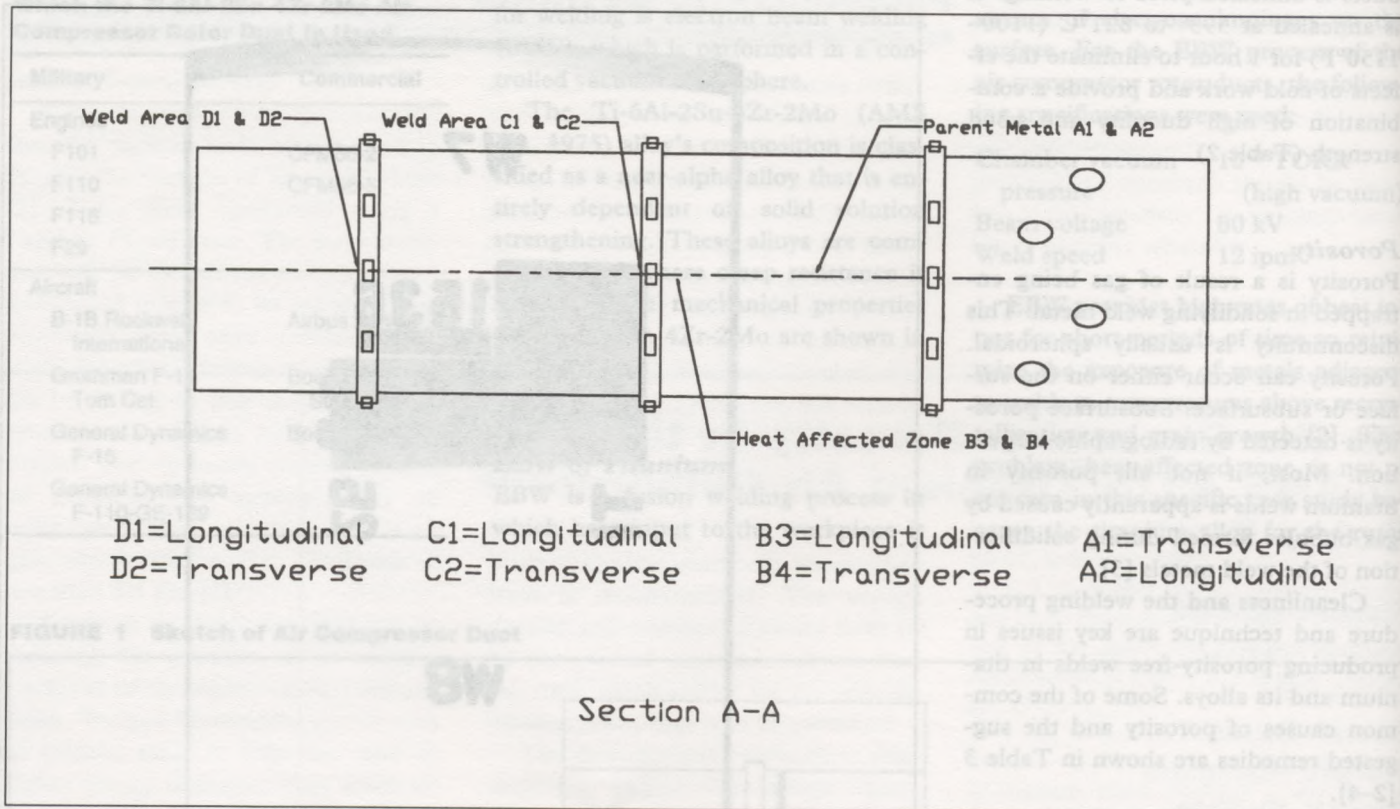
FIGURE 3 Location of the Optical Microstructures

Figure 3 shows the rotor duct. Four areas have been identified: A1/A2 parent unaffected metal; B3/B4 heat affected zone; C1/C2 fusion zones; and D1/D2 fusion zones. The designations 1 and 2 refer to longitudinal and transverse views. In Figure 4, the microstructures of the parent unaffected metal (A1) and the heat-affected zone (B1), top right and left, indicate equiaxed fine grains, whereas those of the fusion zones (C1 and D1), bottom right and left, reveal elongated coarse grains.
