# INSTITUTE of HYDROLOGY

# COLCHESTER CAR AUCTIONS, ESSEX PRELIMINARY HYDROLOGICAL SURVEY

## INTRODUCTION

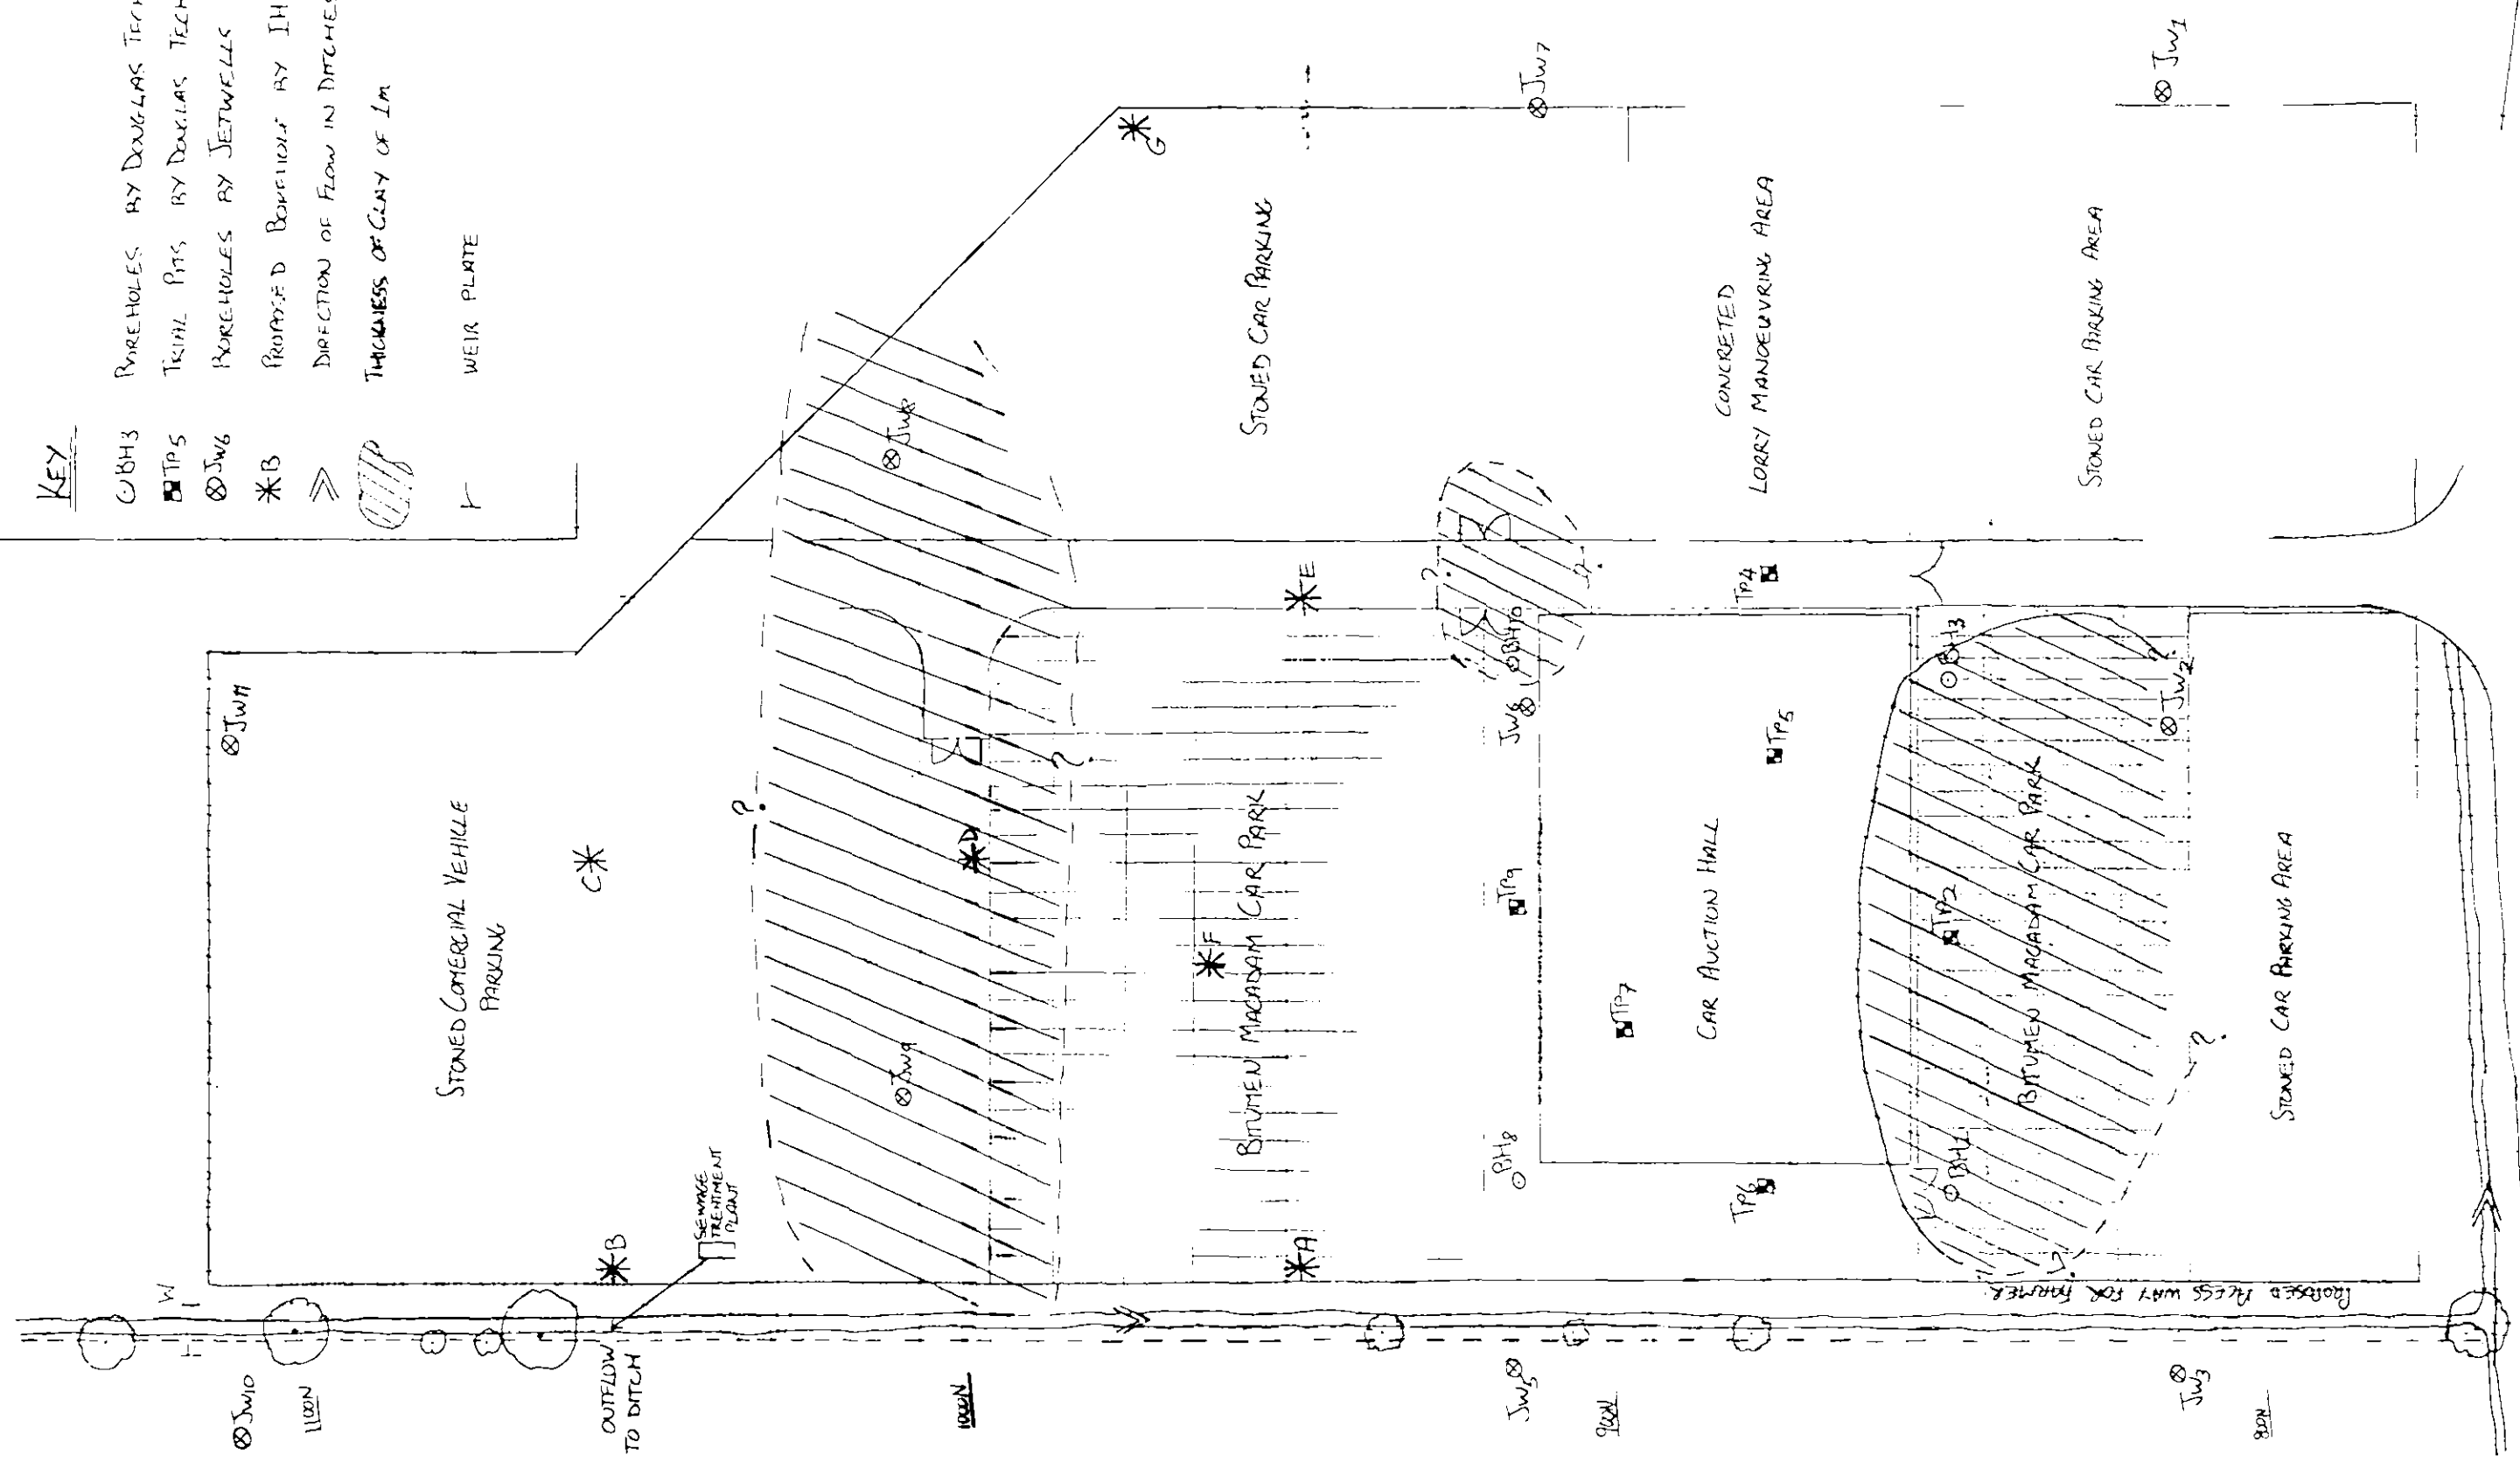
Fig 2.

The available lithological information has been used to indicate the possible extent of the clay layer as shown in Figure 2.

The available information suggests that the clay layer does not underlie the tarmac area north of the auction hall, except perhaps along the western part of this area. However, if this is the case then there may be some difference in the supporting strength at the boundary of the clay layer and the thin soils on sands and gravels when the clay layer is subject to wetting. This is an engineering aspect beyond our particular expertise.

The following programme of further investigation is proposed to obtain information on these aspects. The suggested locations are shown in Figure 2. As far as possible these have been chosen to reduce the amount of drilling on the tarmac area.

- construct seven piezometers (sites A to G in Figure 2) to depths of 3m to obtain lithological information on the surface deposits and for water level measurements
- install a gauging site on the ditch
- install a raingauge at the site.

- construct three piezometers in the immediate area of the tarmac car park (sites A or D plus E and F in Figure 2) for lithological information and water level measurements
- undertake a surface geophysical survey using electromagnetic techniques (EM) to define the distribution of the surface clay layer
- visual records of flow in the western ditch
- use the daily rainfall records of the nearest meteorological station.
