Hybrid Reconnaissance Mission to the 30 October 2020 Aegean Sea Earthquake and Tsunami (Izmir, Turkey & Samos, Greece): Description of Data Collection Methods and Damage

On 30 October 2020, an earthquake of M_w 6.9 hit the Aegean coasts of Turkey and Greece. The epicentre was some 14 km northeast of Avlaxia on Samos Island, and 25 km southwest of Seferihisar, Turkey, triggering also a tsunami. The event has been followed by >4,000 aftershocks up to M_w 5.2 The Earthquake Engineering Field Investigation Team (EEFIT) has immediately gathered a team to conduct a hybrid reconnaissance study, bringing together remote and field investigation techniques. The mission took place between 16 November and 17 December, inclusive of three sets of field study carried out by the field crews for building damage assessment in the affected areas in Turkey and Greece under the coordination of the remote team. The mission also aimed to assess the viability of alternative data sources for an appraisal of the future viability of hybrid missions. This paper summarises the mission setup and findings, and discusses the benefits of and difficulties encountered during this hybrid reconnaissance activity.

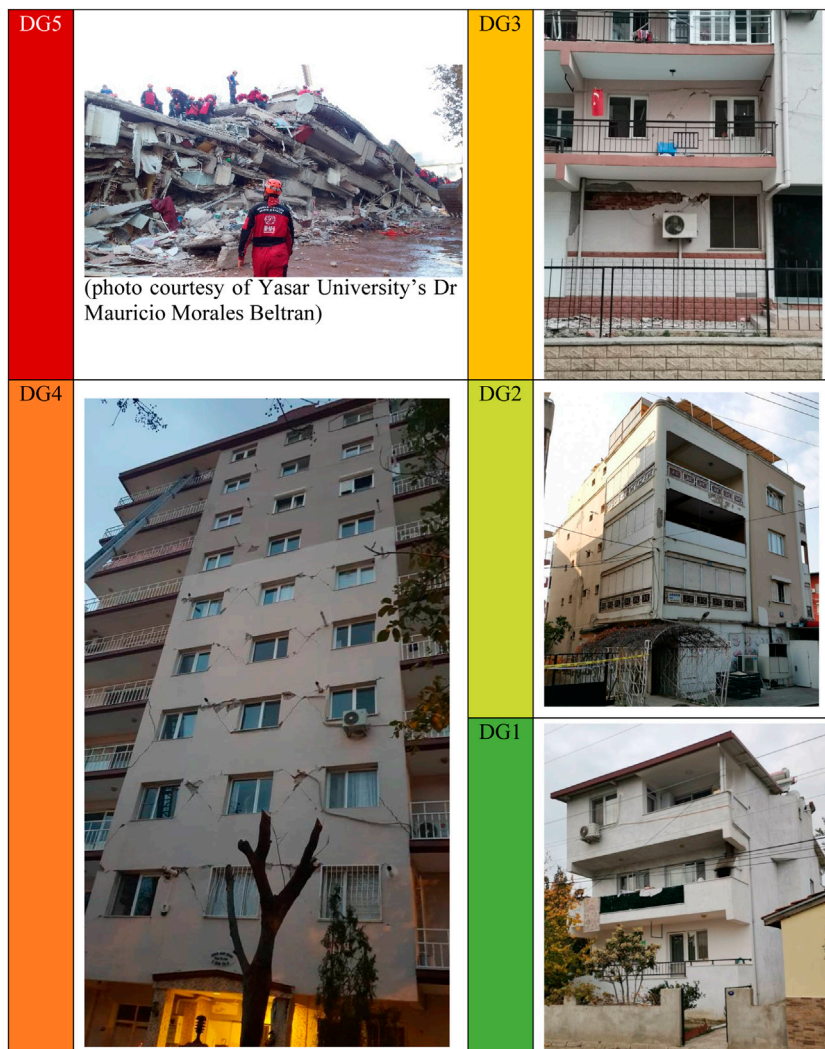
TABLE 3 | Examples of RC structures at different damage classes (all in Izmir, Turkey).

damage. The Doğanlar (DG5 picture in **Table 3**), Karagül and Rıza Bey apartment buildings which collapsed during the event, killing around 50 people and receiving a lot of repercussions in the media, are good examples to demonstrate the extent of lack of code compliance, inefficient communication between institutions, and poor operable quality assurance regulations: Bayraklı Municipality Earthquake Study Center reported in 2008 that all these buildings were found to suffer from door jams, ground floor level irregularities and distortions in the balcony structures due to liquefaction and seismic activity. Another report in 2012 on Rıza Bey apartment building indicated inadequate rebar detailing, moisture induced material degradation, heavy overhangs, flat reinforcement bars and poor concrete quality, requesting a thorough survey. However, in both cases, it was claimed that the ministry was not informed about this (Gurcaner and Torlak, 2020). Other interesting examples are the Yılmaz Erbek Apartments (two buildings of the same design) and Barış building complex (four buildings of the same design), where respectively only one and two buildings collapsed, killing 33 people between them. The difference between the performance of individual buildings here was attributed to the commercial use of the ground floor (which allegedly removed some of the columns), but more interestingly to the use of different contractors during the construction stage as well as for the later modifications.

In addition to the widened openings at the ground floor or non-engineered intervention on the load bearing system, which was common to almost all collapsed buildings in Bayraklı, Turkey, some of the other common irregularities we observe in the reinforced concrete structures in both Turkey and Samos include changes in stiffness due to structures attached to the main buildings and plan and elevation irregularities (**Figure 12**). Examples of the damage cases at each class can be seen in **Table 3**. As can be seen, the damage mechanisms widely range from pancake collapse to shear failure of piers and

spandrels, infill wall failure and column-beam failure. A few cases with minor pounding damage were also observed. Despite that, overall, RC structures performed well in this event with 88 and 67% of our surveyed buildings categorised as DG0 or DG1 in Turkey and Samos, respectively.

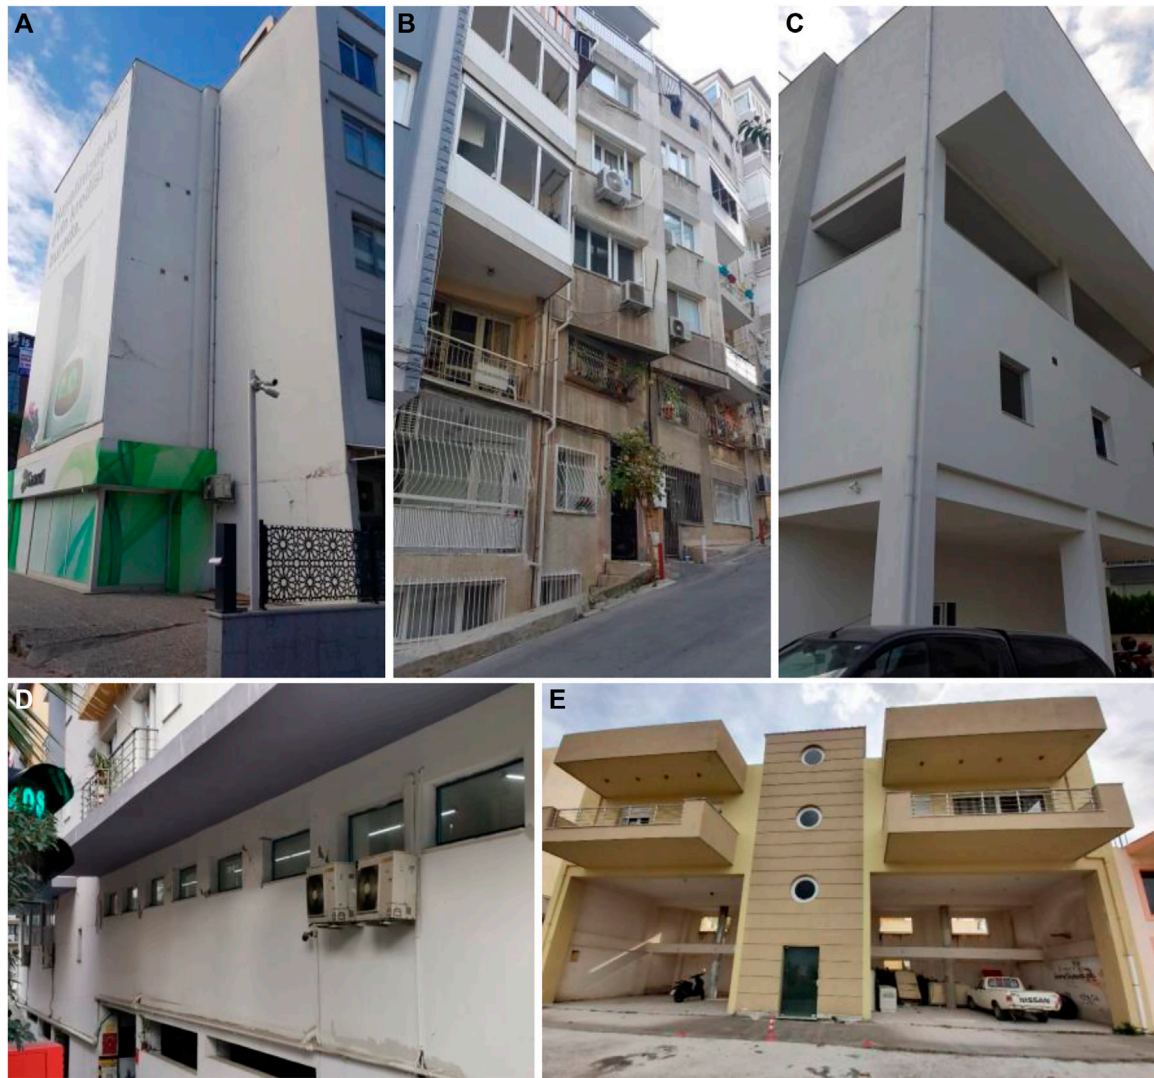
FIGURE 12 | Examples of common irregularities in RC buildings [(A): Changes in stiffness due to structures attached to the main building, (B,C): Elevation and plan irregularities, (D): short columns, (E): plan and elevation irregularity, and large openings at the ground floor].

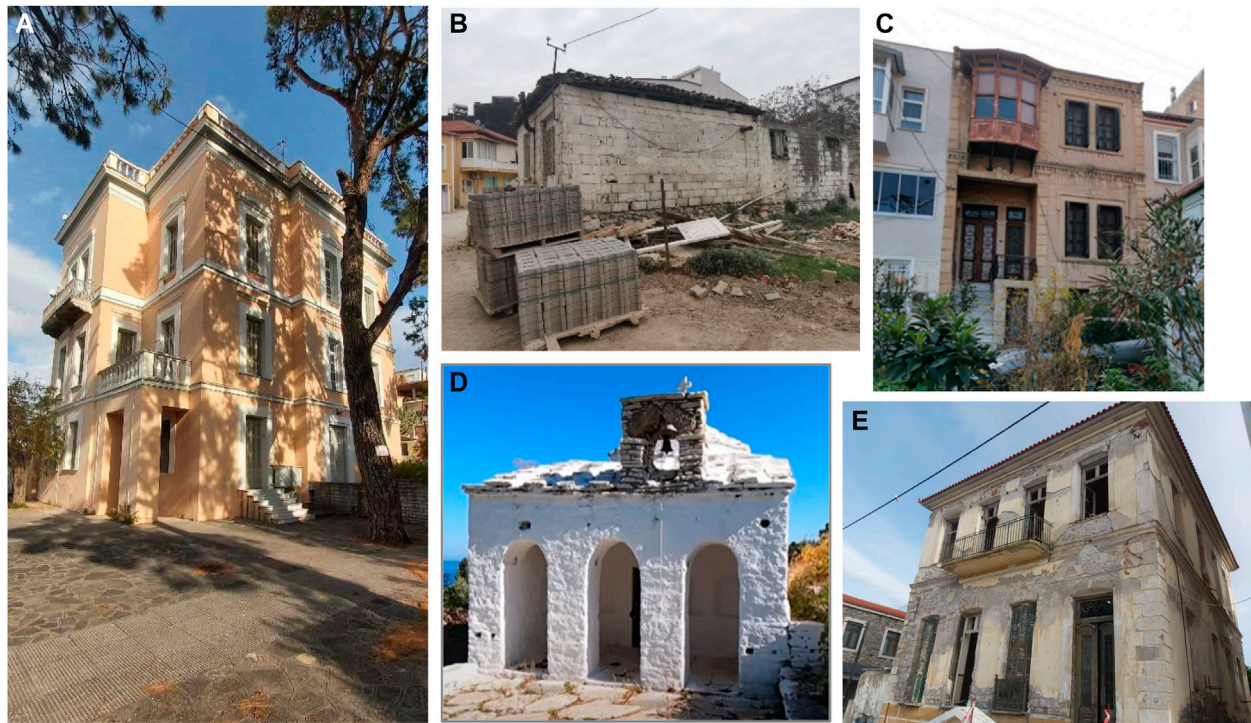
FIGURE 13 | Examples of masonry building stock in the affected areas [(A,D,E) in Samos, (B,C) in Izmir].

monumental or humbler scales and more recent masonry buildings with concrete or hollow terracotta blocks (**Figure 13**). The common irregularities observed in these structures include elevation or plan irregularities, significant variations in the storey heights and changes in stiffness due to structures attached to the main building, which also pose damage risk due to pounding. The damage mechanisms vary from various levels of in-plane and out-of-plane failure, which sometimes propagate partial or total collapse (**Table 4**). Most of these buildings are old and demonstrate a certain level of pre-

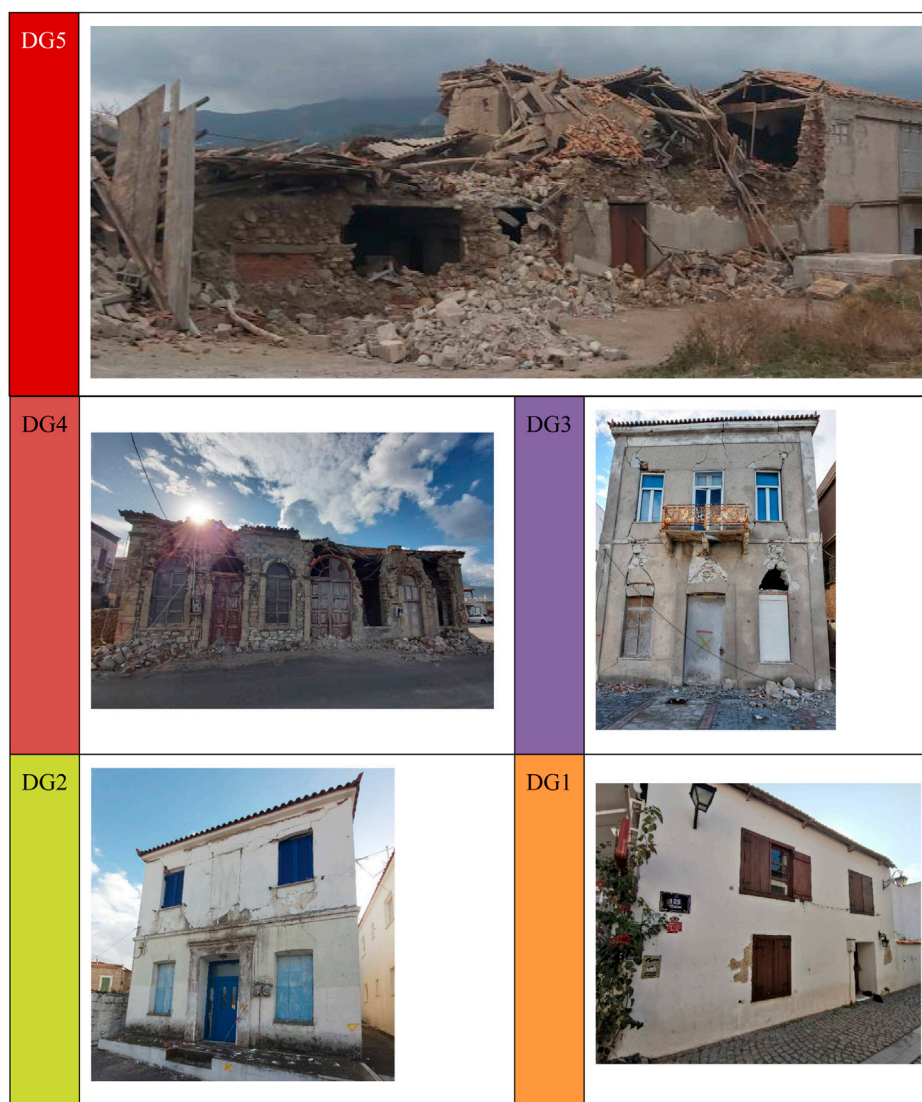
TABLE 4 | Examples of masonry structures at different damage classes (DG1 in Siğacık, DG2-5 in Samos).

earthquake damage/corrosion, which the team did account for while assigning the damage classes. As seen in **Figure 9**, masonry structures in Samos performed proportionally poorer compared to the ones in Turkey, with around 12% categorised as DG4 and DG5, and another 25% DG3. This can be attributed to both lower PGA values in the latter (**Figure 10**) and to less maintenance and more degradation in the Samos building stock.

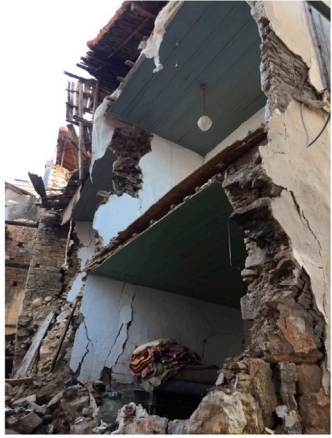
DG5

observe a wide range of damage levels and mechanisms for these buildings following the 30 October Aegean earthquake (**Table 5**). Similarly for this typology of buildings, the sample set from Samos demonstrated more damage than that from Turkey (with 28% categorised as DG4 and DG5, and an additional 32% DG3), due to a clearly higher level of accumulated material and structural damage and higher levels of pga in the former (**Figures 9, 10**). For more information on the behaviour of these structures during the 30 October event, and their fragility assessment in light of observations made in our mission, see Aktas et al. (2022).

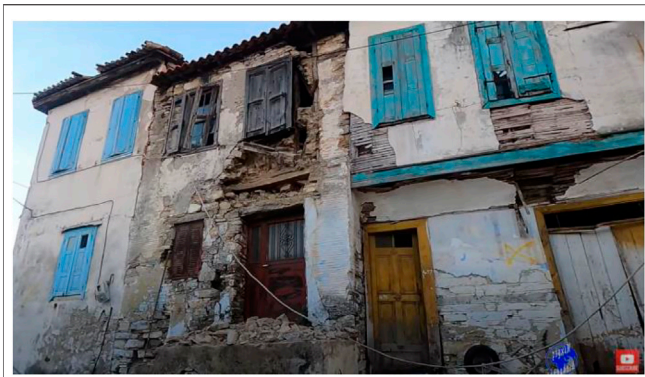
FIGURE 15 | Examples of stone infilled (building in the middle) and bağdadi clad (building on the right) timber-masonry homes (in Samos, picture from Mikres Diadromes Samou, 2020).

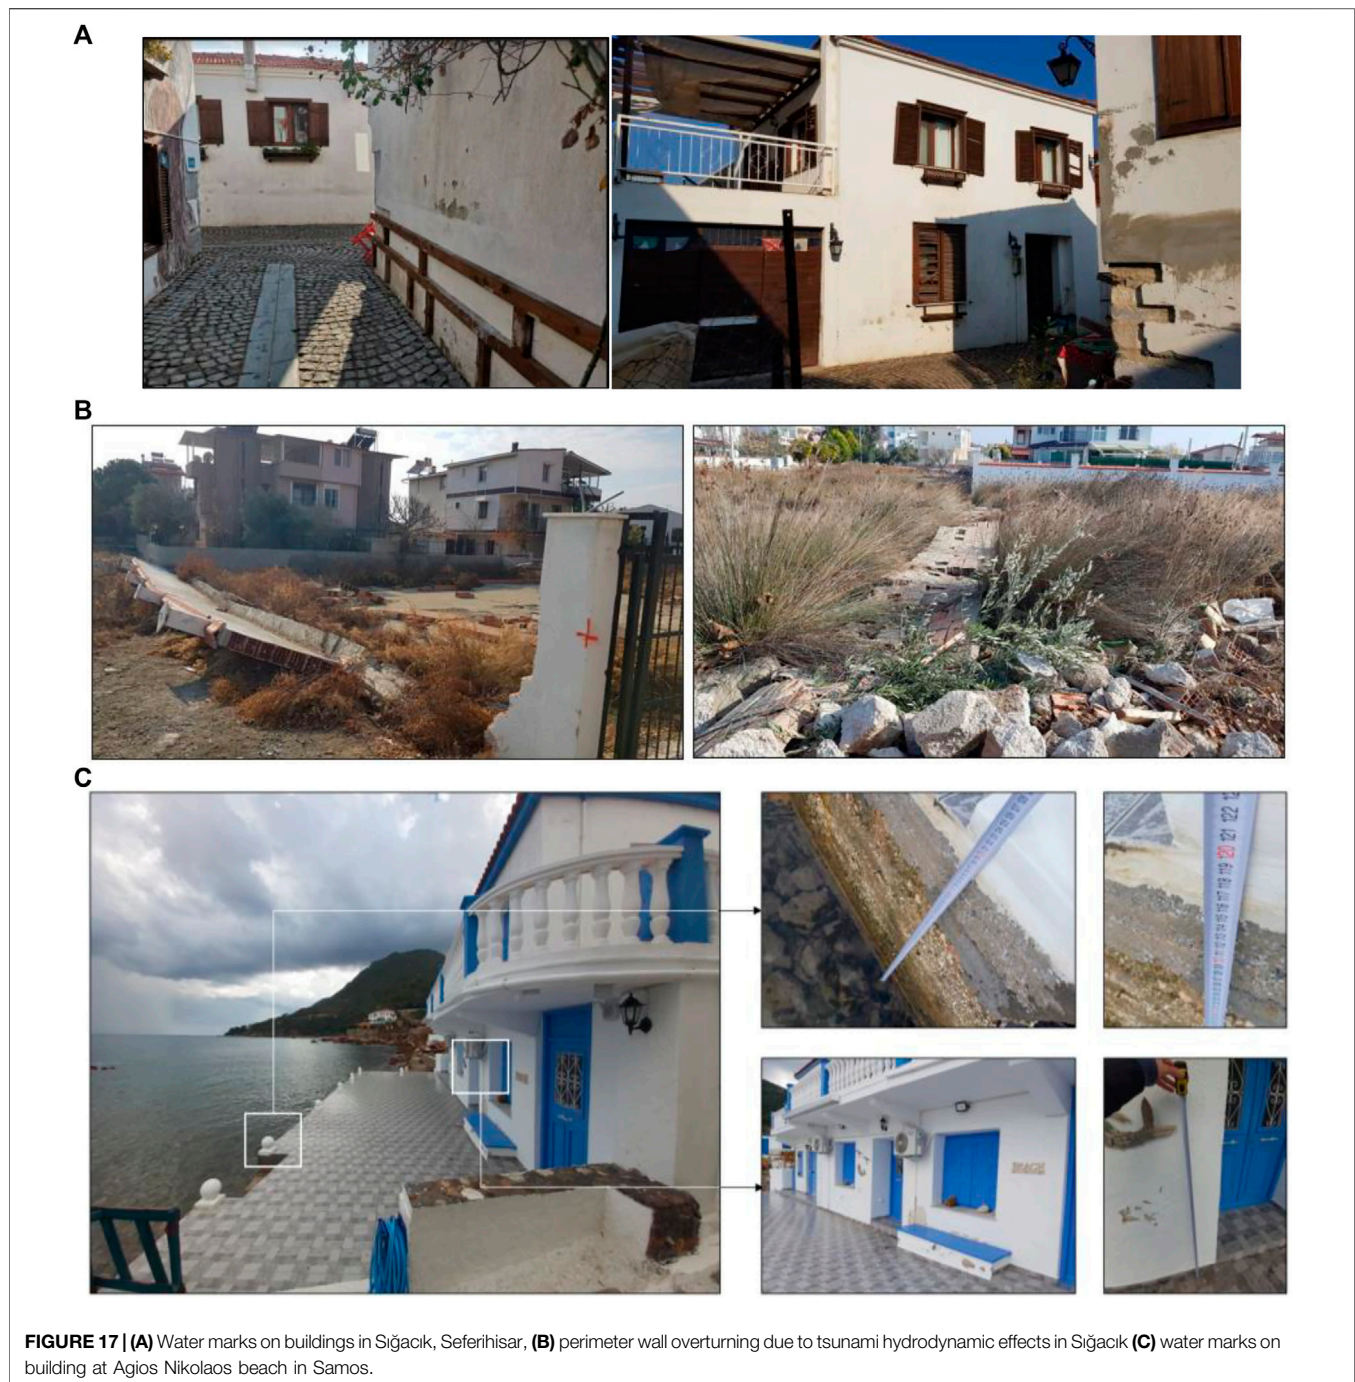
FIGURE 17 | (A) Water marks on buildings in Siğacık, Seferihisar, **(B)** perimeter wall overturning due to tsunami hydrodynamic effects in Siğacık **(C)** water marks on building at Agios Nikolaos beach in Samos.

The 30 October 2020 Aegean earthquake was accompanied by a tsunami, which is not an uncommon phenomenon in the region (**Figure 16A**). The tsunami waves reached up to 2.0 m in this particular event (**Figure 16B**). Therefore, the EEFIT mission also systematically investigated the tsunamic impact on buildings and infrastructure, through a set of questions embedded in the data acquisition system specifically to reflect typical damage mechanisms due to tsunami hydrodynamic effects on buildings. These being: the number and types of openings, particularly at ground floor level; the presence of a basement; assessment of surroundings, including perimeter walls and presence of debris; details of foundation type and damage (if that is visible); and evidence of water marks on the building. Some of these attributes were included in the damage assessment form developed in the 2018 EEFIT mission in Palu (Rossetto et al., 2019), which has been adopted for the damage assessment carried out in this mission. By the time our field crews visited site however, it was already 1 month after the event, and all debris was cleared and no substantial structural and non-structural damage was found despite significant inundation in some localities. In certain cases, water marks were visible on buildings (**Figure 17**).
