Importance of periodic CPCP revisions in the evaluation and improvement of the program

NetJets Europe: a perspective from a business jet operator

Dissertação para obtenção do Grau de Mestre em
Engenharia Aeronáutica
(ciclo de estudos integrado)

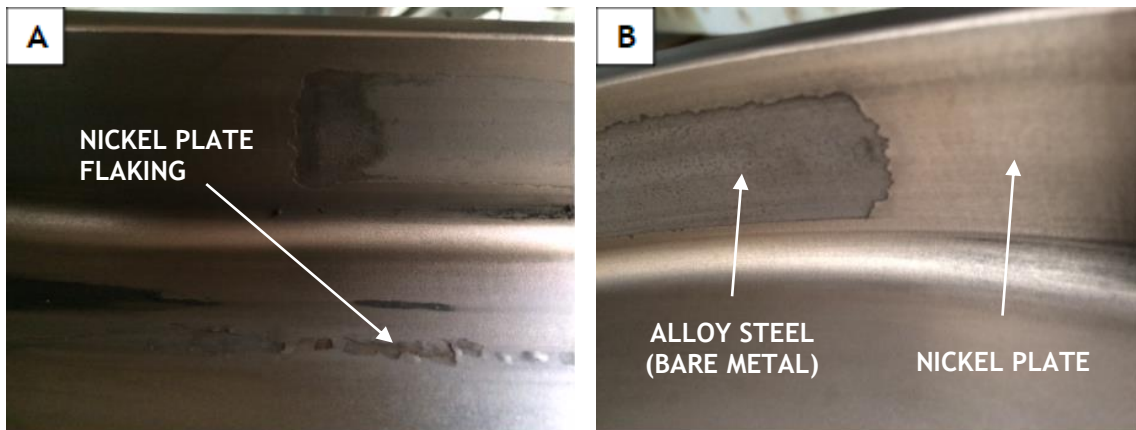
Figure 4.6: Nickel plate wear out (A - track areas with nickel plate flaking; B - track areas with and without protection). (Images obtained from NetJets Europe portfolio)

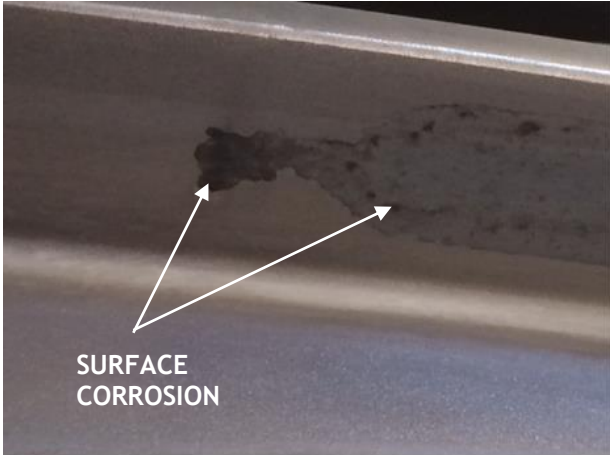
The corrosion present on the track is surface corrosion (Figure 4.8) and pitting (Figure 4.9), as it is visible the presence of tinny pits or holes in the steel surface.

Figure 4.8: Surface corrosion (brown color) visible on the flap track surface. (Image obtained from NetJets Europe portfolio)

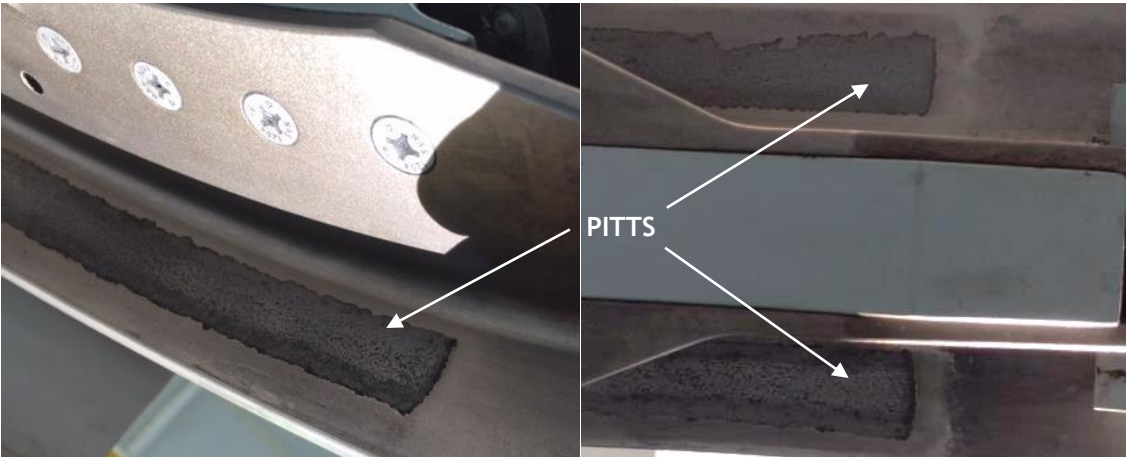
Figure 4.9: Tiny pits (holes) present on the flap track surface. (Images obtained from NetJets Europe portfolio).

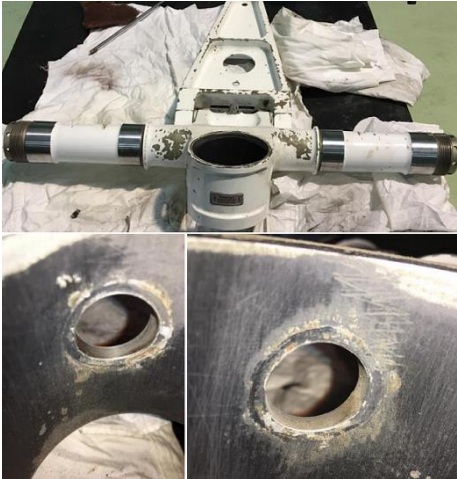
The presence of these corrosive agents between the axle and the sliding tube allowed the corrosion process to start. The corrosion (light brown and white areas) was found in the interior surface of the axle front cylinder (Figure 4.14), sliding tube exterior surface (Figure 4.15), holes of both axle and sliding tube (Figure 4.14 and Figure 4.15) and the retaining bolt (Figure 4.16) that connects the axle to the sliding tube.

Figure 4.14: Corrosion damage detected in the holes and interior surface of the axle front cylinder. (Images obtained from NetJets Europe portfolio)

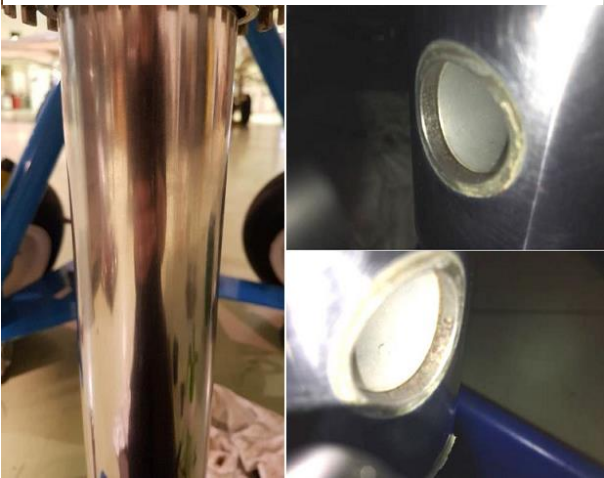
Figure 4.15: Corrosion damage found in the holes and exterior surface on the bottom part of the sliding tube. (Images obtained from NetJets Europe portfolio)

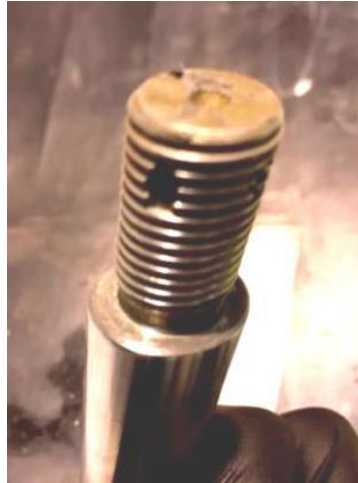
Figure 4.16: Corroded retaining bolt. (Image obtained from NetJets Europe portfolio)

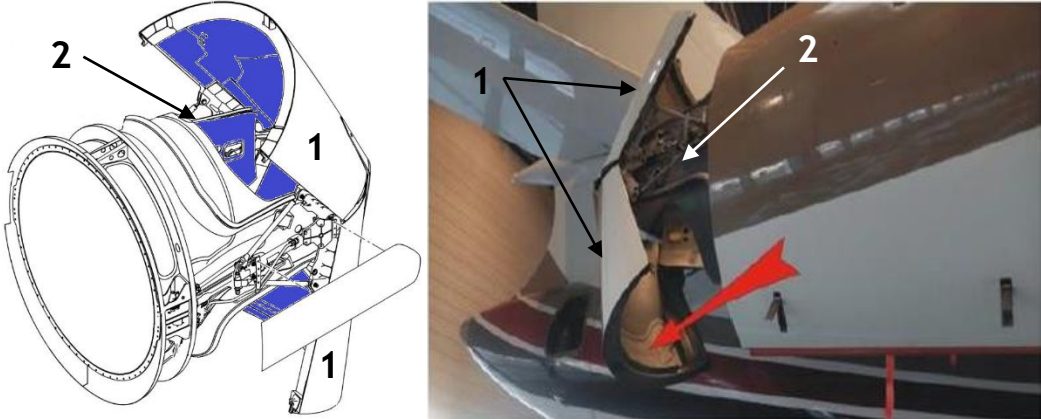
At the A+ inspections (every 8 months), corrosion was found in two locations of the thrust reverser (Figure 4.24): doors (1) and nozzle (2). The exhaust stream from the engine contacts the interior surface of both components, located at the end of the engine nacelle.

Figure 4.24: Falcon 2000ex Easy thrust reverser (1 - doors; 2 - nozzle; in blue: corroded areas) (adapted) [60].

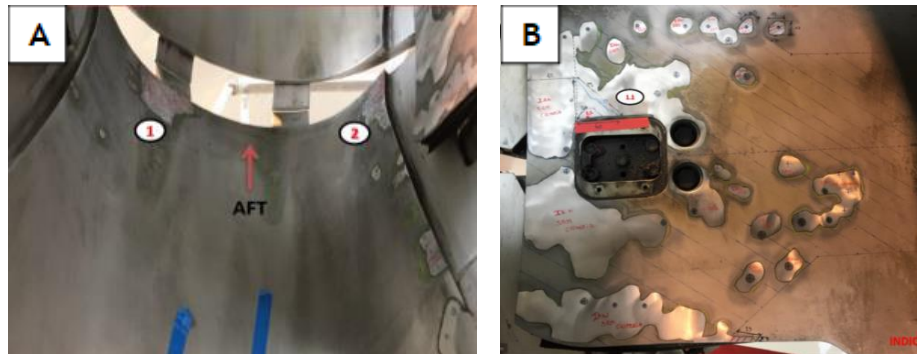
According to aircraft manufacturer information, this problem has been seen in several in-service aircraft, namely that the interior surface of the thrust reverser assembly (Figure 4.25-A and Figure 4.25-B) show signs of premature corrosion. After the completion of tests on material samples taken from the thrust reverser, it was concluded that, under certain circumstances, sulfur dioxide (SO₂) and nitrogen dioxide (NO₂) can mix with water condensation in the exhaust stream, potentially forming a sulfuric acid (H₂SO₄) byproduct [38]. This byproduct can gather in the interior surface of the thrust reverser doors and nozzle, and eventually compromise the existing protective finish and generate surface corrosion [38].

Figure 4.25: Falcon 2000ex Easy thrust reverser affected areas after corrosion removal (A - door; B - nozzle). (Images obtained from NetJets Europe portfolio)

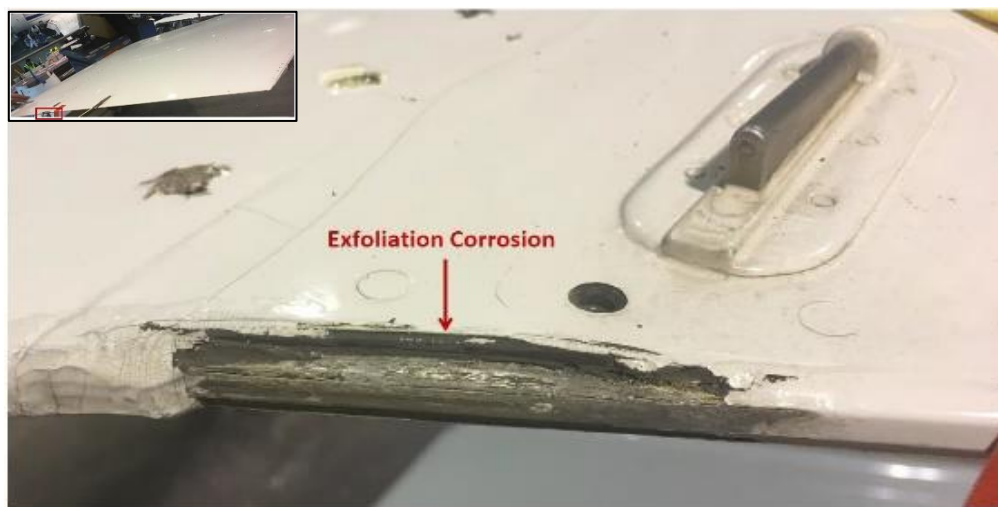
In this case study, corrosion was found in the trailing edge of the horizontal stabilizer, more specifically exfoliation corrosion (Figure 4.28). It is possible to see, in the image, the layered appearance, characteristic of this type of corrosion, due to the expanding corrosion products that force the metal away from the body of the material.

Figure 4.28: Exfoliation corrosion found in the horizontal stabilizer trailing edge. (Images obtained from NetJets Europe portfolio)

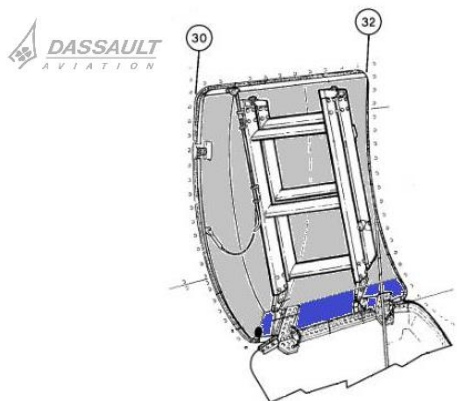
Corrosion was found on the floor beam, located between the fuselage frames 30 and 32 (Figure 4.31), near the entrance of the mechanical servicing compartment, where the door and the stairs that give access to the compartment are attached.

Figure 4.31: Location of the corroded compartment floor beam (in blue) (adapted) [60].

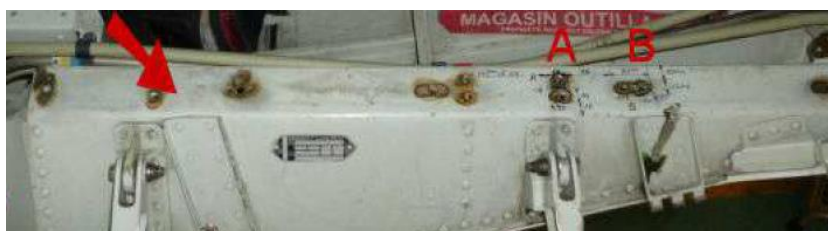
Figure 4.32: Superficial corrosion (light brown areas) found in mechanical servicing compartment floor beam. (Image obtained from NetJets Europe portfolio)

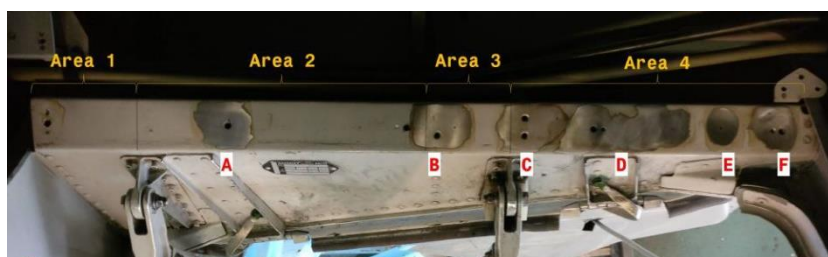
Figure 4.33: Floor beam affected areas after corrosion removal. (Image obtained from NetJets Europe portfolio)
