Survey and alignment of the synchrotron SIS18

V. Velonas¹, I. Pschorn¹, T. Miertsch¹, K. Knappmeier¹
GSI, Darmstadt, Germany

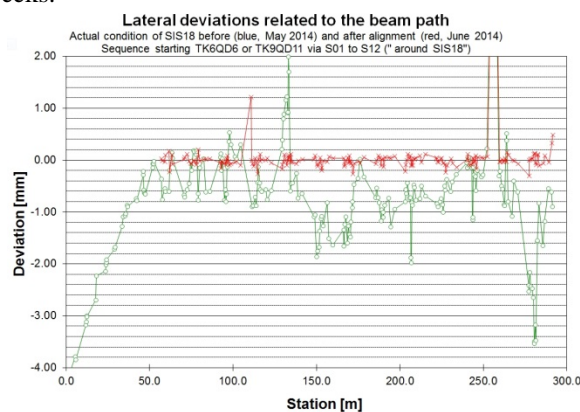
With few exceptions - caused by mechanical reasons - all magnets could be aligned within tolerance (fig. 1, 2). The complete alignment was carried out within four weeks.

Figure 1: Beam plot for synchrotron SIS18. Lateral deviation before (green) and after (red) alignment

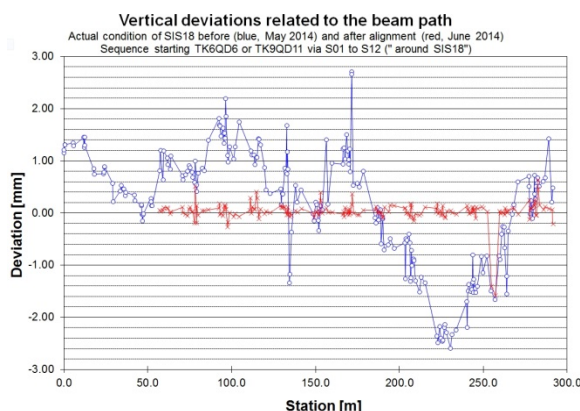
Figure 2: Beam plot for synchrotron SIS18. Vertical deviation before (blue) and after (red) alignment
