## **Case studies and analysis of mine shafts incidents in Europe**

A. Lecomte & R. Salmon (Institut national de l'environnement industriel et des risques)

### **Abstract**

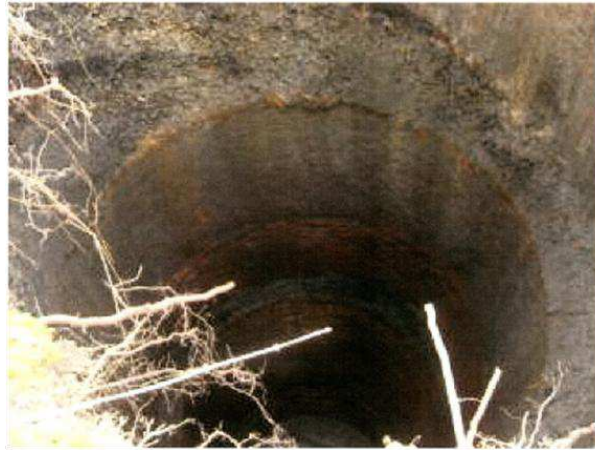
The case of Lancashire n°6 upcast shaft, in England, also illustrates this kind of incident. This 4.1 m diameter circular shaft, around 200 m deep, was filled in 1927 with soft material. In January 2007, a void about 4 m diameter at 20 m depth was observed from ground level. Brick lining remained suggesting a collapse of filling material that did not lead to the rupture of shaft head (Figure 1).

*Figure 1 : Collapses of Lancashire No.6 Upcast Shaft  
(Source: UK Coal Authority).*

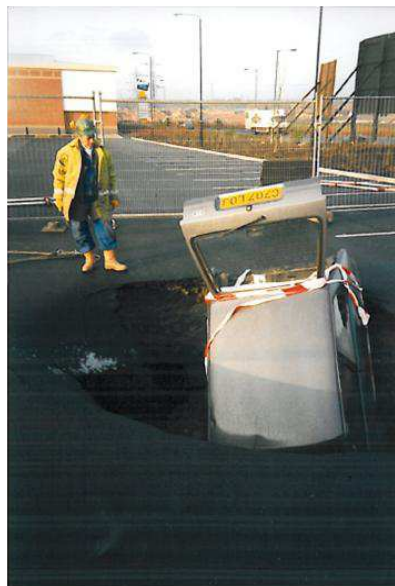
The case of West Midlands Shaft, in England, illustrates this kind of situation. This 3 m diameter circular shaft, 144 m deep, suffered a collapse of ground approximately 3 m diameter and 2.5 m deep in a car park area in 2000. Collapse became apparent when surfacing failed over a void due to weight of a car (Figure 2). Two occupants in the car escaped with only minor injuries.

*Figure 2 : Collapse of ground in the car park area  
(Source: UK Coal Authority)*

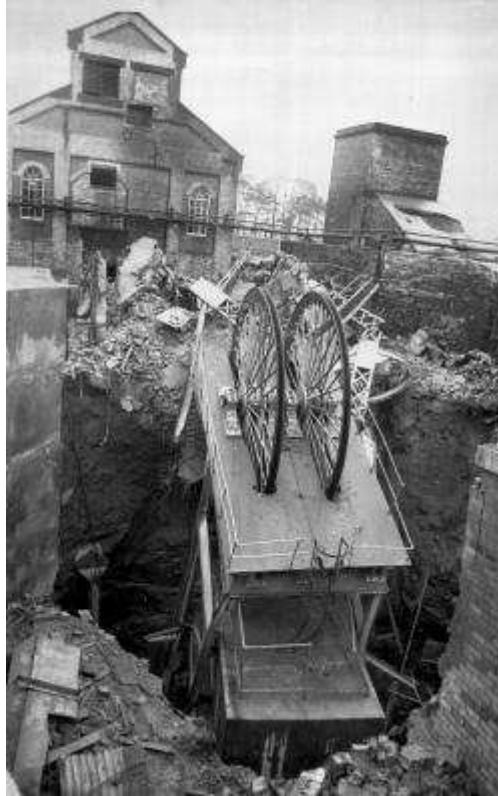
- Coal shaft V, Knurów-Szczygłowice colliery, in Poland. A detailed analysis is presented in Section 3.
- Shaft n°1 and n°2 at Barony Colliery Ayrshire Scotland (England): sunk between 1906 and 1912, shaft n°1 and n°2 are rectangular (resp. [6.4 m x 3.3 m] and [4.9 m x 3.3 m]), wood lined and 633 m deep. In 1960/62, modification of ventilation systems took place. N°1 shaft was originally used as the Downcast / coal winding until 1962. Following completion of works at the shaft head, it was re-commissioned as an upcast. N°2 shaft was an Upcast. After conversion of ventilation system, shaft n°2 collapsed following deterioration of wood lining (Figure 3), that may have been caused by contact with upcast air of high humidity.

Figure 3 : N°2 Shaft following Collapse (Source: MRSL)

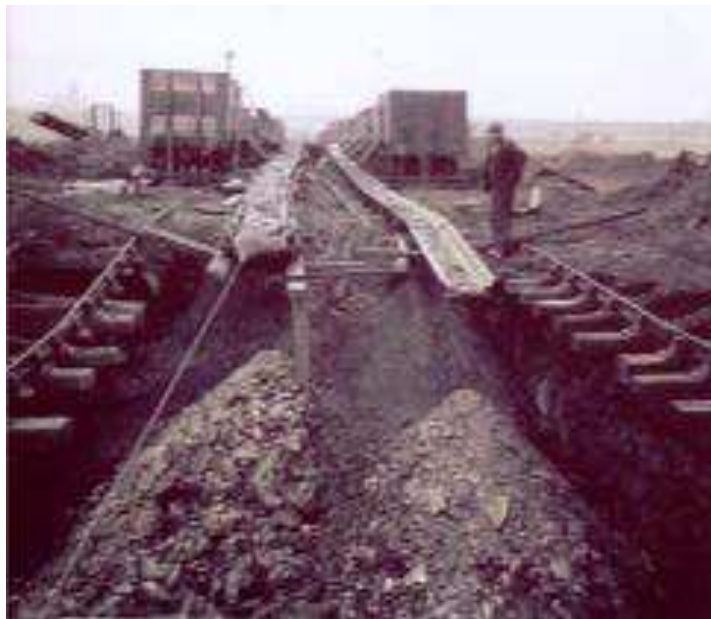
- West Midlands shaft (England), introduced previously.
- Low Hall n°7 (New Zealand Pit) at Abrams Lancashire, in England. The shaft is circular (3.66 m) and 305 deep and was sunk circa 1885. All mining via the shaft was abandoned in 1919 (1924?) although the shaft was retained for ventilation until 1932 (1931?) when it was filled with a reported 8,120T of debris. In April 1945, some 13 years after the mine shaft had been filled the locomotive was shunting a train of 13 loaded coal wagons (full length 86m) when the ground beneath the line cratered and collapsed (Figure 4). The last wagon entered the crater pulling the rest of the train and eventually the locomotive with it. A few days later, when the dust cleared, the front of the locomotive could be made out 30m below pointing upwards.

*Figure 4 : Infilling Shaft Post Collapse (Source: MRSL)*

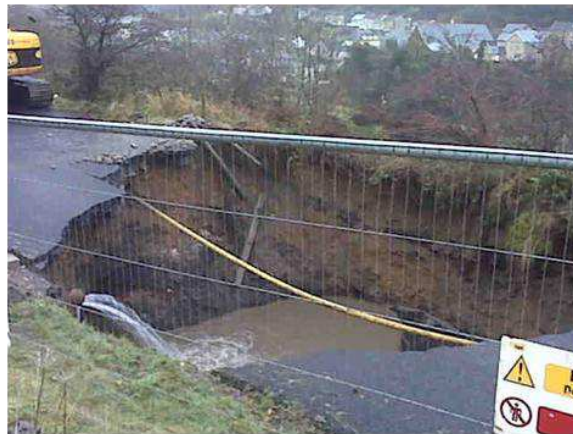
Shaft located at Tirphil, New Tredegar (England): this circular, 10 m diameter, shaft was last recorded in 1965. The collapse of shaft was reported at in November 2010. It was described as a hole in the road, 4 m deep, 4-5 m diameter, brickwork was visible and water was entering the hole from a culvert. The collapse was near the railway line and road between Brithdir and Tirphil. Due to water ingress from the culvert, the collapse grew in size and the following morning was approximately 10 metres diameter, 15 metres deep and filled with water to approximately 4 metres from road level (Figure 5). Whilst the cause of the collapse is unknown the location corresponds with a recorded mine shaft.

According to the desk investigation of Coal Authority data, it was found that the collapse is on the position of a mine entry. Shallow recorded mining exists beneath the site at approx 22m below road level and deep mining between 370 m and 480 m. The Shaft is connected to an adit. The adit is detailed as “the lowest free drainage for the Brithdir Seam in the Rhymney Valley” on abandonment plan 6467. The workings within the Brithdir Seam dip at 1in15 to the SSW. The roadway between the shaft and adit ran on the strike of the seam and the adit was c.20m below the surface level of the shaft.

*Figure 5: the collapsed shaft at road between Brithdir and Tirphil  
(Source: UK Coal Authority)*

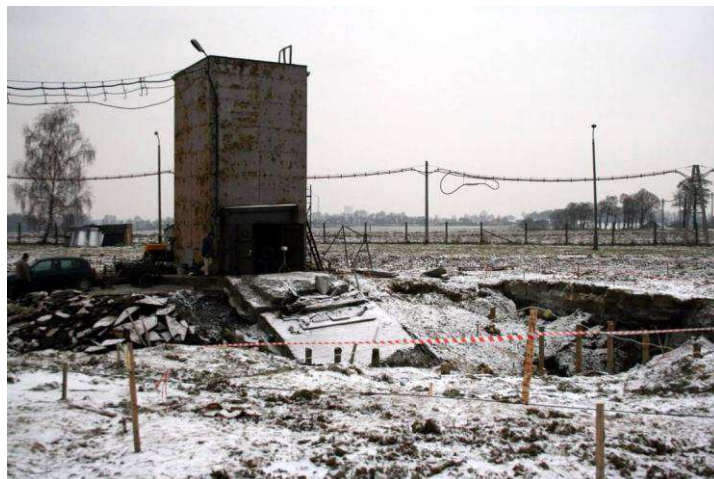
On 5 December 2007 at 12.15 o'clock during an inspection a ground surface deformation was observed between shaft V and a ventilation shaft over a length of 8.0 m. At the beginning, two 1 - 1,5-m deep craters were observed on the south-eastern and north-western side of shaft V, which already on 7 December 2007 had a diameter of circa 5,0 - 7,0 m each. The craters were located on both the sides of ventilation drift at a not large distance to shaft “V”. Not later than the first days after the aforementioned event the craters united into one that continuously grew.

What caused the catastrophe was the inrush of a quicksand strata into the shaft. The strata found a way into the shaft in a leak of the shaft lining at the connection of the ventilation drift to the shaft. This caused loosening of ground under the drift and its vertical displacement by about 2,0 m (Figure 6).

*Figure 6 : The crater in the neighborhood of shaft “V” (Source: GIG / KWSA)*

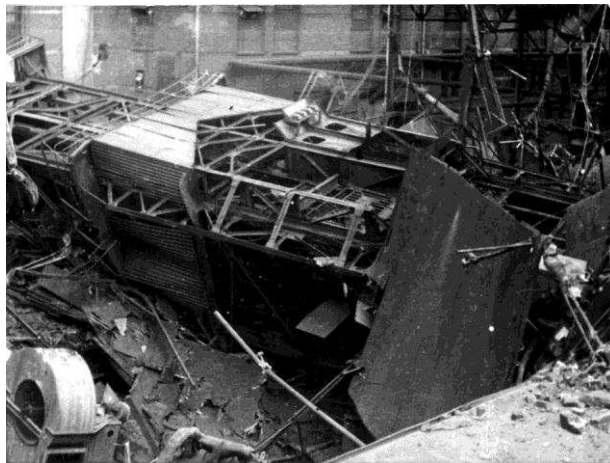
The catastrophe of shaft Bolesław took place on 6 September 1975. On the western side of the shaft a crater came into being that uncovered foundations of the shaft bank house. After several hours the increasing crater caused a collapse of the shaft bank building which leaned against the headframe’s angle struts breaking them and causing a collapse of the headframe (Figure

7). The event was characterised by a very dynamic course and lasted merely 15 hours.

The primary cause of the accident was a quicksand inrush into the shaft at a depth of 24 m. An increased outflow was observed during the nightly shaft inspection before the catastrophe and a vertical fracture of the lining was located below the outflow point. As a result of falling out of an concrete gutter element a 0,8-m long and 0,2-m wide vertical fissure came into being throughout the whole thickness of the shaft lining. Although a provisional packing had been placed in the gap in lining, made of ventilation fabric and planks, a considerable and violent increase of the gap in the lining was observed after a short time since it began, along with an intensive outflow of sand and water. As a result of water influence and changes in load exerted on the shaft lining the latter began breaking along a considerable length. The quicksand inrush caused that it was necessary to fill the shaft at a depth of from 6,0 m to 160,0 m.

Figure 7 : View of the collapsed headframe (Source: GIG / KWSA)

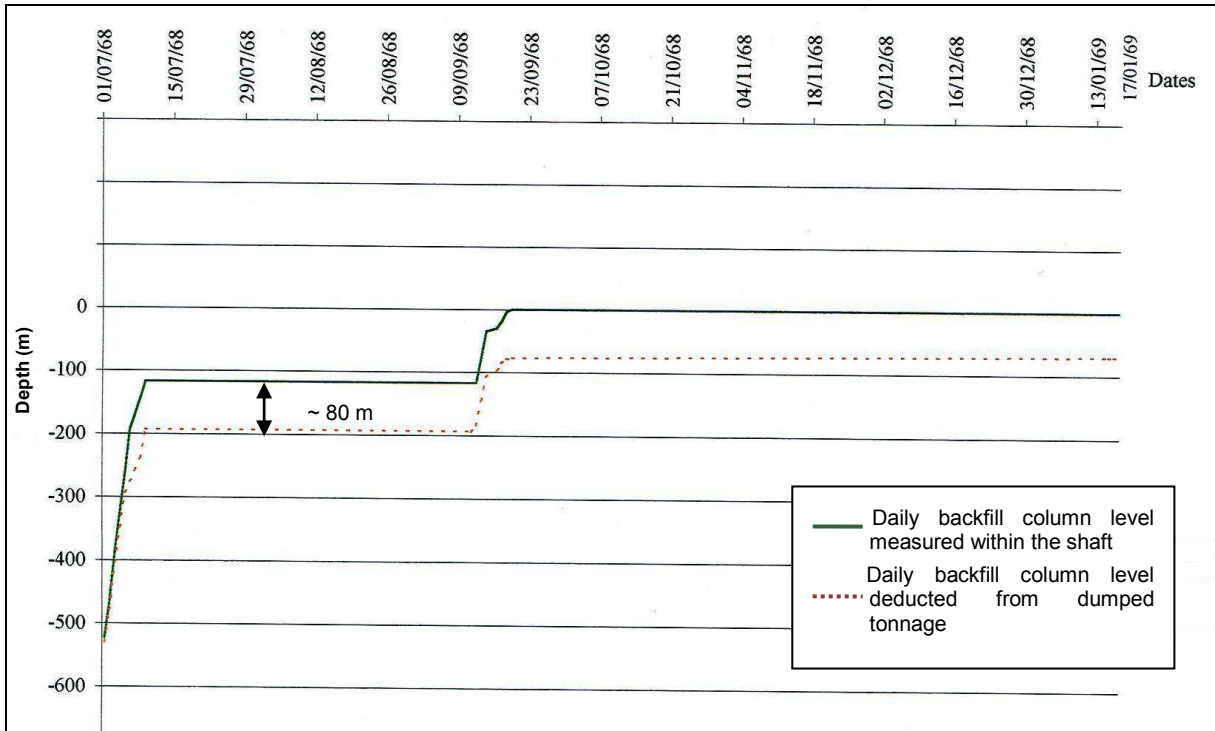
The historic curves deduced from the follow-up of backfill data show sharply the appearance of void formed from the first works of stowing. Figure 9 and Figure 10 show a sensitive and constant distance between the level of backfill material measured in the column of shafts and the level equivalent to the volume of the dumped backfill material. The first one is upper than the second indicating the presence of one or several voids in the column of shafts. Let us note that shafts were not deinstalled before the stowing and the presence of metallic structures within the column of shafts can ease the creation of backfill material vaults.

Figure 9 : backfill level evolution – Shaft n°8 – from 01/07/68 till 17/01/69

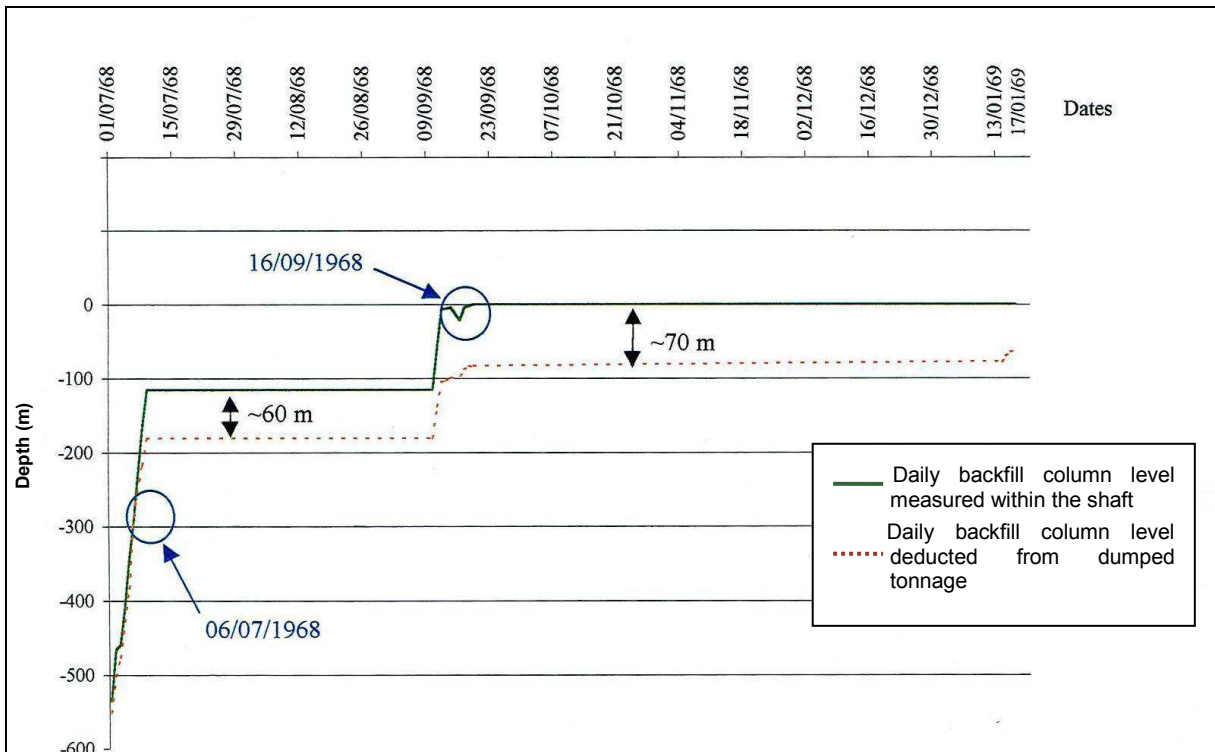
Figure 10 : Backfill level evolution – Shaft n°8 bis – from 01/07/68 till 17/01/69

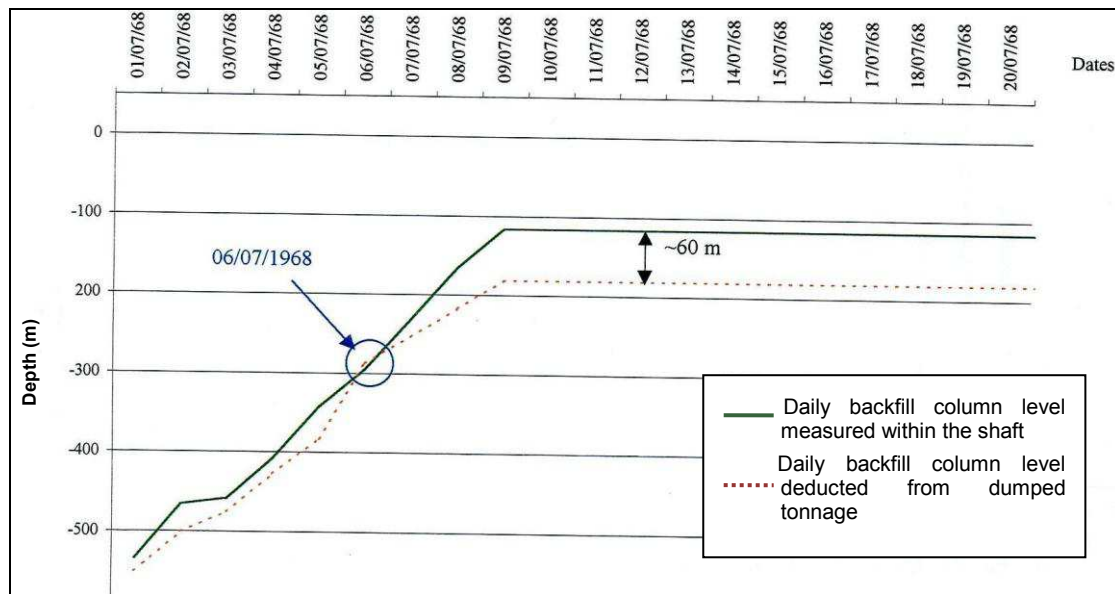
Figure 11 : level evolution – Shaft n°8 bis – from 01/07/68 till 20/07/68

Figure 11 shows the detailed history of the first days of shaft n°8 bis backfilling. It shows that on July 6th, 1968 the measured level is lower than the equivalent level of stowing. 2,035 t of backfill material were dumped. They should have filled an equivalent weight of 92 m but the measure showed that only 48 m of the shaft column were filled actually. The phenomenon of settlement of backfill material in the bottom of shaft column under the weight of superior backfill material does not explain the observed difference:

- the adjustment of the level of the backfill material by filling of the void created previously;
- the failure of the system of closure of one or several stations the departure of backfill material in one or several corresponding galleries.

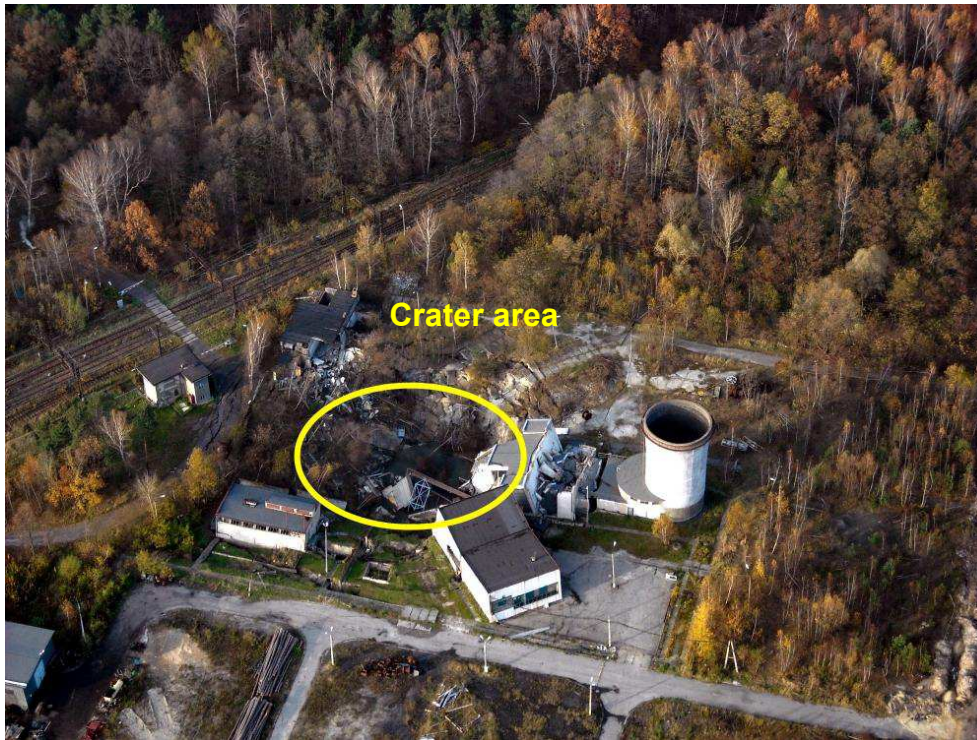
On 4 September 2008 at 4.35 o'clock a catastrophe took place which resulted in shaft lining damage up to a depth of circa 70 m, and afterwards the shaft was spontaneously filled with overburden soil material. This caused that a large crater came into being at the surface that in turn caused damage of building facilities present in its impact zone.

Figure 13 : General view of the scene of the catastrophe of shaft V from the south  
(Source: GIG / KWSA)

The crater had a diameter at the ground surface about 60 m, a depth of around 11 m and an estimated volume of about 30,000 m<sup>3</sup>. Horizontal range of fracture zone at the ground surface affirmed on 4 September 2008 amounted to 67 m.

The primary cause of the accident at the shaft was damage to its lining at a depth of 61 m – 67 m. The damage was a consequence of:

1. Irregular mining repeatedly performed in the neighborhood of the safety pillar of the shaft which influenced hydrogeological conditions which in turn destroyed building-engineering stability of the ground-lining system.

## 2. Poor technical condition of the lining of shaft V.

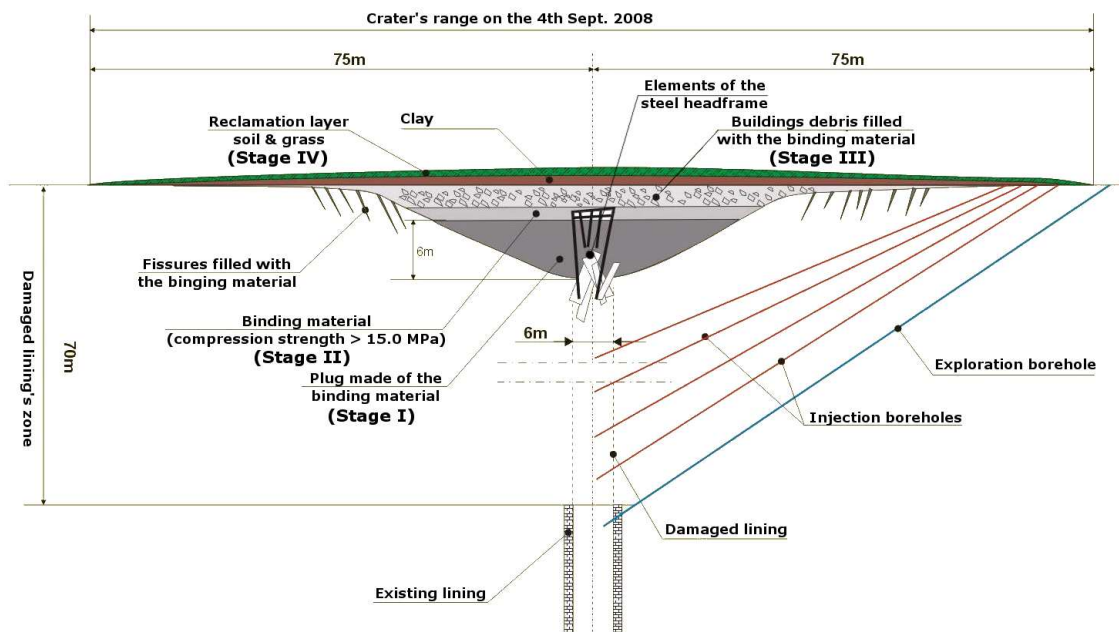
*Figure 14 : Schematic illustration of the crater resulting from the catastrophe of shaft V and its fill*

Empty spaces in the shaft section where the lining damage took place up to the crater bottom were filled with a binder characterised by compression strength of not less than 15 MPa. The spaces were filled after building stoppings at levels 450 m and 350 m. The filling material was supplied through holes drilled from the ground surface in the direction to the shaft at 10 m distance one to another. Before they set to injection, an exploration borehole was drilled to assess the crater's range and scope of damage. Locations of the injection boreholes and the exploration hole are presented in *Figure 14*.

The crater was filled in four stages.

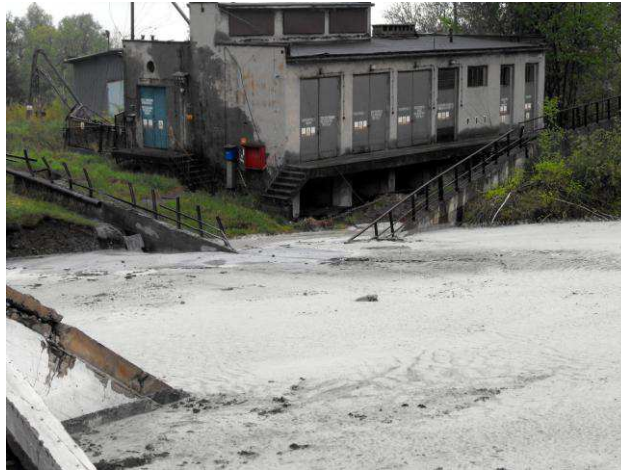
*Figure 15 : The load-bearing layer at the crater – 5 May 2010 (Source: GIG / KWSA)*

*Figure 15 and Figure 16 present results of work performed at Stage II and III.*

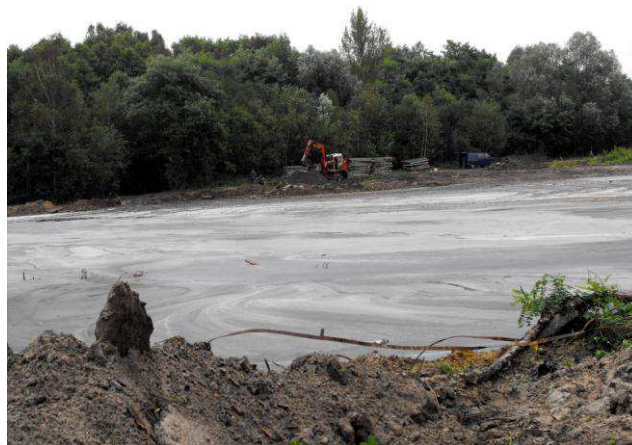
*Figure 16 : Final crater fill with building debris mixed with binding material – 31 August 2010 (Source: GIG / KWSA)*

The third stage (Stage III) included further filling the crater up to the ground surface by means of a mixture of building debris (stemming from demolishing) and a binding material with compression strength of at least 5 MPa. Moreover all fissures that came into being in the vicinity of the crater were filled with the binding material used at the second stage.
