Enhancing the performance of dowel type fasteners and a case study of timber truss failure

1.2 Light Frame Building Construction

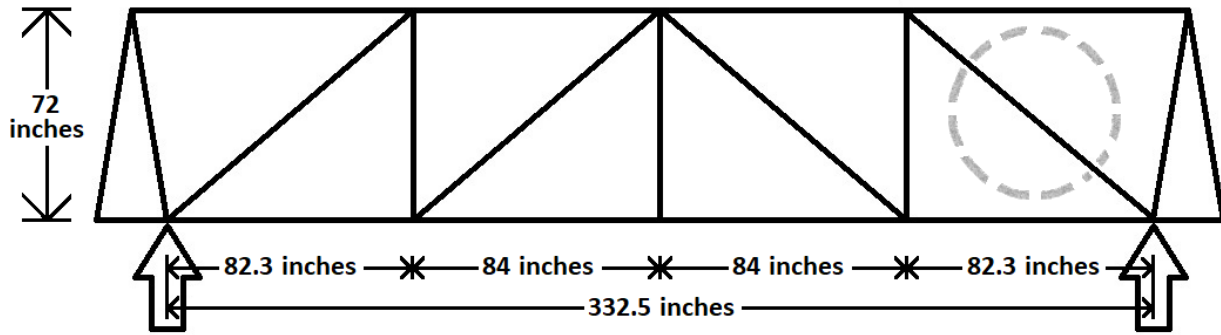
Figure 1.1 Truss diagram. The support reactions are shown at the centerline of the exterior support walls. The dotted circle indicates the web member that failed on multiple trusses and appears to have initiated the collapse.

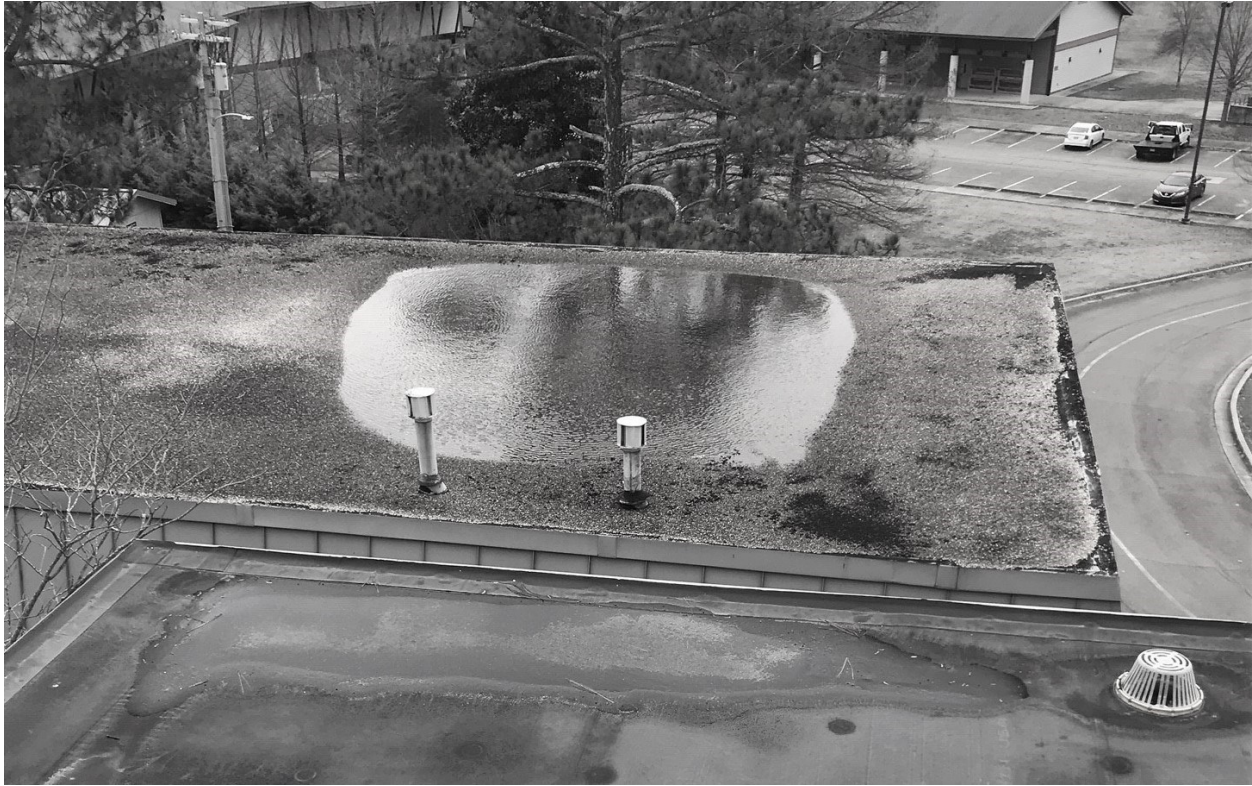
Exterior inspection revealed water ponding, on the roof, over approximately half of the span of three of the trusses. That is, the ponding extended across several trusses. The trusses were shored up by reducing the span and locating supporting beams underneath the top chords of both the failing trusses as well as the trusses immediately adjacent thereto. This repair transferred a portion of the loading through an interior wall, the floor system, and down to the building’s

Figure 1.2 Ponding on roof, over an estimated 6.7 x 6.7 meter (22 x 22 foot) area, hours before a heavy rain and windstorm event during which the roof collapsed.

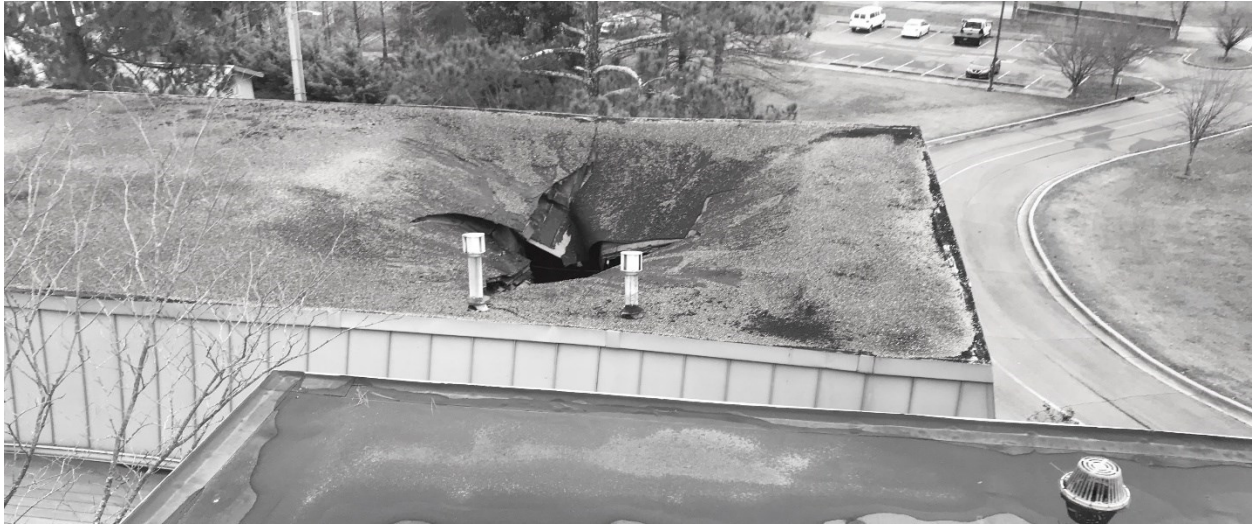
During the winter of 2019, occupants again noted audible wood failure inside the building's ceiling, this time toward the building's southwest end. The area of the building at issue was vacant at the time. The area was cordoned off, locked, and then immediately inspected. The suspended ceiling tile system had come down as much as 12.25 cm (6 inches) under some of the trusses in the area of failure. Inspection of the roof truss system, by ladder from inside the building, indicated that several trusses were failing. Ultimately, these failures should likely be classified as deflection induced, that is, long and unbraced columns deflecting, which led to ponding, which exacerbated the deflection, and so on up until catastrophic failure. Common to these failures were the unbraced compression web members immediately atop the southeast wall (similar to the web members that broke and were repaired, in another area of the building, approximately 15 yr prior). Inspection of the roof showed ponding, that is, additional dead weight on the system. The pond's maximum depth was estimated at 7.5-10 cm (3-4 inches) and its area was estimated at approximately 6.7×6.7 m (22×22 feet) (Fig 1.2). At that stage, it appeared that catastrophic roof failure was likely imminent and there would not be time to propose and/or enact a repair. As such, the area at issue under the roof was blocked off to avoid any potential injury. That evening, during a heavy rain and wind event, approximately 8 h after the initial reports of "wood breaking" were received, the roof collapsed (Fig 1.3).

Figure 1.3 Roof section, approximately 7.3 x 8.5 meters (24 x 28 feet), (7 trusses each 28 feet long) immediately following collapse.

will be recommended that the roof system be completely redesigned and rebuilt prior to reoccupancy or that the structure be razed and rebuilt depending on the associated costs of each alternative.

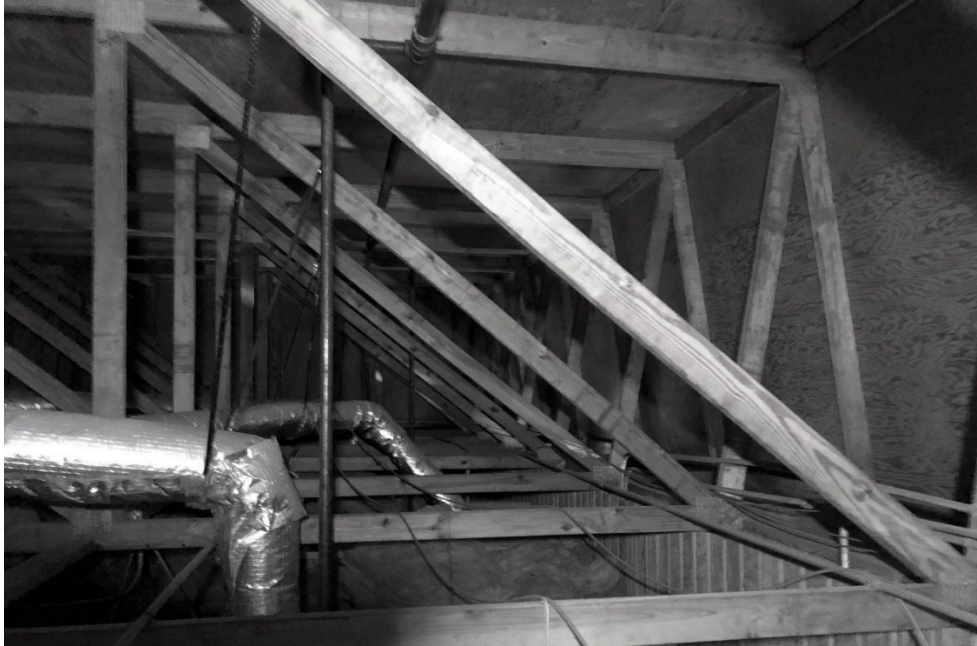
Post-collapse inspection of the remainder of the building's non-collapsed roof framing, revealed significant compression-induced deflection in the web member of interest. Fig 1.4 illustrates a series of trusses with their unbraced web members as they sit atop the exterior wall. An exemplar web member (Fig 1.5) was photographed in an effort to measure the deflection against a stringline. At the time of the photograph in Fig 1.4, there was no standing water on the roof. Thus the only loading on that truss at that time is the approximate 0.67 kPa (14 psf) dead load. At 1.63 kPa (34 psf) combined load, 9.22 m (30.25 foot) top chord length, and 1.22-m (4-foot) spacing, each truss is intended to carry 1866 kg (4114 pounds). That level equates to 202 kg per lineal meter (136 pounds per lineal foot), uniformly distributed along the symmetric truss length. As such, the estimated reaction at each exterior wall is 933 kg (2057 pounds). The load from the outermost half of the outermost 243.8-cm (96-inch) section of top chord is subtracted from this value to determine the reaction force that is pushing on the web member of interest. The top chord span above the exterior wall is approximately 243.8 cm (96 inches) (Fig 1.6). The loading associated with outer most 1.22 m (4 feet) (half of the chord) is transferred to the reaction wall through the shorter web member that extends from the exterior wall, slightly outward, to the top corner of the roof. That vertical reaction load value associated with that web member is estimated as 246.75 kg (544 pounds) (1.22 lineal meters [4 lineal feet] times 202.4 kg per lineal meter [136 pounds per lineal foot]). The balance of the reaction force (933 kg – 247 kg = 686 kg [2057 pounds – 544 pounds = 1513 pounds]) is transferred vertically through the web member of interest.

Figure 1.4 Series of repetitive flat roof trusses sitting on the exterior roof wall. Of particular interest is the unbraced 2x4 compression web member running diagonally up from the exterior wall.

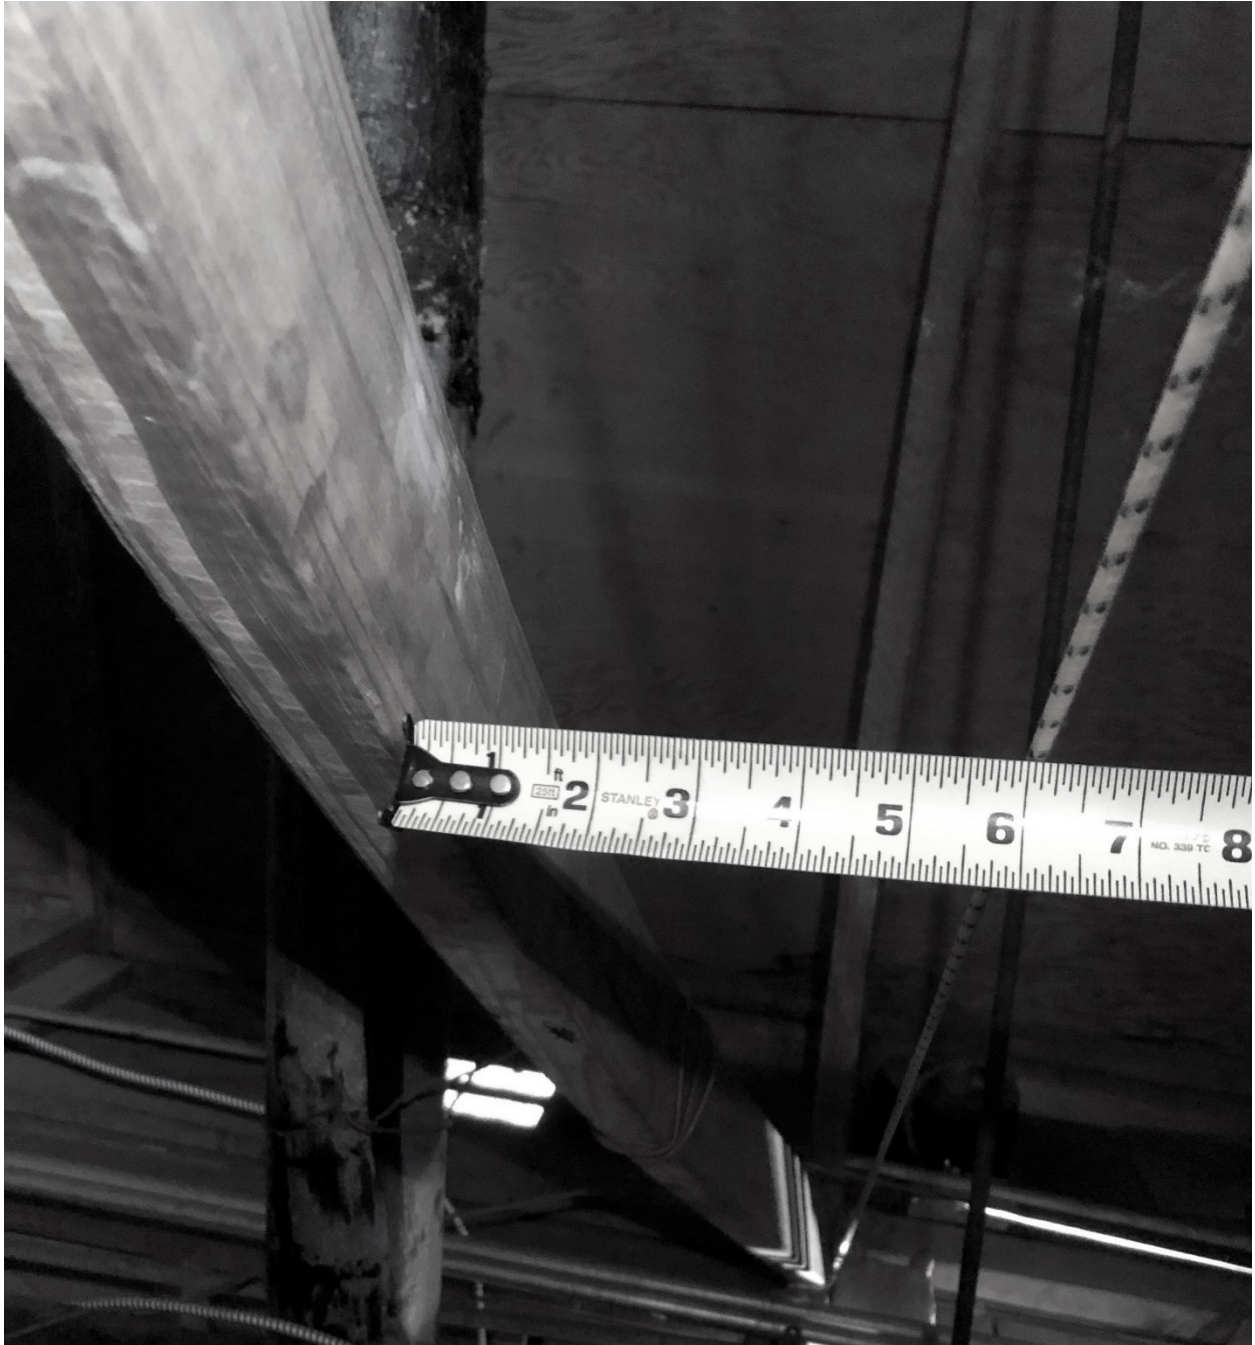
Figure 1.5 Exemplar web member showing 15.5 centimeters (6-1/8 inches) of deflection. The member is 2x4, #2 as called for in the truss diagram. Its unbraced length is 256.6 centimeters (101 inches). The truss had a little or no live loading at the time of the photograph.

As measured, the unsupported length of the web member of interest is 256.5 cm (101 inches). Its vertical rise is 160 cm (63 inches), that is, 182.9-cm (72-inch) total truss height less the 8.9-cm (3.5-inch) deep bottom chord and 14-cm (5.5-inch) deep top chord. As such, with respect to the horizontal, the web member's angle theta is 38.6 degrees ($\sin 38.6 \text{ degrees} = 63/101$). At that angle, the 686 kg (1513 pound) vertical reaction force equates to 1100 kg (2426 pounds) of compressive force to the web member of interest. With a cross-sectional area of 33.9 cm^2 ($3.8 \times 8.9 \text{ cm}$) (5.25 inches^2 [$1.5 \times 3.5 \text{ inches}$]), the web member of interest is estimated to be routinely experiencing 3185 kPa ($1100 \text{ kg}/33.87 \text{ cm}^2$) (462 psi [$2426 \text{ pounds}/5.25 \text{ in}^2$]) of columnar compression due to total loading.

Thus, the estimated bending stress (s), absent any creep, to create the level deflection as observed is 4,4692 kPa (6482 psi) in a series of compression web members whose F_b value is 9308 kPa (1350 psi) (Southern Pine Manual of Standard Wood Construction 1975).

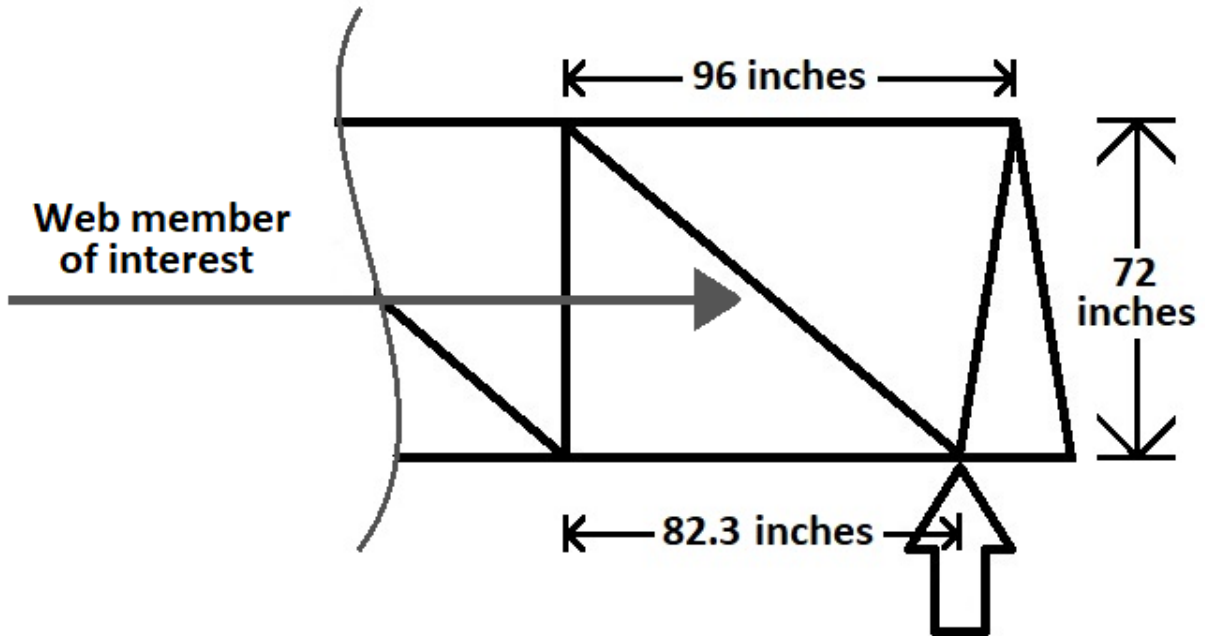
Figure 1.6 Determination of reaction force transferred to the web member of interest. The total vertical reaction is estimated as 933 kilograms (2057 pounds). The load from the outer 1.22 lineal meters (4 lineal feet) (246.75 kilograms or 544 pounds) of the top chord is transferred to the support wall by the outer compression web member. The balance, 686.3 kilograms (1513 pounds) is the vertical reaction force that the web member of interest resists.
