# SEISMIC DAMAGE OBSERVATIONS OF PRECAST HOLLOW-CORE FLOORS FROM TWO FULL-SCALE SUPER-ASSEMBLY TESTS

Büker, F.<sup>1\*</sup>, Parr, M.<sup>2</sup>, De Francesco, G.<sup>3</sup>, Hogan, L.S.<sup>4</sup>, Bull, D.K.<sup>5</sup>, Elwood, K.J.<sup>6</sup>, Liu, A.<sup>7</sup>, Sullivan, T.J.<sup>8</sup>

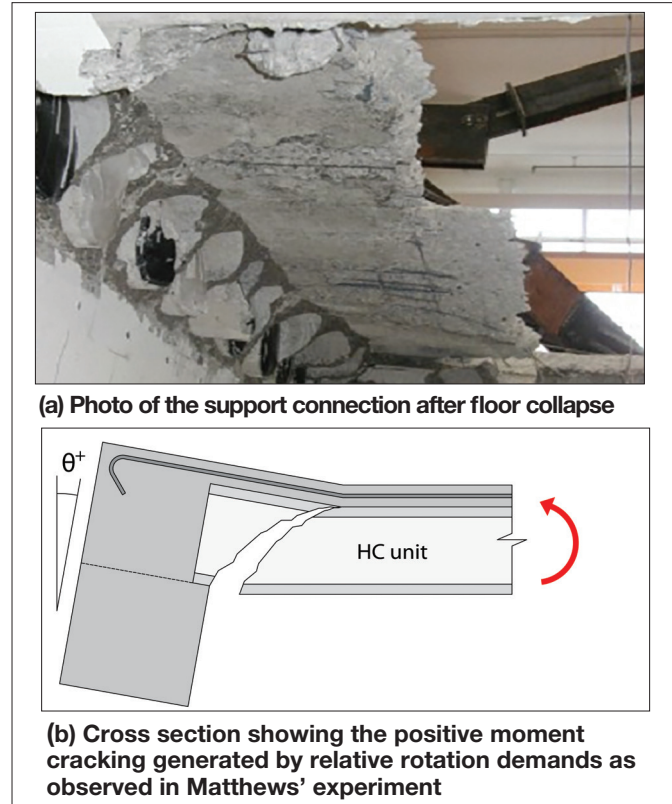
One of the critical observations was that the damage occurred within the hollow-core units themselves (see Figure 2), disproving previous assumptions that all the deformation and damage manifests at the beam-to-floor interface.

**Figure 2: Cracking within the hollow-core units (adapted from Matthews (2003))**

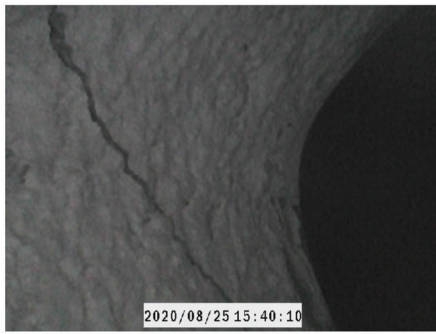
Although, at this stage, there was only minor cracking visible on the exterior of alpha unit U8, a web crack was suspected of having formed at the south support during the 0.5% drift cycles. This web crack was detected through simple acoustic testing by tapping a hammer on the underside of the floor lengthways along the webs. A distinct difference in the pitch of the sound response could be heard where the crack was suspected. Nonetheless, visual confirmation of the crack was not possible with a borescope camera at this stage. The web crack at this previously identified location became clearly visible at +1.0% ( $\parallel$ ) drift, as indicated in Figure 12c.

(12c) Web crack in alpha unit U8 at +1.0% (||) (where at 0.5% drift a web crack was detected via acoustic testing)

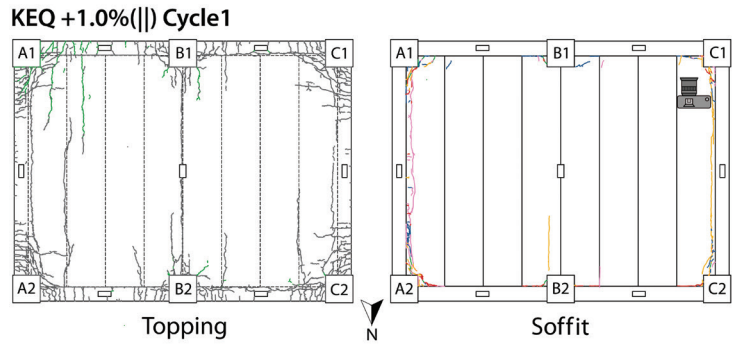
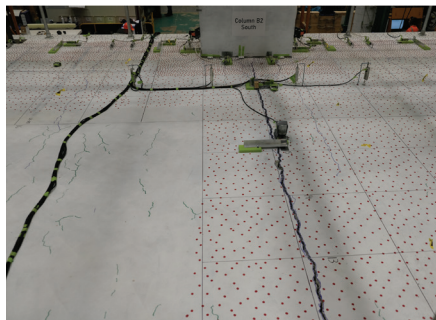
With further progression of loading, the elongation from the plastic hinges at the intermediate columns B1 and B2 concentrated in the split between the two beta units U4 and U5. As a result, the non-ductile 665 mesh wires across the split fractured while loading to +1.5% ( $\perp$ ) drift (Figure 12d).

(12d) Widened longitudinal split between beta units after rupture of mesh reinforcement shown after 1.5% drift cycles

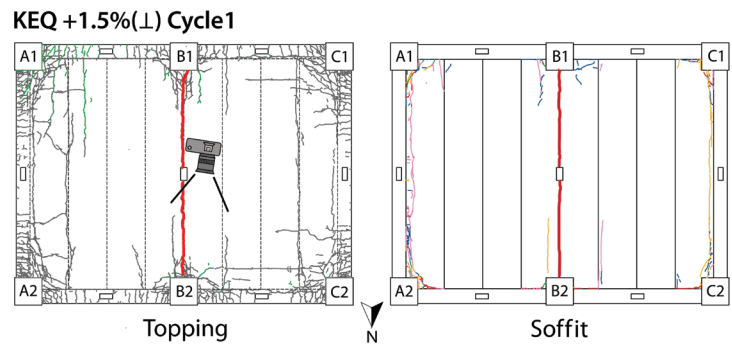
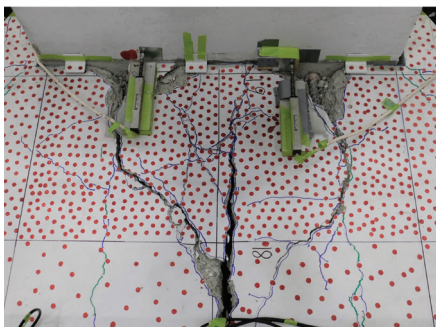
Throughout the seismic loading, splitting cracks along the column ties had developed in the vicinity of the intermediate columns. During the cycles to 2.0% and 2.5% the topping concrete over the column ties at the face of the columns spalled off, exposing the reinforcement (Figure 12e).

(12e) Extensive spalling and splitting cracks at 2.5%

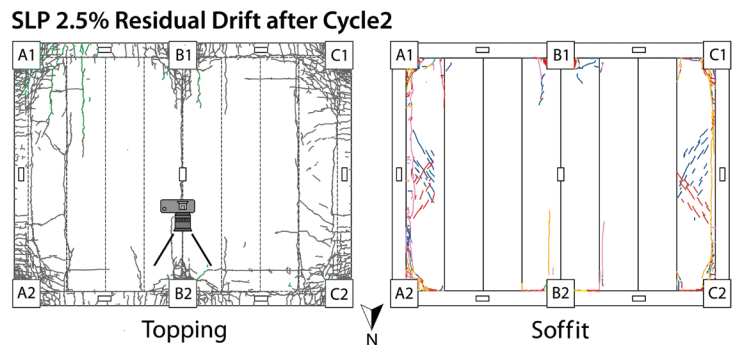
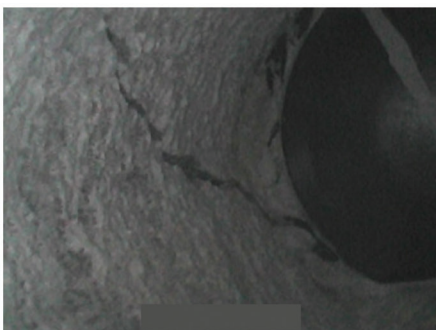
From the borescope inspections conducted during the 2.5% drift cycles it was concluded that web cracking was present in multiple locations, as indicated in Figure 12f. Only alpha and beta units exhibited web cracking in this first test. The majority of detected web cracks were an extension of the soffit cracks and propagated at an angle of 45° or steeper in the direction of the gravity shear, which is consistent with the positive moment crack propagation observations from Matthews’ super-assembly experiment (2003, see Figure 2).

(12f) Extensive web cracking in multiple hollow-core unit ends at 2.5%

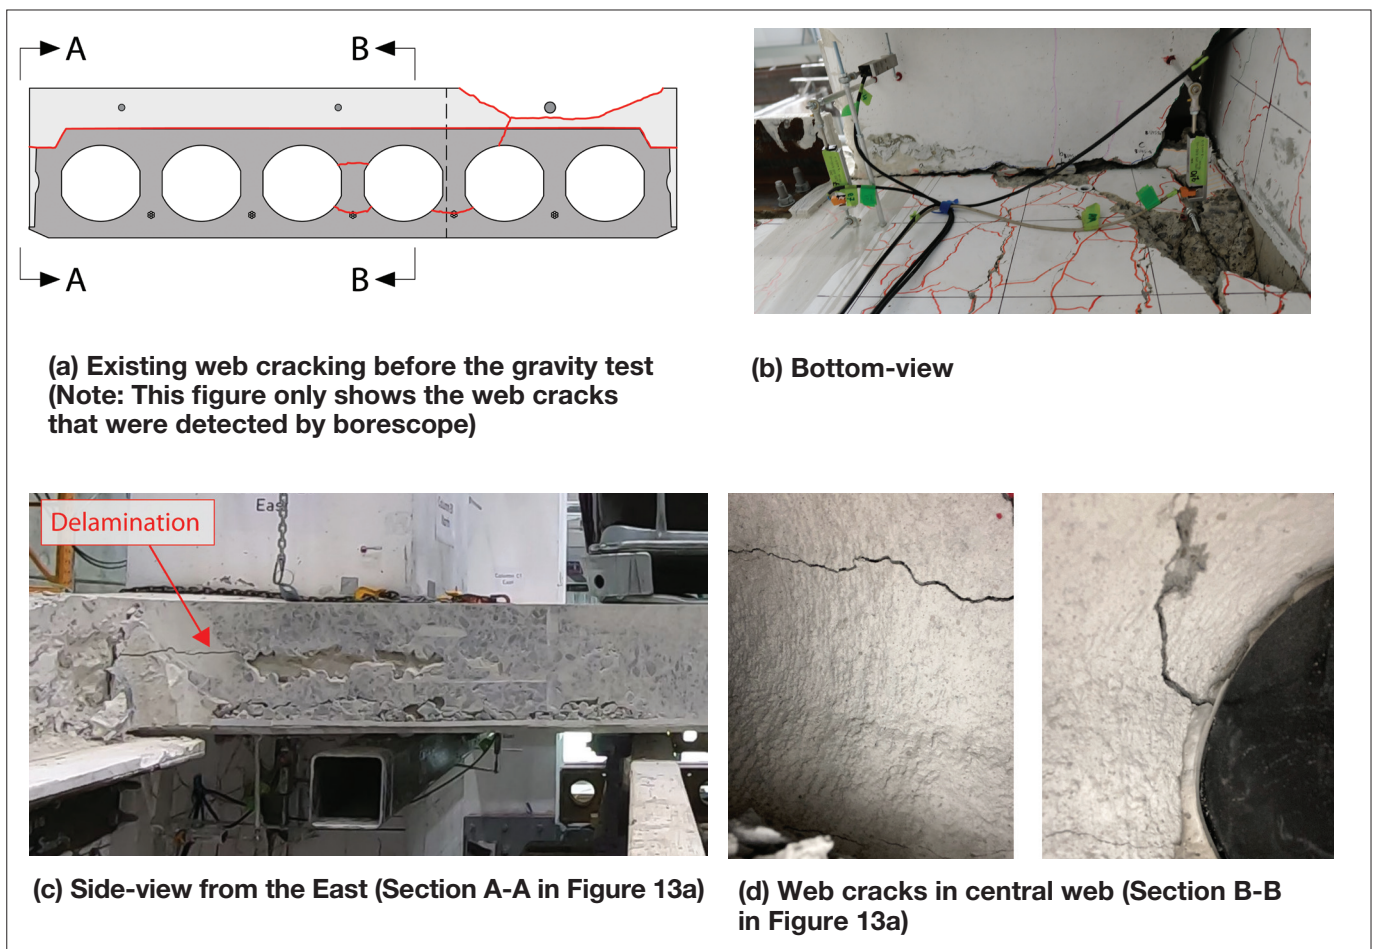
affected beta unit U4 at the south support because column B1 was accidentally pulled outwards by 29 mm when the specimen was at -1.5% ( $\parallel$ ). Before the gravity test the loading error was partially corrected by pushing the column back inwards by 8.3 mm and bringing the specimen into the upright position (0% ( $\parallel$ ) drift). This correction reinstated the initial conditions to a satisfactory extent because the displacements imposed by the loading error concentrated at the back face of the unit and did not cause noticeable additional damage to the hollow-core unit itself. The web cracking and delamination that beta unit U4 sustained during the earthquake loading are illustrated in Figures 13 a - d. As shown in Figure 13b, the floor was only partially seated.

**Figure 13: Condition of beta unit U4 (south support) after seismic demands and before gravity test**

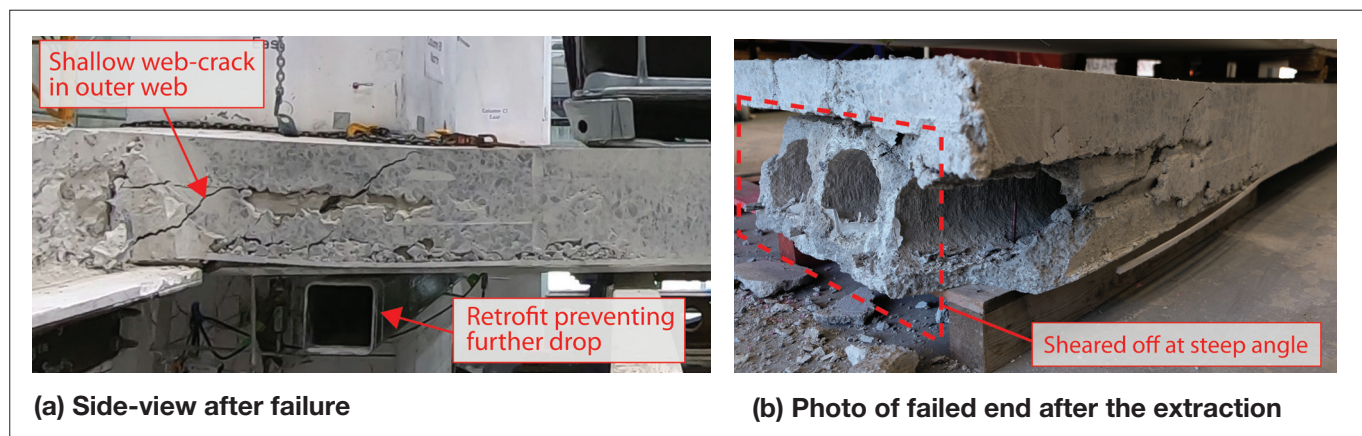
During the gravity test, beta unit U4 could sustain shear loads of up to 38.7 kN and sudden brittle failure occurred when this load was reached, as shown in Figure 14a. Further drop was prevented by the SHS that was installed as a seismic ‘catch beam’ retrofit underneath this hollow-

core unit as part of the overall retrofit solutions (Table 1). Extraction of the failed beta unit U4 gave further insights into the failure mechanism. While the outer web failed in a shallow web-shear crack (Figure 14a), the three interior webs sheared off at a much steeper angle (Figure 14b).

**Figure 14: Gravity Test of a damaged beta unit U4.**

The shear load of 38.7 kN at which the hollow-core unit failed corresponds to 91% of the design gravity shear demand (1.2G+1.5Q with  $Q = 3.0$  kPa). When comparing the measured shear loads to the design web-shear capacity, they correspond with 52% of the design web shear capacity per NZS3101:2006-A3 (SNZ 2017) when accounting for the reduced section due to the notches and omitting the strength reduction factor of 0.75. While only indicative, given the wide variability in web damage expected in beta units due to earthquake damage and potential effect from the actuator control issue, the test results give a sense of how much web cracking may compromise the residual gravity capacity of hollow-core floors.

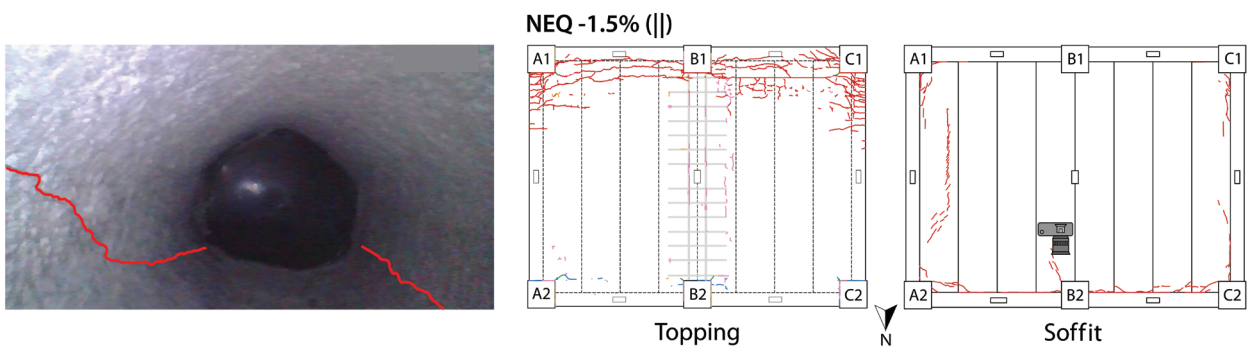
At -1.0% (||) drift a vertical offset of 1.3 mm across the soffit crack at the north support of beta unit U5 was measured. During the loading to -1.5% (||) drift the vertical offset across the now 3 mm wide soffit crack increased to 2.6 mm and thus exceeded the vertical offset benchmark of 2 mm, which indicates a loss of reliable load path (Corney et al. 2021). The vertical offset measured across the soffit crack in beta unit U4 (north end) was even more pronounced, measuring 3.7 mm. This soffit crack formed approximately 100 mm from the support beam ledge and propagated internally as a shallow web crack approximately 400-500 mm towards mid-span, as shown in Figure 16c.

(c) Web cracking in beta unit U4 (North support)

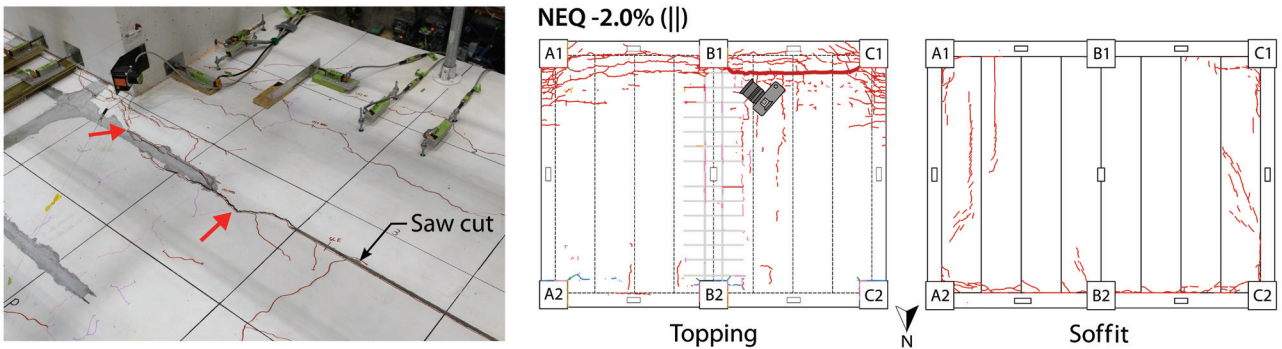
With further loading the negative moment crack at the end of the starter bars along beam B1-C1 continued to widen. From -1.6% (||) onwards, the 665 mesh at the end of the starter bars fractured starting at column C1 and progressing to column B1. When -2.0% (||) drift was reached the width of the negative moment crack ranged from 3.5 mm (at beta unit U5 – Figure 16d) to 5.0 mm (at alpha unit U8) and a substantial vertical offset of up to 3.2 mm (at beta unit U5) was measured across this crack.

(d) Negative moment crack shown at -2.0% (||) after mesh rupture at -1.6% (||)

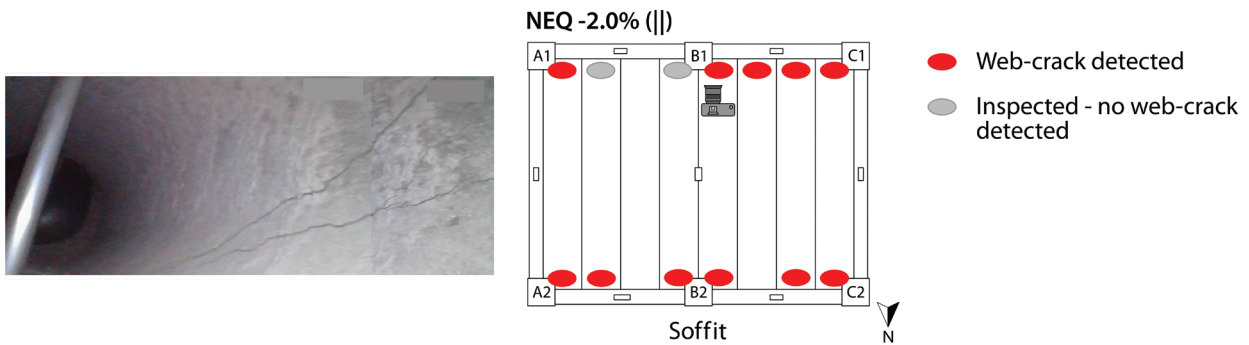
The presence of web cracking in every hollow-core unit was confirmed at the peak of the first pulse (-2.0% (||) drift) as indicated in Figure 16e. Furthermore additional vertical offsets across the transverse cracks in the soffit of beta units U4 and U5 were recorded, with a magnitude of 6 mm and 4.5 mm respectively. Figure 16f illustrates the extent of the vertical offset in beta unit U5. It should be noted that further vertical offset of beta unit U5 was prevented by the strongback retrofits, but the cable-catch retrofit under beta unit U4 allowed for additional vertical offset.

(e) Web cracking at -2.0% (||). The photo shows a web crack that is an extension of the negative moment crack in unit U5.

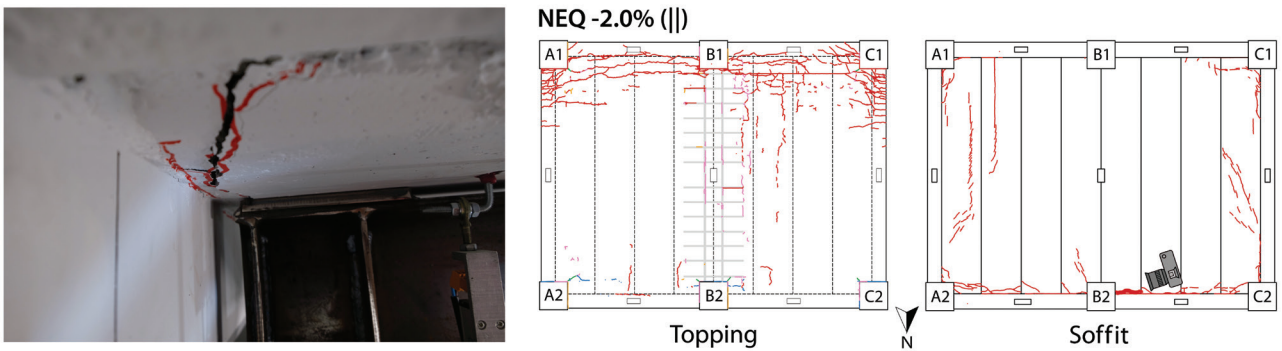
(f) Vertical offset in beta unit at -2.0% (||)
