**STRUCTURAL MECHANISMS CONTRIBUTING TO
LARGE-SCALE HANGINGWALL INSTABILITIES ON THE
UG2 REEF HORIZON**

MSc Mining

UNIVERSITY OF PRETORIA

2019

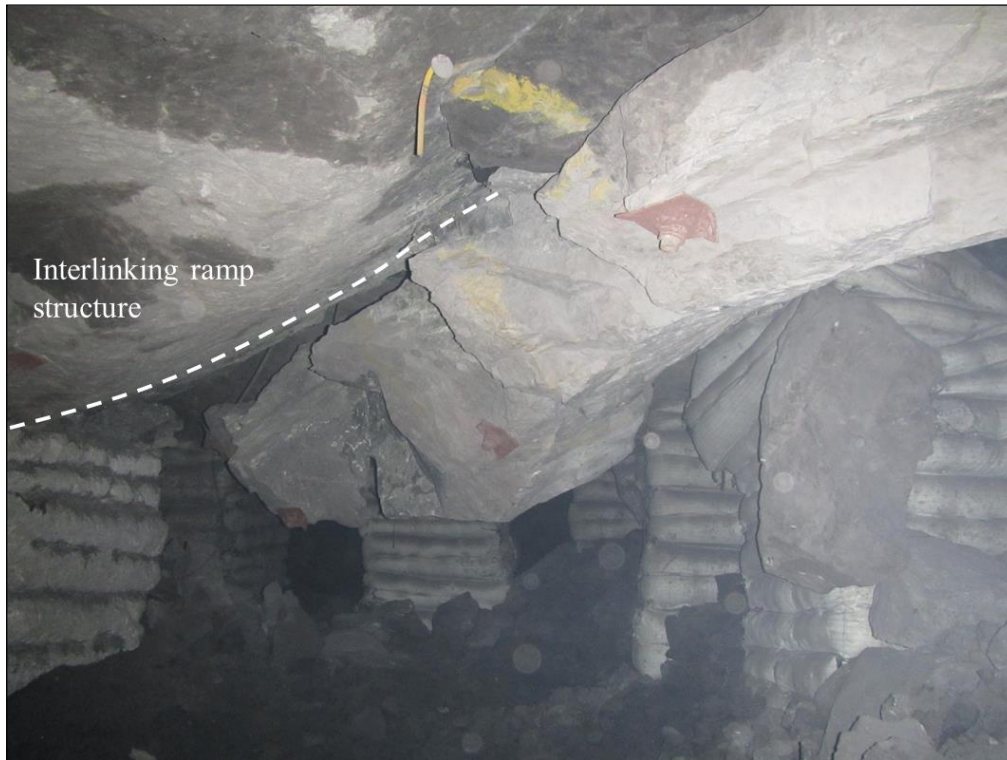
Figure 1.8: Unstable hangingwall conditions along a ramp structure. The only support on the edge of the brow was in-stope rock bolt support. The structure ramped up to the position of the UG2A markers (located at 3 – 4 m in the hangingwall). A large fall of ground occurred in the panel face where another ramp structure was intersected. This resulted in the panel being abandoned.

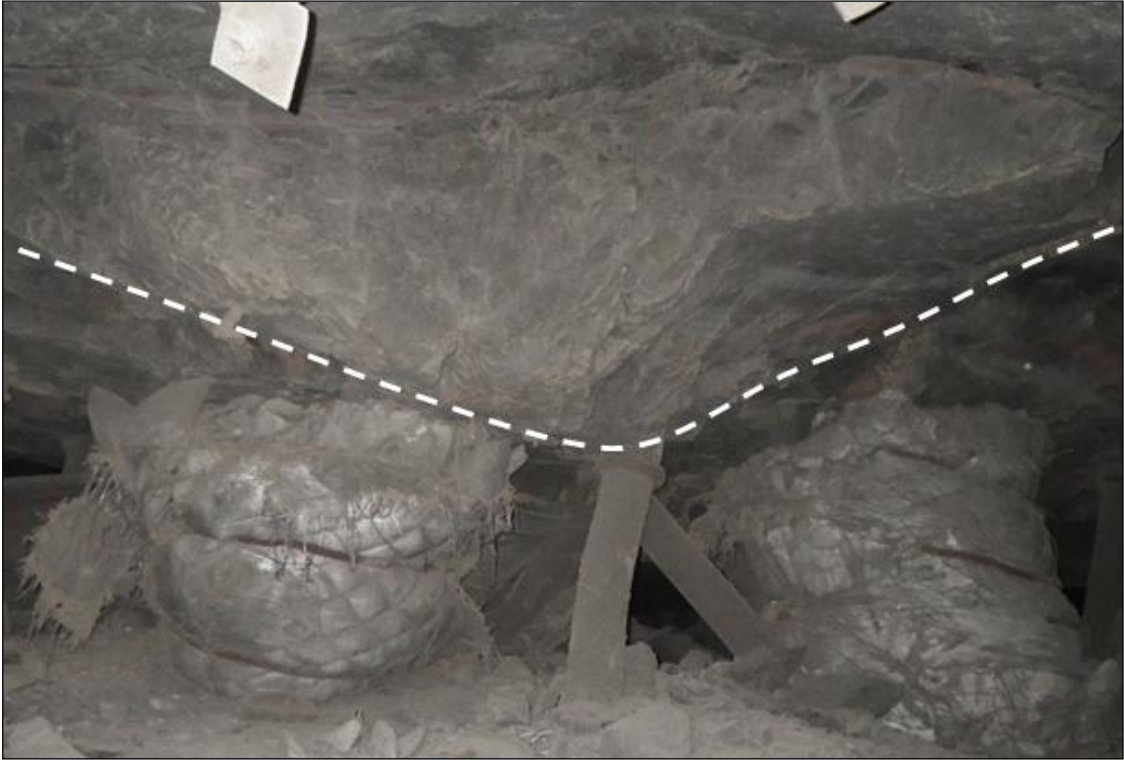
Figure 1.10: Large-scale instability showing the loading and failure of the support units. The support units were loaded as a result of separation along the hangingwall 1A/hangingwall 2 contact (12 – 15 m in the hangingwall). The peak support capacity for elongates are 27 t and for the 1.2 m diameter grout packs are approximately 500 t. The panel was abandoned and had to be re-established.

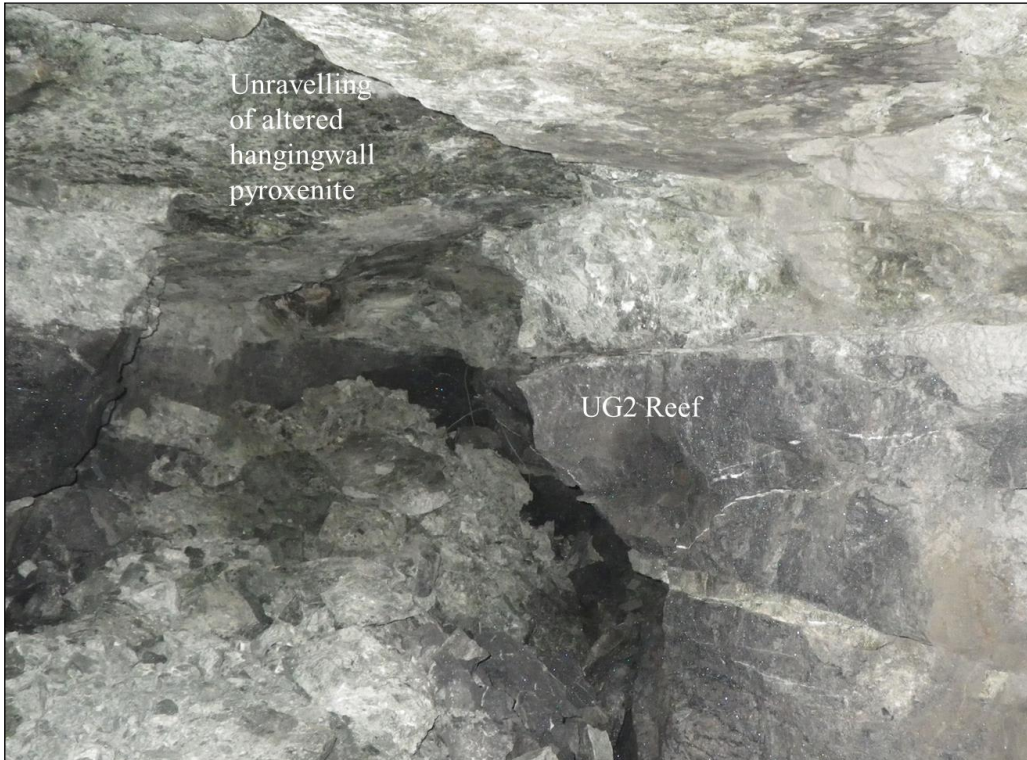
Figure 1.11: Alteration zone along hangingwall pyroxenite, causing unravelling between installed support units. This development end was abandoned and had to be re-established.

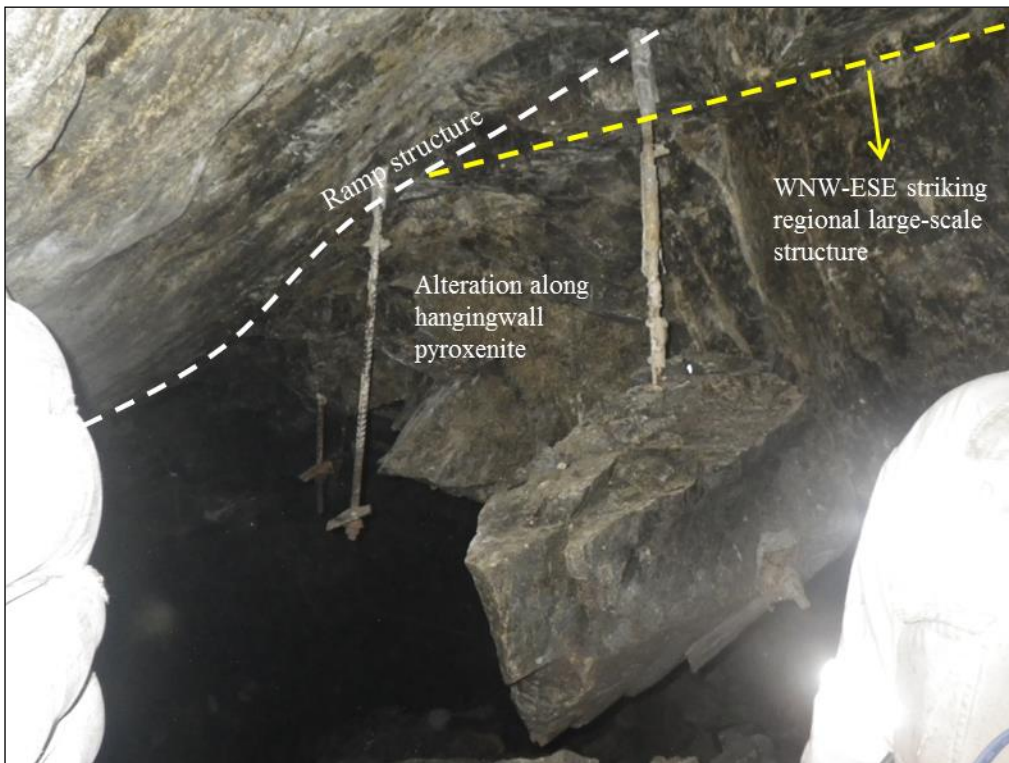
Figure 1.12: Catastrophic failure where geologic structures and a hangingwall alteration zone were exposed, causing falls of ground. This ledge was abandoned and a new panel had to be established.

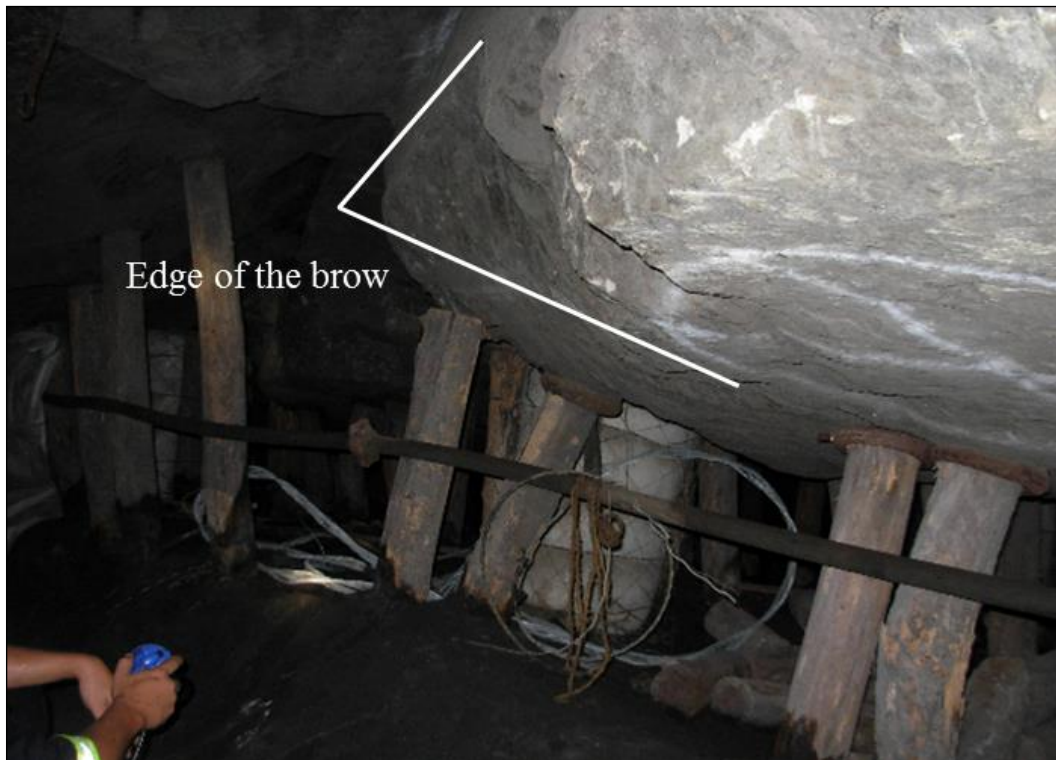
Figure 2.17: Buckling of timber elongates as identified during a 2009 study. The Marikana structure defines the edge of the brow.

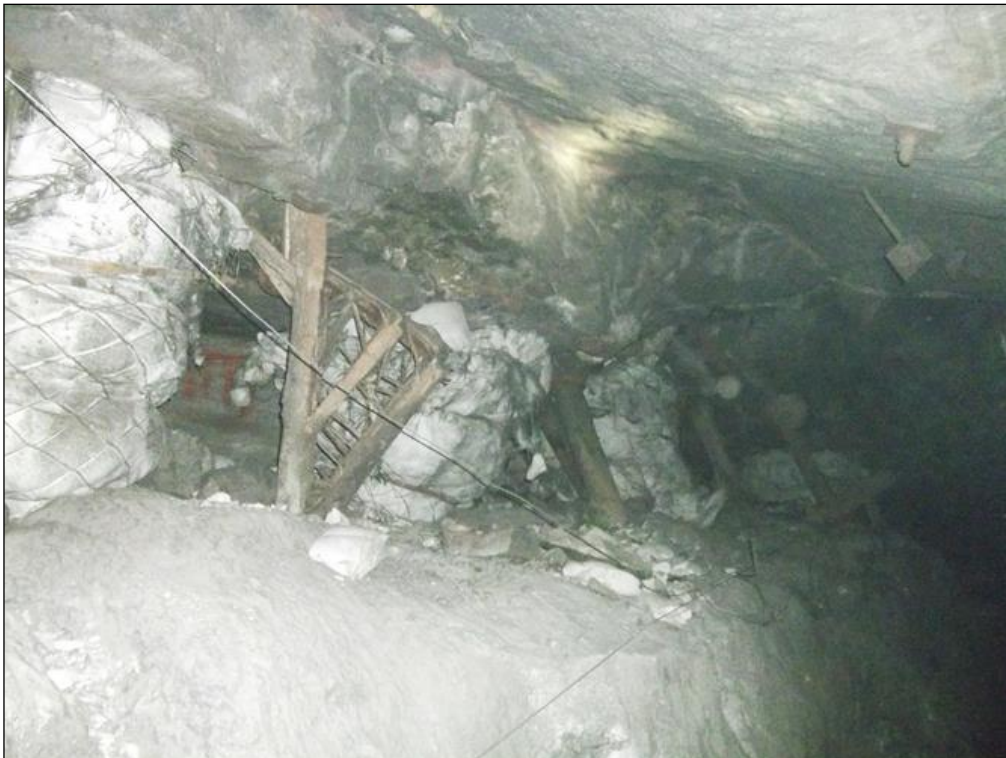
Figure 2.19: Fall of ground visible along a gully at Saffy Shaft where the support units failed when the hangingwall beam detached at a height of approximately 15 m at the hangingwall 1A/hangingwall 2 contact. This resulted in failed timber elongates and crushed grout packs.

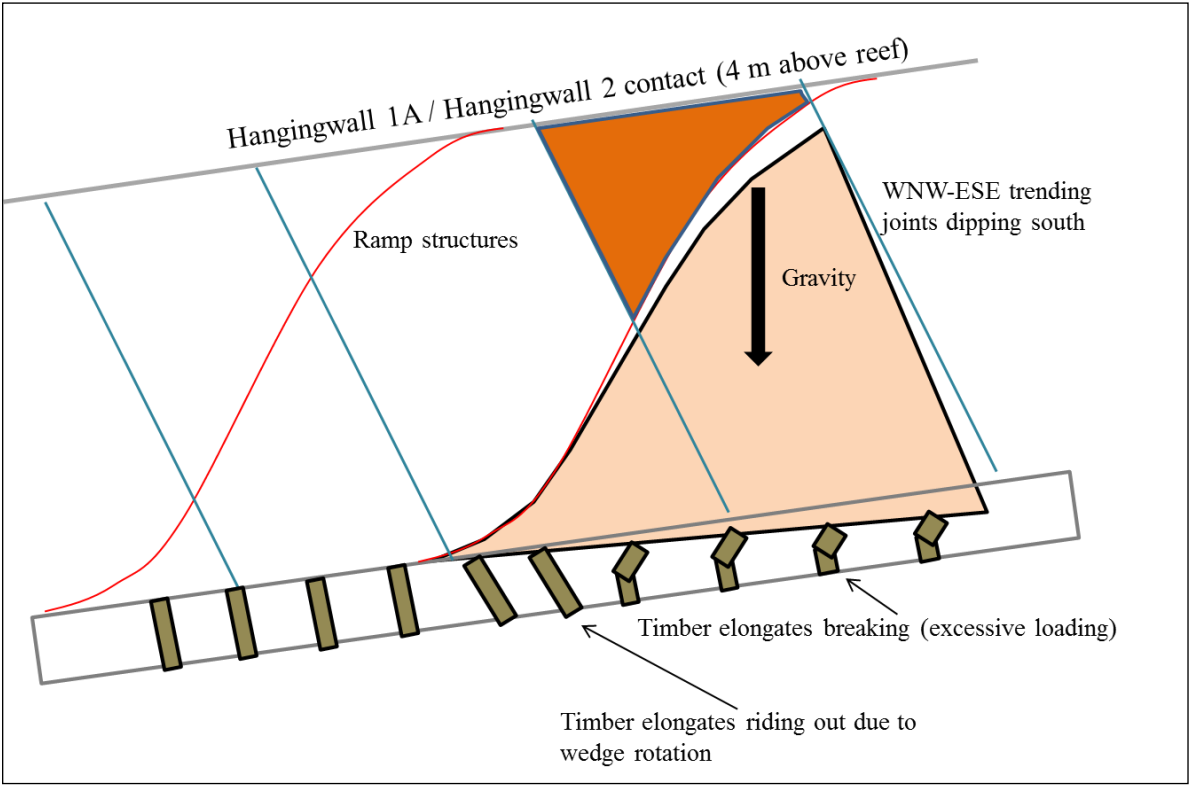
Figure 3.9: Section view illustrating the failure mechanism which resulted in the instability and subsequent collapse.

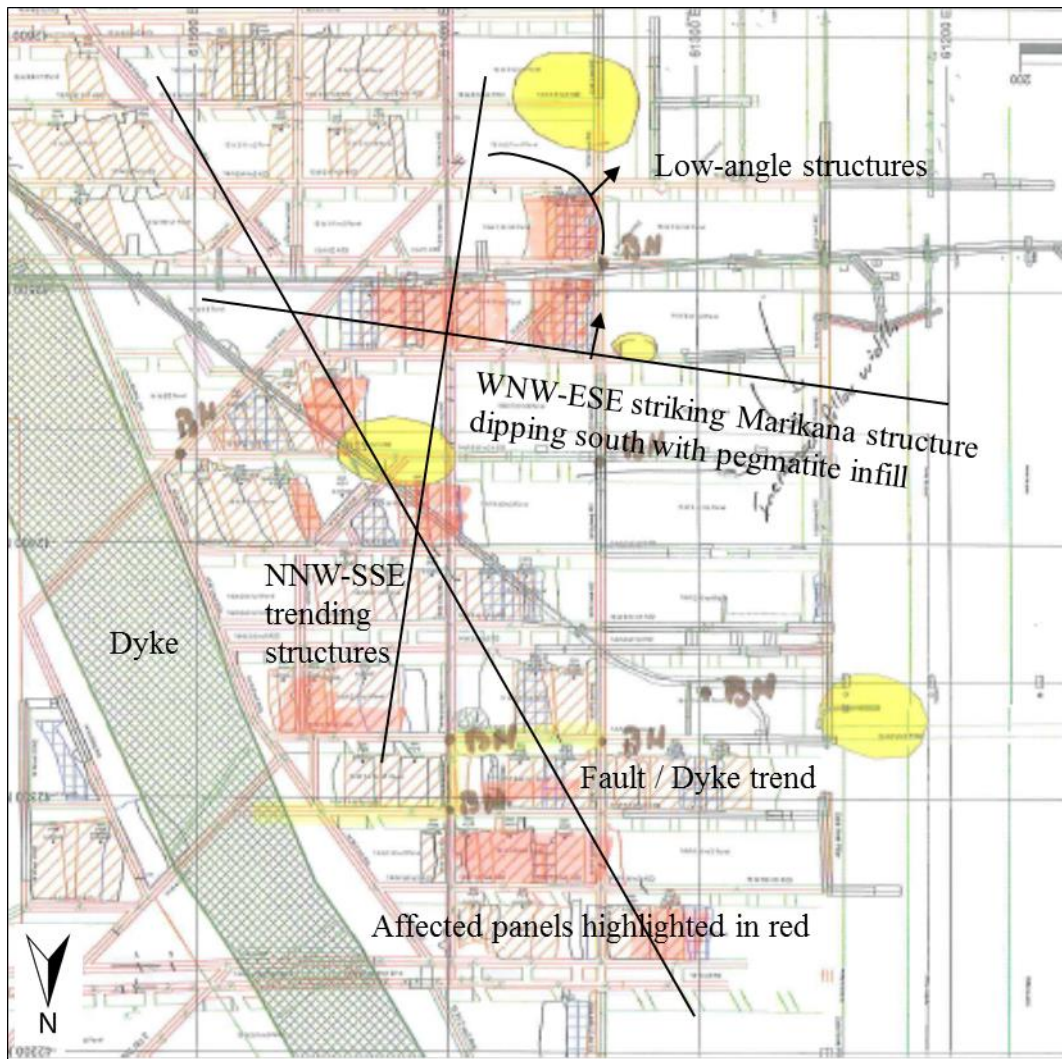
Figure 3.12: Plan indicating areas affected at Saffy Shaft (red hatched areas). Instabilities occurred in the red hatched areas and the panels were abandoned and barricaded off. The Pilansberg diabase dyke is indicated in green, striking NNW-SSE.

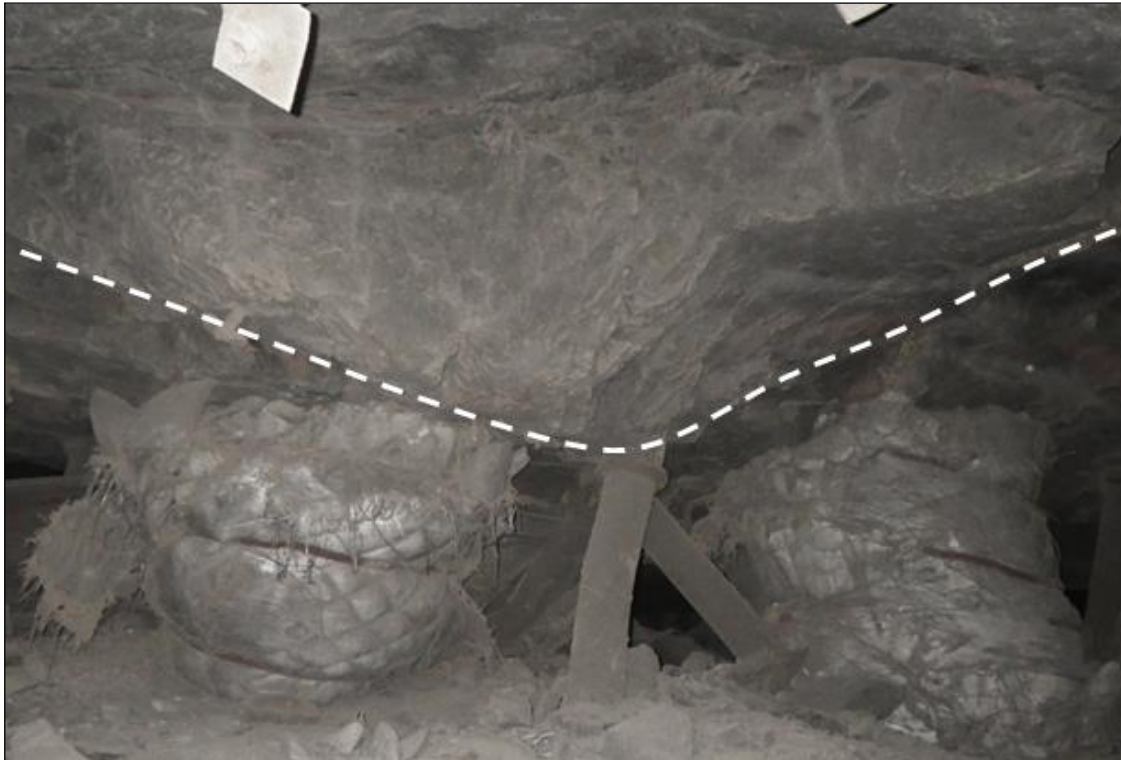
Figure 3.15: Failure of grout packs and timber elongates owing to excessive loading from probable separation along the hangingwall 1A / hangingwall 2 contact.

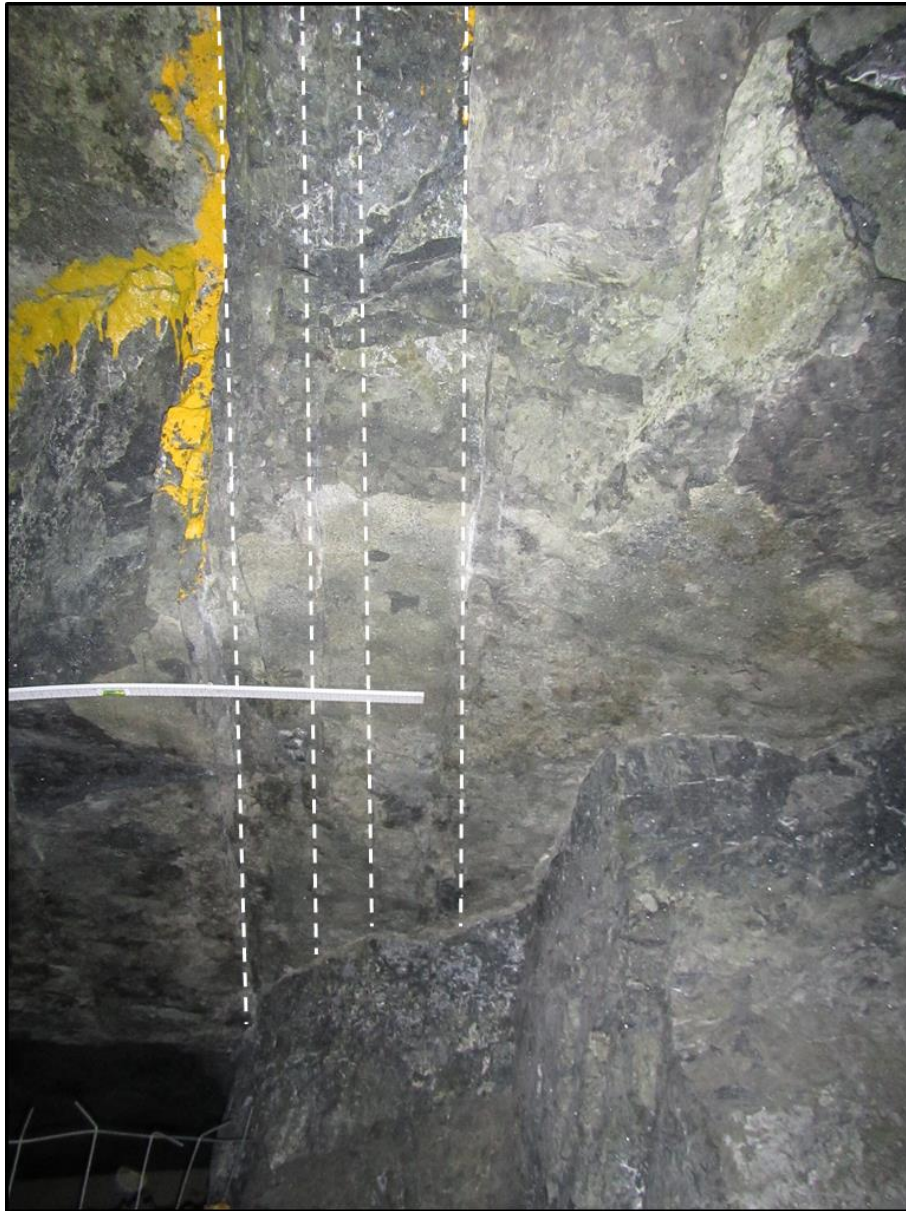
Figure 3.17: NNW-SSE striking cluster of joints exposed along the edge of a pillar that may contribute towards pillar slabbing.

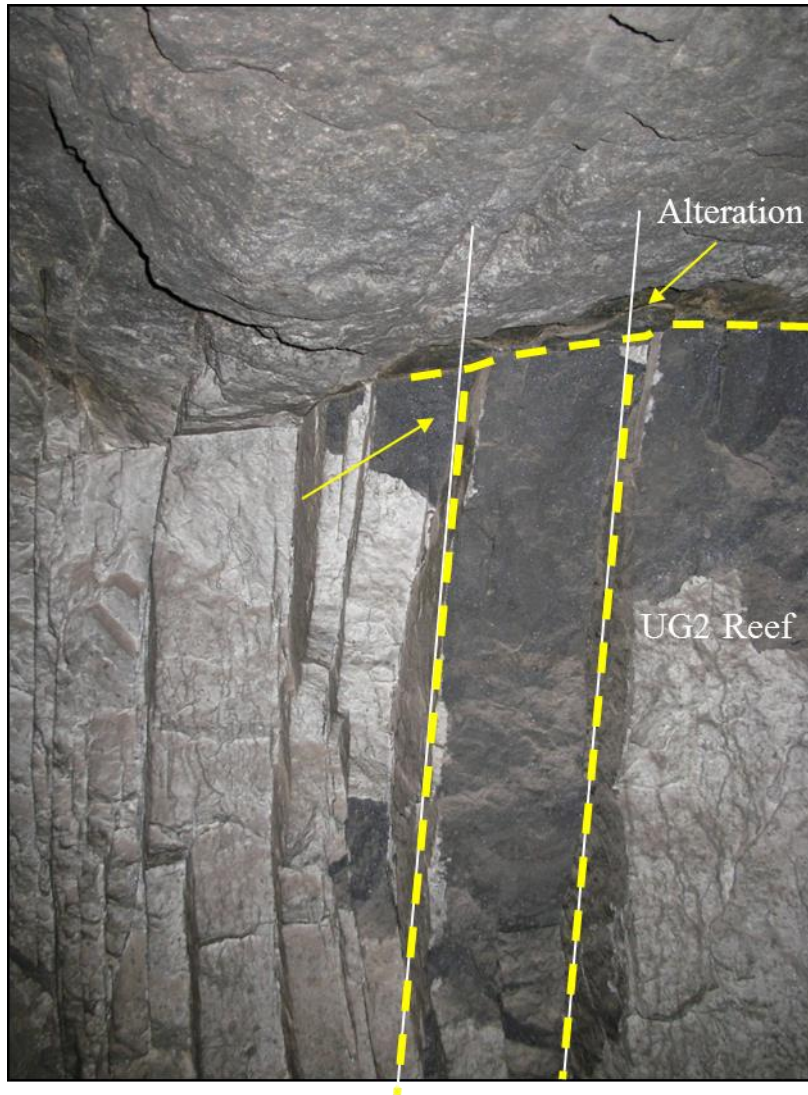
Figure 3.23: Slabs defined by joint planes at 10 Chrome West 33 Raise line. Joint planes intersecting pillars at oblique angles resulting in the observed slabbing of pillar material along joint planes.

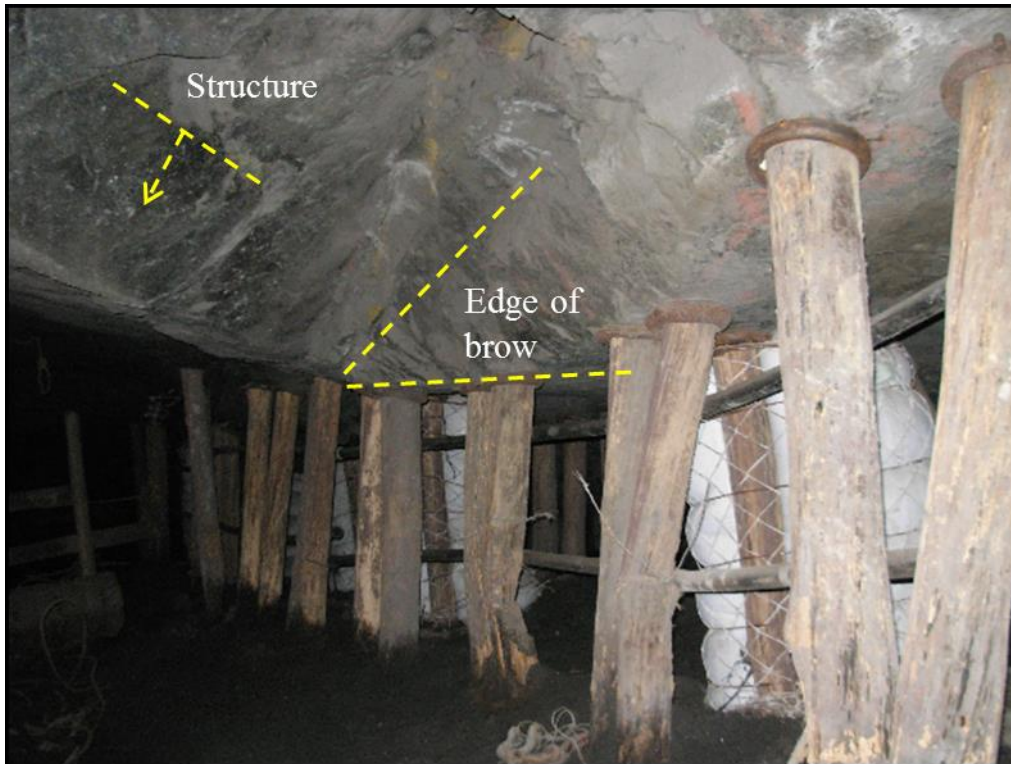
Figure 3.24: Unstable hangingwall condition in the back area with the buckling of timber elongates located on the down-dip side of the Marikana structure.

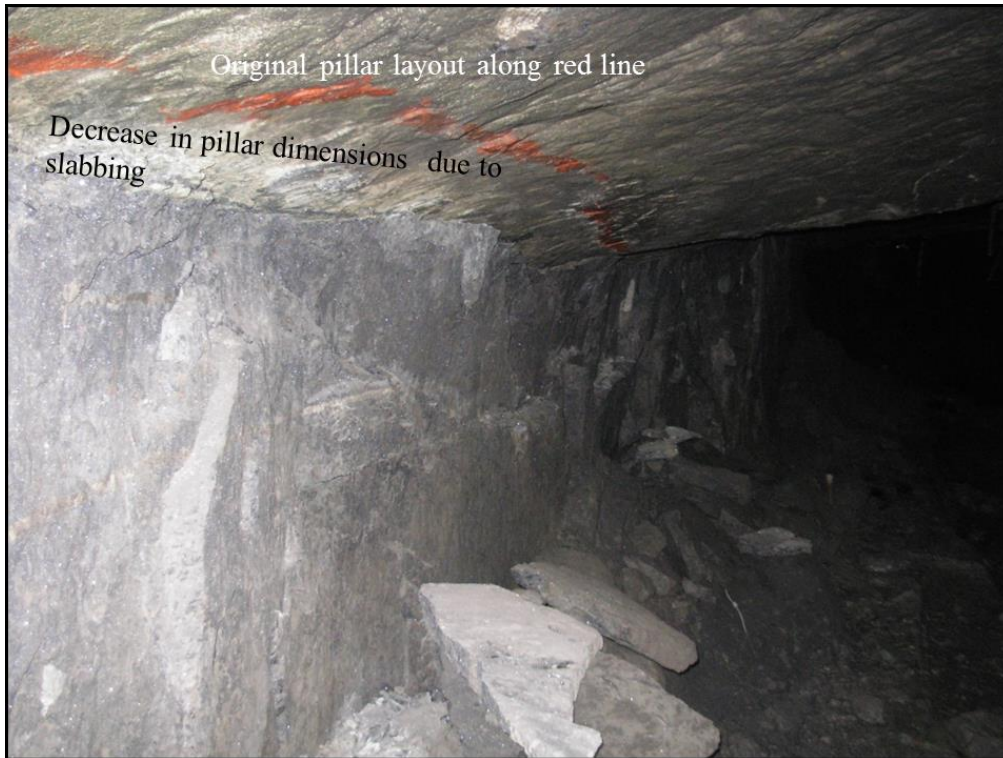
Figure 3.28: Time-dependent pillar slabbing along a belt drive. The red line on the hangingwall indicates the original size of the pillar.

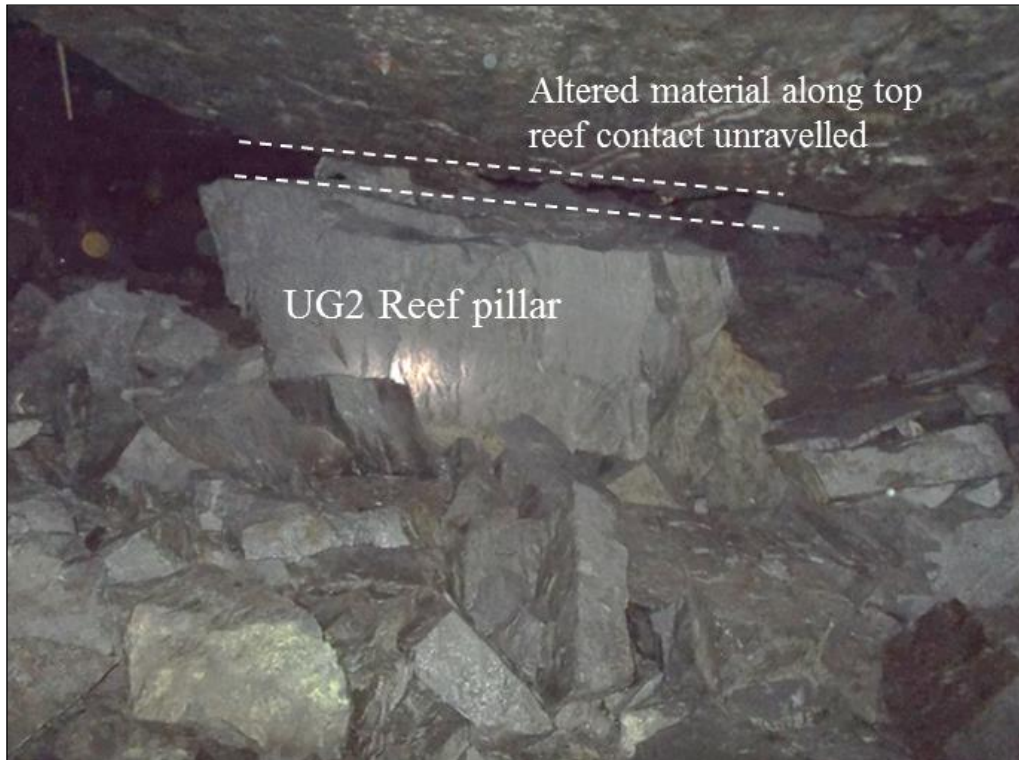
Figure 4.4: An alteration zone along the top reef contact affect the pillar strength and integrity.

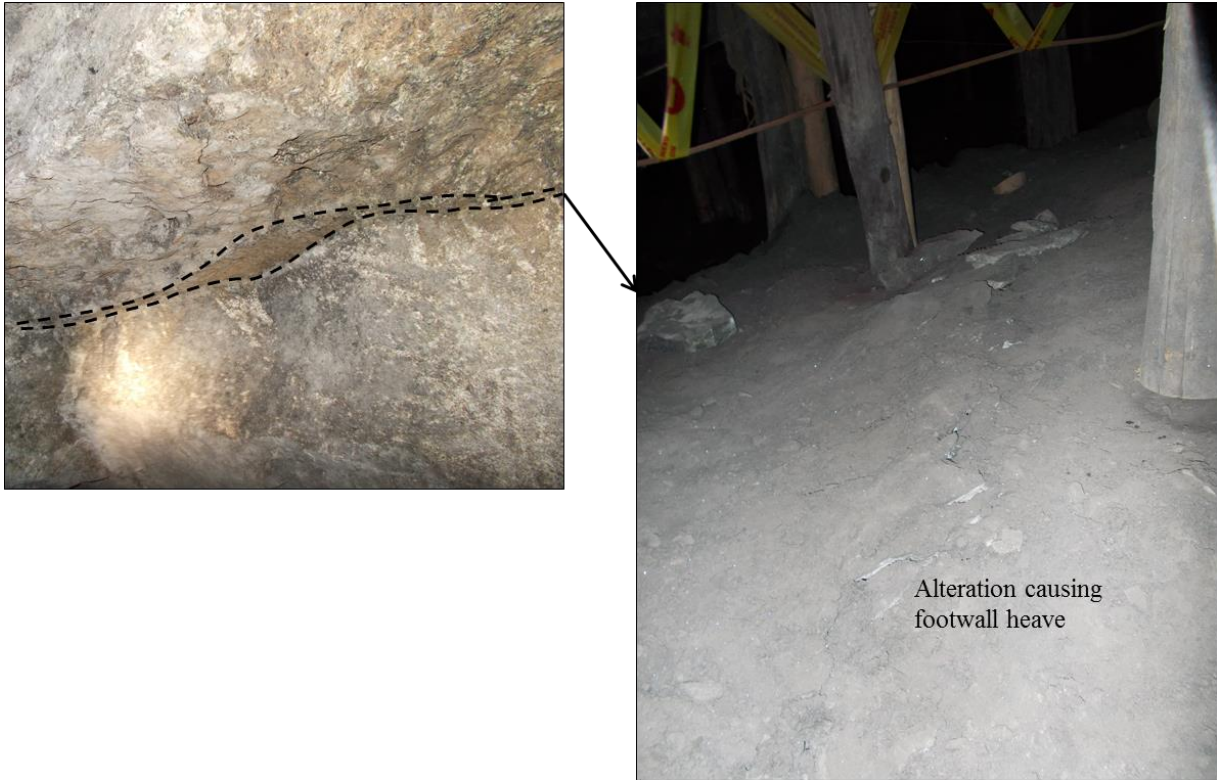
Figure 4.8: An alteration zone along the footwall contact of the UG2 Reef causing footwall heave and premature failure of the installed timber elongates. This can result in large-scale hangingwall failure.

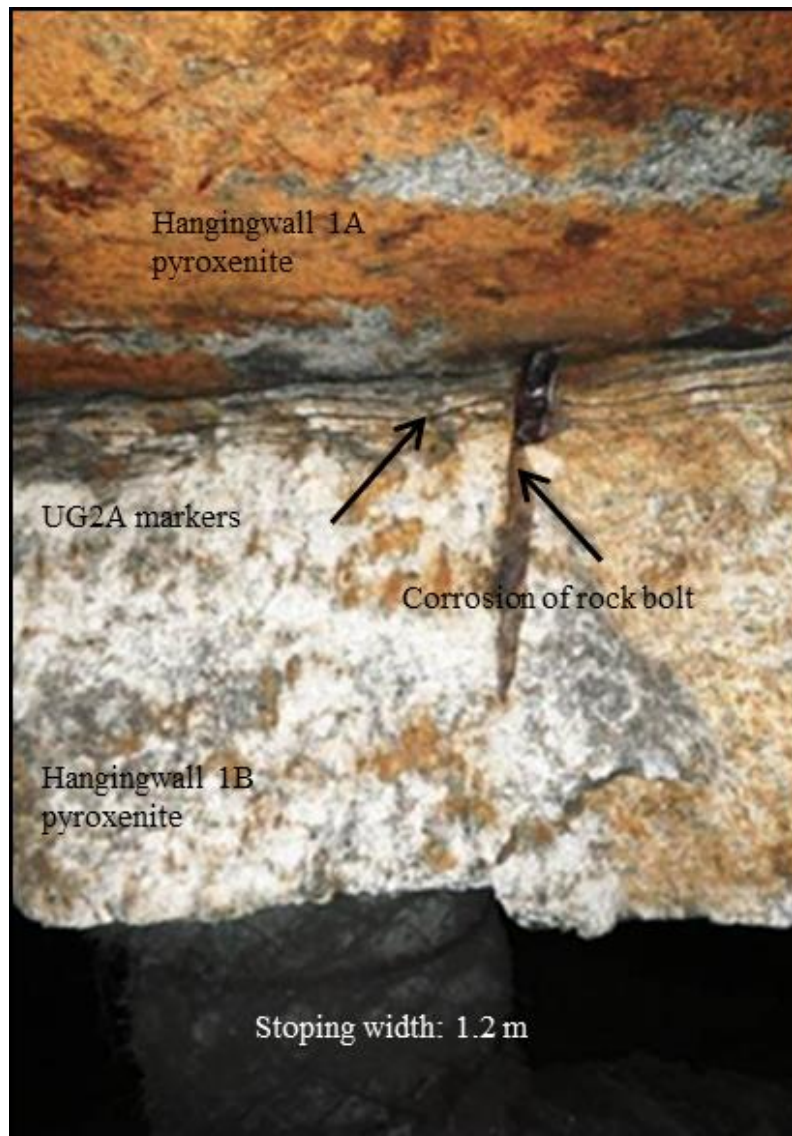
Figure 4.13: Fall of ground caused by ineffective support and corrosion of rock bolts.

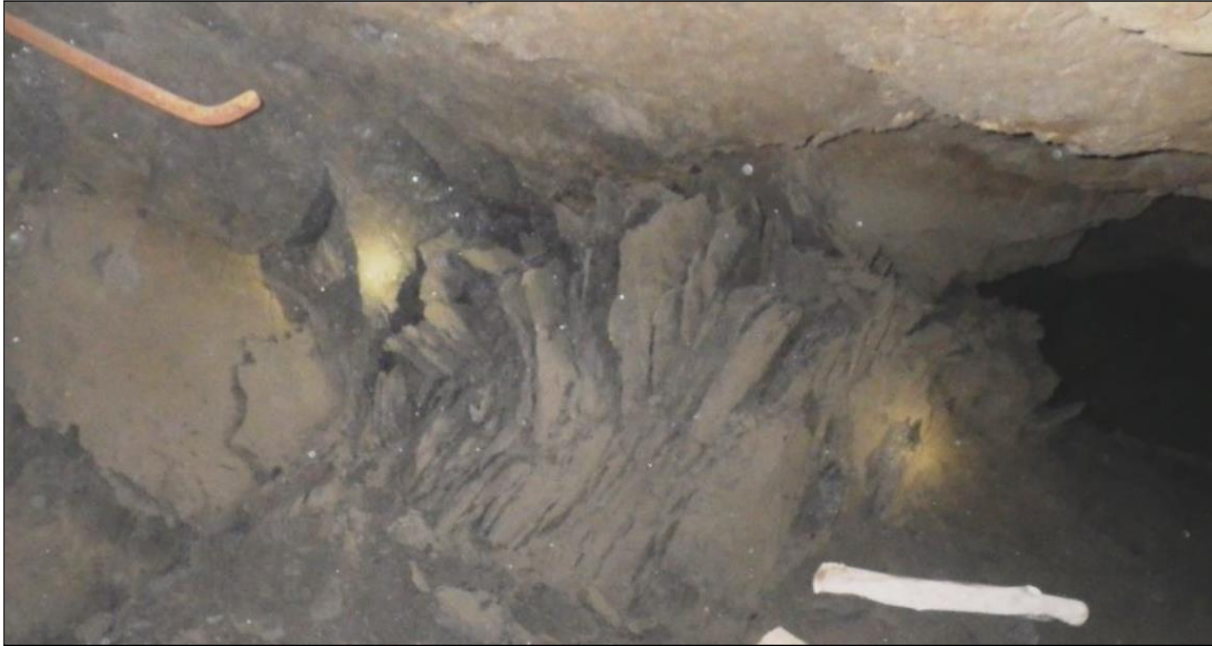
Figure 4.14: Anomalous pillar behaviour (illustrated in Figure 4.19) where stress fracturing was identified in the vicinity of the fall of ground where an alteration zone occurred along the top reef contact.

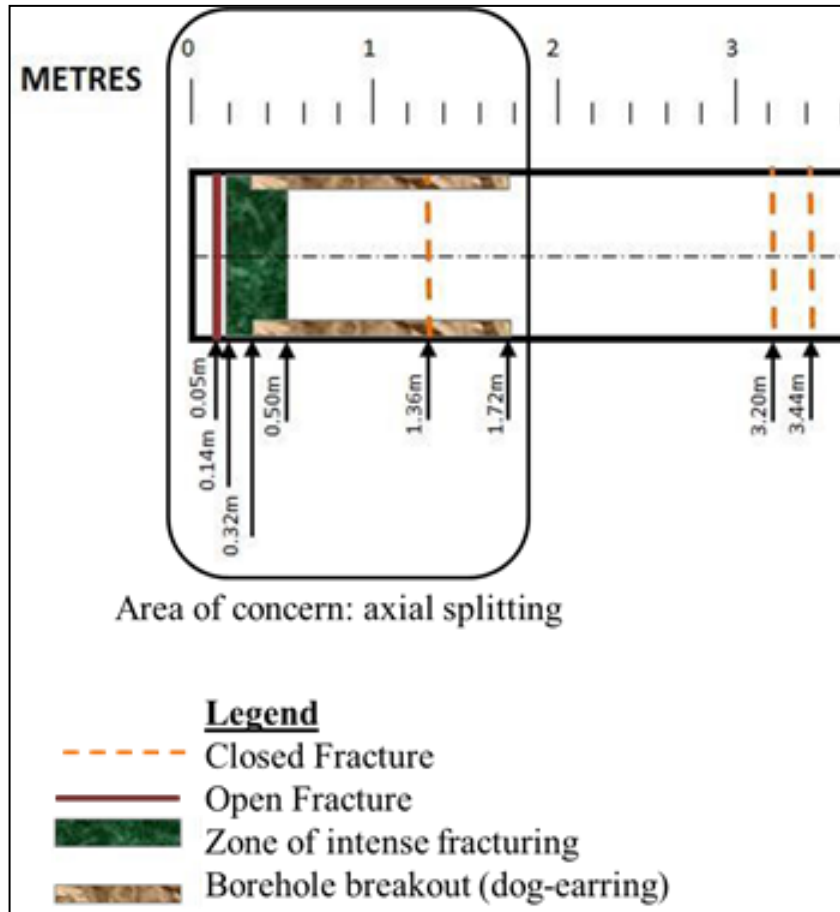
Figure 4.18: Horizontal borehole fracture log that was recorded in the pillar borehole (Figure 4.15) to determine the depth of fracturing. Visible from the log is that the zone of intense fracturing extends for a distance of 0.5 m. Dog-earring along the pillar was observed to a depth of 1.72 m.
