Marina el-Alamein. Polish-Egyptian Restoration Mission: Conservation work in 2008

Author(s): Stanisław Medeksza and Rafał Czerner with Grażyna Bąkowska, Wiesław Grzegorek, Renata Kucharczyk, Joanna Lis and Piotr Zambrzycki

Source: *PAM 20 (Research 2008)*, 103-128

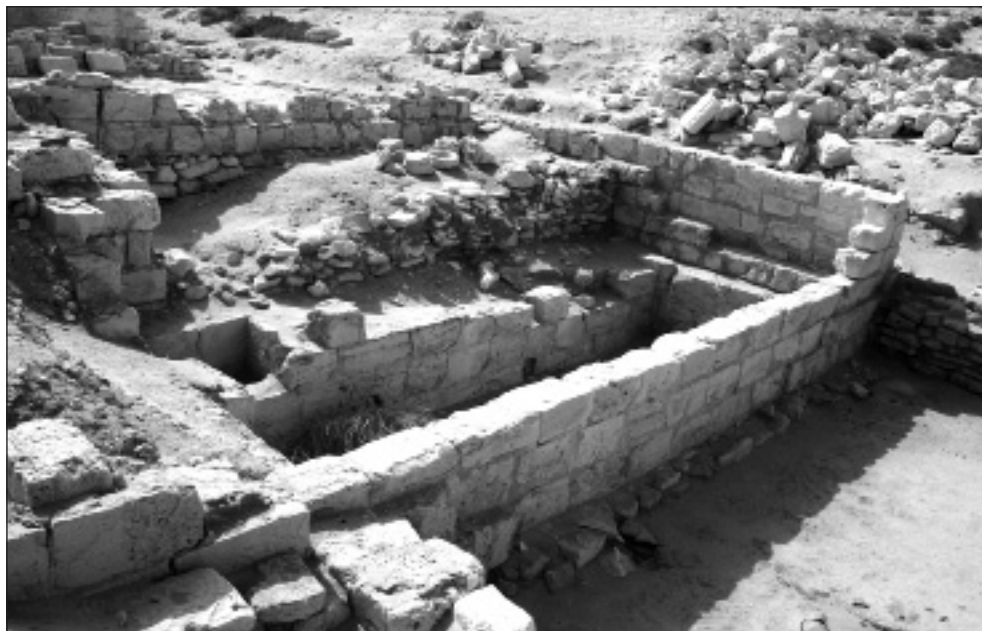
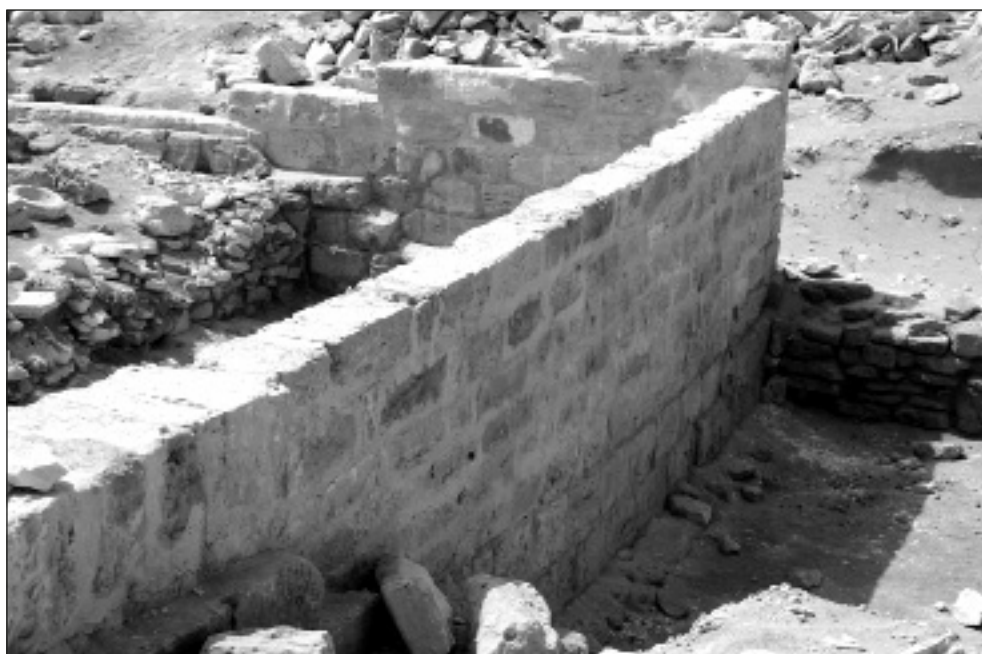
The southwestern part of the enclosure wall, encompassing the south and west walls of Room 27, which are at the same time the outer walls of the house [*Fig. 1*], continued to be reconstructed, building up now on the foundations and lower courses laid already in 2006 and 2007 — three courses in the south and five in the west (using blocks 0.30 m wide). By the same, the corner of the house has finally been raised high enough to become visible in the surrounding area [*Fig. 2*].

Fig. 2. House 1, southwestern corner before (top) and after conservation in 2008, view from the northwest (Photo P. Zambrzycki)

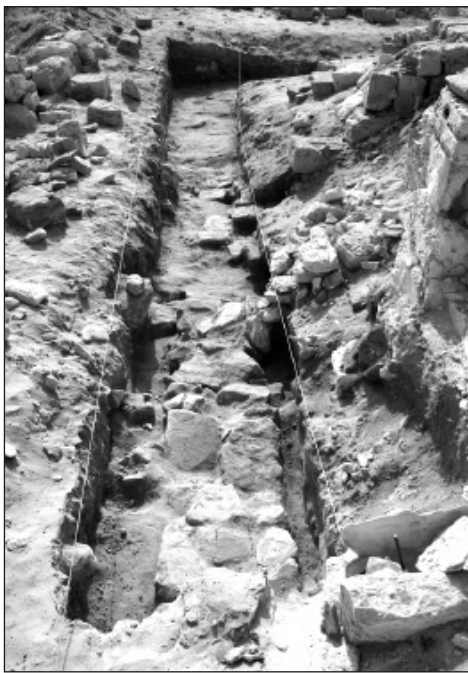
The reconstruction of the foundation of the northeastern corner proceeded in preparation for the restoration in the future of the north wall, which was presumably the main house facade. Both the northern and eastern facades have been recognized in the record, and only this corner had been lost during the original building works in 1986 when the site was discovered. The building technology of the foundations was also clear, consisting of a broken-stone wall in mud mortar laid in a narrow trench [*Fig. 3*] and the space between the stones and trench wall (approx. 0.15 m) packed with mud (possibly also mud-brick) and

Fig. 3. Foundation of the northeastern corner of House 1 after clearing for conservation, view from the west (Photo P. Zambrzycki)

The foundation of the northeastern corner was rebuilt of broken stone but bonded in lime-cement mortar (not mud mortar as originally) to a height of 0.30 m and on top of this two courses of transversely laid stone blocks were introduced [Fig. 4]. At the western end of the reconstructed section of the north

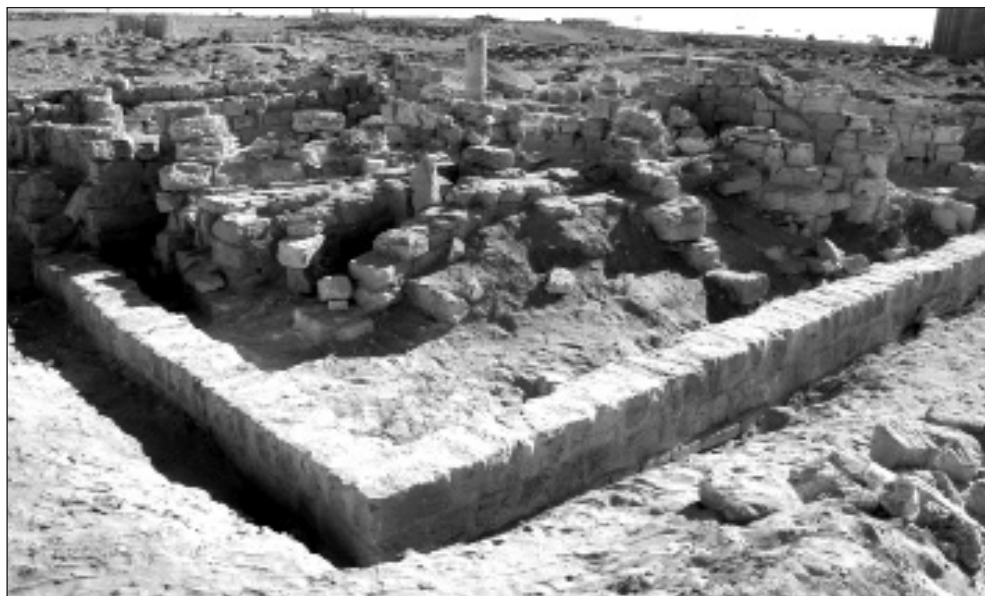
Fig. 4. House 1, northeastern corner after restoration in 2008, view from the northeast (Photo P. Zambrzycki)

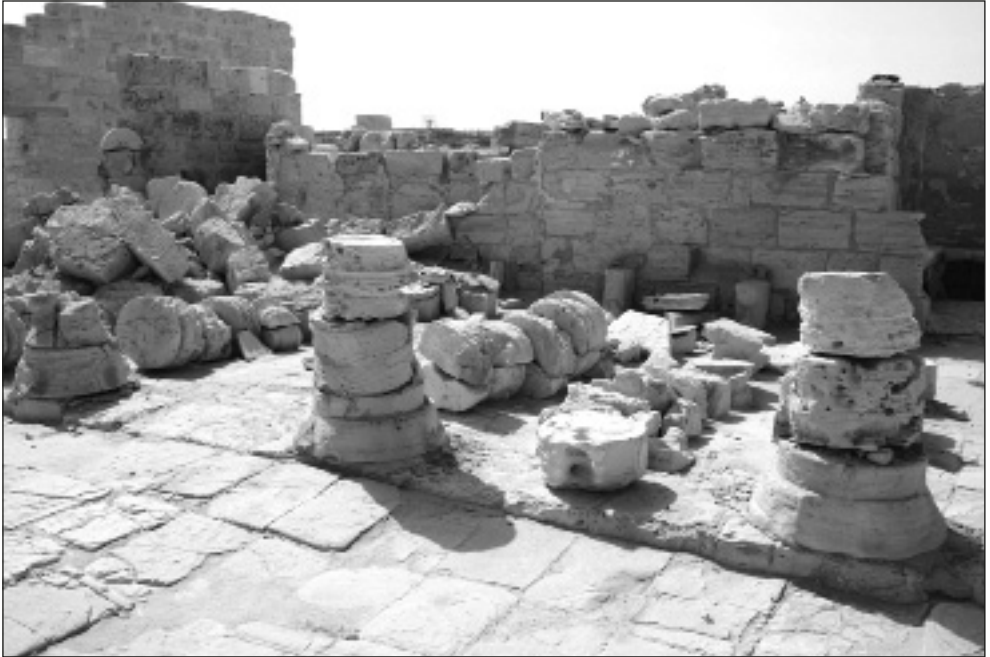
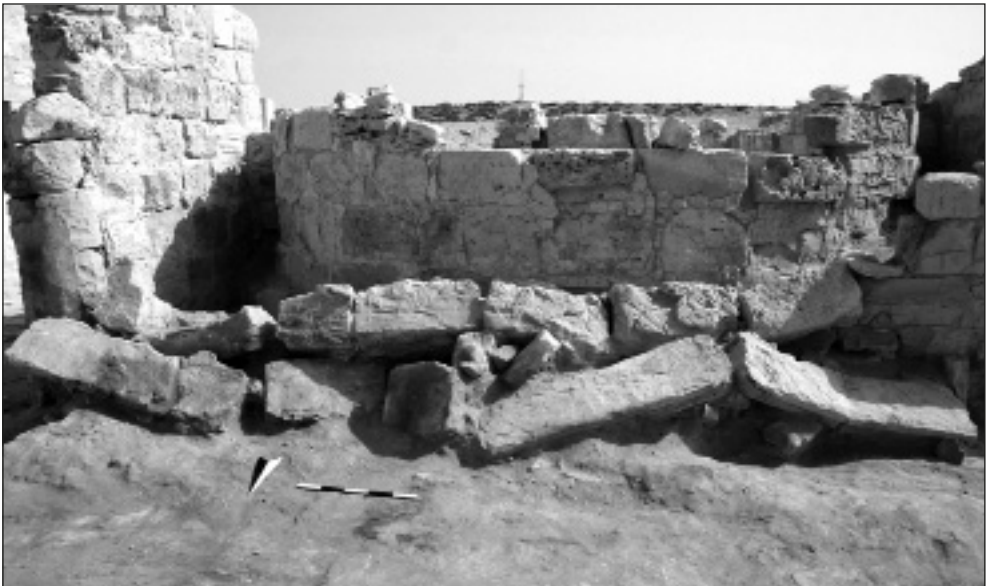
The collapsed wall in the eastern end of the portico was cleared under archaeological supervision, particular elements marked and the original arrangement reconstructed [Figs 6, 7]. Two building phases were recognized in the process. The western section of the wall, which was 3.49 m long, was erected first, followed by the section further away from the exedra, only 0.95 m long, built to adjoin the southeastern corner column of the portico. This narrower section of the wall must have once contained a slab, possibly decorated or inscribed, set into a carelessly cut niche on the back, that is, southern,

Fig. 6. Back wall of the south portico in the main town square, state before preservation with arranged elements of the collapsed columns (top) and close-up of the eastern end of this wall and the bench during clearing of debris (Photos P. Zambrzycki)

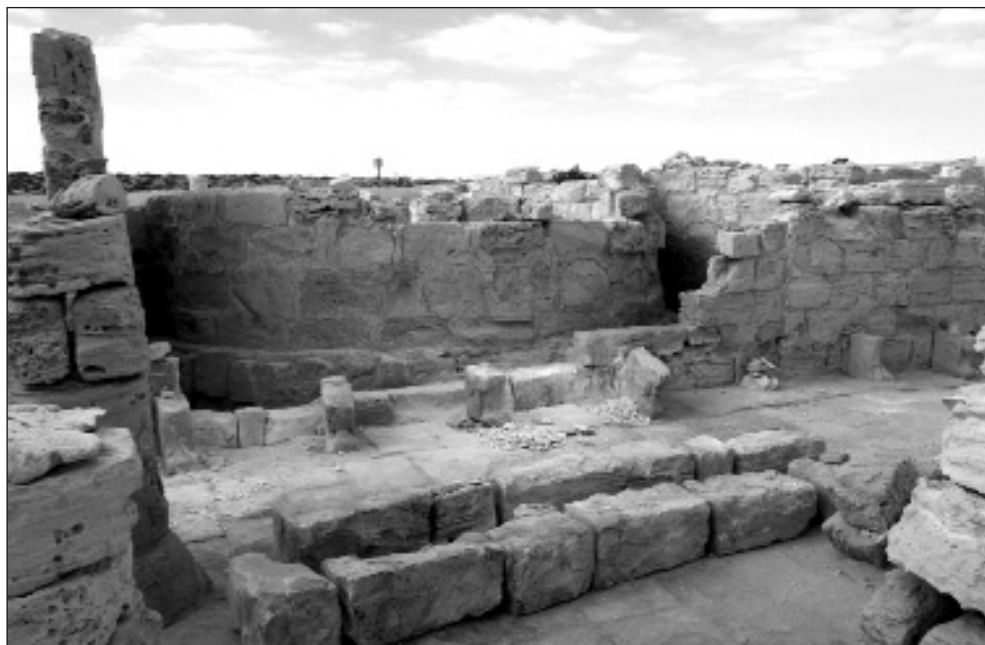
Fig. 7. Back wall of the south portico in the main town square after clearing of rubble and sand (Photo P. Zambrzycki)

The relics were studied and restored in position, the arrangement reconstructed in the course of raising this section of the portico back wall [Fig. 8]. Original elements were replaced in position with only sporadic additions of blocks that

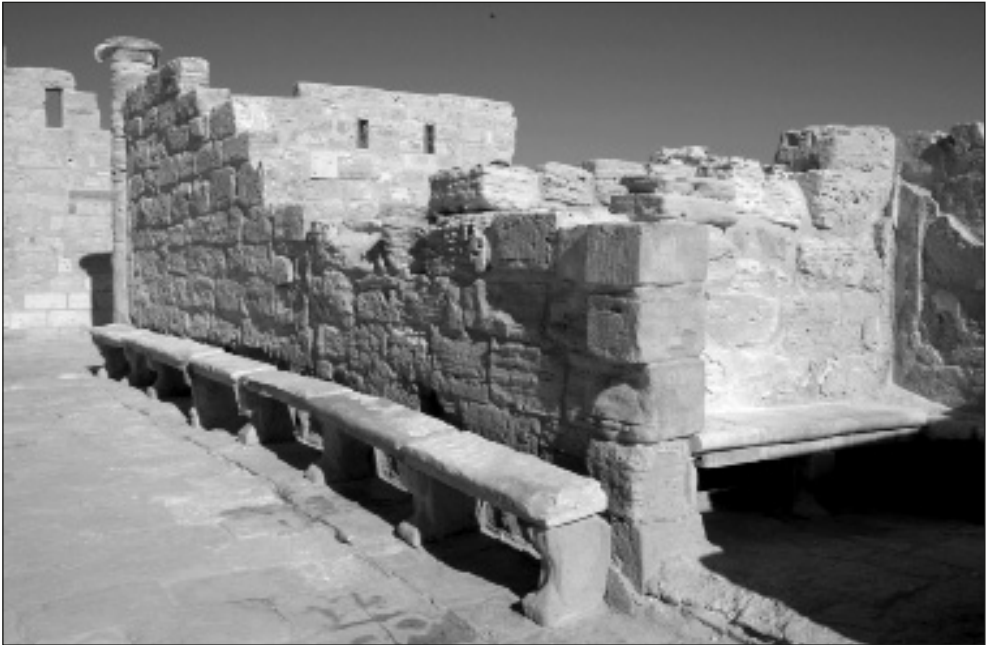
Fig. 8. South portico of the main town square with the back bench, after restoration in 2008
(Photo P. Zambrzycki)

With regard to the wall bench, once the slab seating and lion-paw supports were conserved (see below), they were rebuilt in position. The one missing seat (second counting west from the exedra) was reconstructed. Two of the supports, which were the most eroded, were also replaced. Fortunately, all of the supports had been found in place, leaving no doubt as to

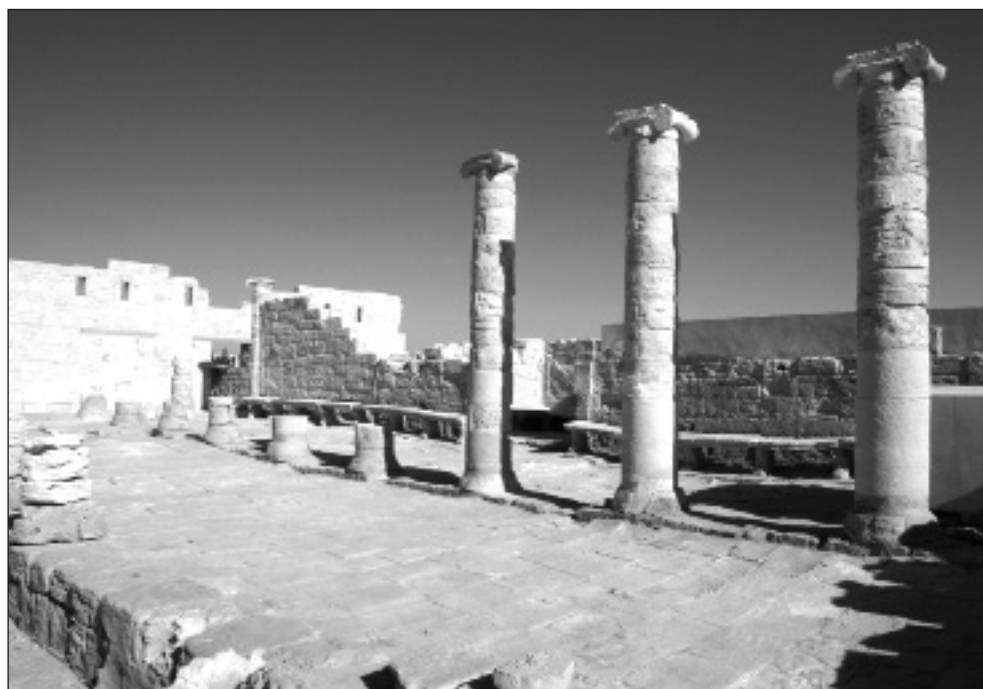
Fig. 10. *Columns of the south portico restored, view from the northwest*
(Photo P. Zambrzycki)

Since only the bottom parts of columns, that is, bases and lowermost drums have been found, the broken elements, even though they have been preserved, had to be replaced with new, reconstructed elements. The upper parts of the columns were reconstructed of mostly original elements preserved in fair condition, as follows:

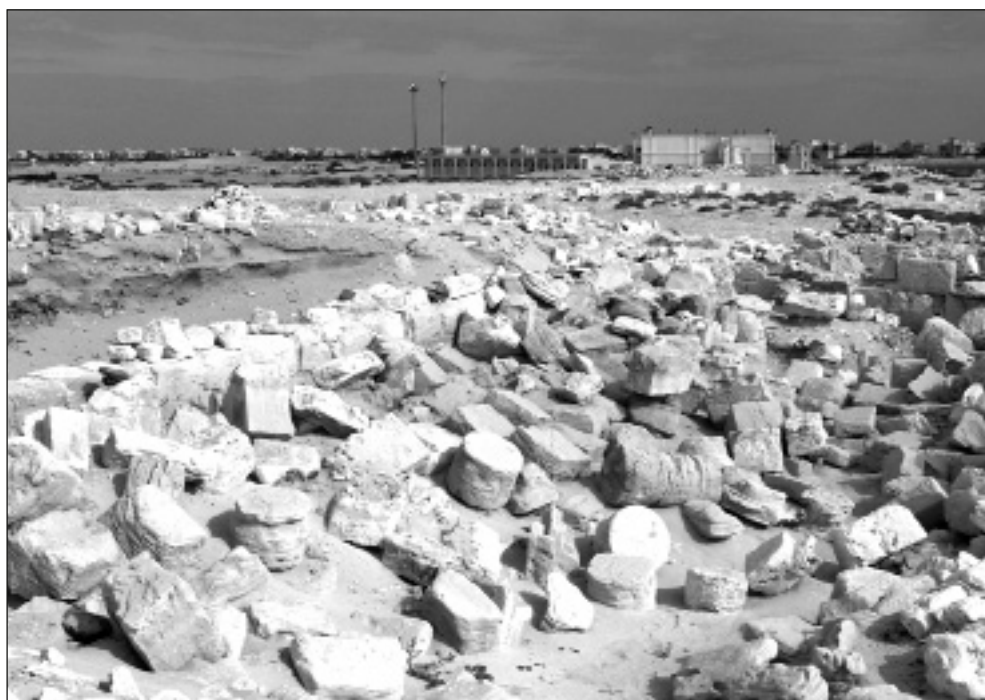
*Fig. 11. General view of the south bath portico (unit no. 4) before conservation
(Photo P. Zambrzycki)*

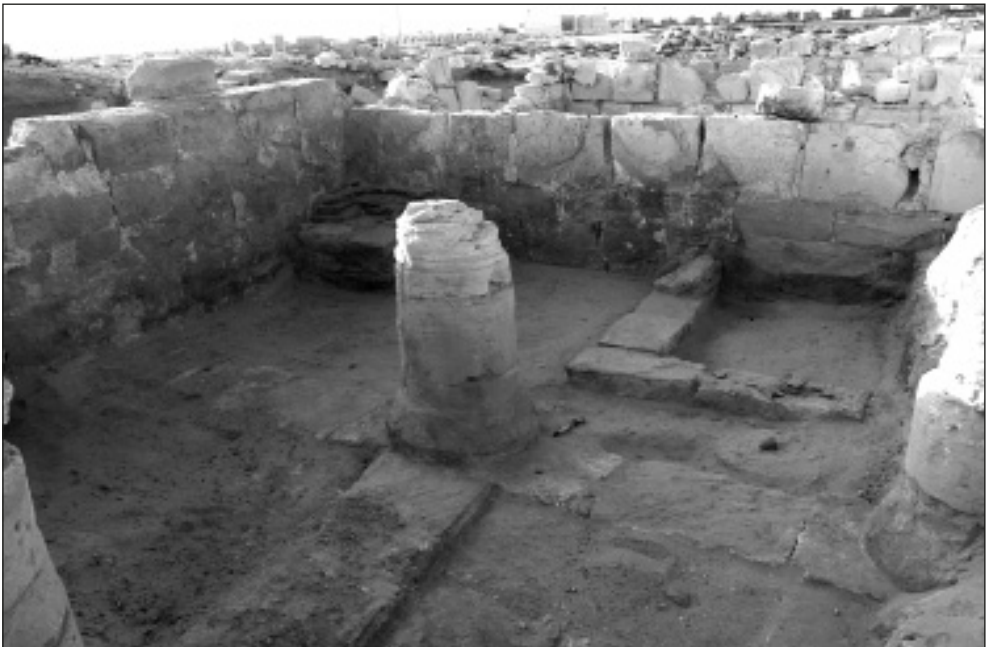
Fig. 12. Northwestern corner of unit no. 4 of the south bath portico after clearing in 2008
(Photo P. Zambrzycki)

The cleaning and conservation–preservation program started from the north-western corner of the portico [Fig. 12]. The positioning of columns in this part was determined as composed of three columns along the north wall. Two building phases were distinguished. Conservation objectives called for protecting the crest of the west wall in its northern half. The three most eroded blocks from the topmost preserved course were replaced and two more courses added in the northern
