XII | DBMCInternational Conference on Durability of Building Materials and Components
PORTO - PORTUGAL, April 12th-15th, 2011

Experimental evaluation of plasters durability aimed at maintenance planning and scheduling

2 CASE STUDY: THE FACULTY OF ENGINEERING OF PALERMO

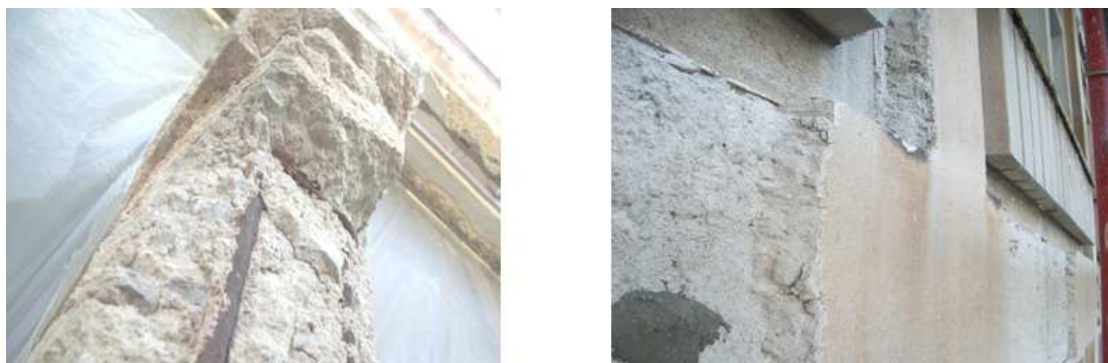
- Dripping stains below the drips of the window modules;
- Lack of plaster and concrete cover, due to the degradation of reinforced concrete of the window modules, as in 'Fig. 4';
- Superficial deposits, characterized by yellowing of the plaster surface, due to loose material, as in 'Fig. 5'.

Figures 4 e 5. Lack of plaster (left) superficial deposits with yellow patina (right)

- The weathering, in particular the action of wind, which is crucial for the transport of marine aerosol and loose material on the surface;
- The quality of raw materials making up the plaster and the concrete;

- The thick plaster (even more than 8 cm), misplacement of the window sills and consequent lack of appropriate slope.

The intervention on the facades, after the consolidation of degraded reinforced concrete elements, provided for the restoration of the plaster base and the finishing with a plastic coating applied to continuous (RPAC), made of inorganic binder potassium silicate based, inorganic pigments and selected aggregates, at medium particle size, according to the classification of the UNI 8682:1984. The coating that has the nature of a smoothing product, which makes it akin to the class of plasters, was applied by stainless steel trowel, on plastered surfaces treated with an appropriate primer to enhance adhesion to the substrate. The nature of the RPAC provides thickness between 1 and 15 mm, depending on the size of the aggregates, that is between 1 and 7 mm, resulting in three classes of RPAC, known by the letters from G1 to G3, in ascending order of applied thickness. The product used in the case study has been classified as G3 and has a pasty consistency. In particular, the feature of silicate RPAC is to react with carbon dioxide present in the atmosphere, giving rise to colloidal silica fixing the coating components together and with the support, resulting in a structure similar to the plaster support. This ensures excellent breathability of the treated surface, as a consequence of the porosity to water vapour of the microcrystalline structure of thickness applied, arising from the crystallization of silica, while the treated surface is impermeable to weathering. In the application under study two different colours were used: white in the reinforced concrete structure and gray in the window modules.

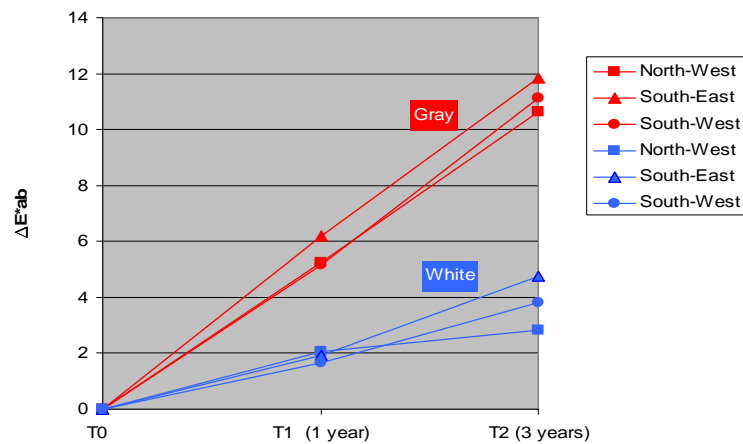
Figure 8. Colour changing on the North-East facades (natural ageing)

- After one year of natural ageing, white colour shows a medium colour change of almost 2 points, becoming lighter, for all facades; after three years, on the South-West facade, the trend is increasing and the medium value is 3,5 points, with a maximum recorded of 4,5 points in the S-E front.

- After five years of natural ageing, North-East facades show a medium white colour change equal to 2,5 points, with a maximum on the N-W front of over 3 points.

- For the gray colour, after one year of natural ageing, colour change is between 5 and 6 points in the South-West facades; the North-East facades show higher colour difference equal to 3,5 points in the S-E e N-W exposures, while the difference is more evident on the N-E fronts, over 8 points.

- After three years, South-West facades have a medium gray colour change equal to 11 points and after five years, the North-East ones show a strong difference between the main NE front, over 15 points, and the other two orthogonal, 10 points, remaining the trend to become lighter gray.

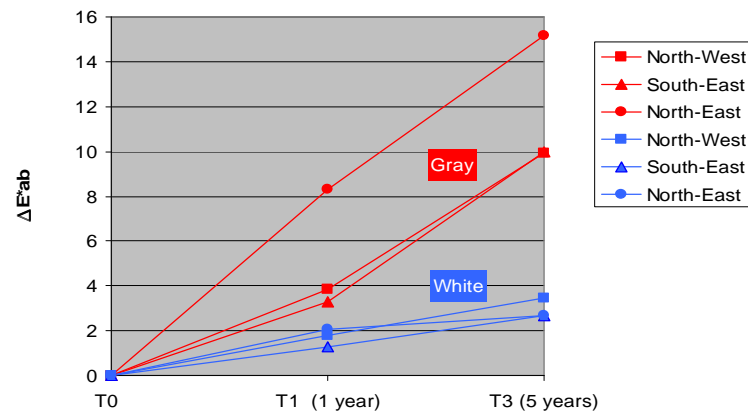
Figure 9. Colour changing on the South-West facades (natural ageing)

- The environmental conditions and microclimate produce after three years, on the South-West oriented facades, a greater degradation than the North-East ones after five years, for both colours, white and gray, with the exception of the N-E, for gray, that is more faded after five years.

- On all the facades, the front surfaces do not suffer the greatest colour change, but those orthogonal to them.

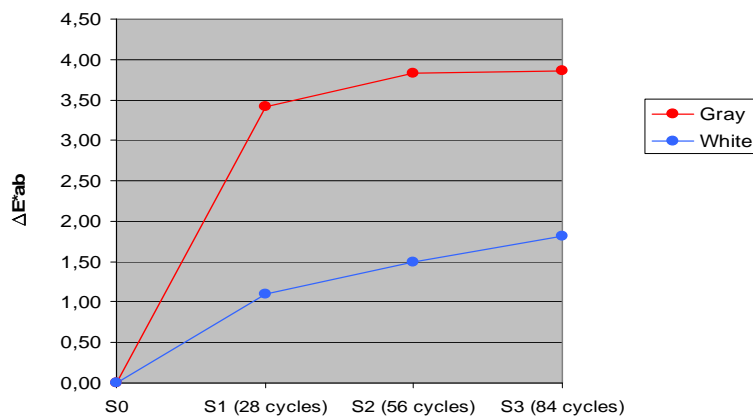
Figure 10. Colour changing on the laboratory samples (artificial ageing)

- The first attempt at rescaling, for white colour, shows that the degradation produced artificially in laboratory, after application of 84 cycles of ageing (S3), is equal to the natural degradation measured on surfaces naturally aged after a year, so it is appropriate to proceed with further steps to reach ΔE^*_{ab} values comparable to natural ageing after a year. Regarding the gray colour, the application of three cycles of ageing involves a colour difference measured comparable to the North-East one after a year of natural ageing.
