## Understanding the “Blue Spot”

### *Sodium Chloride Hot Salt Stress-Corrosion Cracking in Titanium-6246 during fatigue testing at low pressure*

EA Saunders<sup>1</sup>, TP Chapman<sup>2</sup>, ARM Walker<sup>3</sup>, TC Lindley<sup>2</sup>, RJ Chater<sup>2</sup>, VA Vorontsov<sup>2</sup>, D Rugg<sup>3</sup>, D Dye<sup>2</sup>

<sup>1</sup>Rolls-Royce plc., Materials – Failure Investigation, Bristol, BS34 7QE, UK

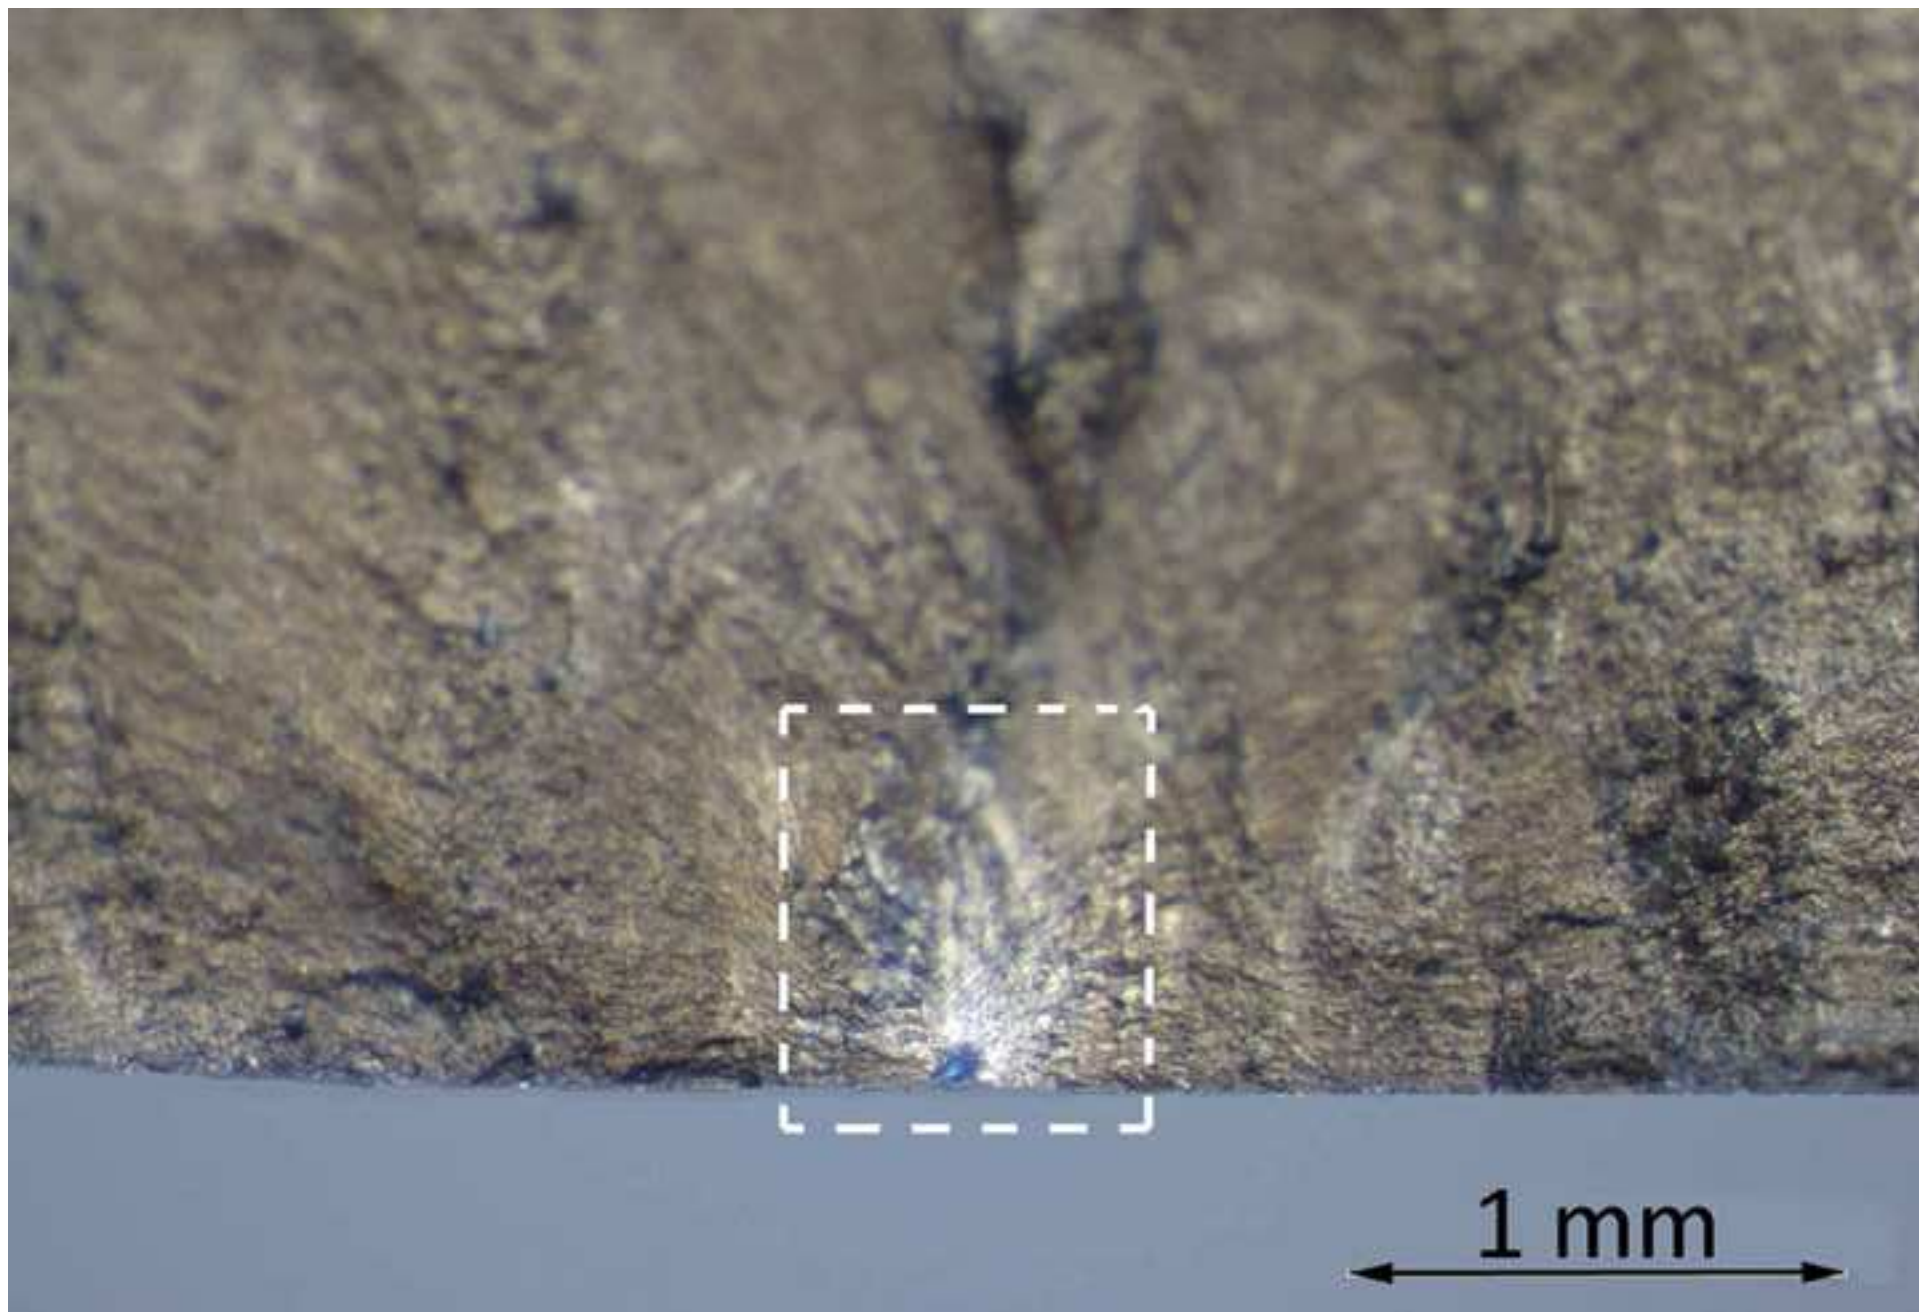
Initial macroscopic fractographic examination at Rolls-Royce revealed tiny optically blue-coloured elliptical features of  $\sim 0,1$ mm dimension present at the origin of both component crack systems. These have come to be known as the "blue spot" (sometimes "blue/ grey") [11]; figure 1.

The "blue spots" were bounded by an abrupt colour change that is unconventional compared to normal „growth-out“ temper-colouration on hot cyclic fatigue fracture surfaces [12,13].

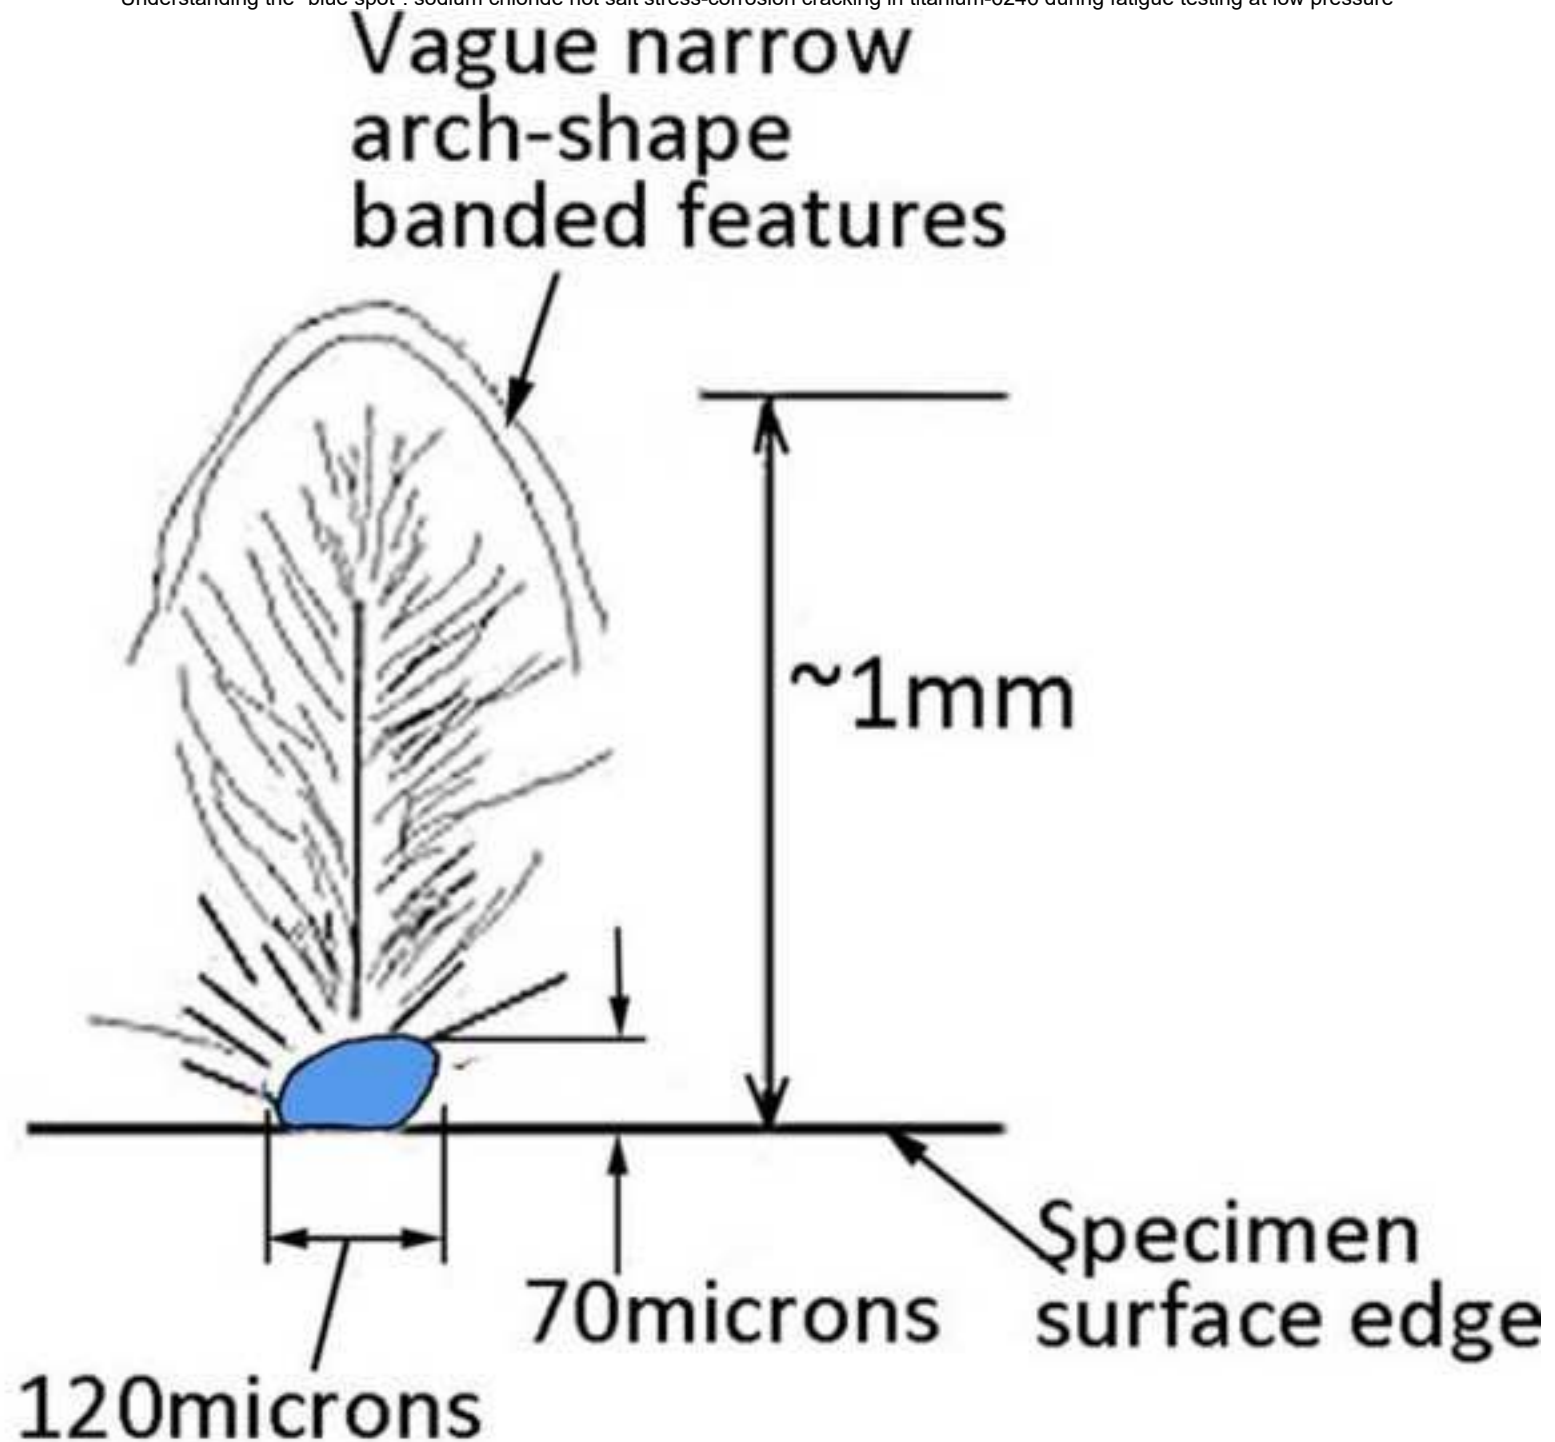
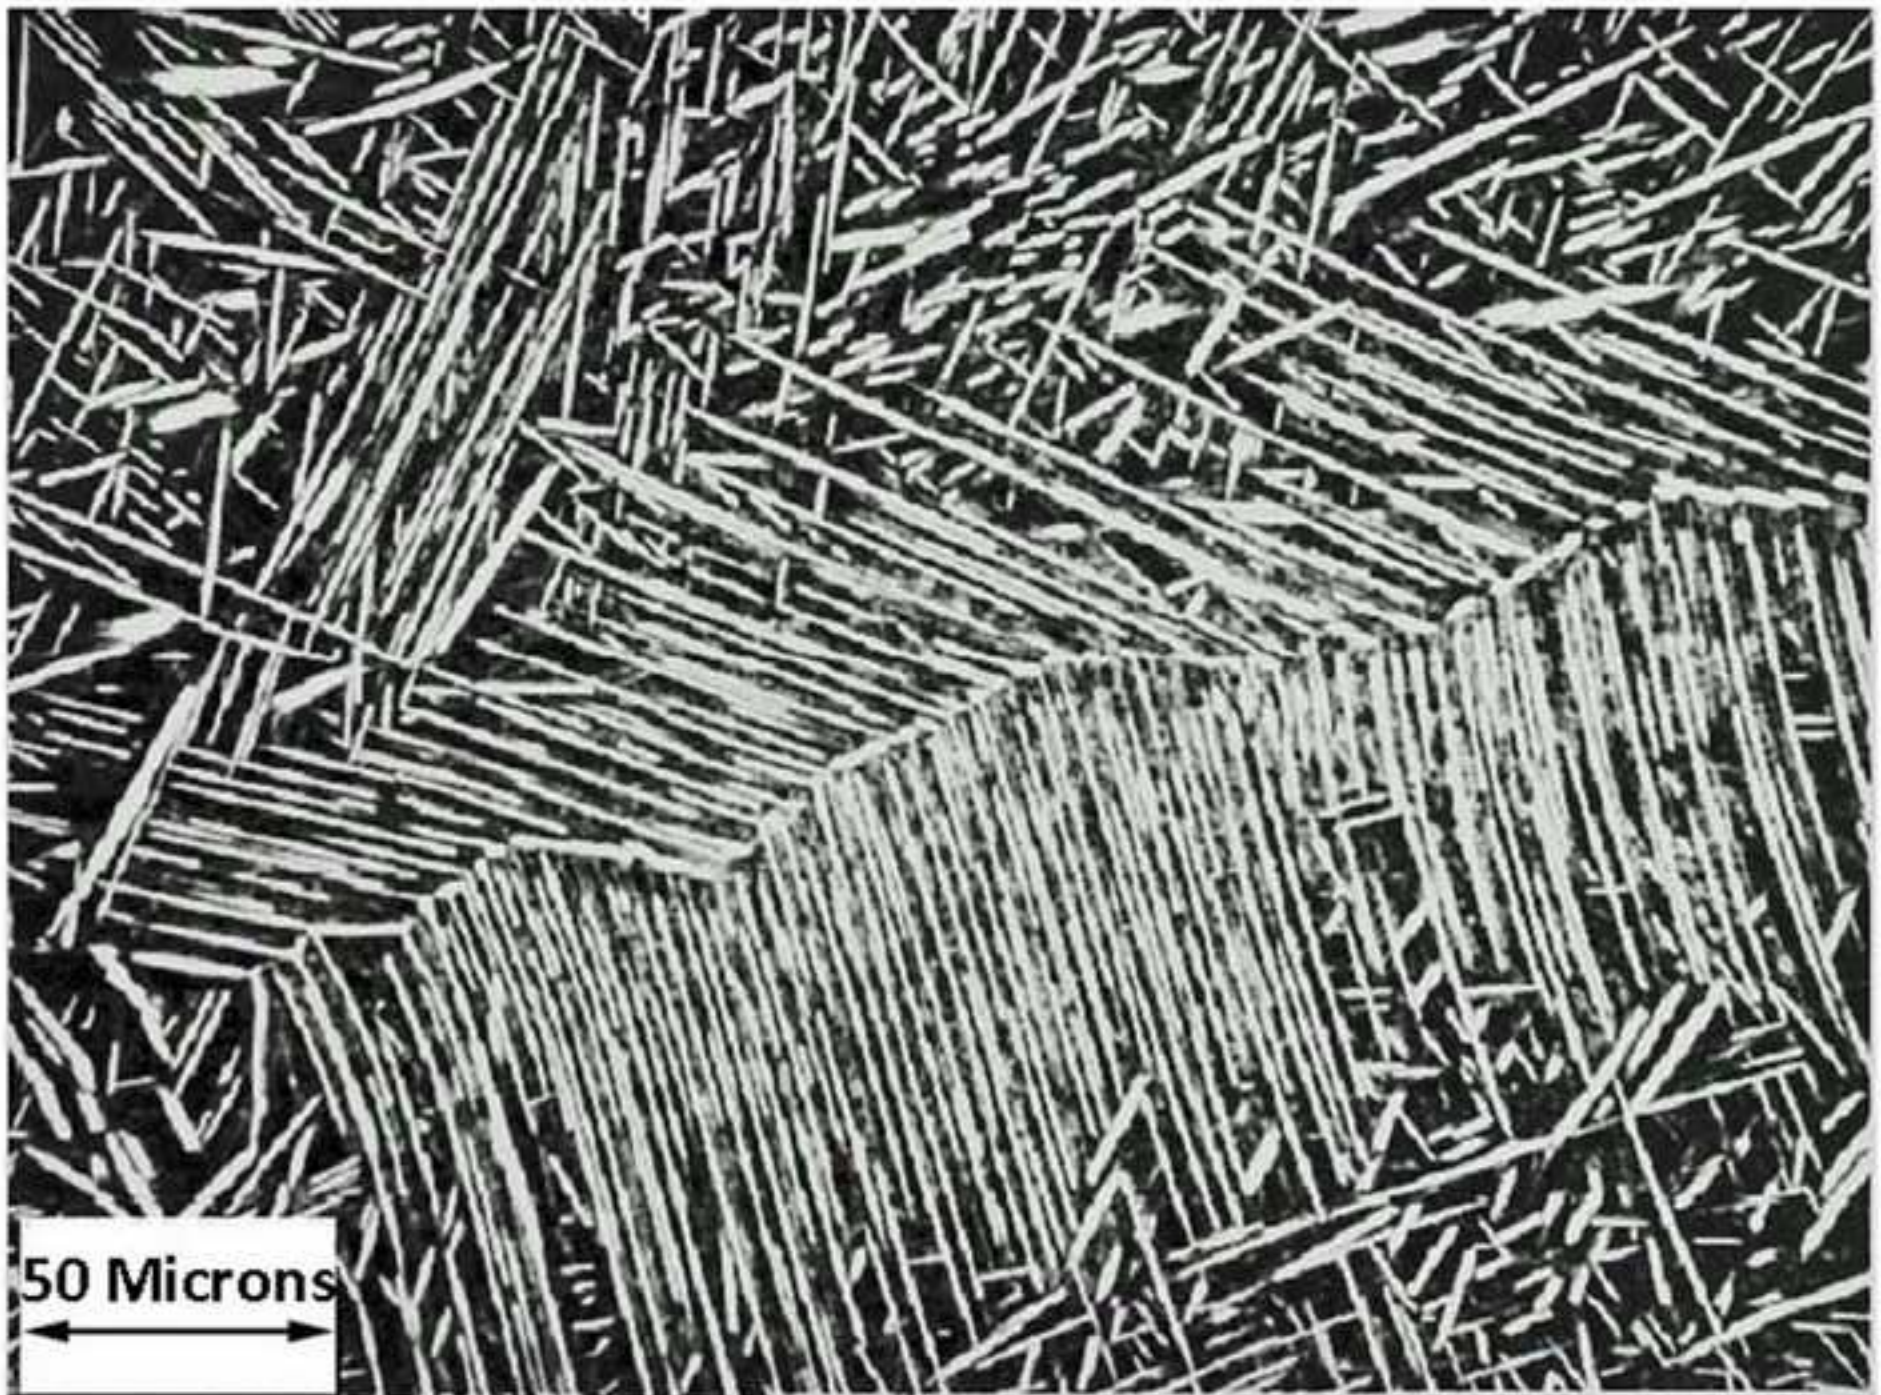
Initial investigation deemed that fractographic characteristics within the blue spot resembled microstructure ("structure-sensitive"; figure 2) [15,16]. A stress-corrosion mechanism was considered, but at the time no corrosive species were identified using the available techniques on either ST1 or ST2. It was generally commented that the crack was due to low cycle fatigue (LCF) development, but, although describing the fractographic characteristics within the "blue spot", no conclusion could be given as to its nature or cause at that time.

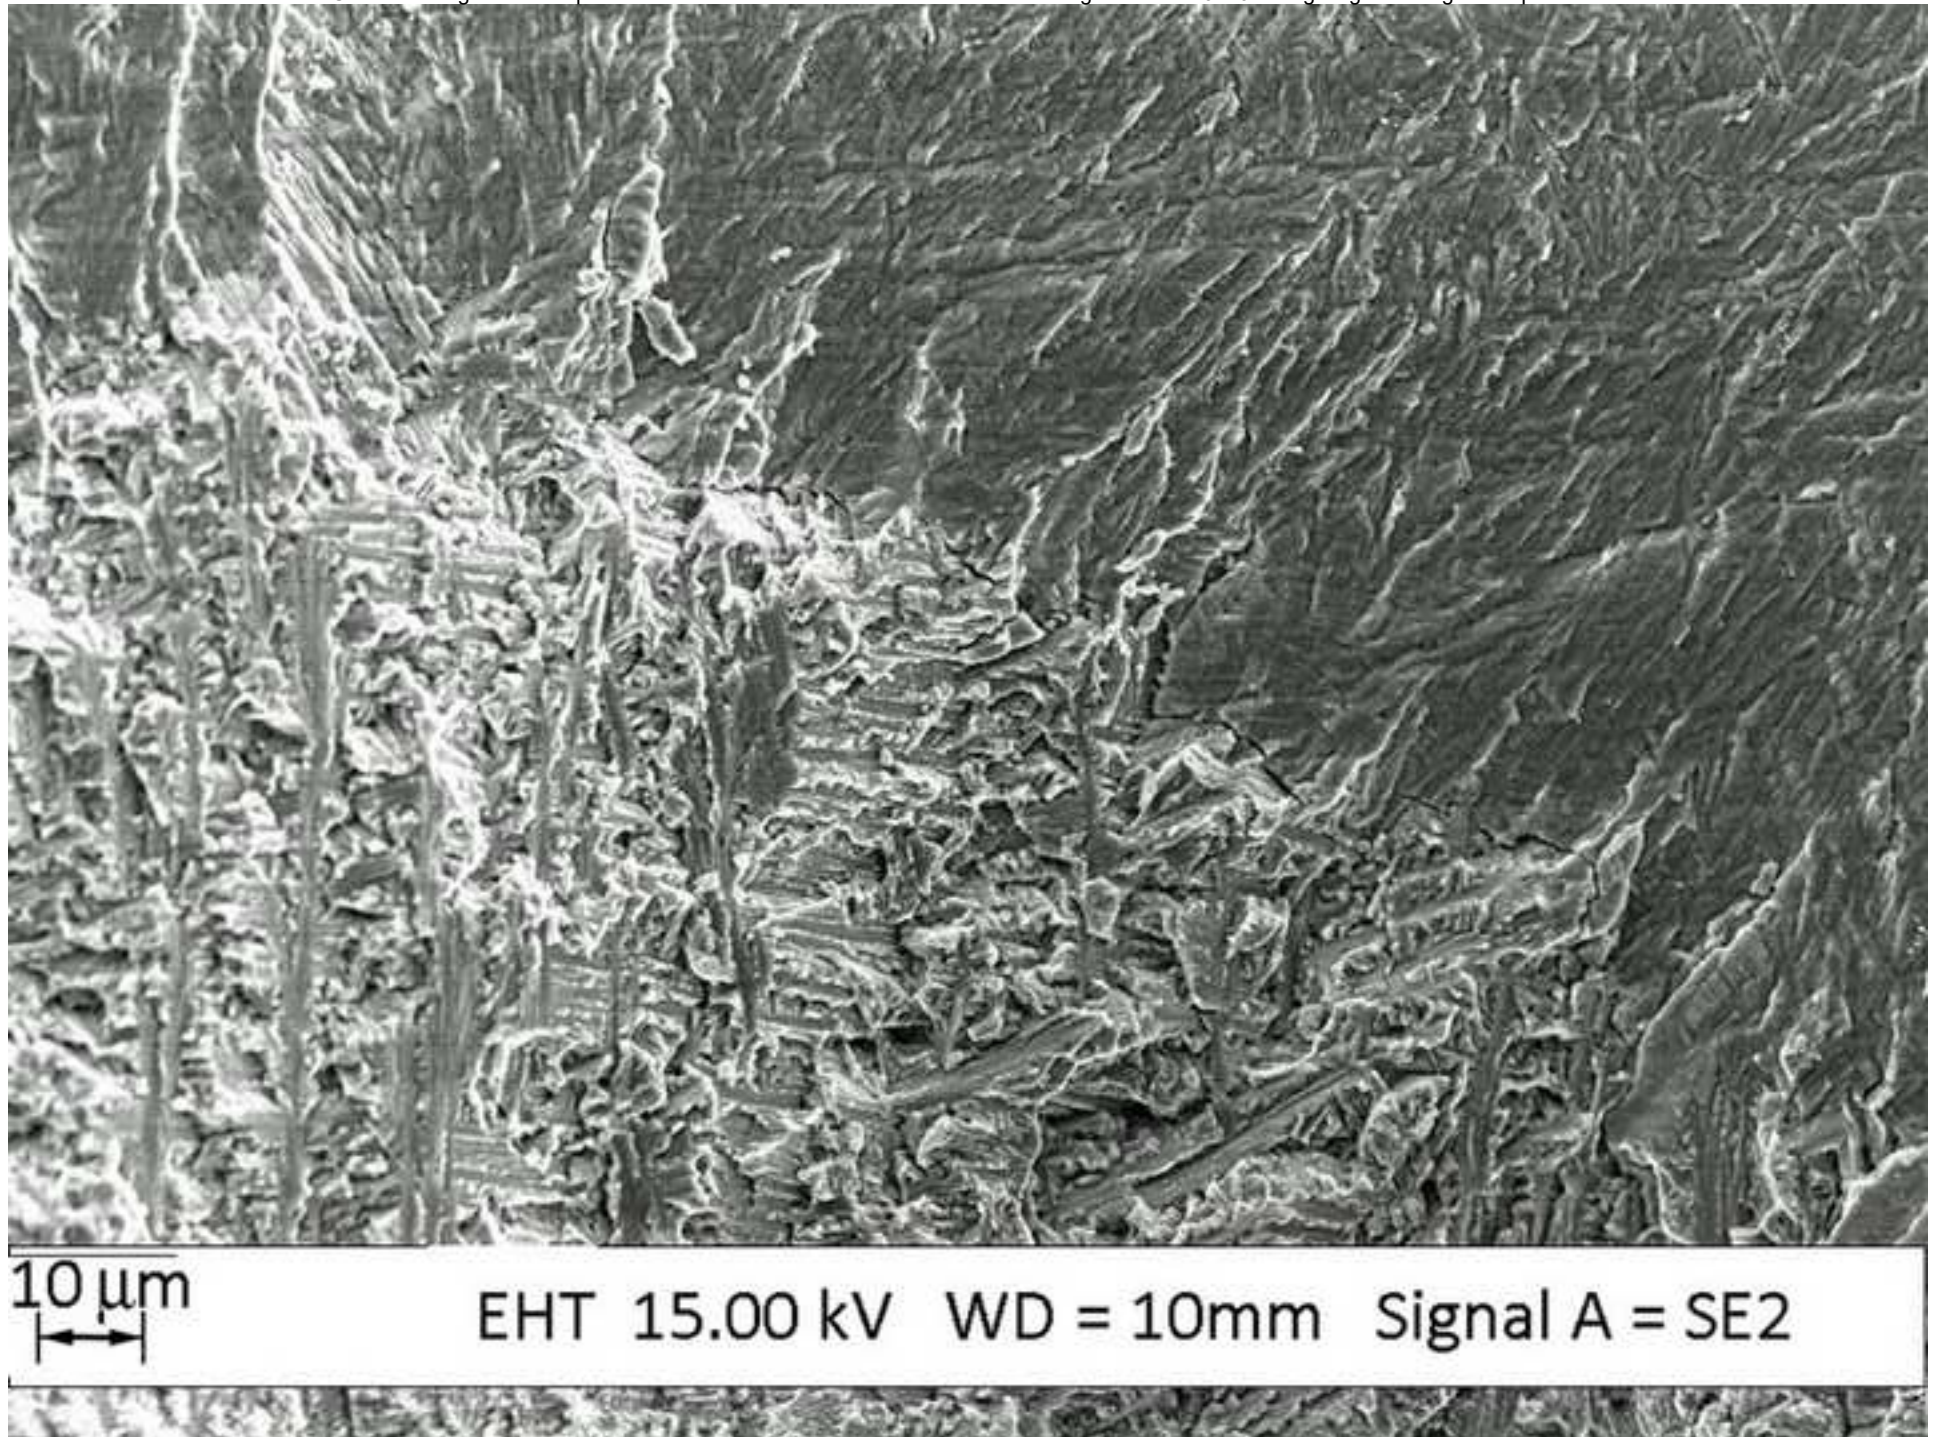
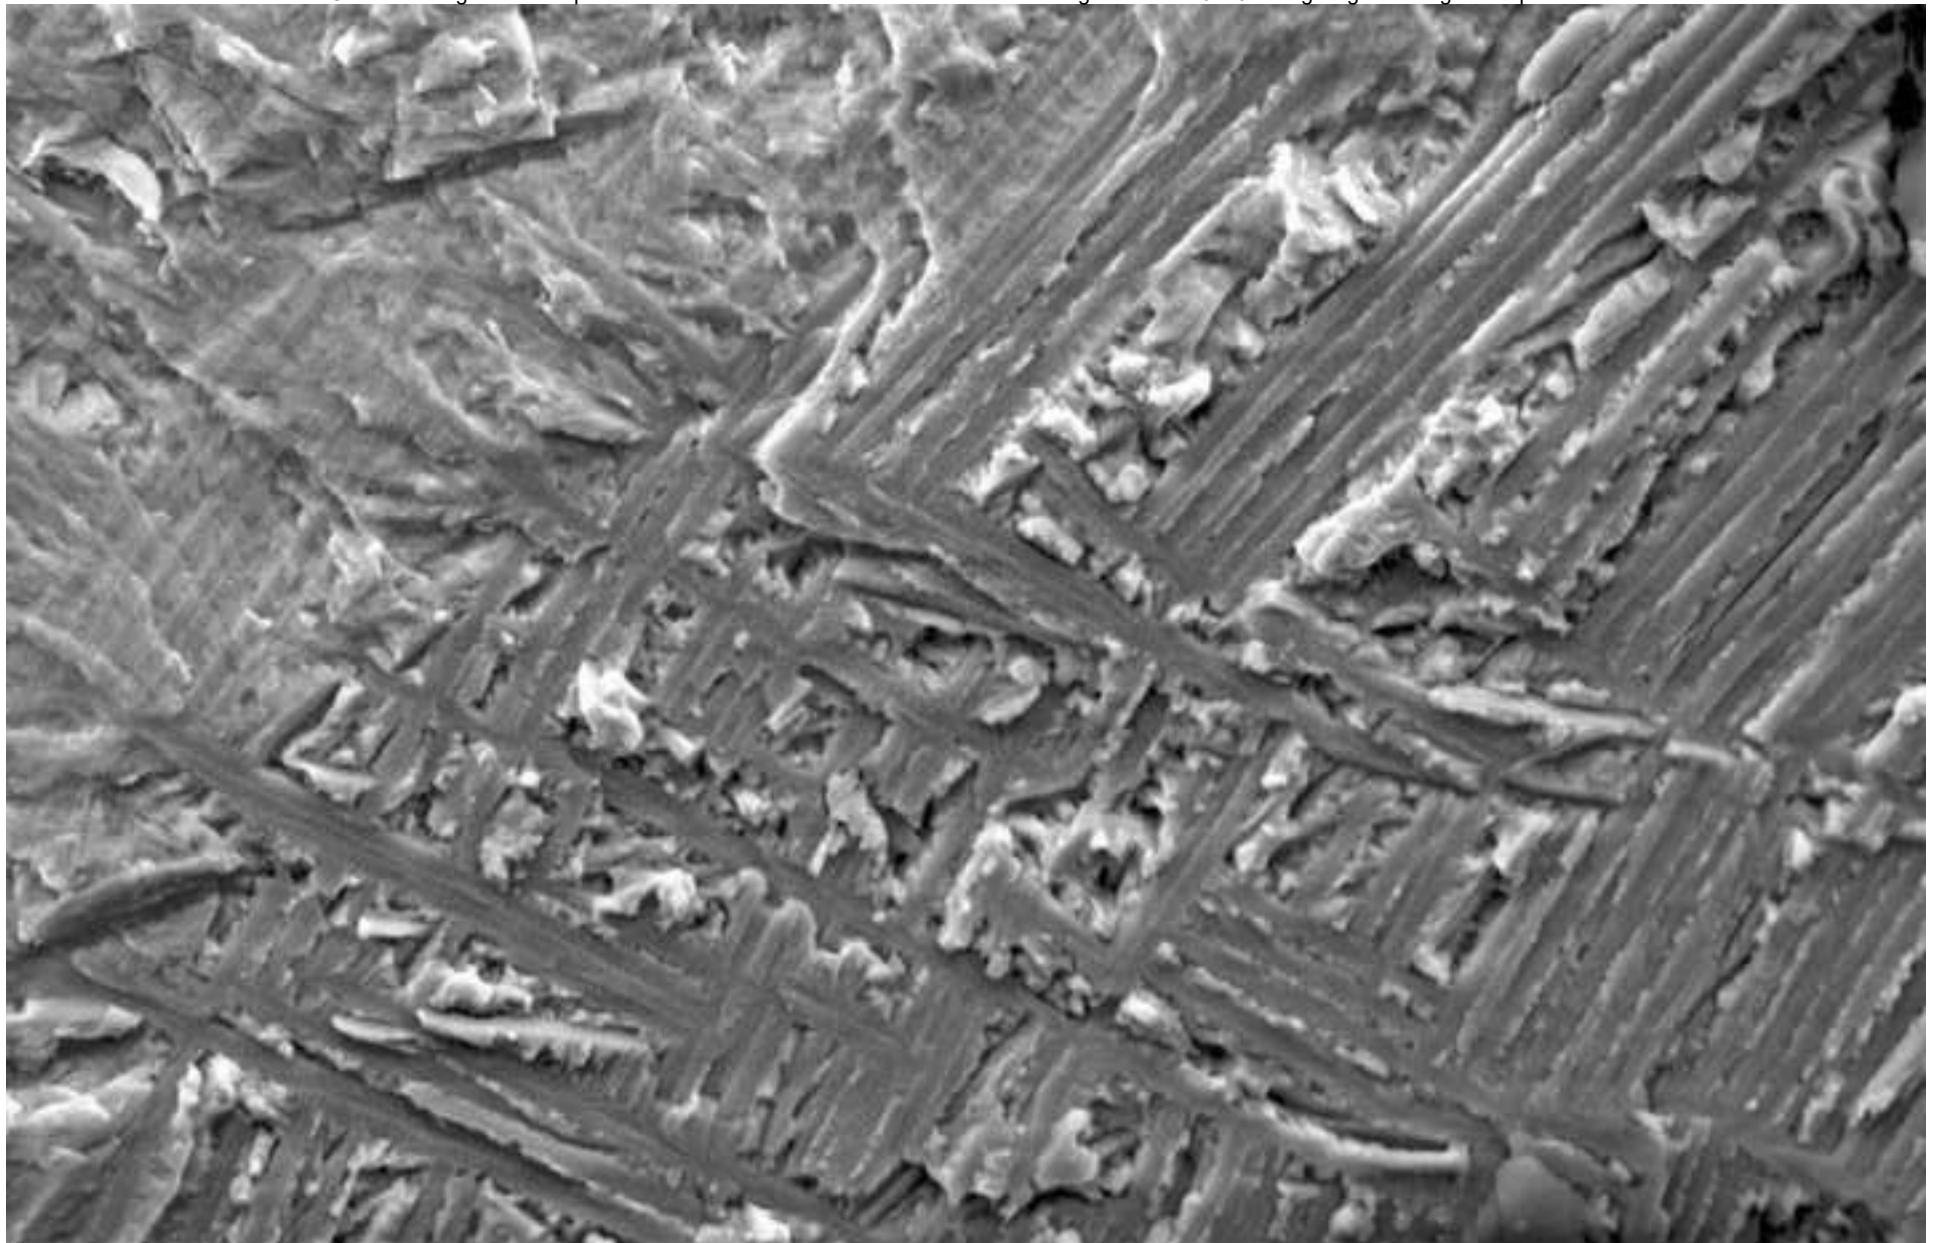
Figure 5b

The appearance of the "trans-lamellar cleavage" fracture mode only *subtly differs* from that of "structure-sensitive" stage 1 fatigue propagation, so recognition of the fracture type was enhanced by viewing transitions from "trans-lamellar cleavage" to fatigue within the same field of view; figure 5.
