## Understanding the “Blue Spot”

### *Sodium Chloride Hot Salt Stress-Corrosion Cracking in Titanium-6246 during fatigue testing at low pressure*

EA Saunders<sup>1</sup>, TP Chapman<sup>2</sup>, ARM Walker<sup>3</sup>, TC Lindley<sup>2</sup>, RJ Chater<sup>2</sup>, VA Vorontsov<sup>2</sup>, D Rugg<sup>3</sup>, D Dye<sup>2</sup>

<sup>1</sup>Rolls-Royce plc., Materials – Failure Investigation, Bristol, BS34 7QE, UK

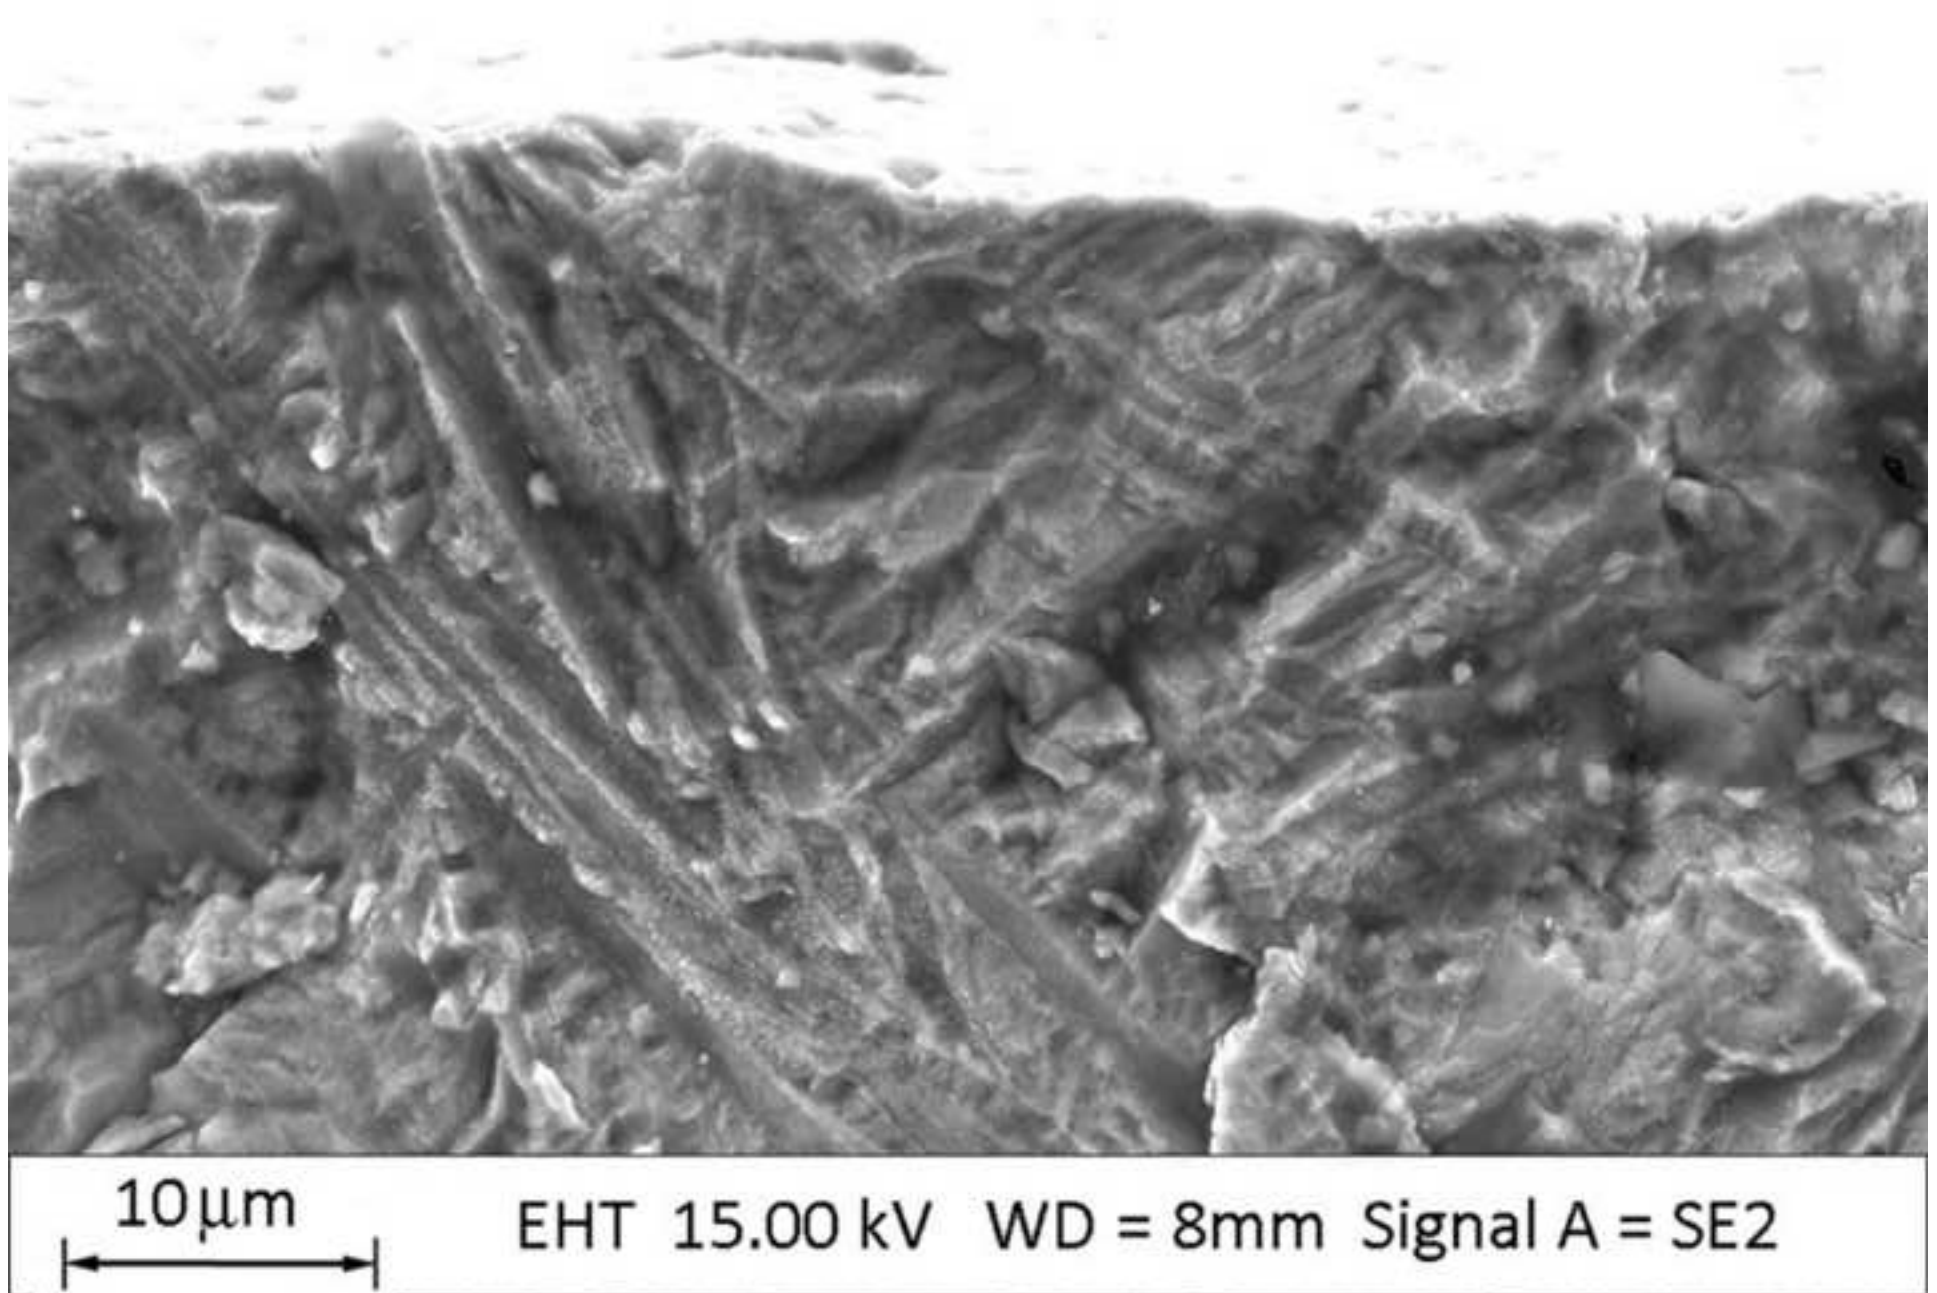
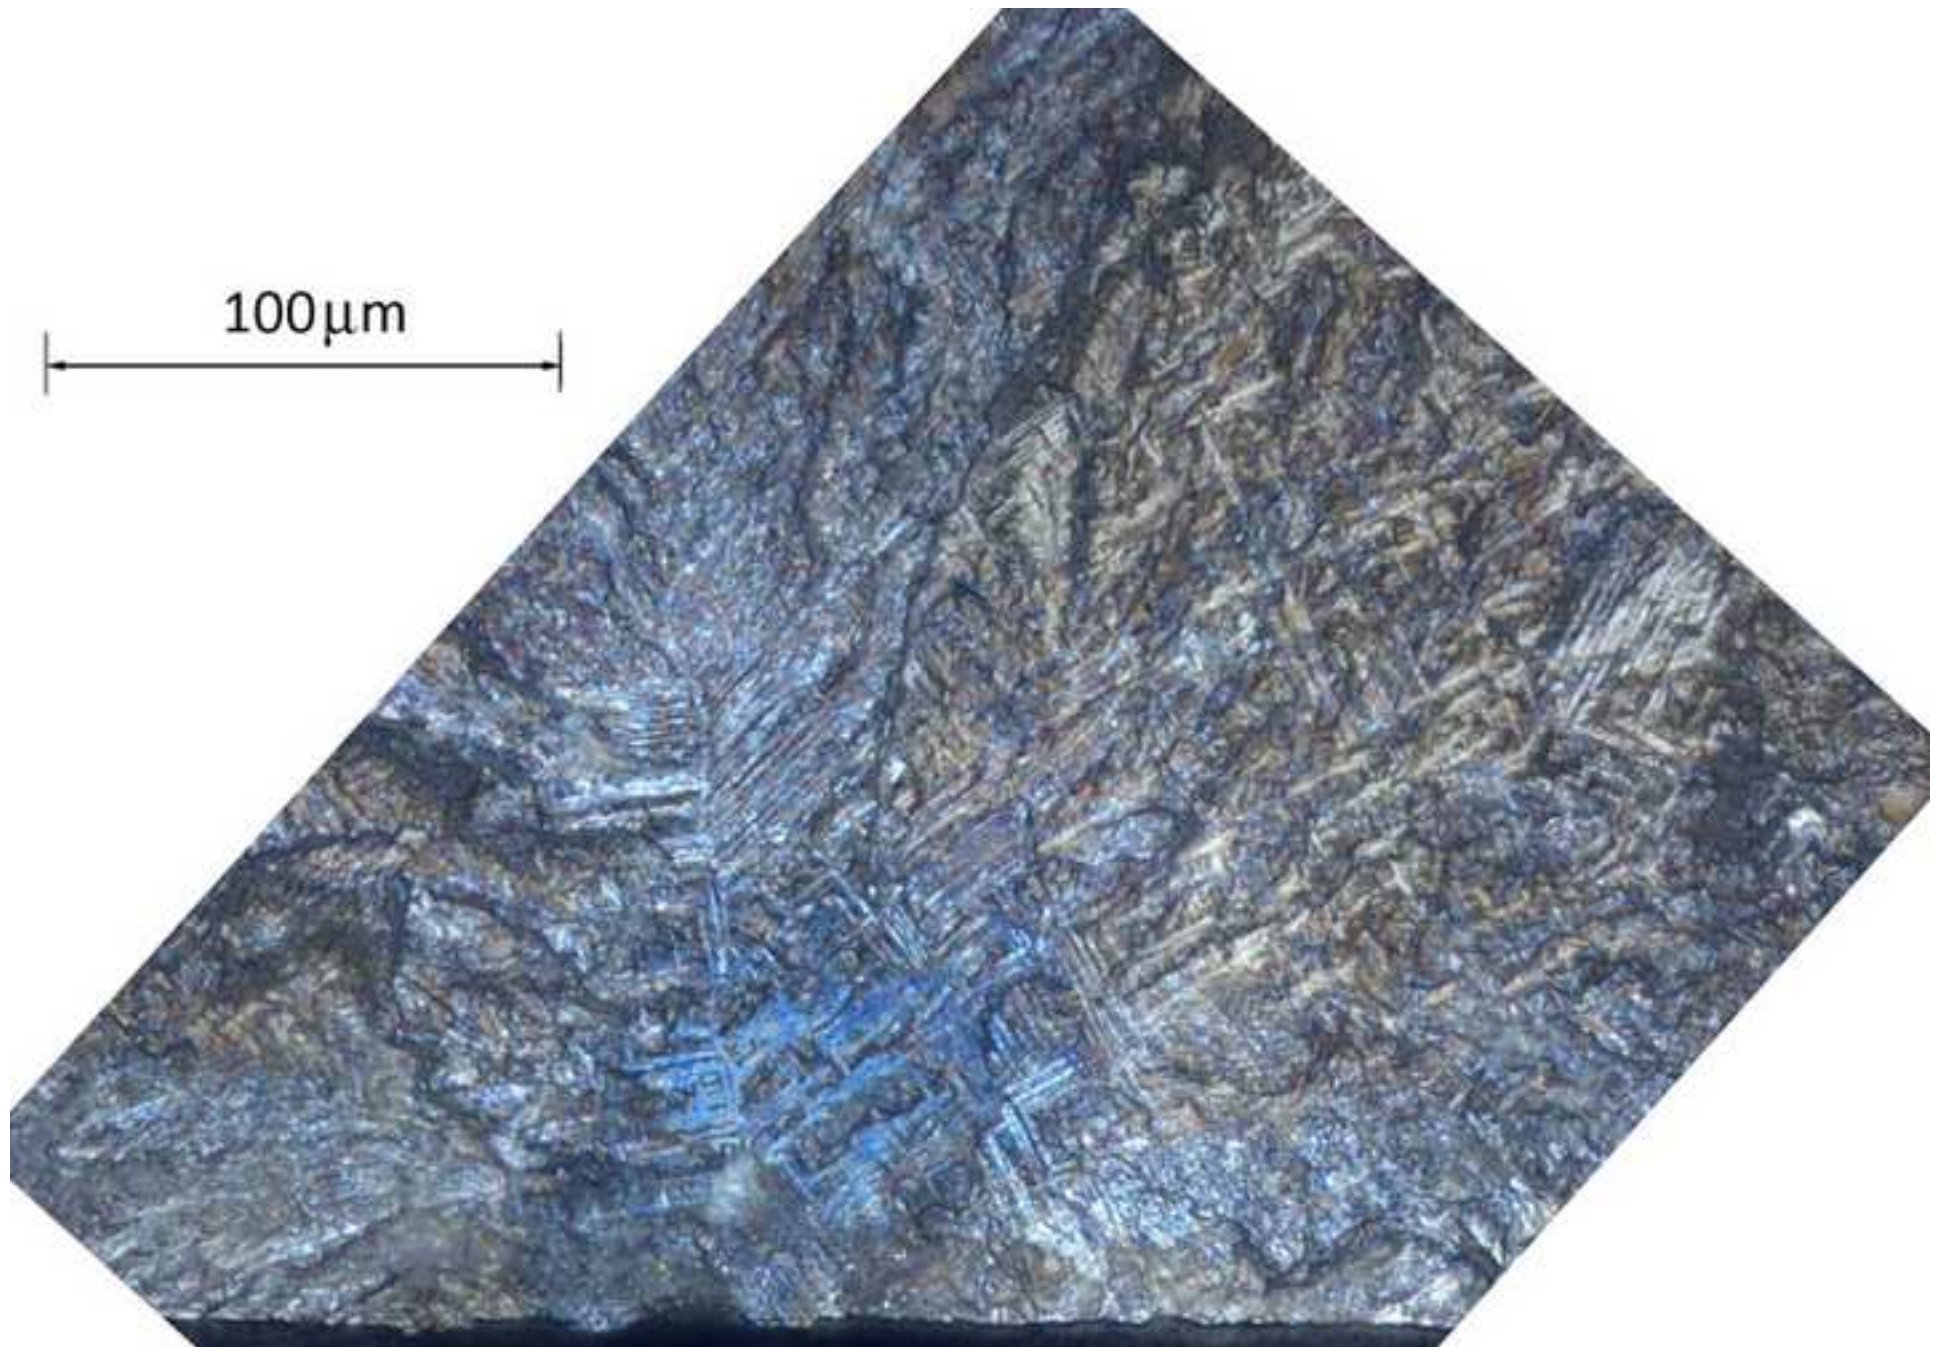
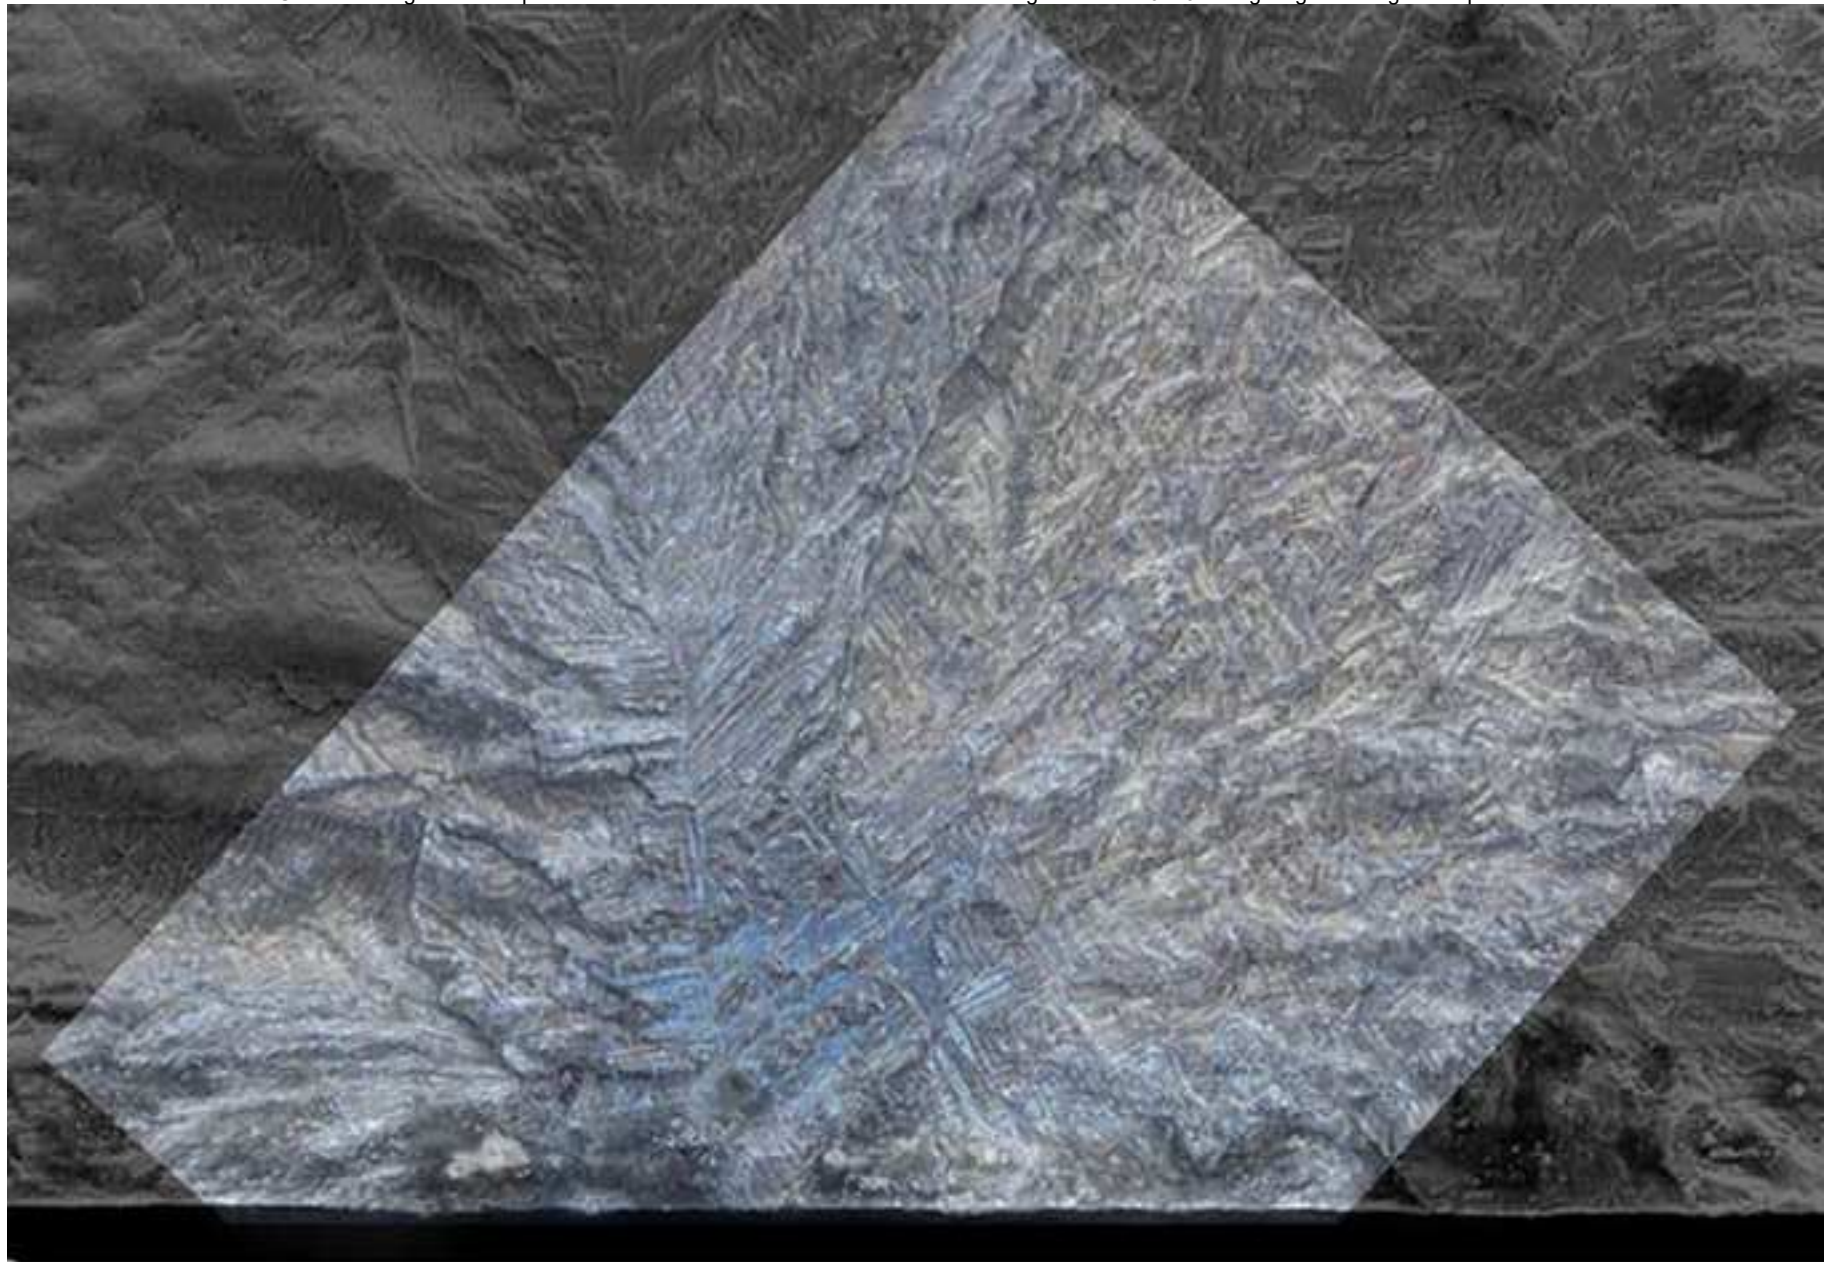
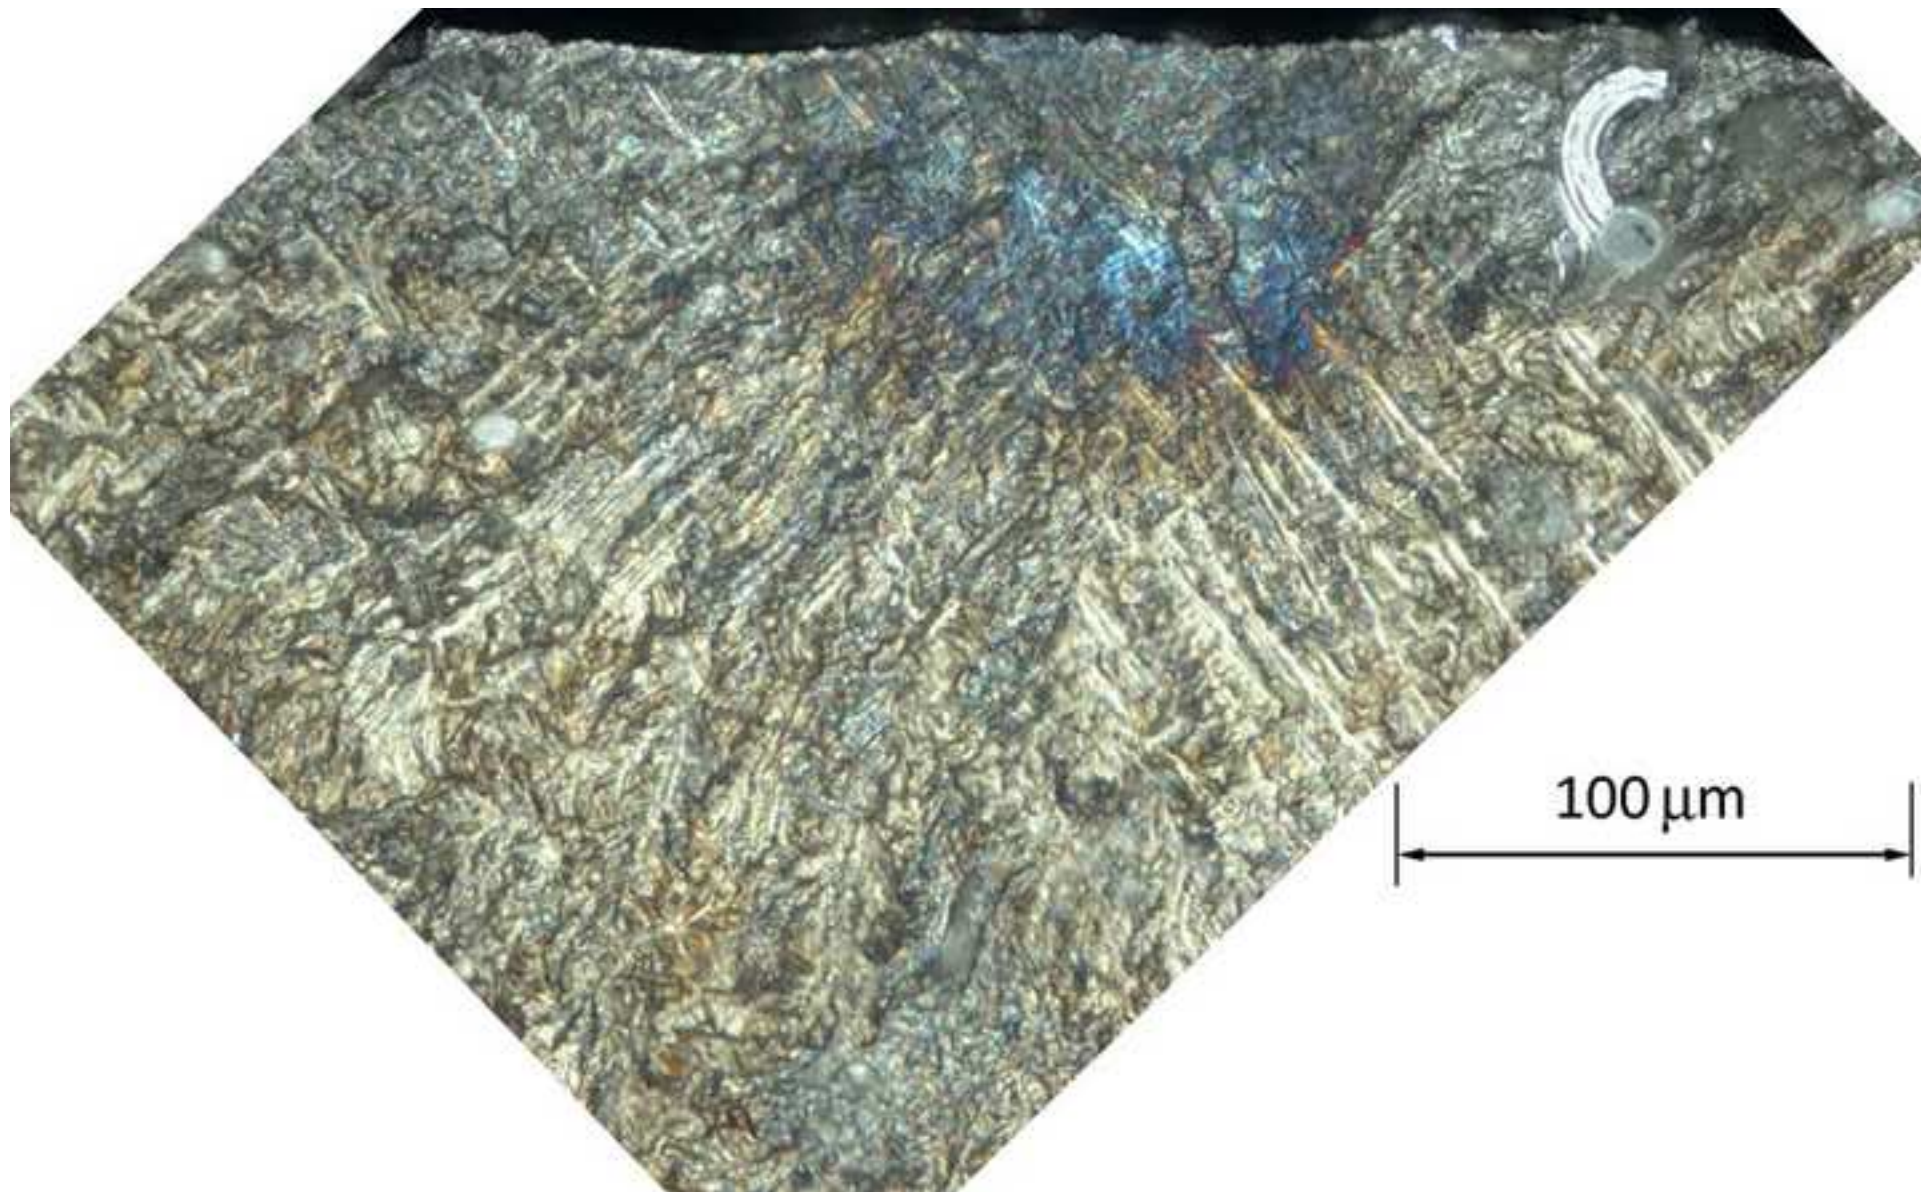
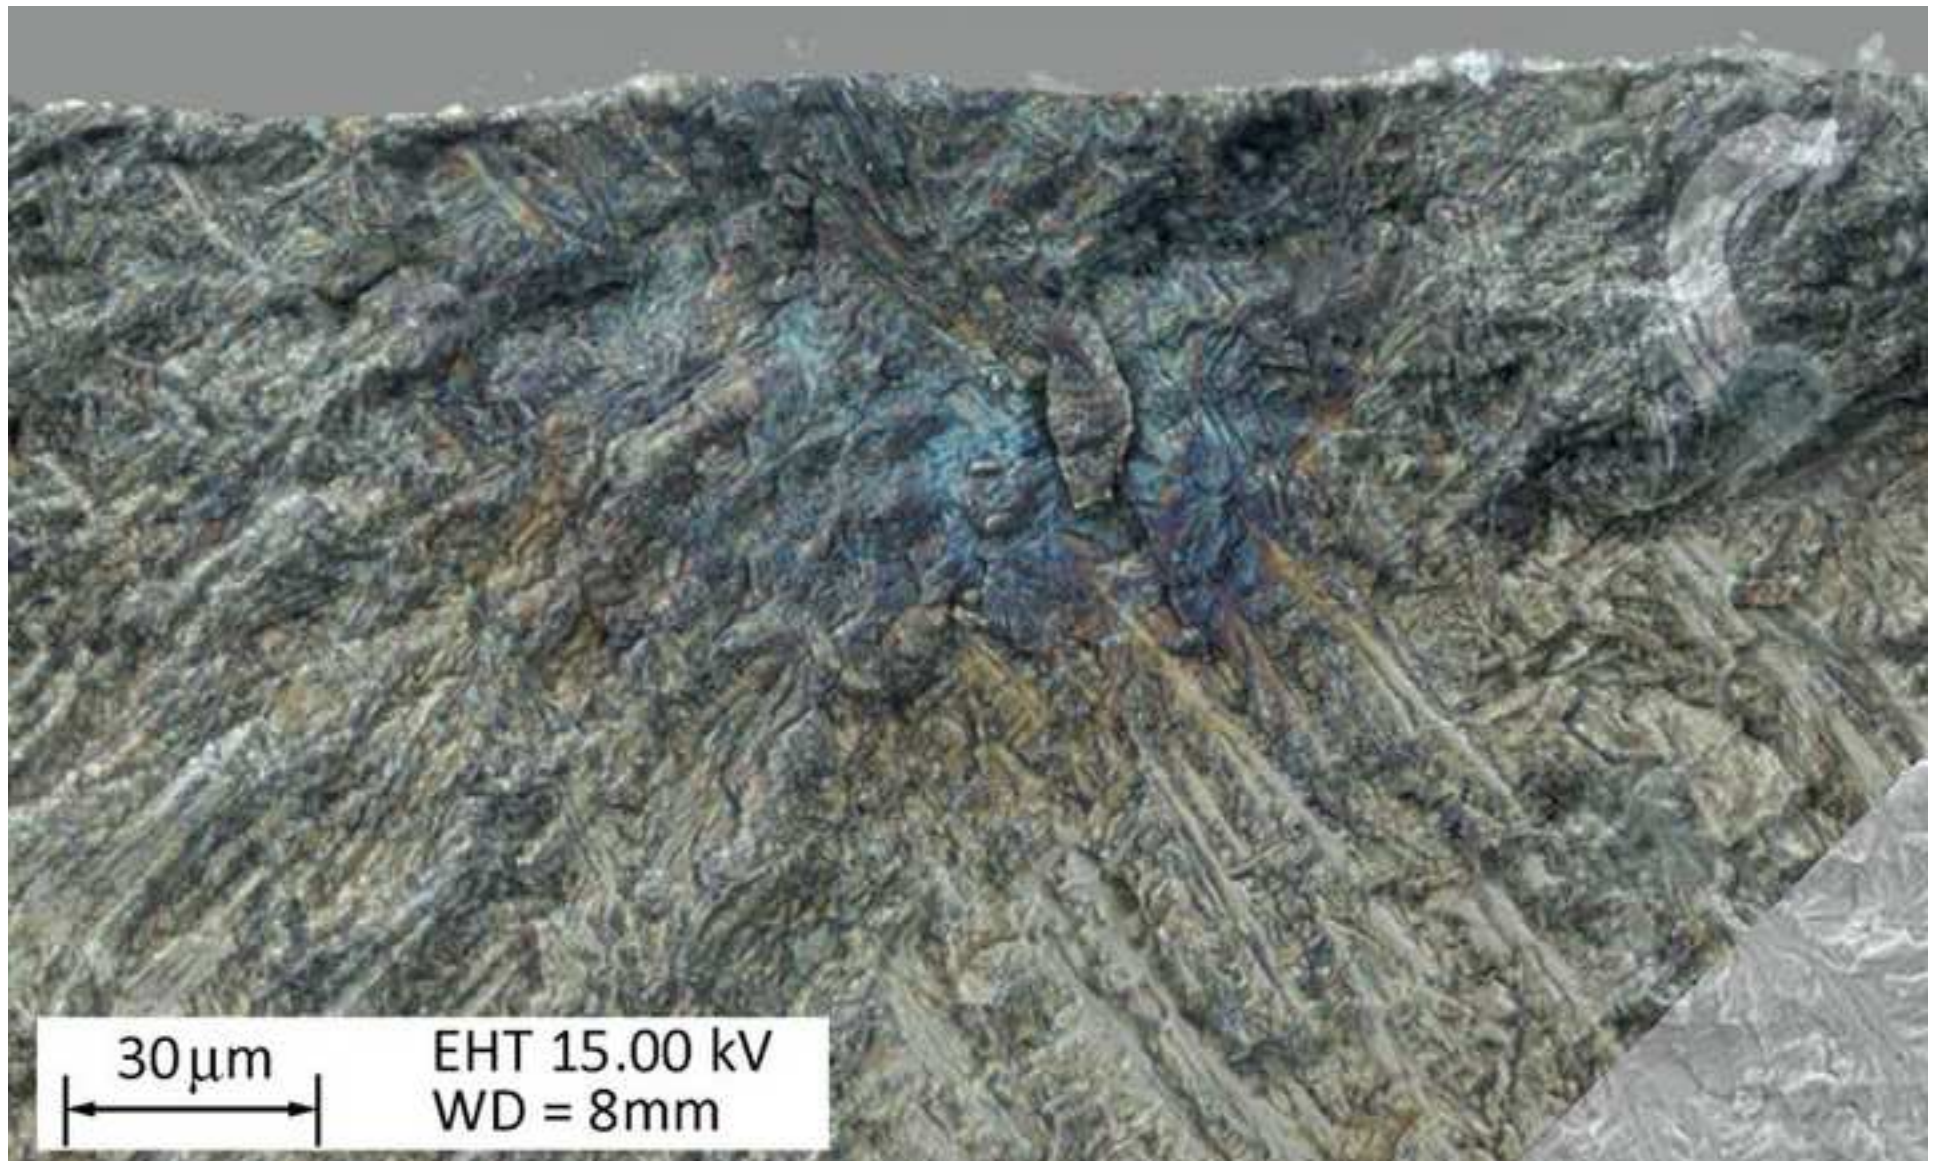
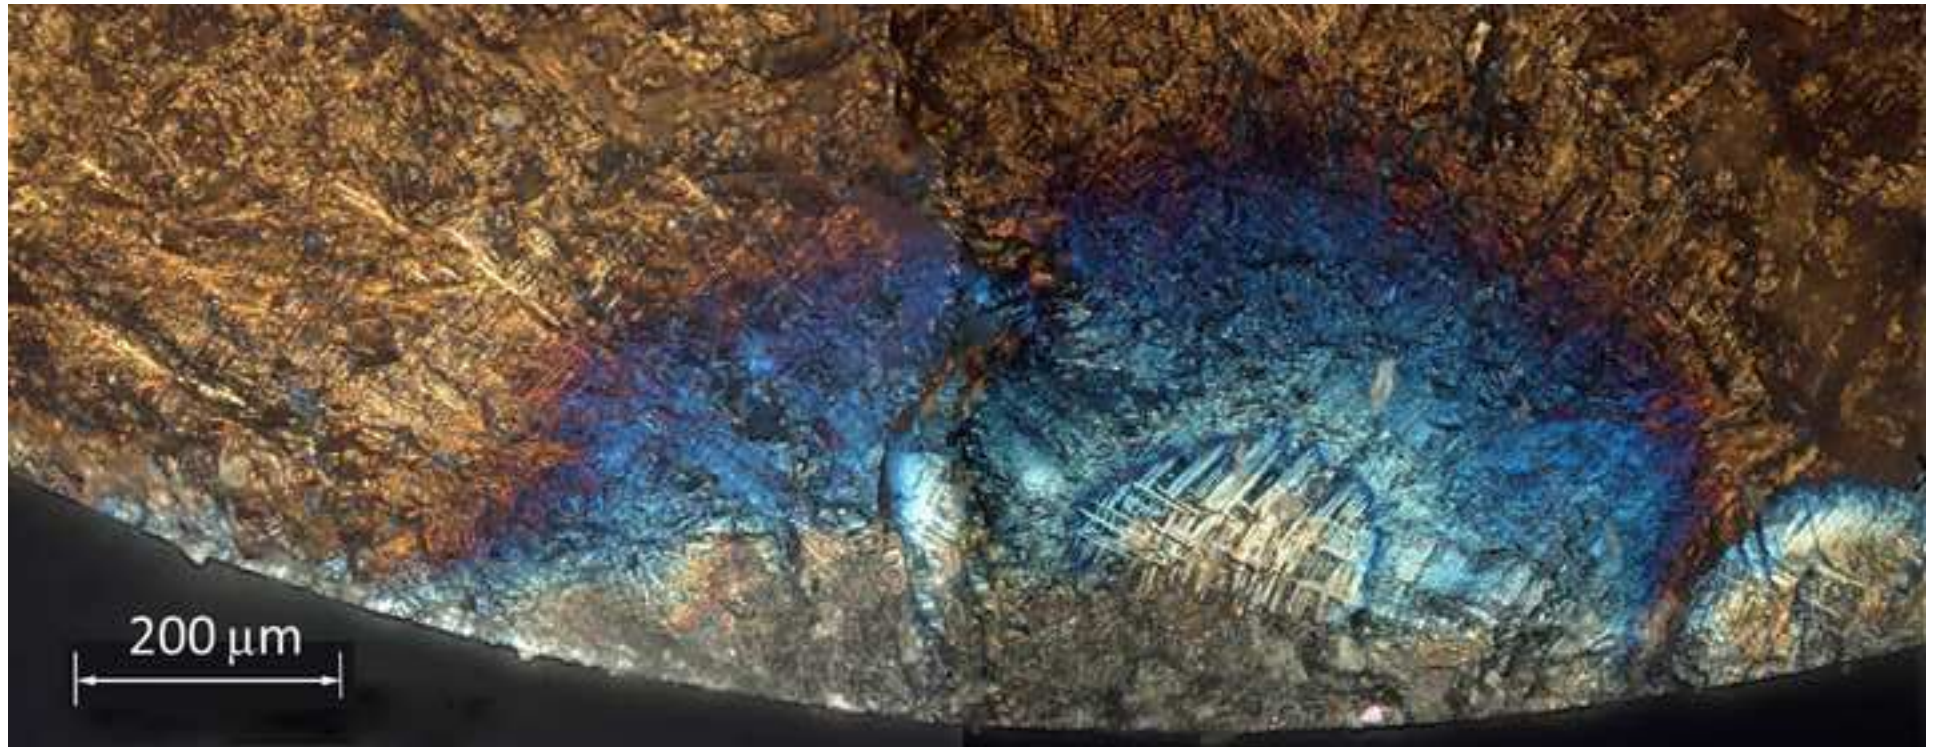
Optical (microscopic) multi-focus fractographic imagery on the blue spot origins (200x, 500x), established a link between the blue colouration and the "brittle structure-sensitive" characteristics observed with electron optics; figure 7. The demarcation between the two fractographic types ("trans-lamellar cleavage" to fatigue) was also visible as the blue colouration periphery seen optically.

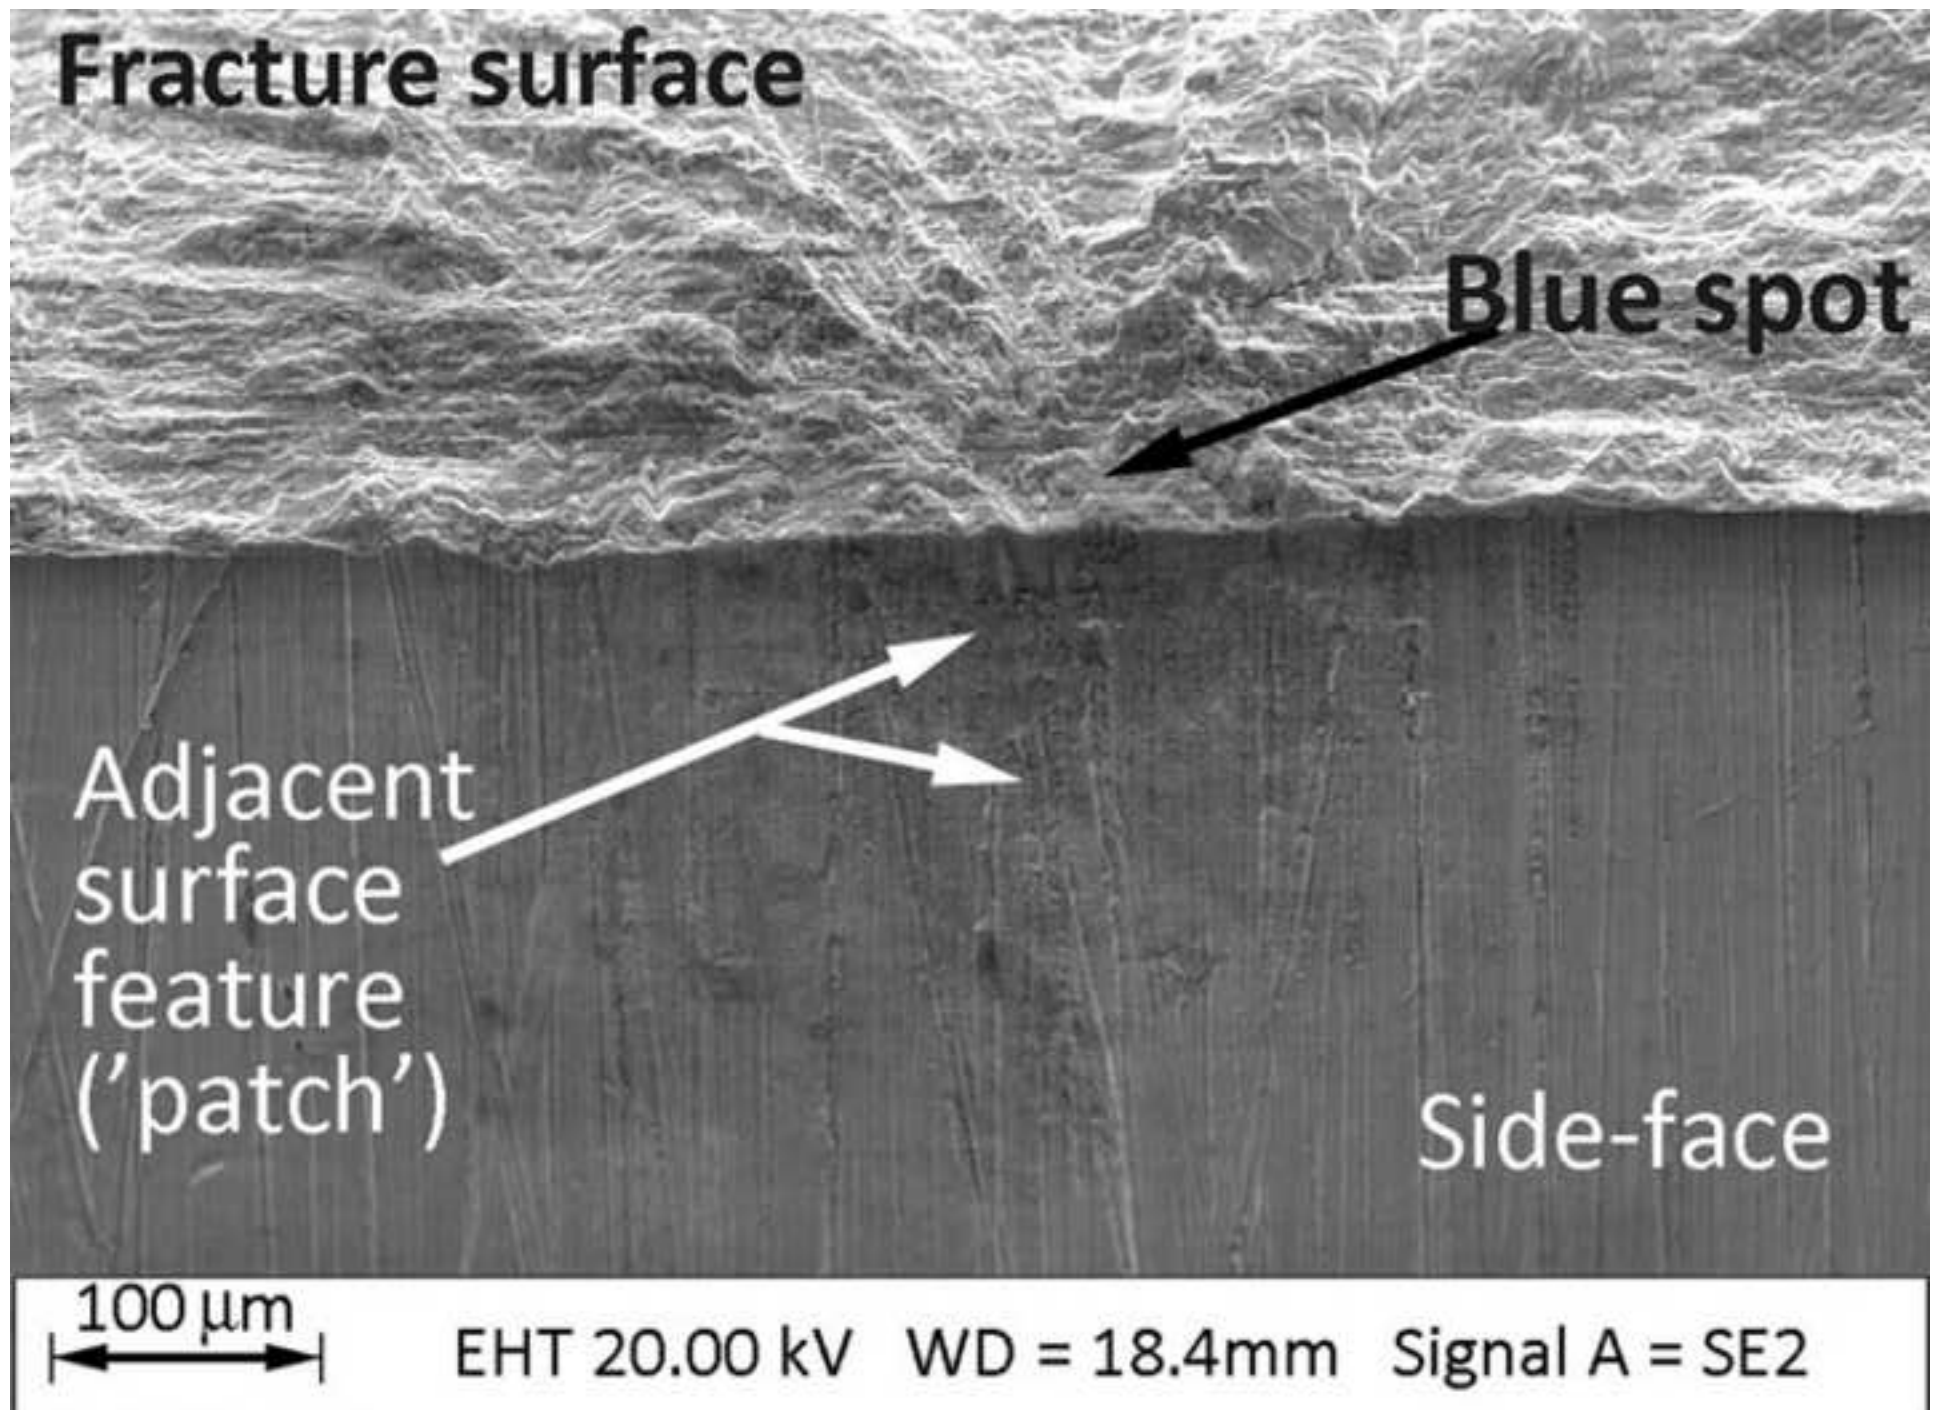
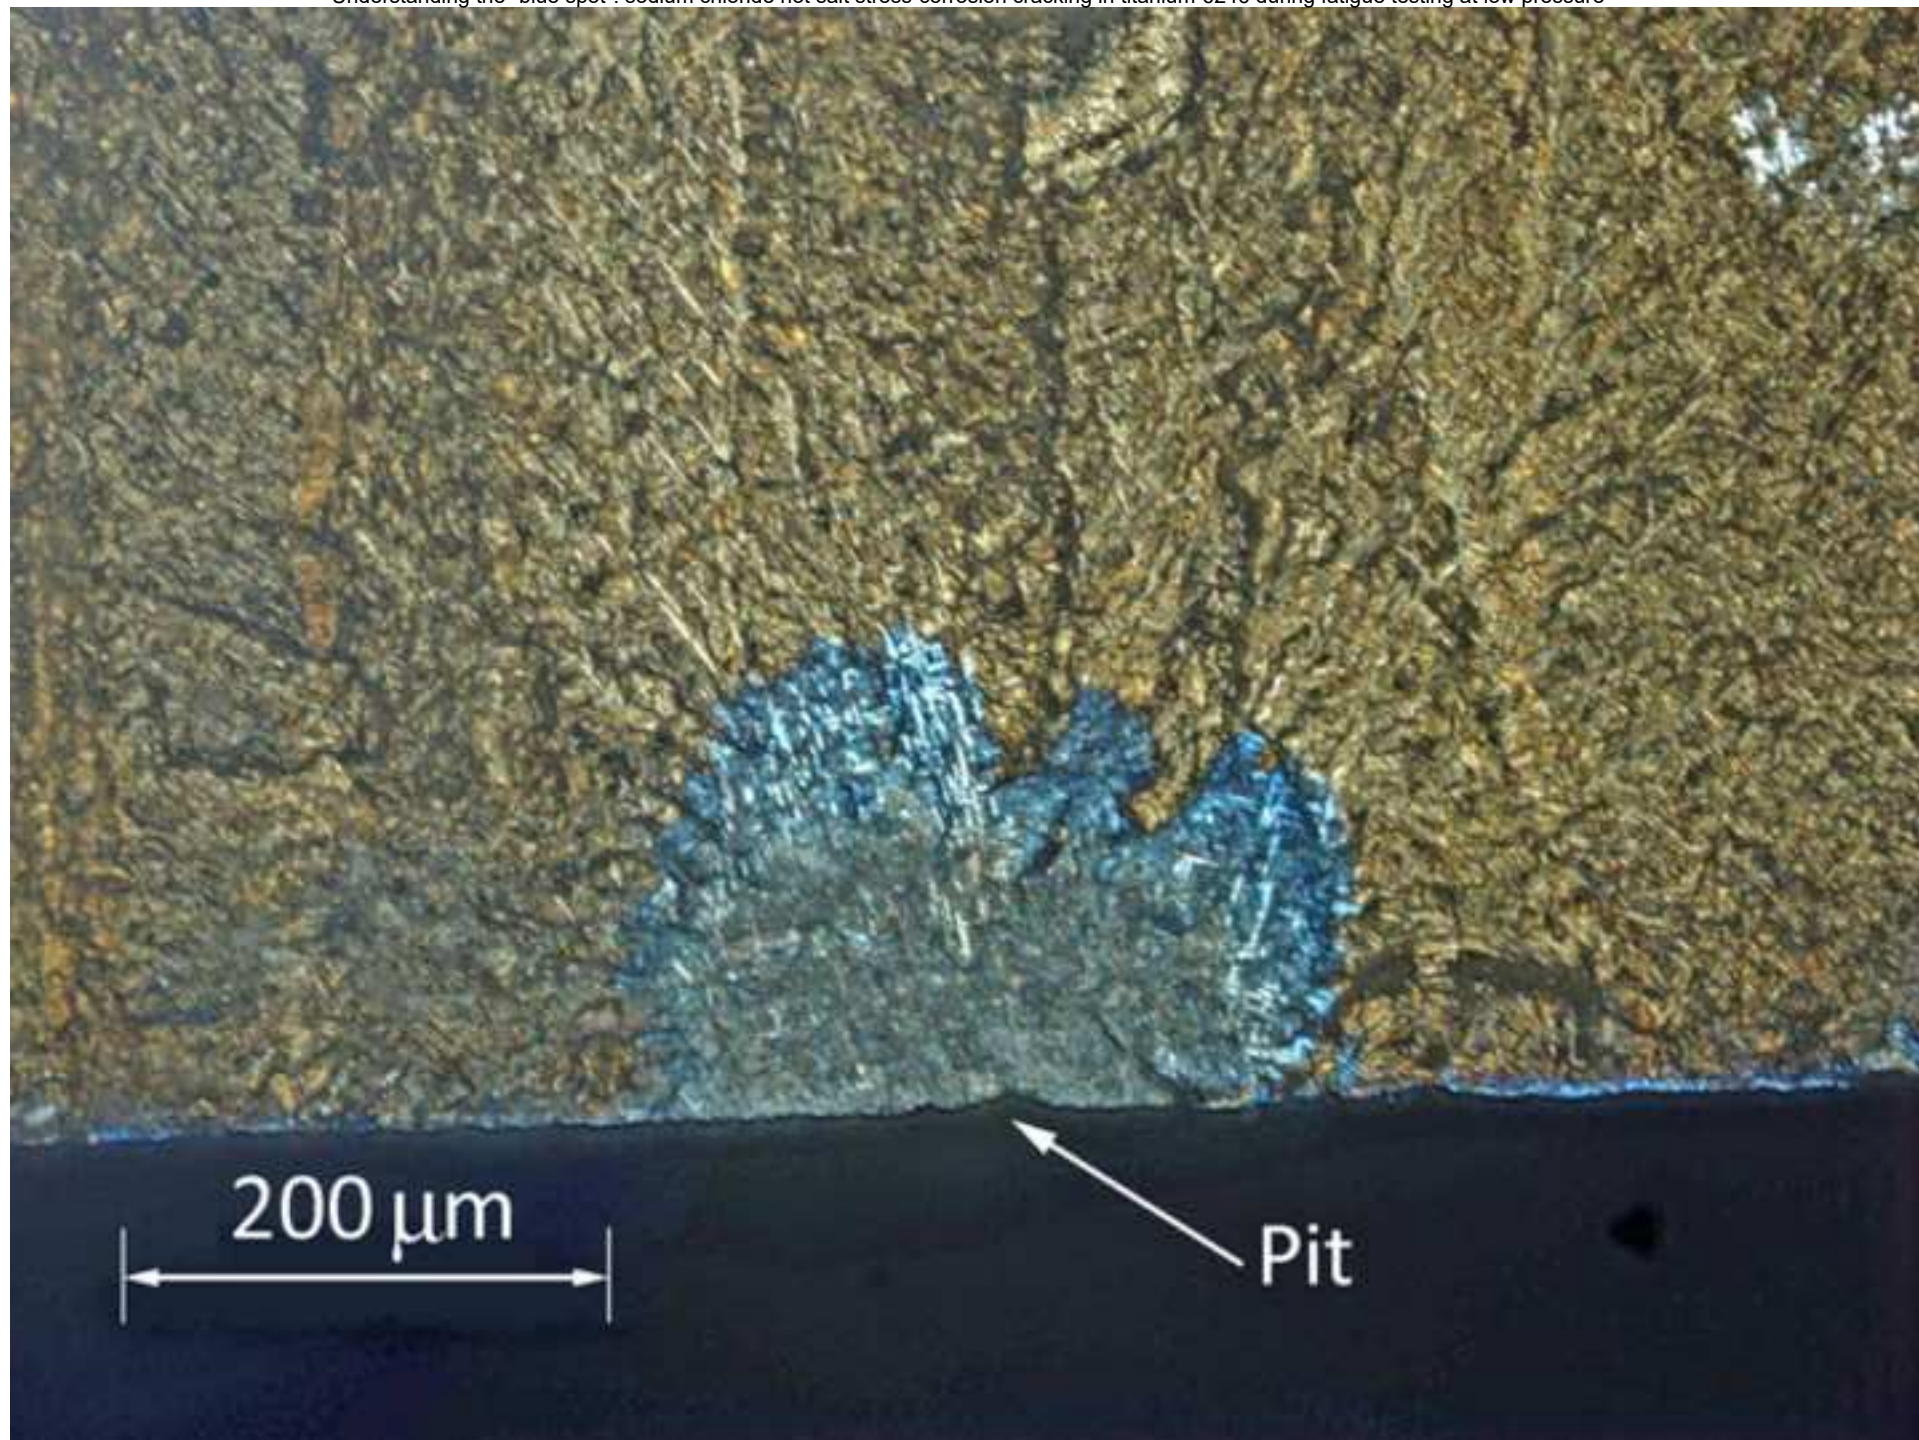
Certain test specimens exhibited macroscopically visible „patches“ of deposit/ residue on the side-face immediately adjacent to the blue spot fracture surface; figure 8. These patches were often semi-elliptical in appearance (possibly „splash“ or „droplet“ related), not necessarily positioned centrally to the "blue spot". Corrosive-reaction product or sometimes pitting could be observed within the patches; figure 8(b).
