## Understanding the “Blue Spot”

### *Sodium Chloride Hot Salt Stress-Corrosion Cracking in Titanium-6246 during fatigue testing at low pressure*

EA Saunders<sup>1</sup>, TP Chapman<sup>2</sup>, ARM Walker<sup>3</sup>, TC Lindley<sup>2</sup>, RJ Chater<sup>2</sup>, VA Vorontsov<sup>2</sup>, D Rugg<sup>3</sup>, D Dye<sup>2</sup>

<sup>1</sup>Rolls-Royce plc., Materials – Failure Investigation, Bristol, BS34 7QE, UK

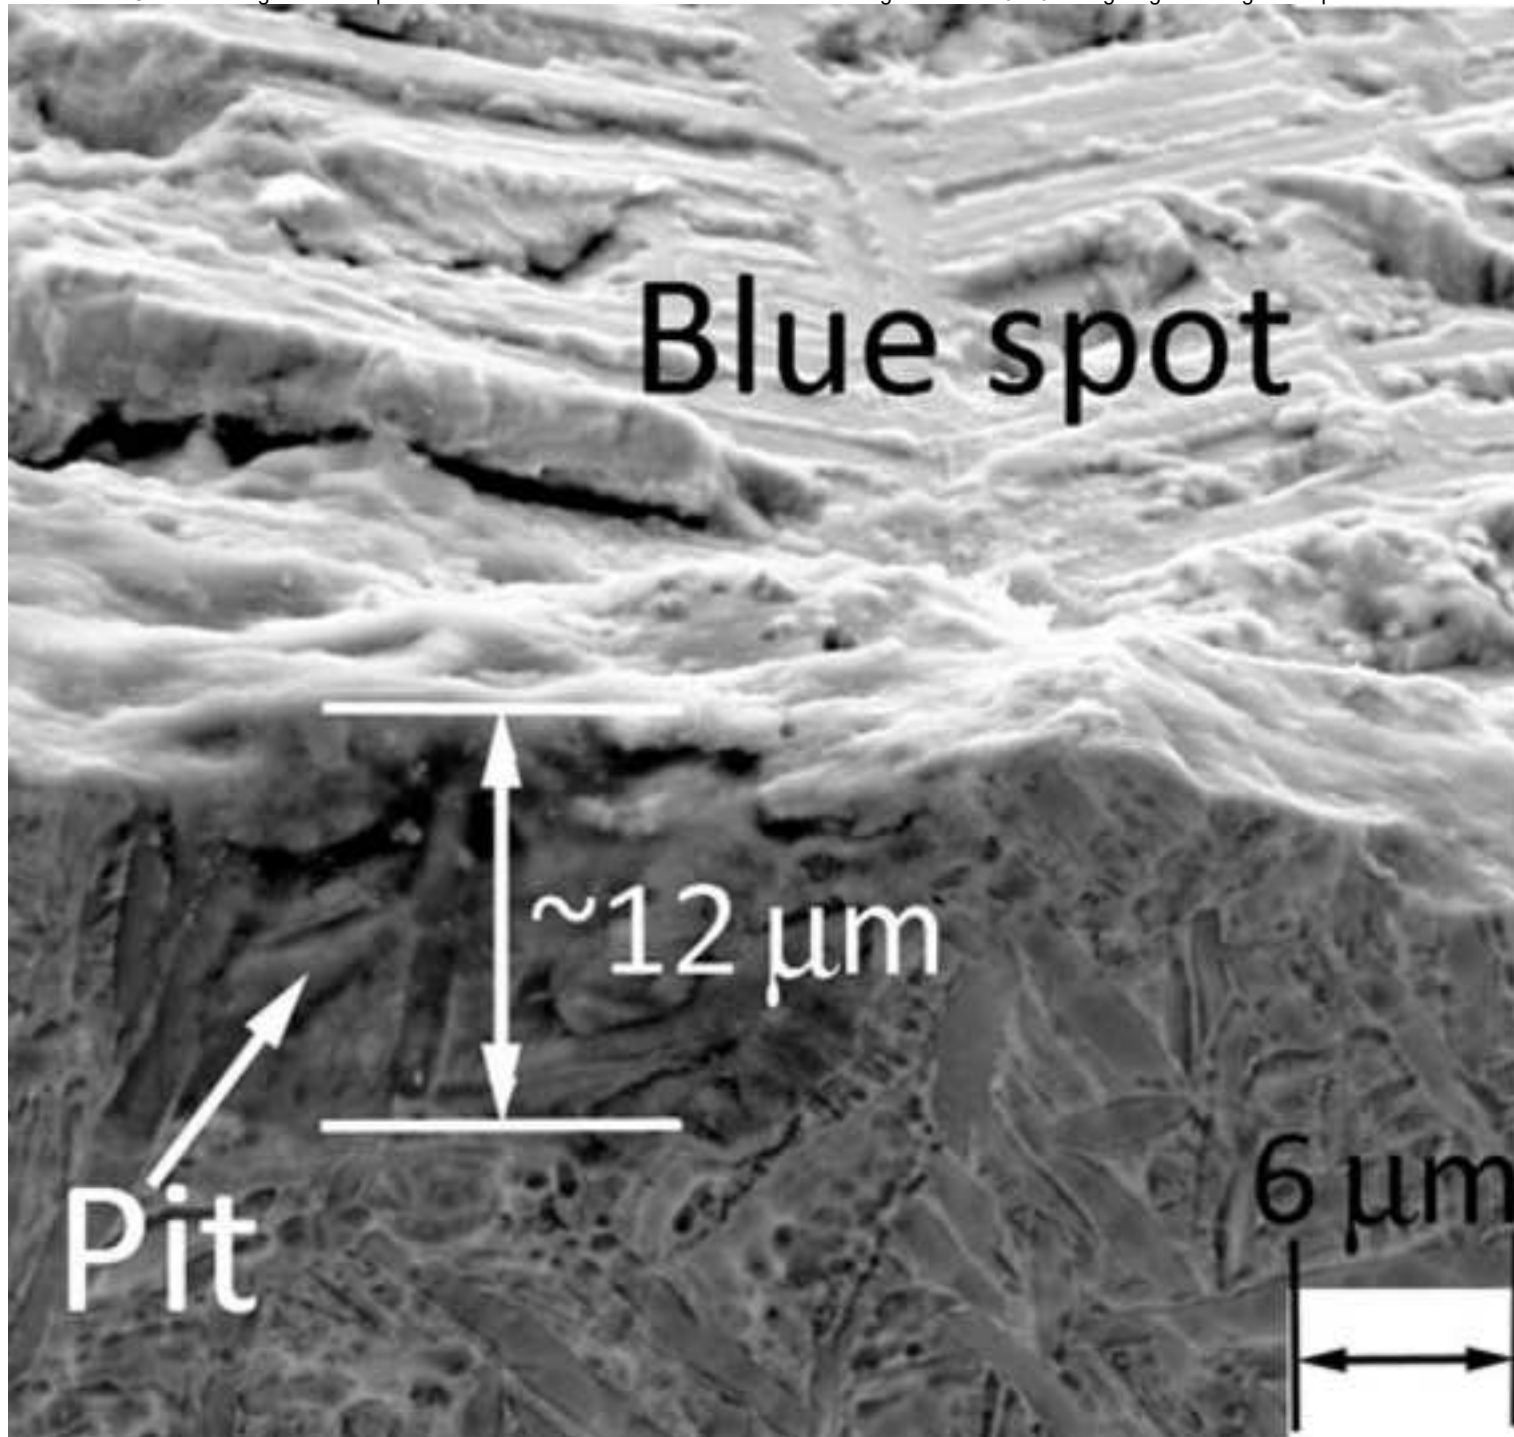
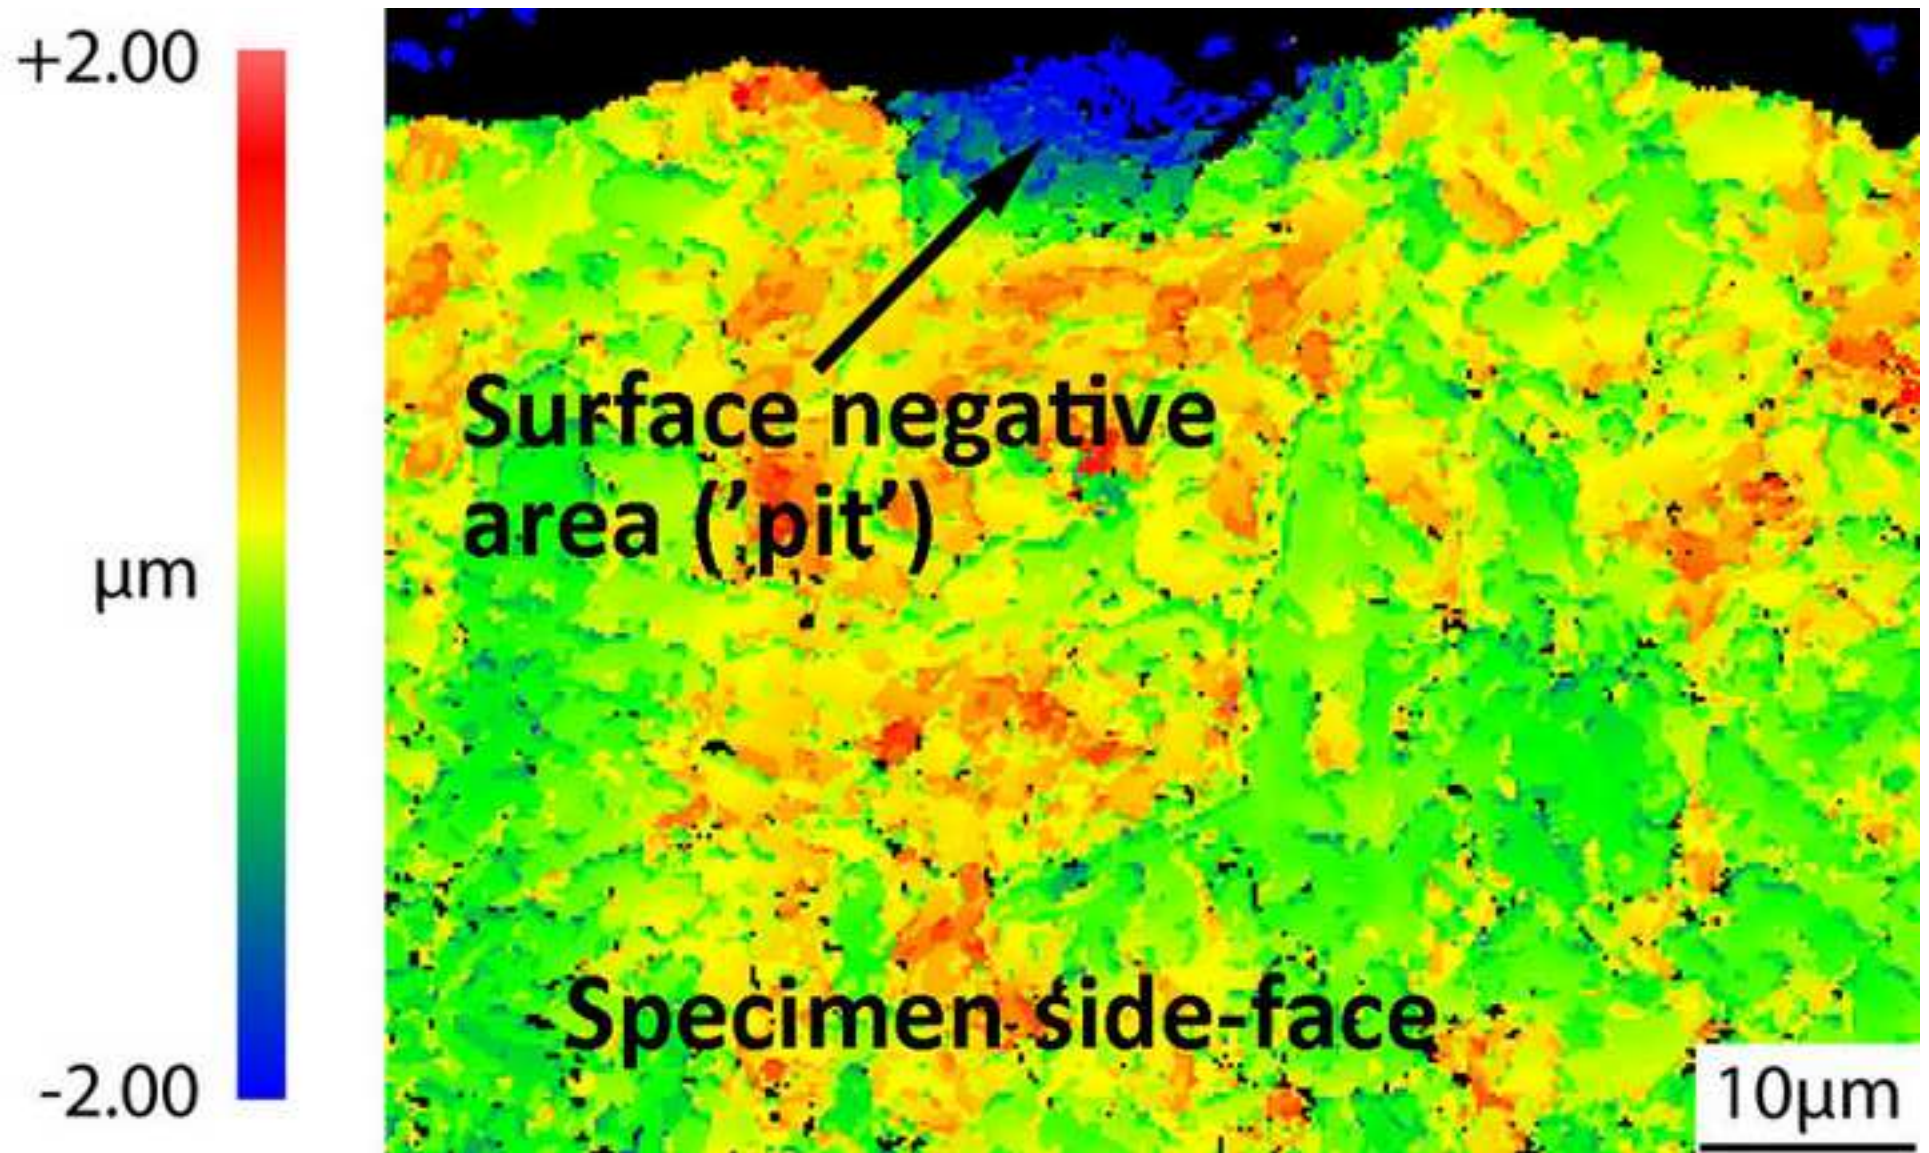
Close examination of ST1 identified a tiny „surface-negative“ area (pit) of  $12 \times 21 \mu\text{m}^2$  on the side-face immediately adjacent to the fracture surface blue spot; figure 9. Although no residue patch was observed, it is probable that the previous cleaning had removed it to expose a pit.

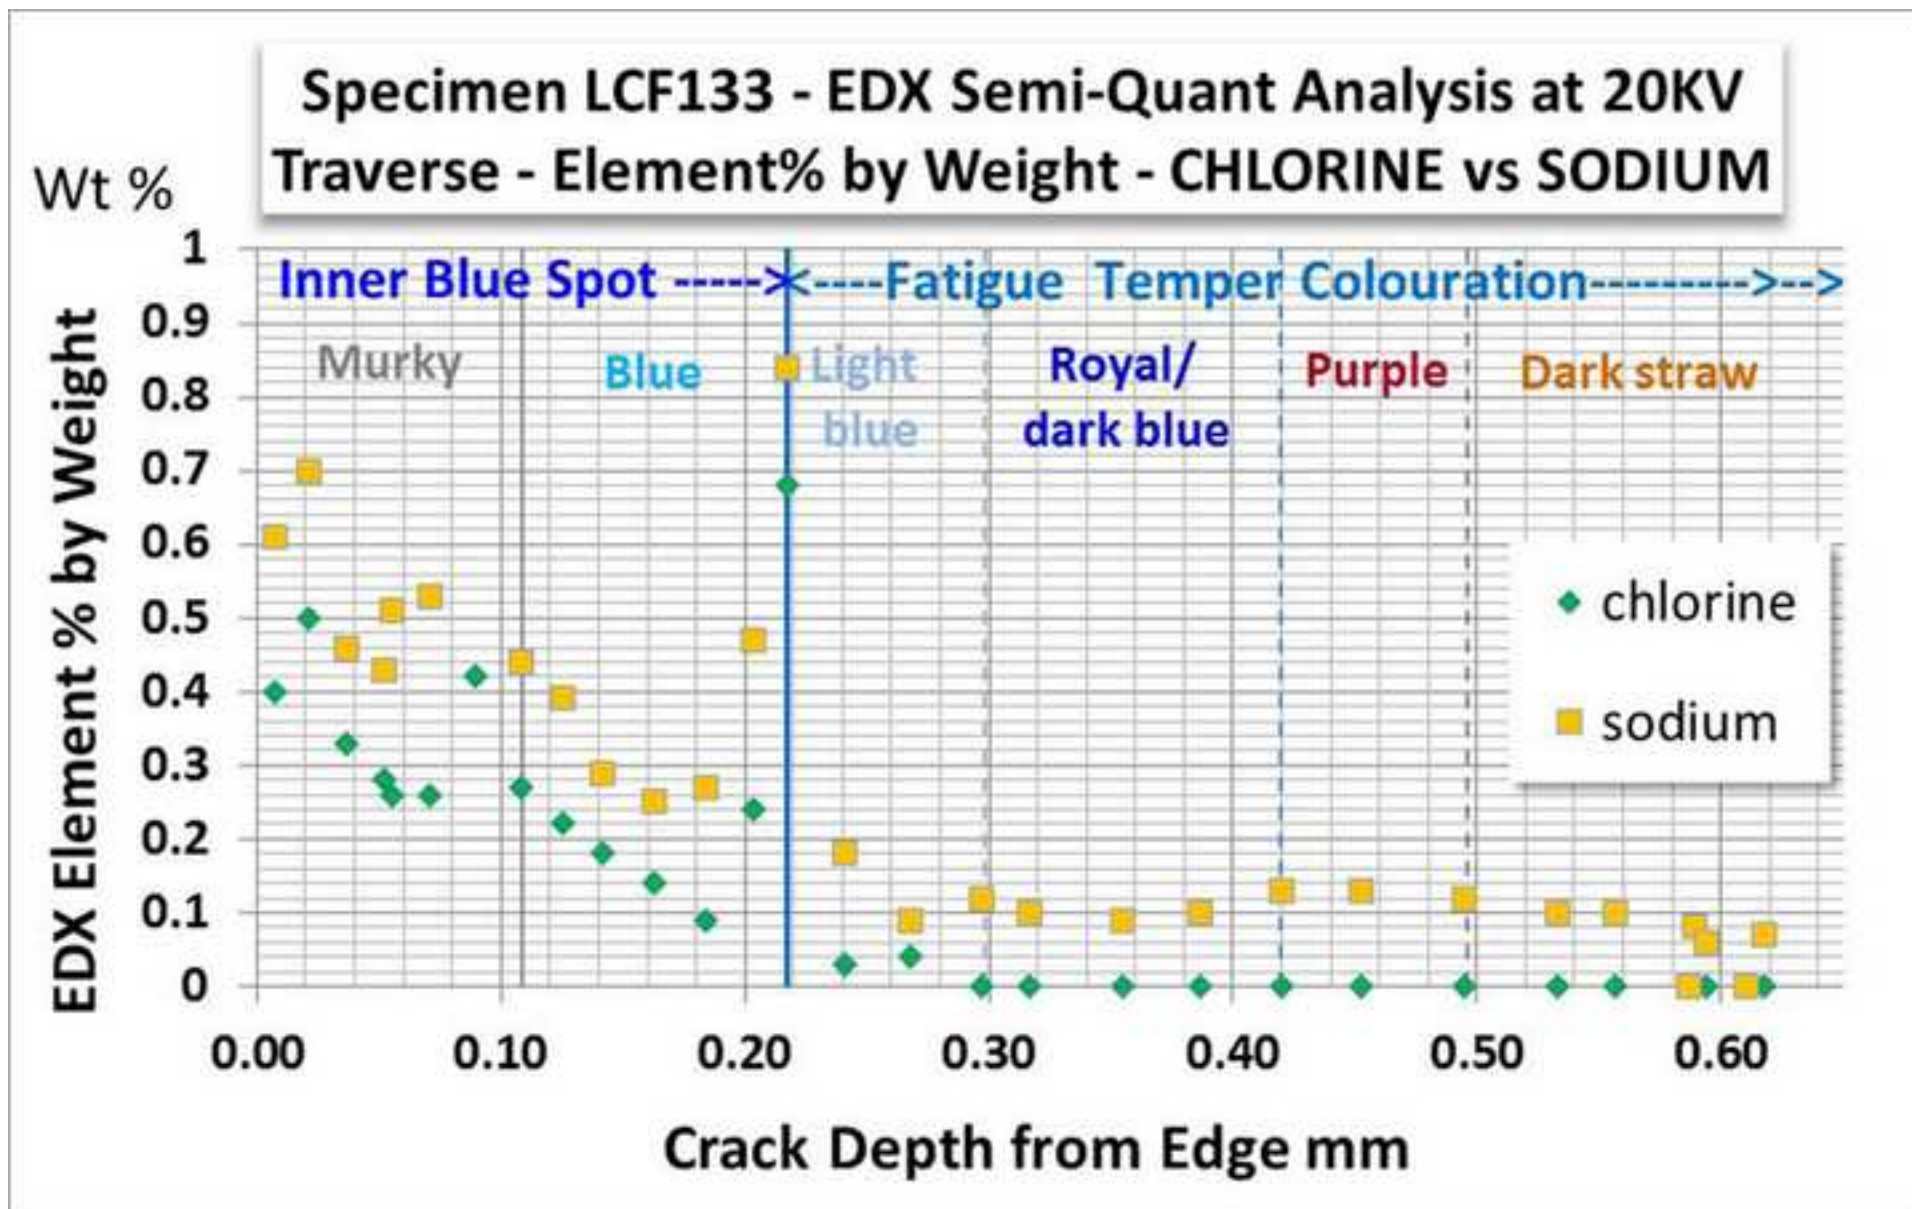
Similar analyses were performed on the known salt-contaminated LCF test specimen LCF133, with similar findings; figure 16. Mg, Ca and K were not identified in semi-quantitative EDX analysis of the blue spot fracture surface, for in that case NaCl had been applied in a purer form (not human perspiration derived).

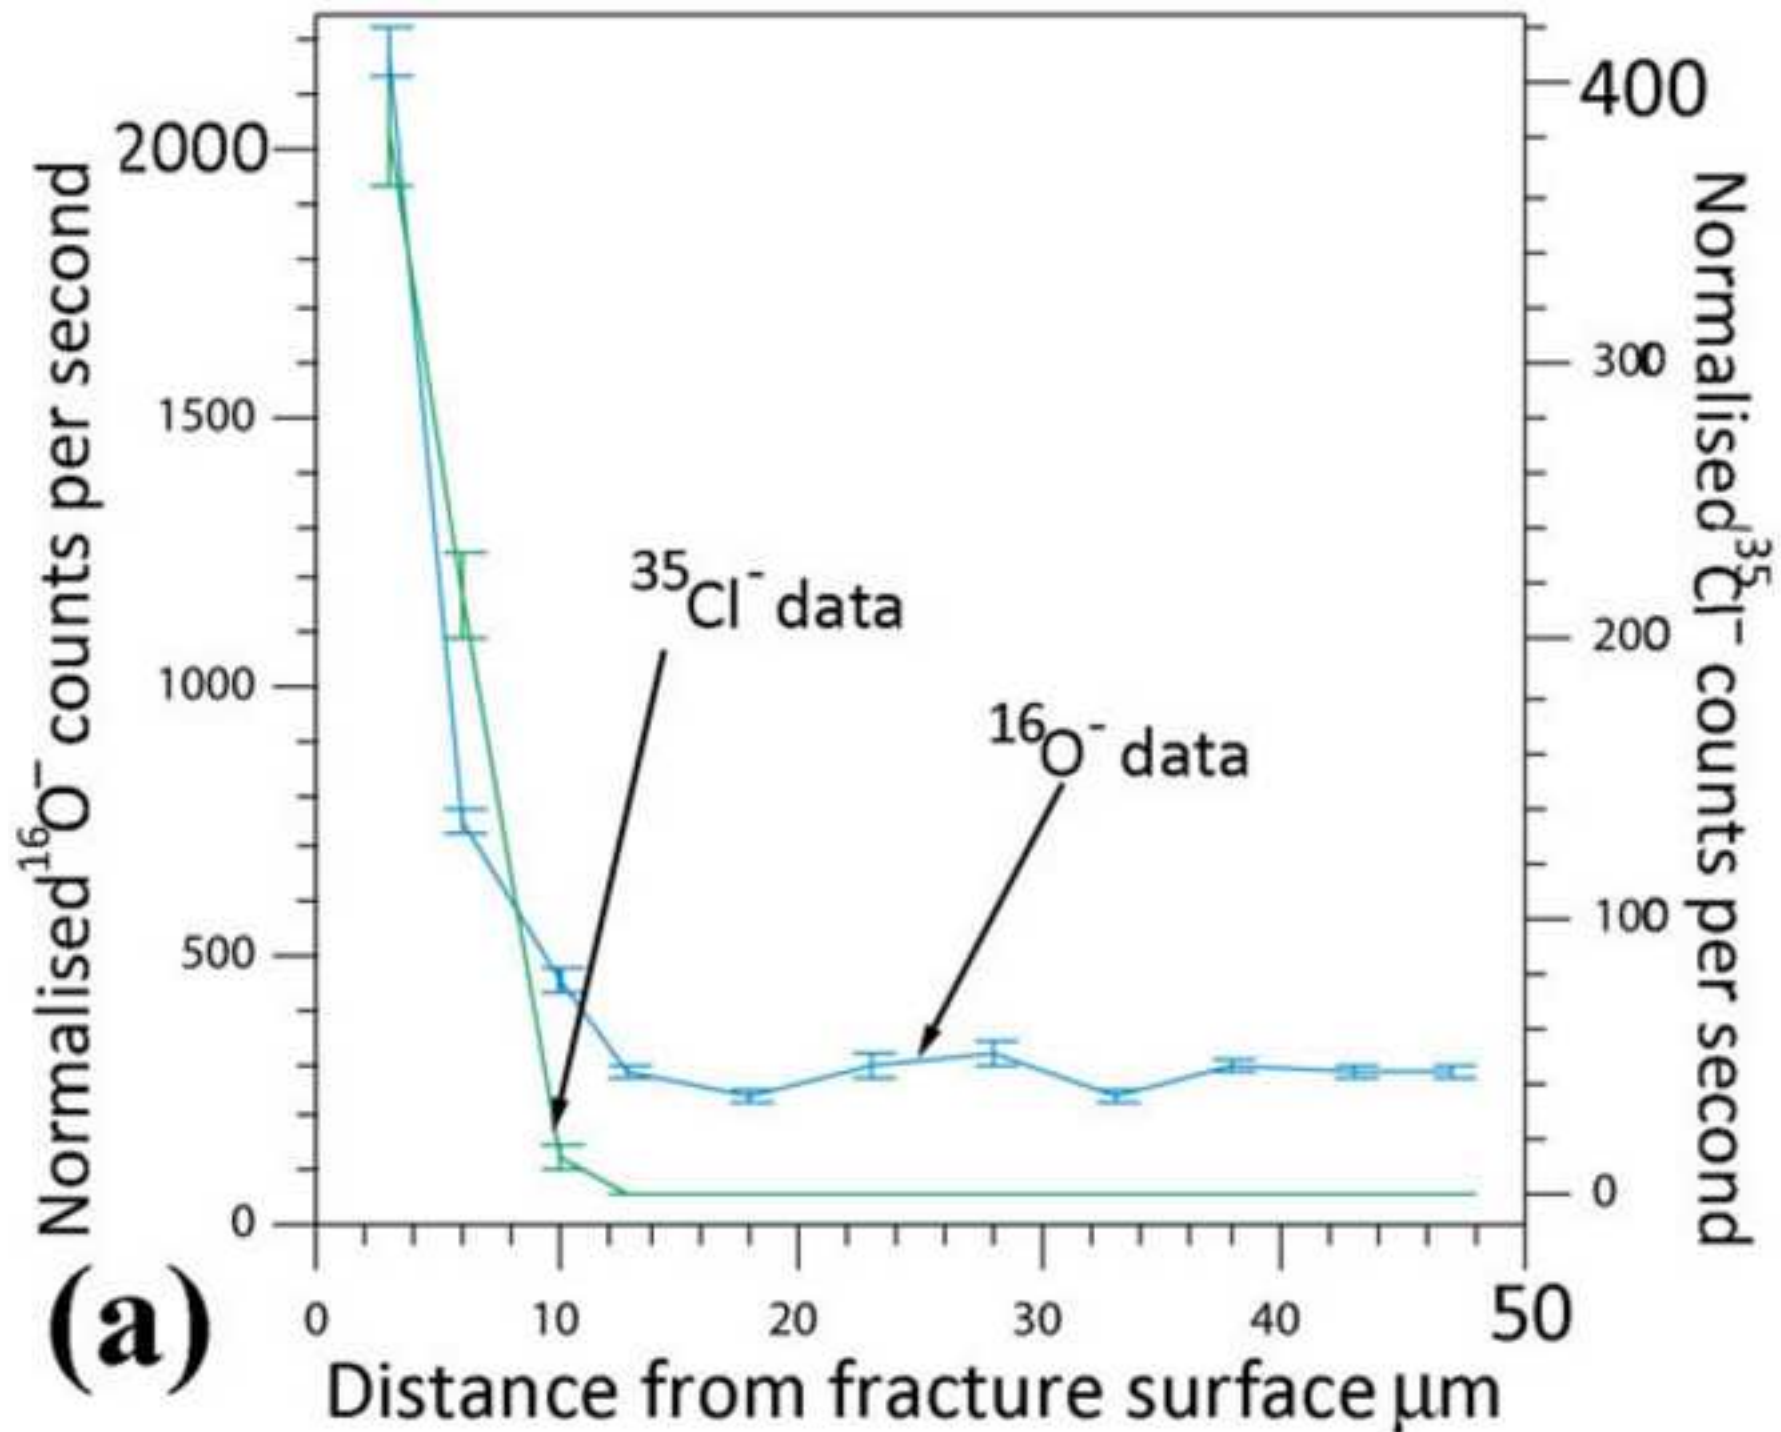
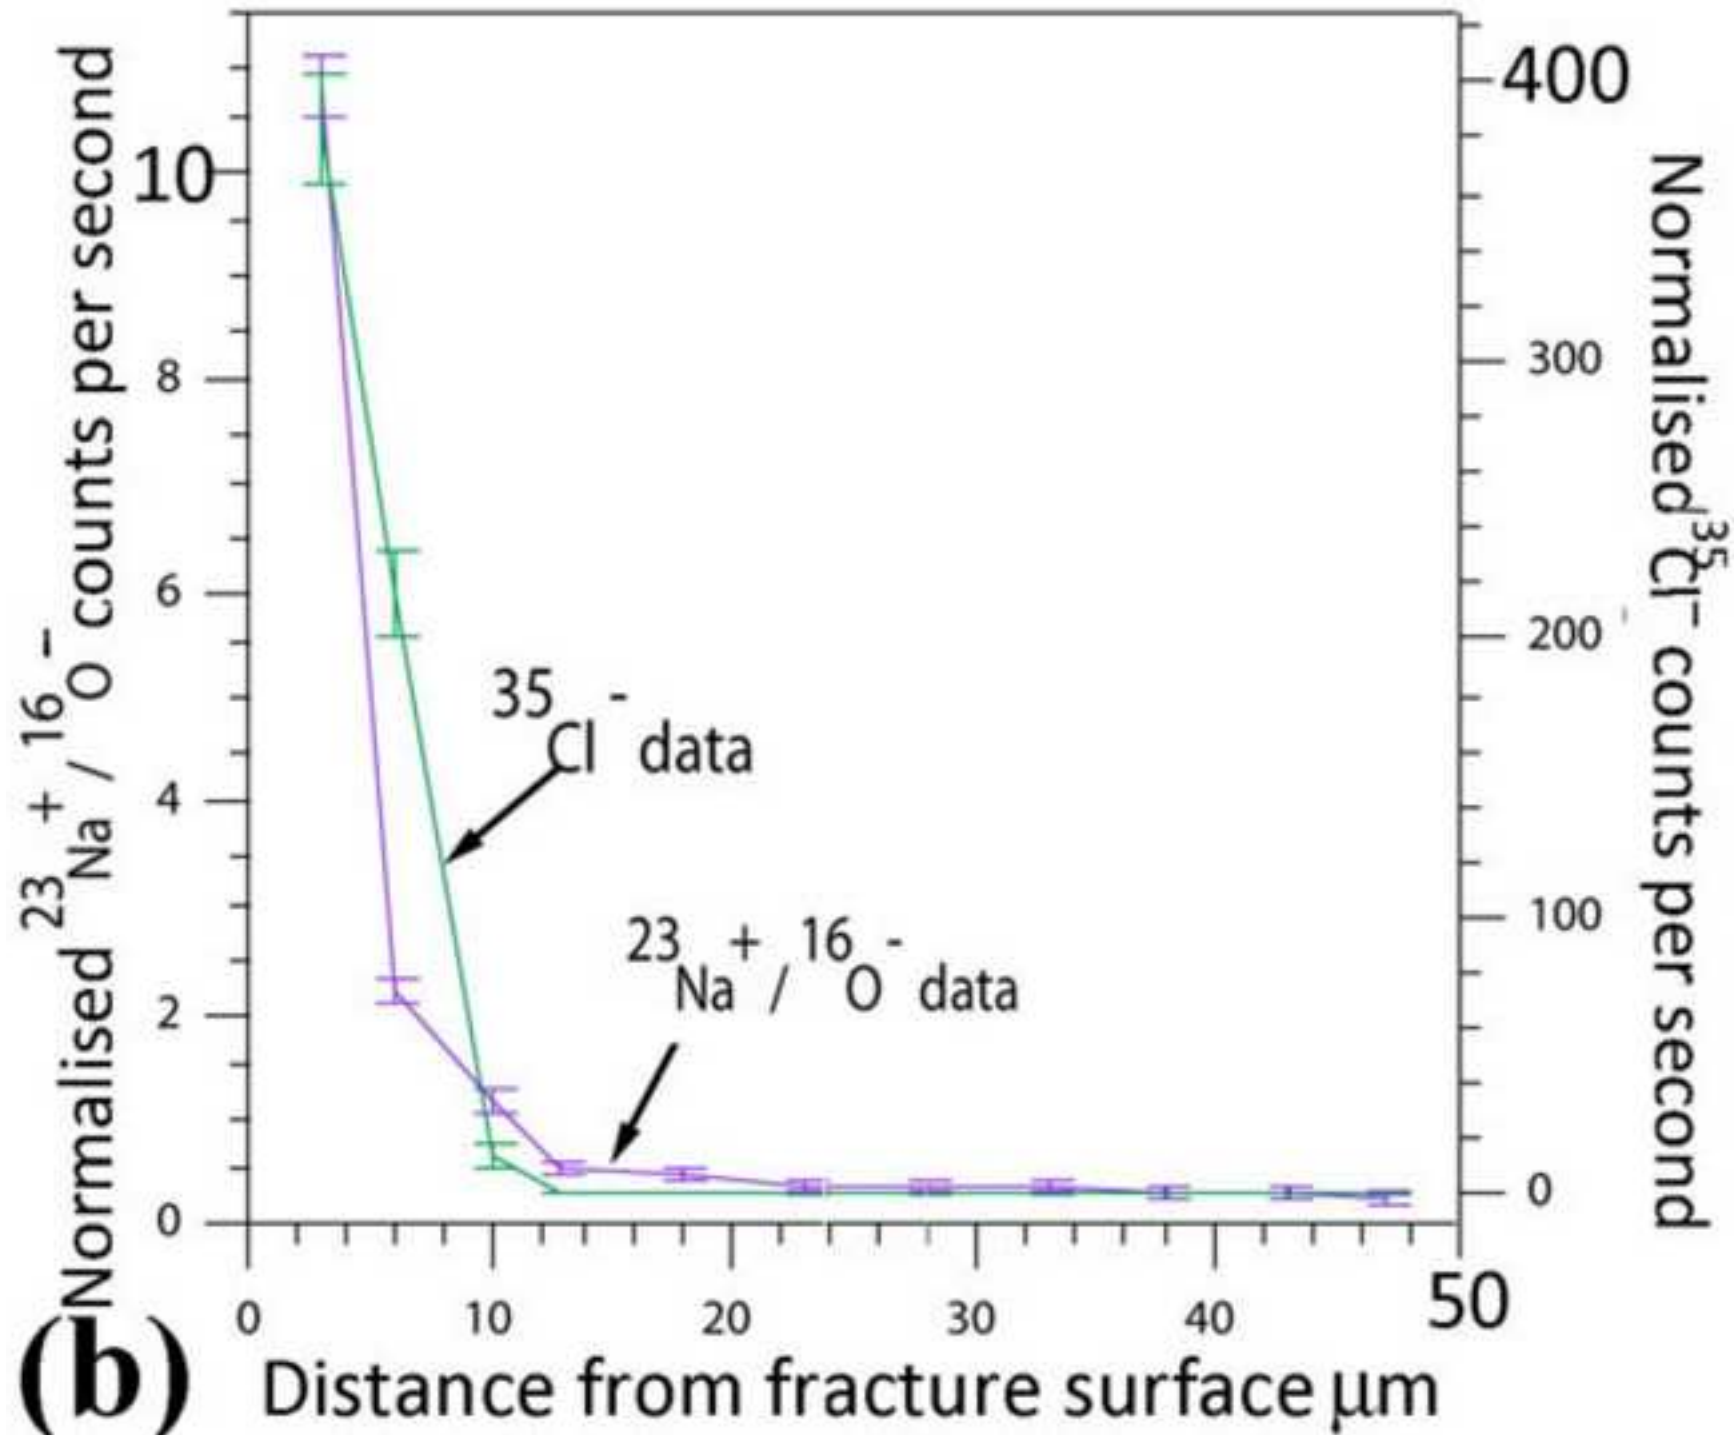
For ST1, LCF133 and other specimens [11], elevated  $^{16}\text{O}^-$ ,  $^{35}\text{Cl}^-$ , and  $^{23}\text{Na}^+$  ions were identified in the profiles close to the fracture surface within the side-face patches (figure 18), although not found for specimen ST2. The same procedure on the control specimen LCF127 did not identify any significantly elevated  $^{35}\text{Cl}^-$  or  $^{23}\text{Na}^+$  compared to the datum trenches.

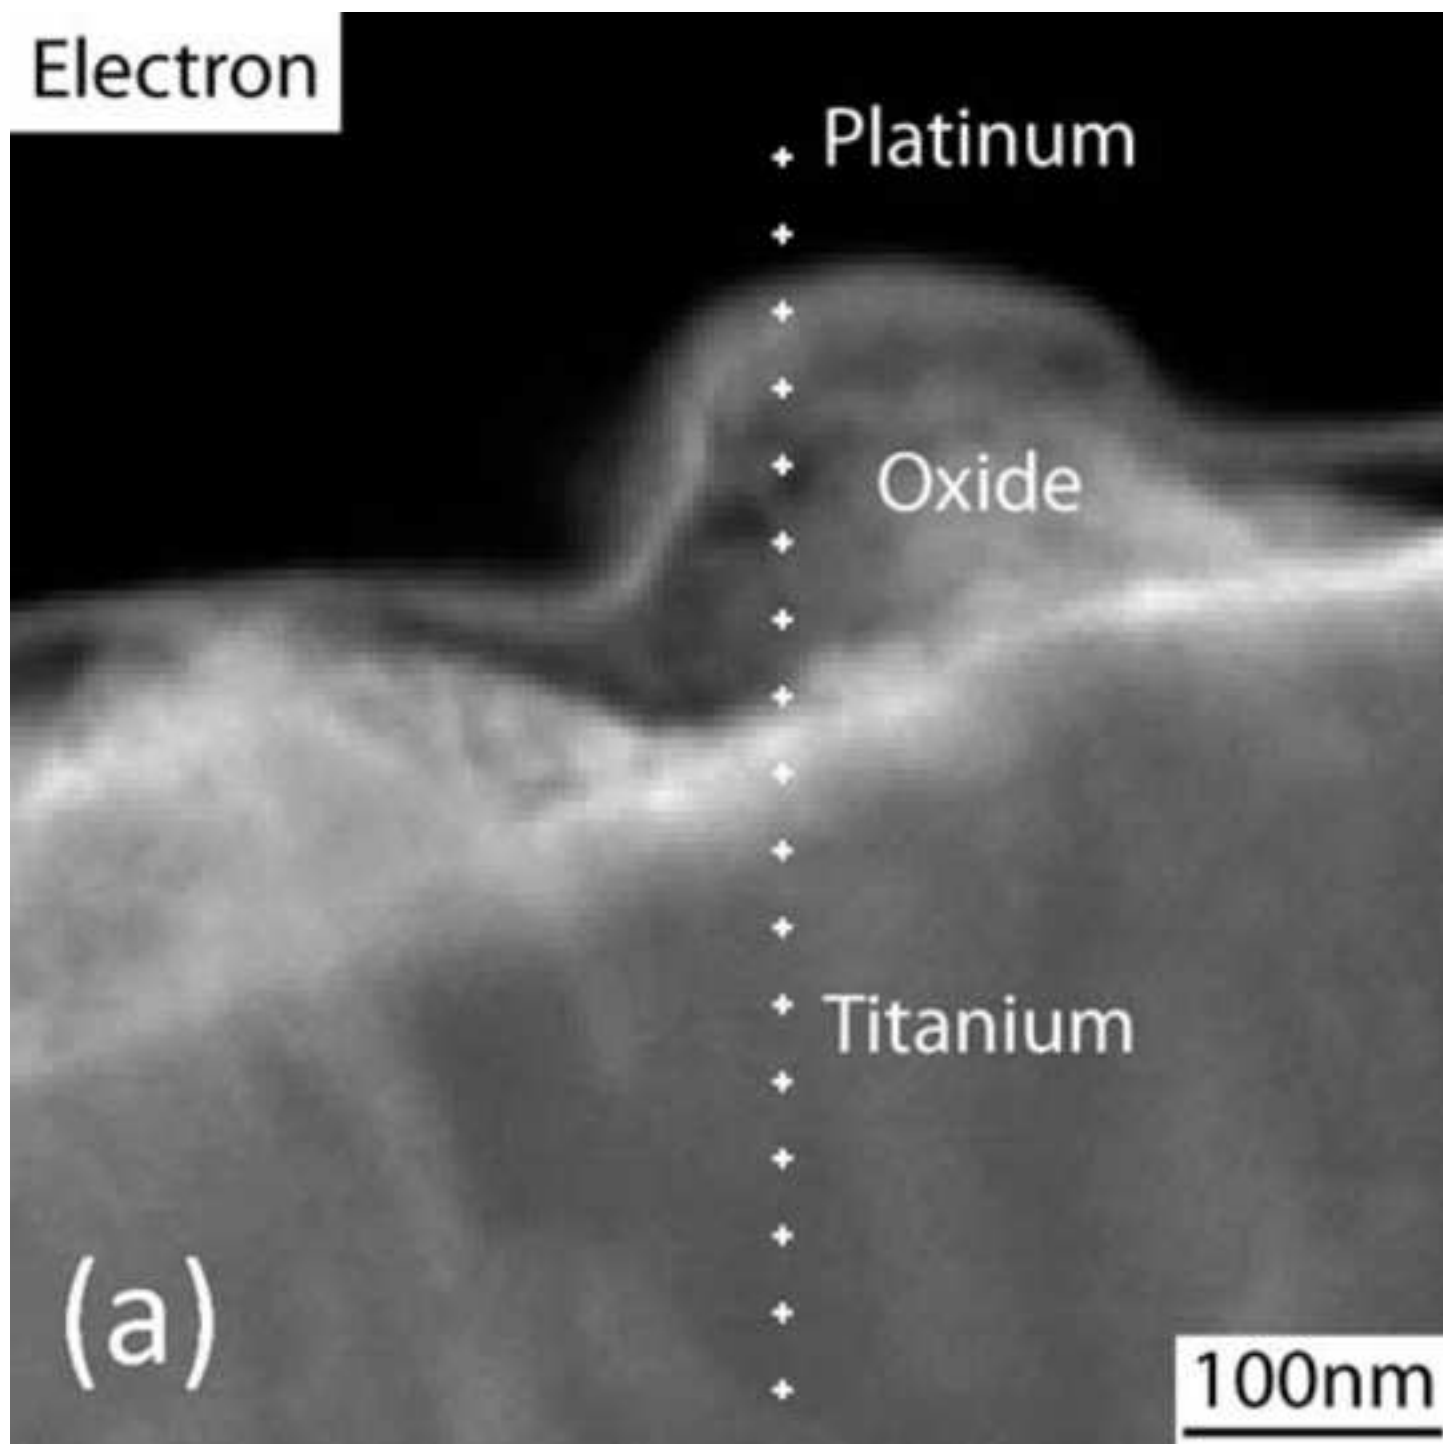
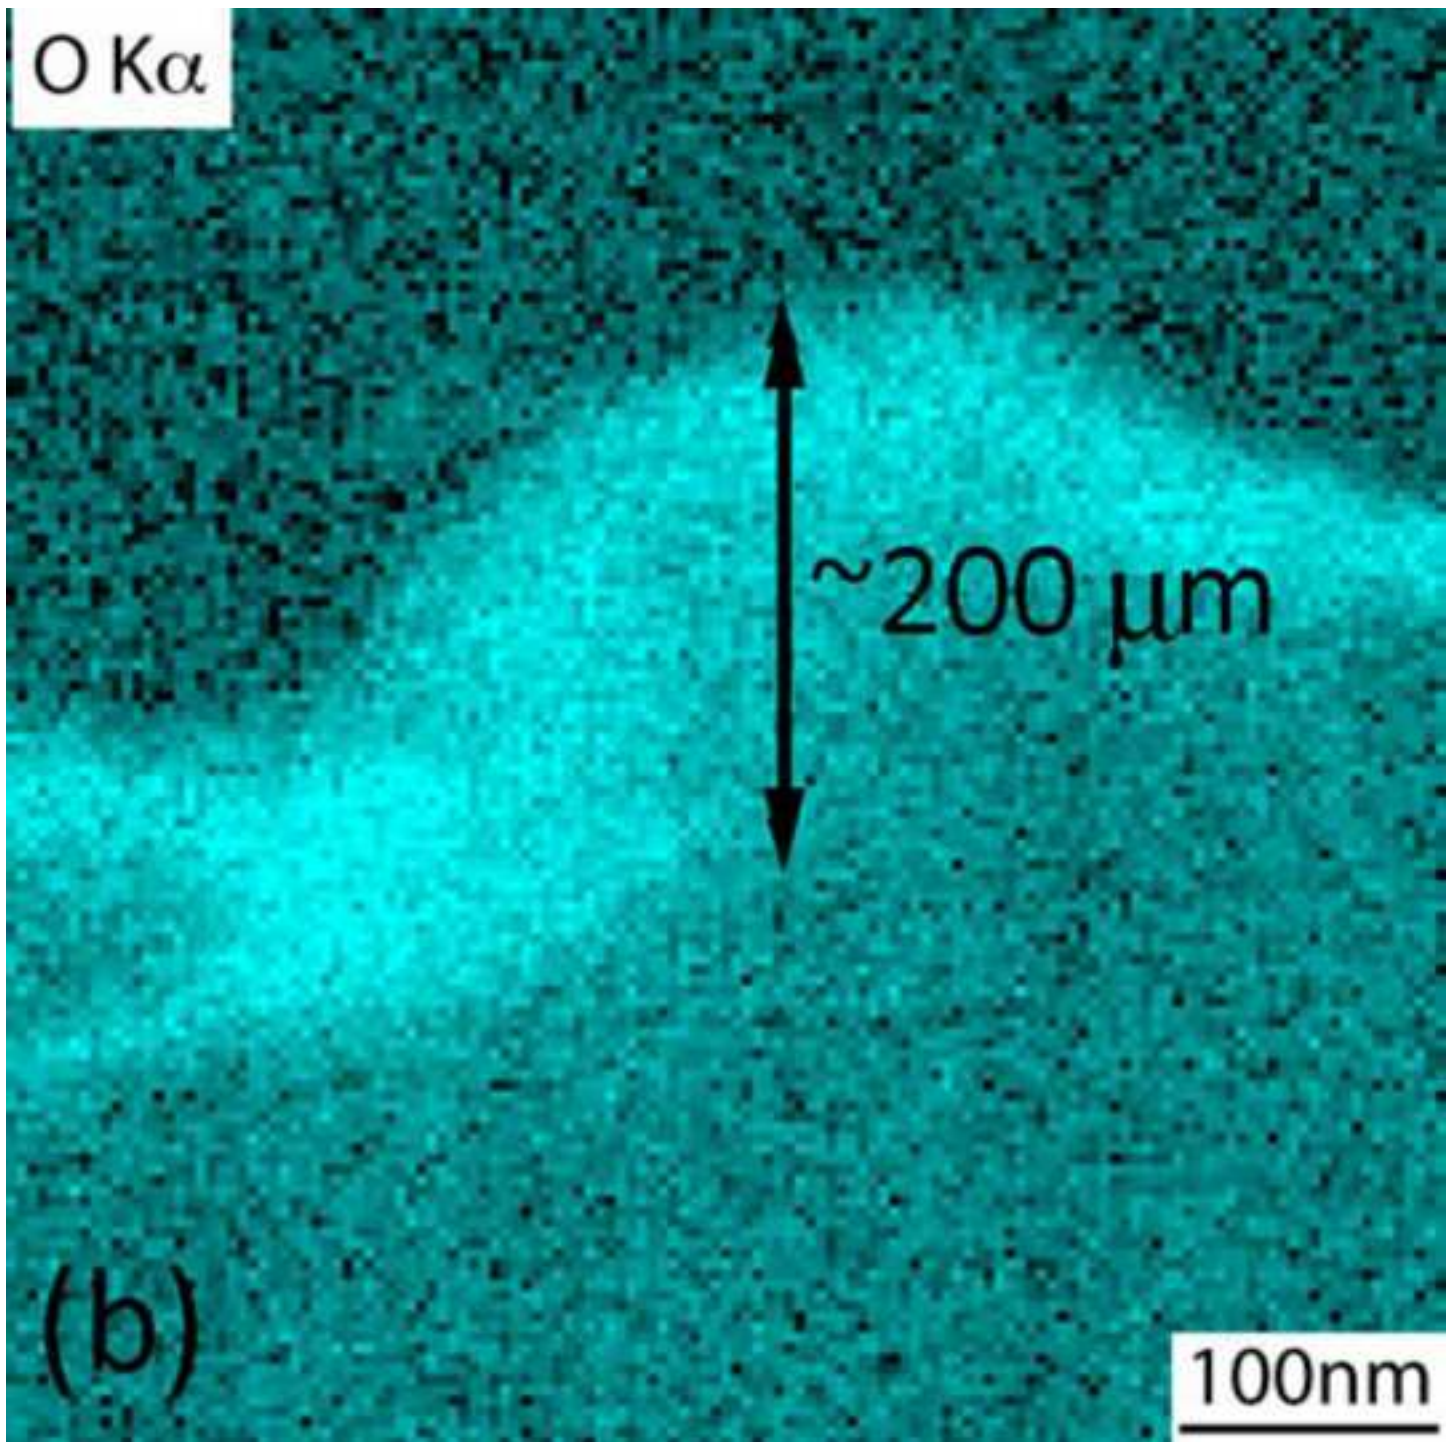
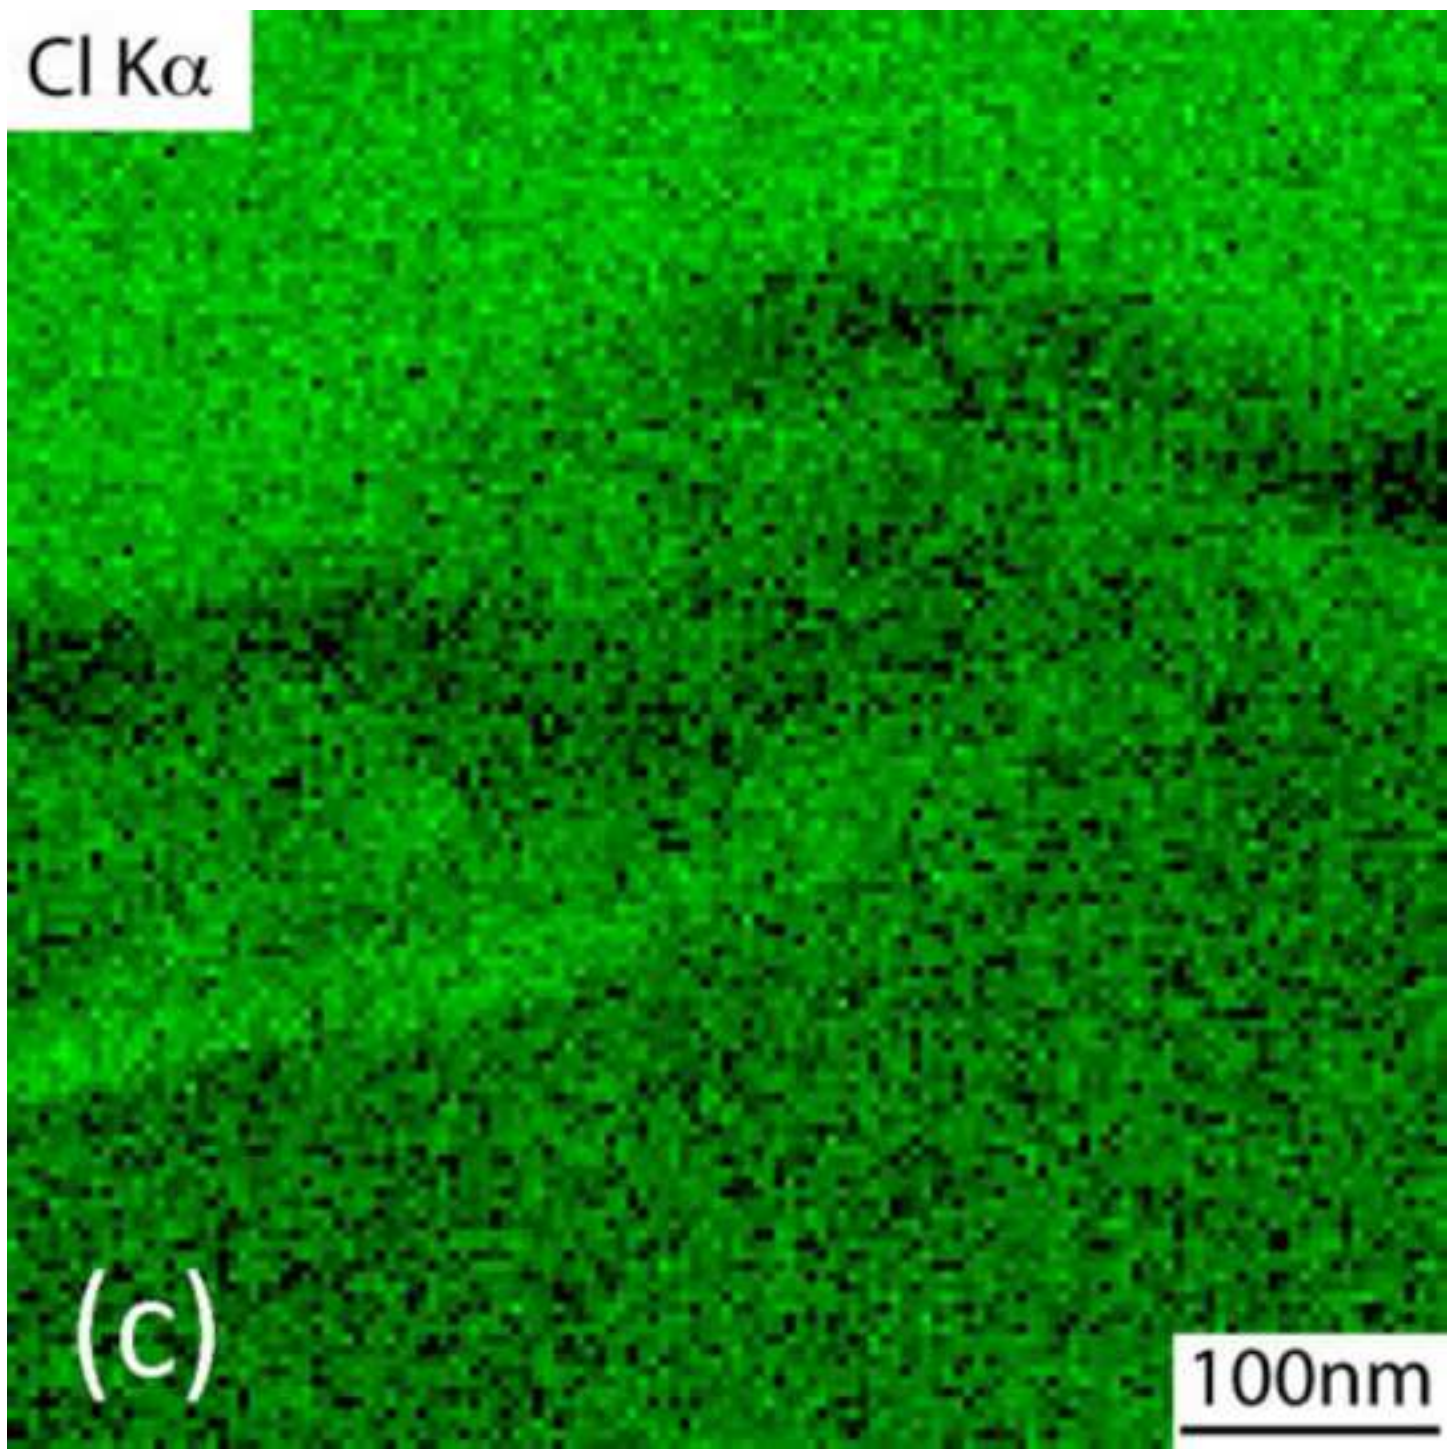
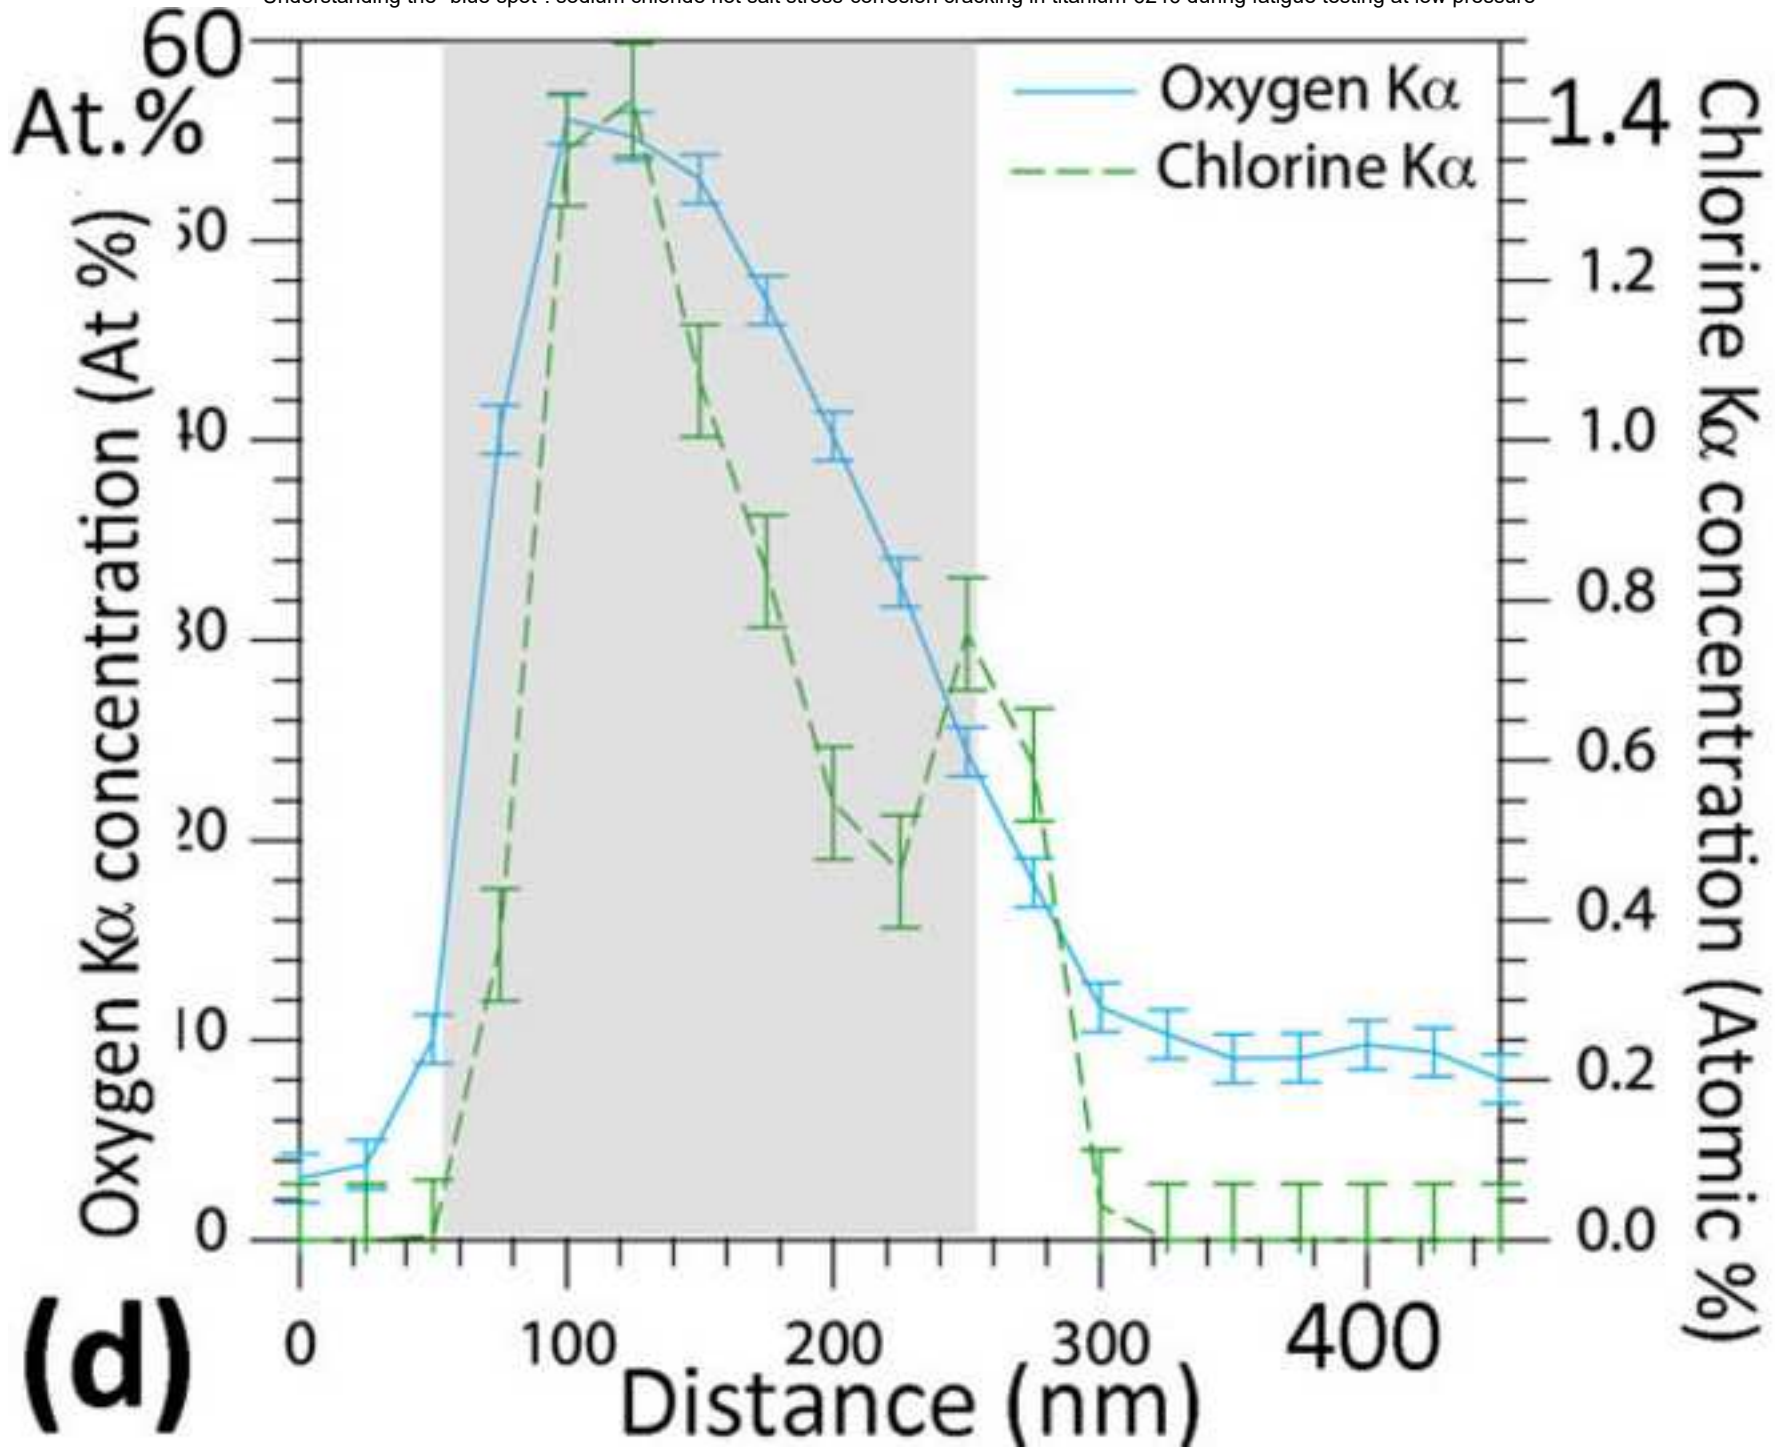
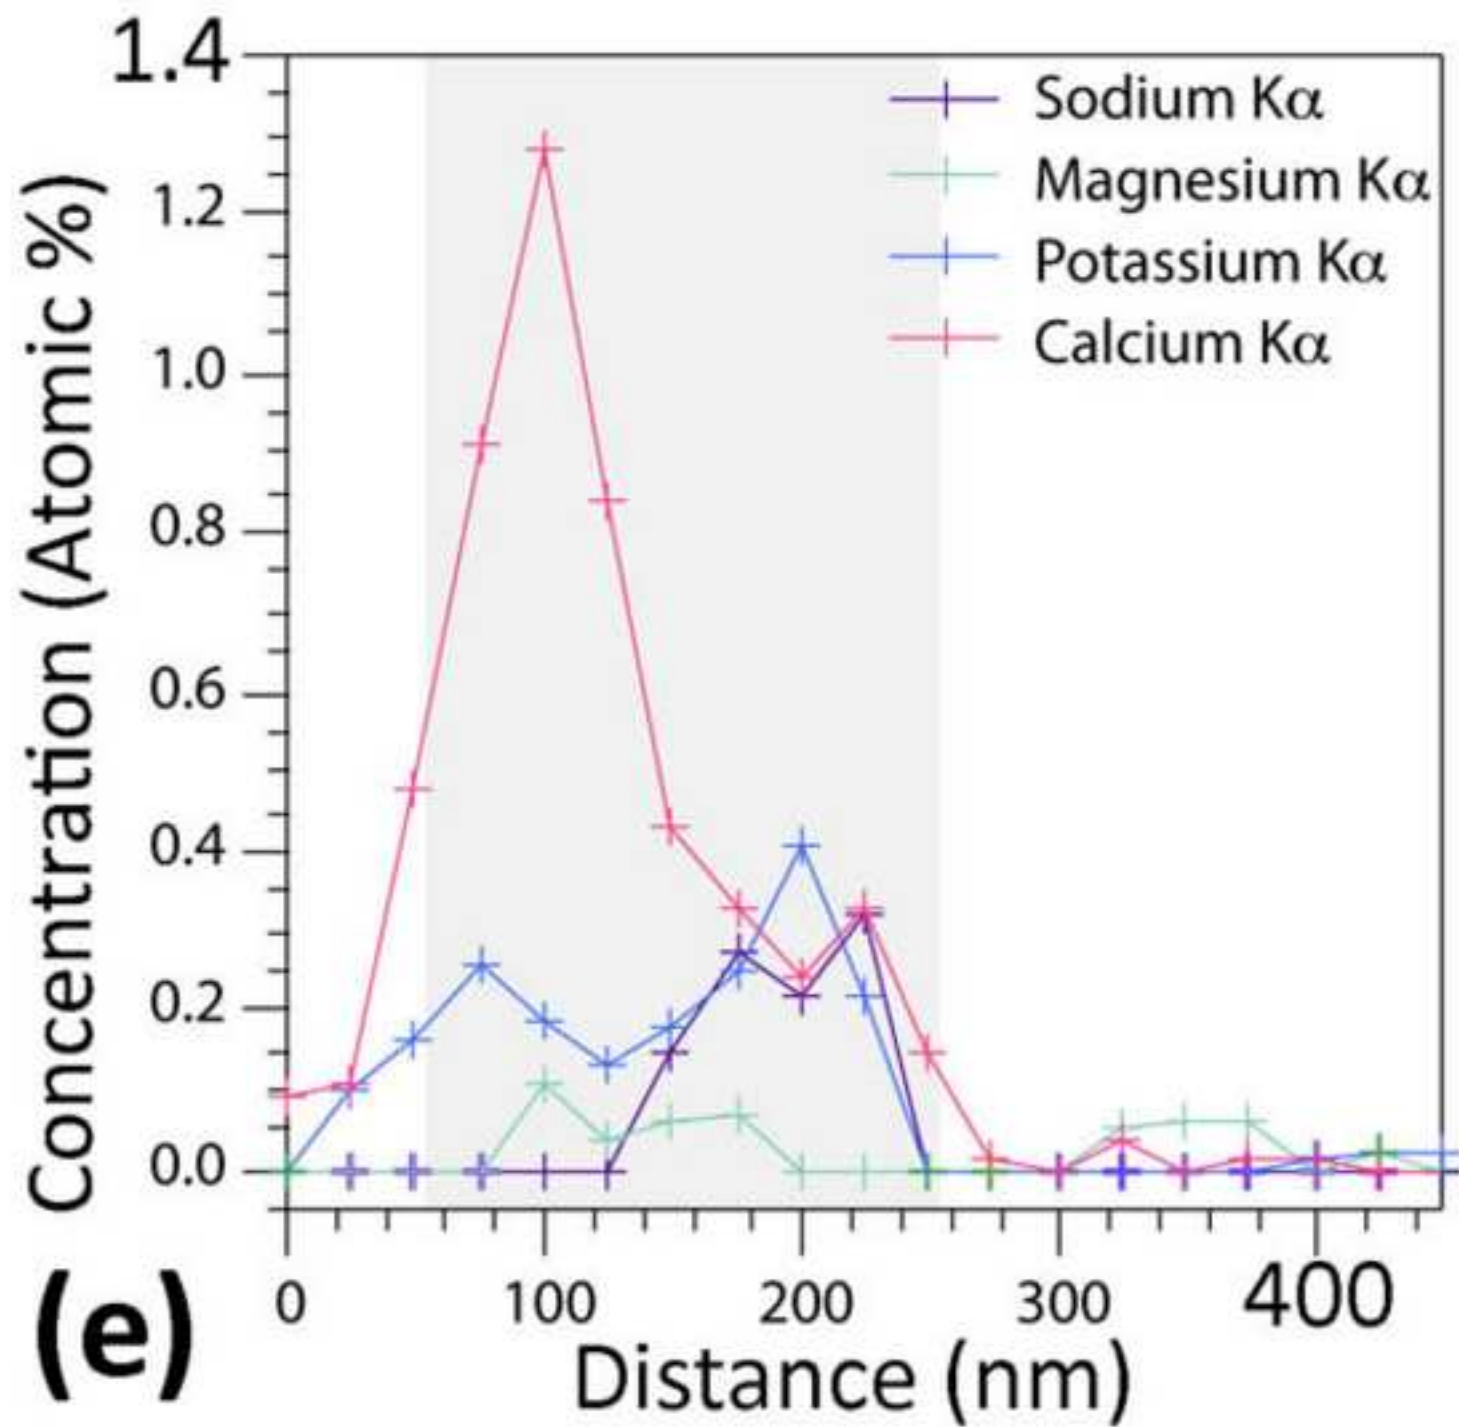
The EDX maps demonstrated the oxide film to have variant thickness but typically ~200nm (figure 20), occasionally dropping to ~50-100nm. Chlorine was partly intermingled and lying immediately beneath the oxide layer (figure 20), suggesting the Cl presence to be a result of a reaction process, not post-contamination. Line scans through the oxide into the parent microstructure confirmed elevated O, Cl, with traces of Ca, K and Mg (figure 20).
