# Risk Assessment of Fuel Quantity Indicator Replacement in ATR72 Aircraft

**R. M. Ardito Marretta\***

**J. A. "Drew" Bedson**

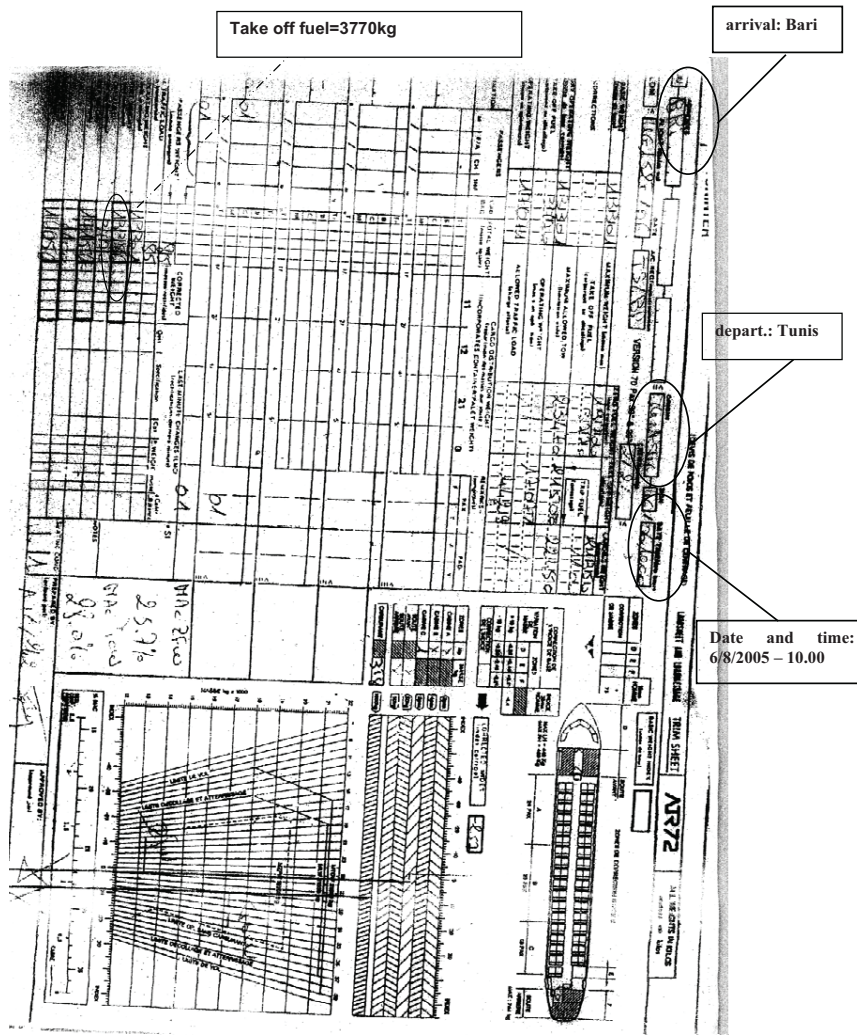
Fig. 4. Load sheet and trim for ATR 72 (flight Tunis-Bari)

The Load and Trim sheet for the flight from Tunis to Bari (Fig 4), the flight immediately preceding the accident flight, shows 3770 Kg of fuel aboard for the flight to Bari. Based upon the report of the ANSV, the aircraft had 2300 Kg aboard upon arrival. There is no indication whether the crew conducted a "reasonableness" test of the 1470 Kg fuel burn from Tunis to Bari, a flight of approximately 400 nm. Further, there is no indication whether there was any notice of the fact that if the aircraft just consumed 1470 Kg on a flight of approximately 400 nm and it would be reasonable to assume that it would use 50% more fuel for the 600nm flight to Djerba or approximately 2200Kg, slightly less than the indicated total fuel aboard the aircraft for the flight to Djerba.

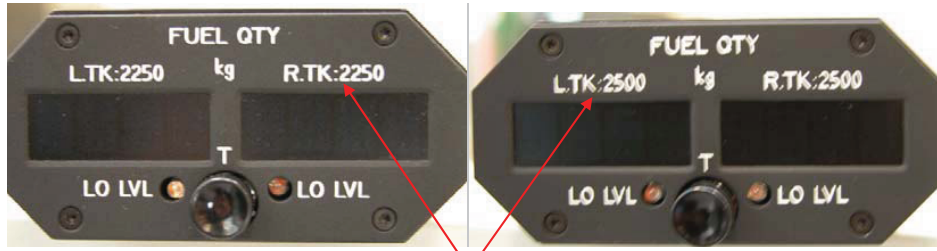
(a) ATR FQIs cartridges

Differences between the FQI for the ATR 42 and the ATR 72 can be found in the stampings on the faceplates of the FQIs in which the allowable fuel is indicated (Fig 6(a), Fig 6(b), Fig 6(c)) and on the cartridge labels in which the silkscreen of P/N and S/N are shown. The FQIs of the ATR 42 and the ATR 72 allow a universal modularity for each type of cockpit; moreover, the rear plunging connectors (S/N 1004 53T - 2B P, NAS 1599 TYPE 14 - 19 SW; S/N 1004 53T - 3B P) are interchangeable.

fuel max quantity per tank  
(difference evidence between ATR 42-left and  
ATR 72-right)

7. Develop a system to incorporate a highly visible labeling system for the case of the FQI indicating that the unit is appropriate for the ATR 42 only or the ATR 72 only. This system should be expanded to cover all ATR components where the possibility of installation in the wrong model of aircraft is possible.

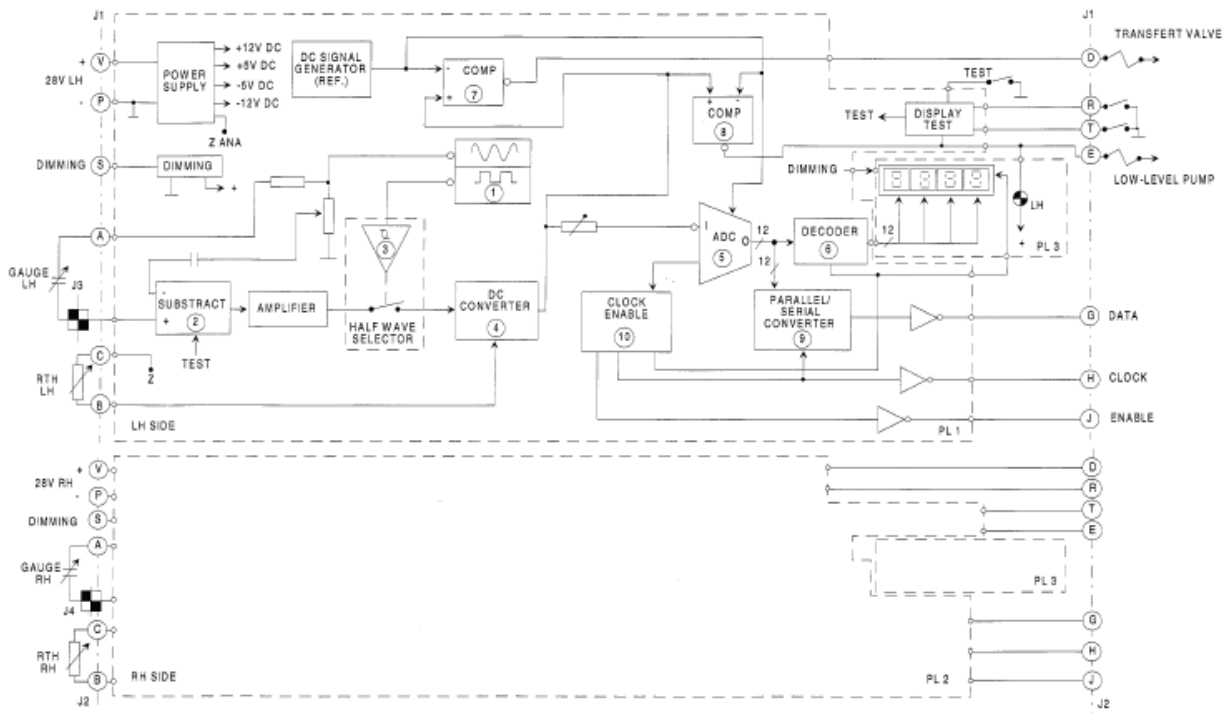
(b) FQIs block diagram for both ATR 42 and ATR 72

This is true of both the first and the second generation of FQI. Anyway, the FQIs of the ATR 42 and the ATR 72 show exterior and interior differences being the former the part/number (P/N) and serial/number (S/N) on the cartridge identification label and the hardware circuitual components the latter (the values of resistances R20, R21, R41 for the chain

of diodes MA1, MA2, MA4, MA5 as electronic components of FQI block diagram (Fig 6(b)). These differences are relative to non-ETOPS (Extended-range Twin-engine Operational Performance Standard) FQIs like those of the aircrafts under examination. The circuital differences are linked to the different input signals (and different electronic processing) arising from the tank probes having different capacitances for ATR 72 and ATR 42.

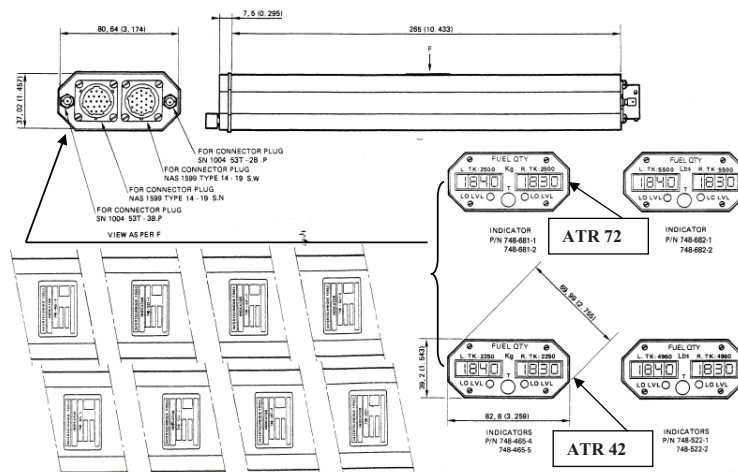
(c) ATR 42/72 fuel quantity indicator plug-ins ((note the same connection plug-ins!))

Close inspection of the FQIs appropriate to the ATR 42 and the ATR 72 show a similarity among their basic external architectures and the circuitual hardware ((Fig 6(a), Fig 6(b), Fig 6(c)).

The type set of the external labeling and the similar part numbers seem to be identical, (Fig 6(a), Fig 6(b), Fig 6(c) and Tables 3, 4).

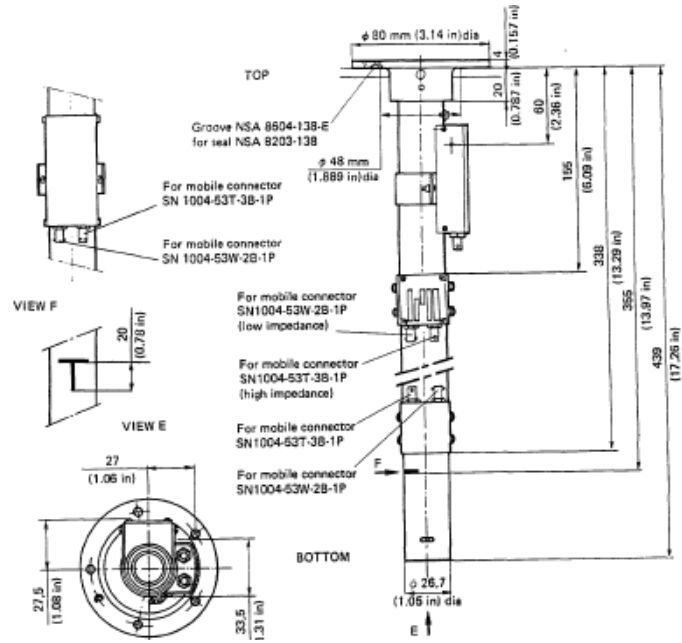
As noted in figures (Fig 7, Fig 8), the capacitance at the "empty" or minimum point varies significantly between the aircraft types (here only the first probes for both aircrafts are shown). Further, as noted previously, there is an additional probe in the ATR72. Following the line and components chain of Fig 9, one can note the signals from the probes to the FQI. This circuital architecture undergoes slight differences when the independent low-level "warning-lights" signal has to be provided for ETOPS configuration of aircraft (see Fig 10).

Fig. 7. Fuel probe no1 ATR42 798038 empty capacitance 6,4pF

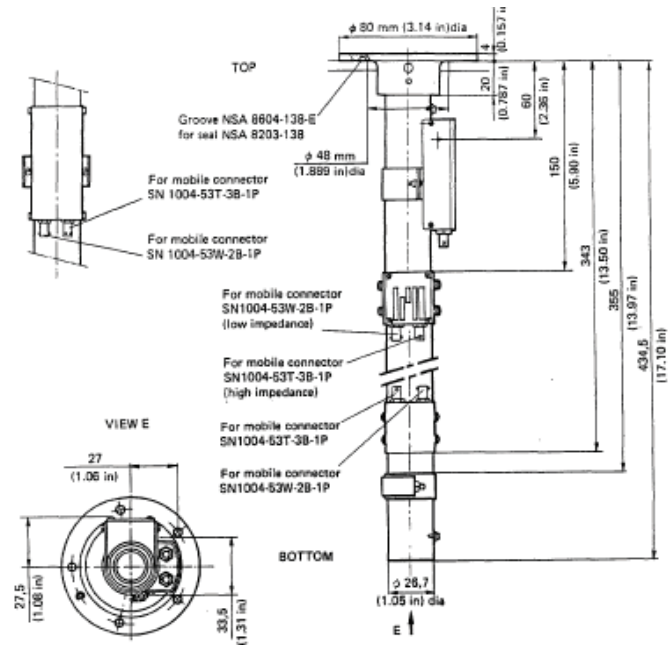
**Fig. 8.** Fuel probe no1 ATR72 766983-1 empty capacitance 8,55pF (with low-level sensor)

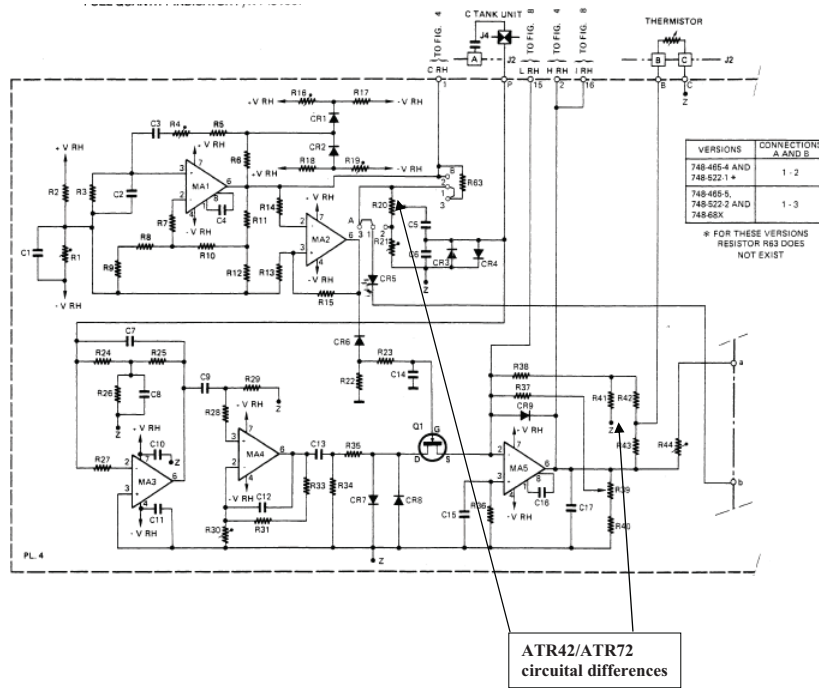
When evaluating the empty tank capacitance of the FQI system circuits of the ATR 42 vice the ATR 72 there are noticeable differences whether ETOPS or non-ETOPS (Fig 9, Fig 10). As previously mentioned, these figures sketch the circuital design for non ETOPS and ETOPS FQIs architectures. In non ETOPS FQI (both for ATR42 and 72) the low level electrical signal is running in serial bus with the output tank probes capacitance signals (dependent low-level scheme). In the ETOPS FQI different data bus is processed in parallel and it is not directly dependent on the output tank probes signals. Anyway, this paper deals with the FQIs of ATR42 and 72 of the first type only. When the system capacitance for the FQI system of the ATR 42 and the ATR 72 are summed at the FQI there are significant differences as noted in Fig 11. The data in Fig 11 make a compelling argument for directly evaluating the effect of ATR 72 FQI probe set capacitance when mated with an ATR 42 FQI.

**Fig. 9.** Non ETOPS FQIs: circuitual-probes differences between ATR 42 and ATR 72 (different hardware circuitual components are present (the values of resistances R20, R21, R41 for the chain of diodes MA1, MA2, MA4, MA5))

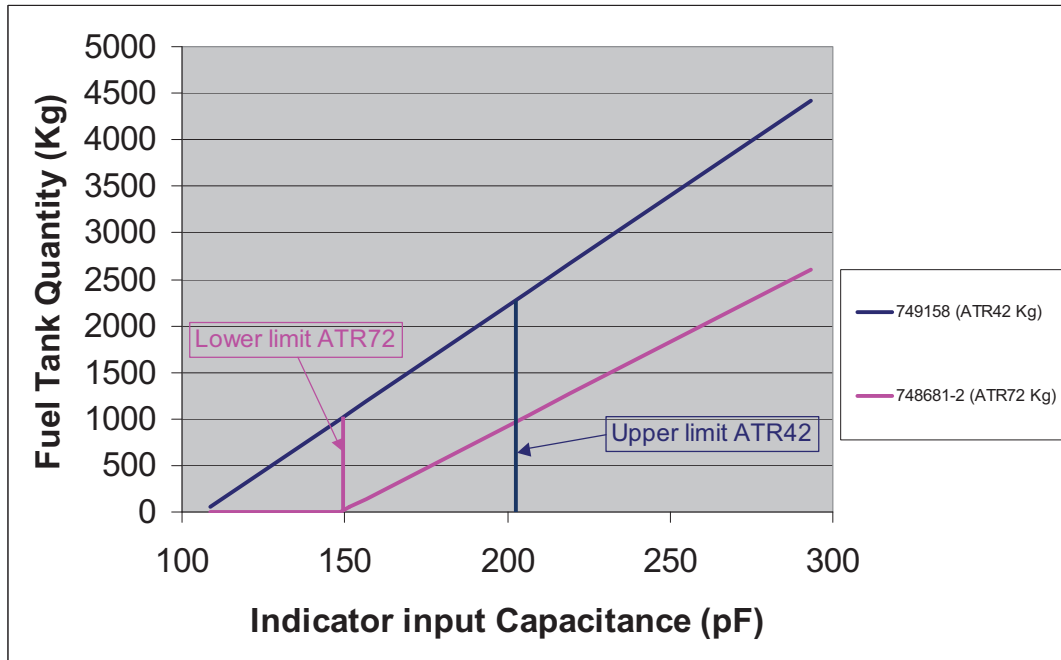
**Fig. 11.** Comparison diagram (fuel vs capacitance) between FQI P/N 748681-2 (ATR 72) and P/N 749158 (ATR 42)

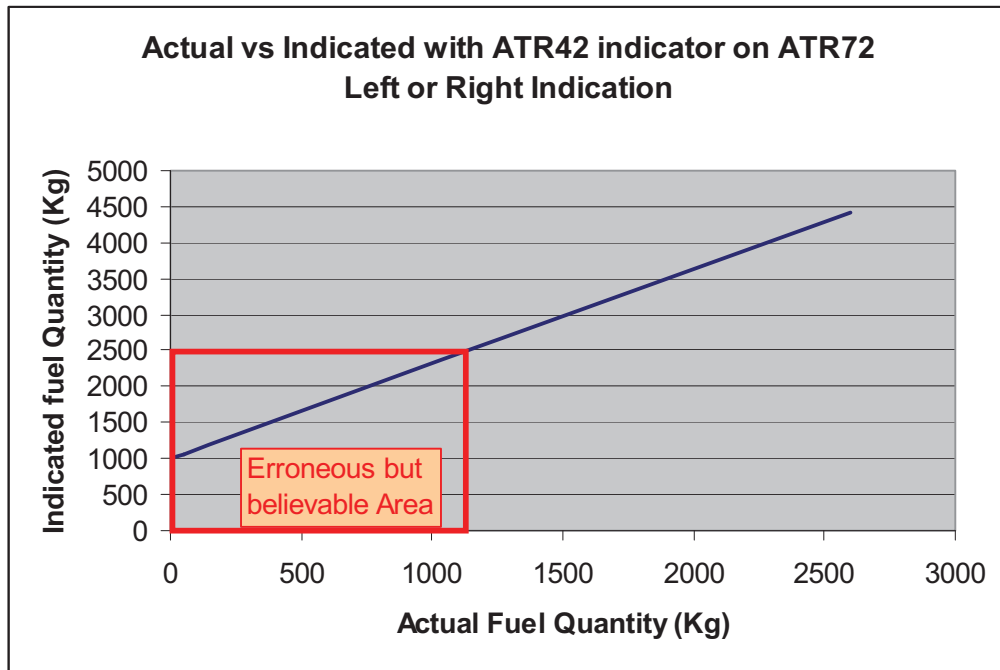
(FQI 749158 of ATR 42) was the total capacitance arising from the fuel probe-set of the ATR 72. From the given partial capacitances, one obtains the total capacitance be equal to 144.7pF with (real/virtual zero quantity of fuel on board). When this value of capacitance (for ATR 72) was processed by the test-bench into the FQI (ATR 42), the FQI indicated a fuel quantity of 910Kg and 890Kg (910Kg and 890Kg of fictitious fuel in the left and right tanks, respectively). Following the same procedure, the range of capacitance values (from empty to full tank configurations) the "mismatching FQI" law was obtained and is shown in Fig 13.

**Fig. 13.** Effect of incorrect replacement between FQI 749158 (ATR 42) and FQI 748681-2 (ATR 72): fictitious fuel quantity vs real fuel quantity (for each tank)
