## The combined use of PSInSAR and UAV photogrammetry techniques for the analysis of the kinematics of a coastal landslide affecting an urban area (SE Spain)

**Abstract** In the present work, the case of the Cármenes del Mar resort (Granada, Spain) is shown. It can be considered one of the most extreme examples on the Mediterranean coast of severe pathologies associated with urban development on coastal landslides. The resort, with 416 dwellings, was partially built on a deep-seated landslide which affects a soft formation composed of dark graphite schists. In November 2015, the City Council officially declared a state of emergency in the resort and 24 dwellings have already been evacuated. We have used two remote sensing techniques to monitor the landslide with the aim of identifying and measuring a wide range of displacements rates (from mm/year to m/year): (1) PSInSAR, exploiting 25 ENVISAT SAR images acquired from May 2003 to December 2009, and (2) photogrammetry, considering the output from two Unmanned Aerial Vehicle (UAV) flights made in June 2015 and January 2016 and the outdated photos from a conventional flight in 2008. The relationship between the geology of the site, d

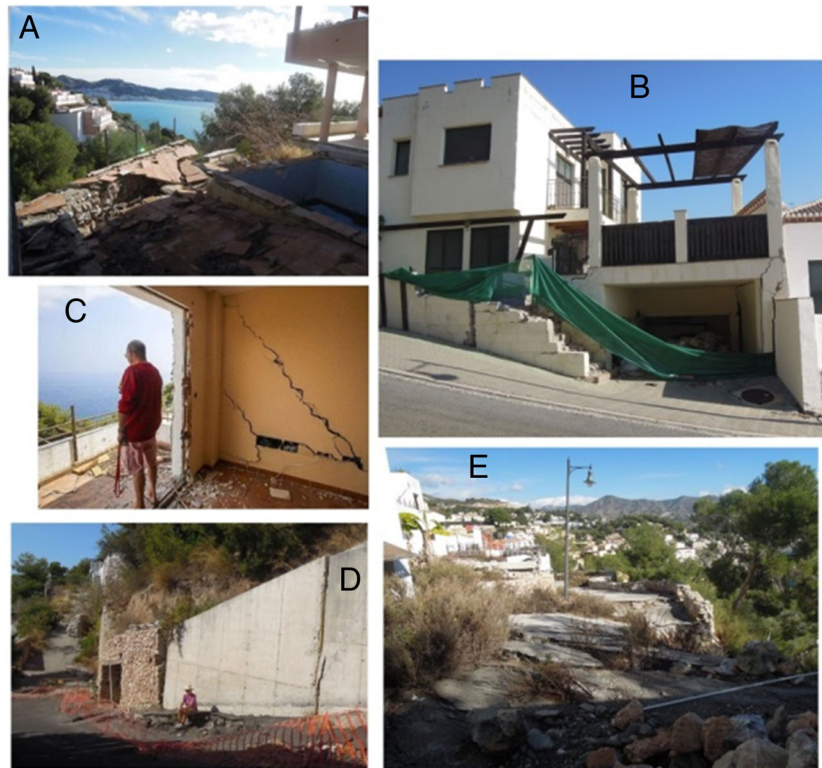
**Fig. 5** Photos of damage. **a** Garden area of a house located in the NE extreme of Calaiza; **b** house in Pueblo with very severe damage; **c** detail of the interior of a house in Pueblo; **d** access road and retaining wall in Atarazanas; **e** access road in the Especiales site

During the rainy winter of 2009–2010, there was a notable increase in the damage (Rodríguez-Ortiz 2011) which spread to other parts of the resort: the Pueblo, Atarazanas and Calaiza developments, where some homes had to be evacuated as well as in the *Especiales* development. The deterioration of the resort has worsened during the past 5 years and specifically during the later rainy winter 2012–2013: numerous dwellings require partial or complete rebuilding and new cracks have appeared in the access roads and retaining walls. In November 2015, the City Council officially declared a state of emergency in the area and a total of 24 dwellings have been evacuated. Great social alarm has been caused in the neighbourhoods as the evacuation is planned to be extended to 40 more dwellings in the coming months. Figure 5 shows some recently taken photos of the most damaged areas.

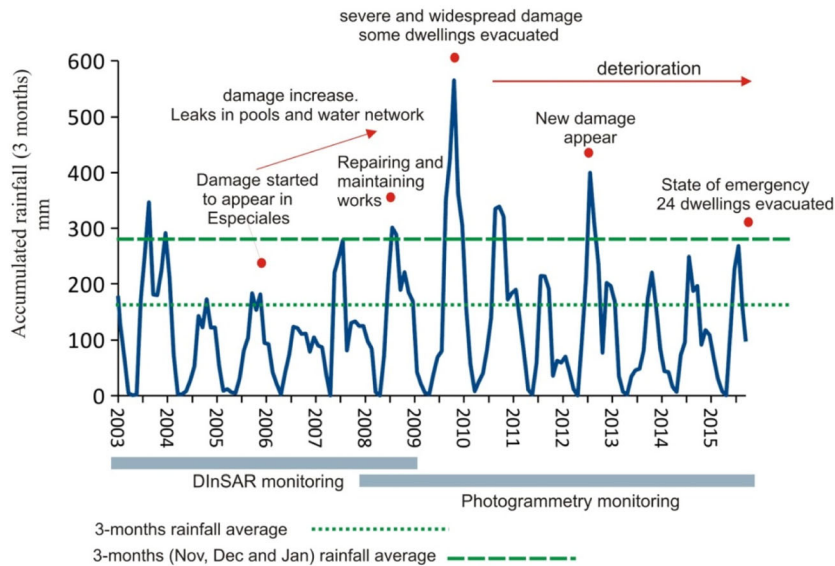
Damage history in the resort seems to show a clear relationship between the most damaging events and water recharge episodes (rainy events and leaks from swimming pools and the water supply network). To prove this temporal connection, monthly rainfall data has been recorded by the nearest weather station (Cuevas de NerjaES77, AEMET-Spanish Meteorological Agency) for the period spanning from January 2003 to January 2016. Figure 6 represents the accumulated rainfall (3 months) for this period and the history of damage. We have considered the 3-month accumulated rainfall period as the rainy months in the region are November, December and January, and thus, we can represent their influence better. Figure 6 shows that 2009–2010 winter was extremely rainy in the region, when accumulated rainfall was almost twice the average value. The most severe and spreading damage was reported at this time, as also happened in the Marina del Este resort (Notti et al. 2015). Later, during the rainy winter 2012–2013, new damage appeared which led to the progressive deterioration of the resort until the current state of emergency.

**Fig. 6** Three-month accumulated rainfall for the period January 2003–January 2016 and the temporal representation of the main damage events. Two rainy winters (2009–2010 and 2012–2013) occurred and severe and new damage appeared. The monitoring periods have also been indicated

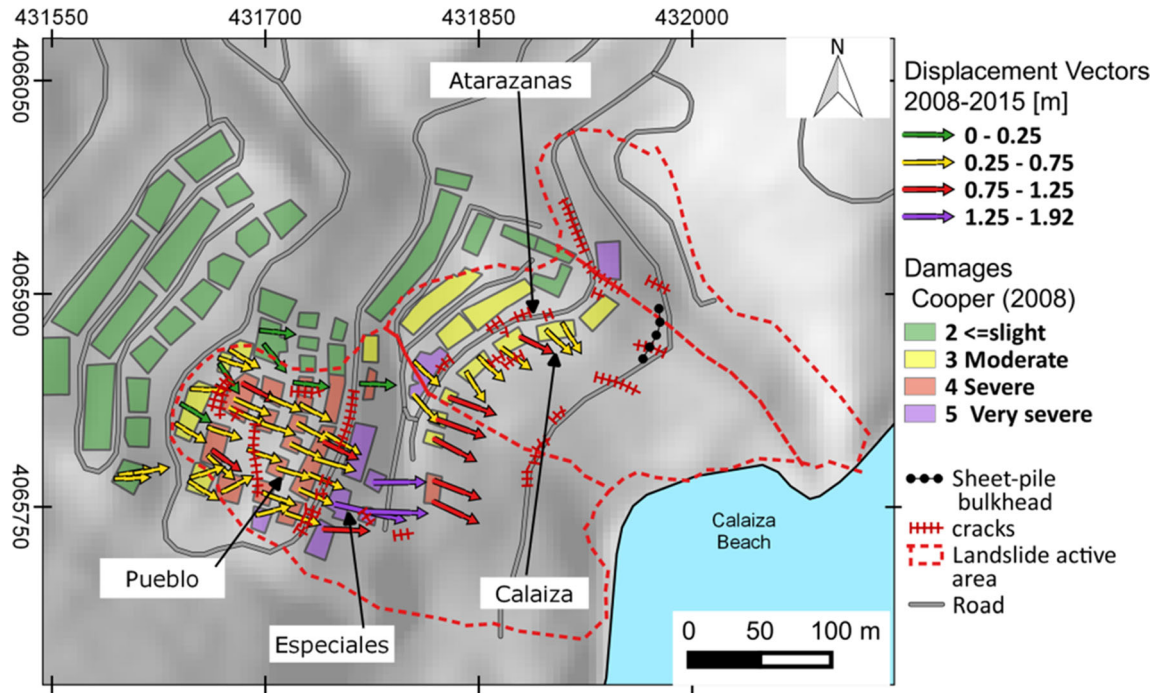
**Fig. 10** Displacement vectors of the buildings for the period spanning 2008–2015 superimposed onto the damage inventory map. A general NW-SE direction of the movement can be observed, each vector allows the landslide flanks as well as the previously defined lobes, to be defined with accuracy. The southwestern sector of the resort is the most active and is where major building displacements (up to 1.92 m in 8 years) and the most severe damage have been detected

In general, the flanks and toe areas of the original landslide are the most damaged, and are where higher displacement rates have been observed (Fig. 10). Ephemeral streams are located along the flanks of the landslide and fluvial erosion contributes to the instability of these areas. Additionally, marine erosion tends to steepen the front of the active toe, this area being one of the most rapidly evolving places in the landslide, where numerous cracks and shallow failures have appeared and where the highest values of  $V_{slope}$  have been detected. The push exerted by the material advancing from behind produces significant deformations and changes in the morphology of this sector and can explain the high displacement values (0.75–1.5 m) obtained in the southern sector of Calaiza (Fig. 10). Nevertheless, some of these houses located on the seafront, despite photogrammetry showing large displacements, only present moderate damage. They are terraced houses, not detached, and have probably moved as one unit. Conversely, a group of houses located in the central lobe, in the western extreme of Atarazanas, shows severe damage but the displacements obtained are in the mid-range (0.25–0.75 m). They are detached houses in a very steep area, and they seem to have been affected by spatially heterogeneous deformations. Additionally, some houses located at both sides of Pueblo site, and outside the current landslide boundaries, show displacements (up to 0.75 m in 8 years) which could indicate a future expansion of the landslide body and the consequent emergence of new damage.
