Universidade do Minho
Escola de Engenharia

Seismic behaviour and strengthening of barrel vaults of Augustinian churches in Mexico

Doctoral Thesis
Civil Engineering

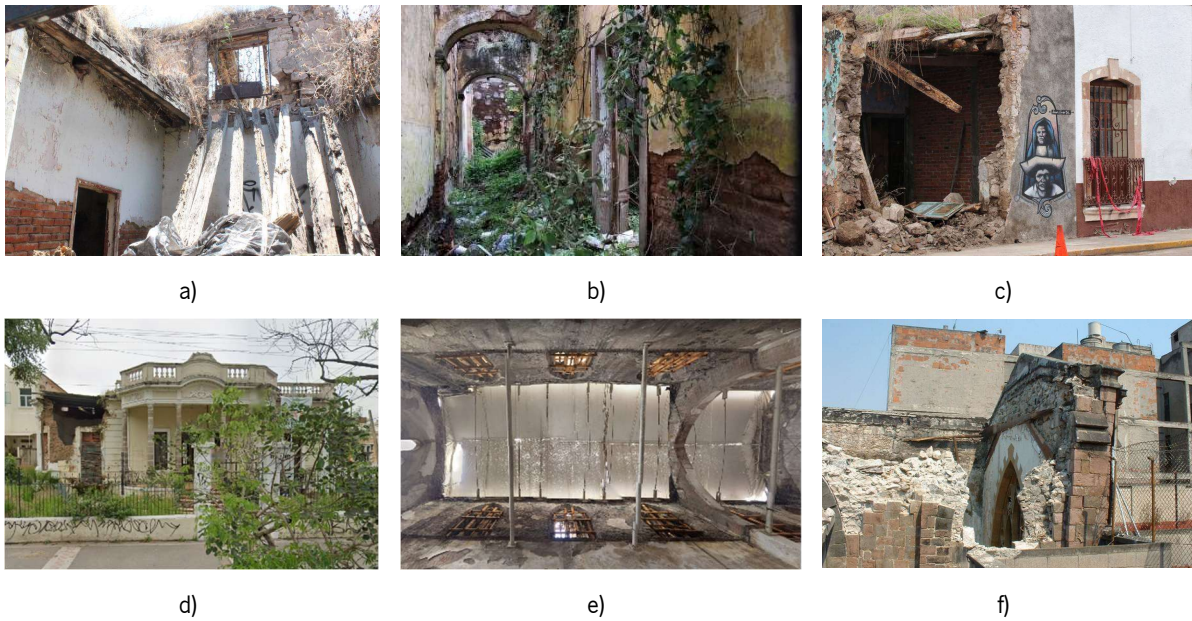
Figure 1-1. Long-term deterioration of Cultural Heritage. Ancient houses at Morelia historical city centre: a) picture by Luna (2019); b) and c) pictures by Maldonado (2019a, 2019b). d) *Castello* house at Guadalajara historical city centre (Google Maps, 2021). Old Christ Church in Mexico city: e) missing roof (Google Maps, 2019); f) back wall of the presbytery (Piñón, 2014).

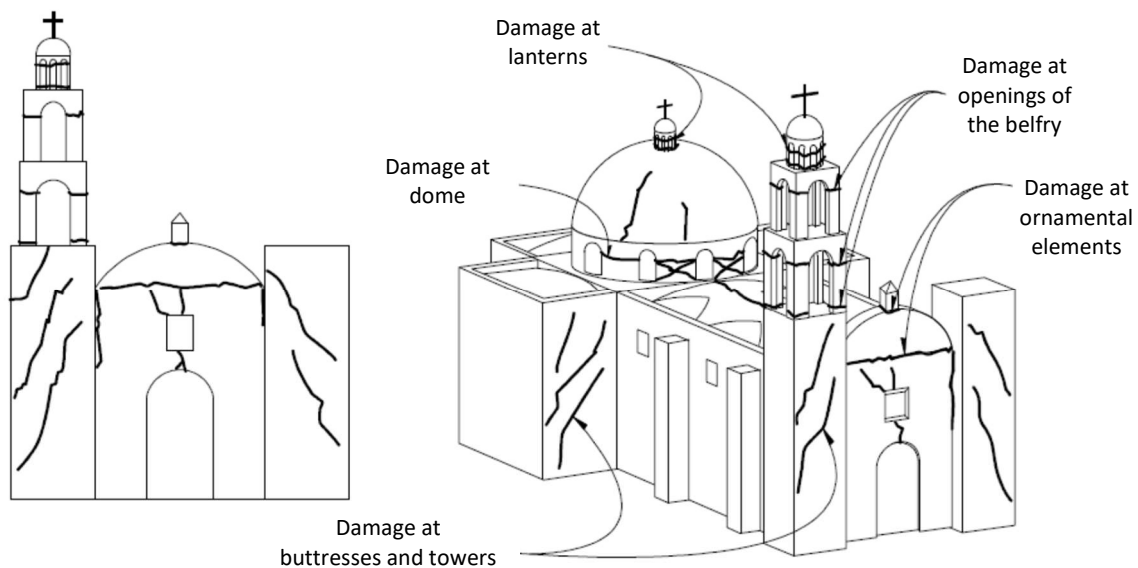
Figure 3-8. Common damage observed in churches due to the earthquake on June 15th, 1999 [adapted from (Alcocer et al., 1999)].

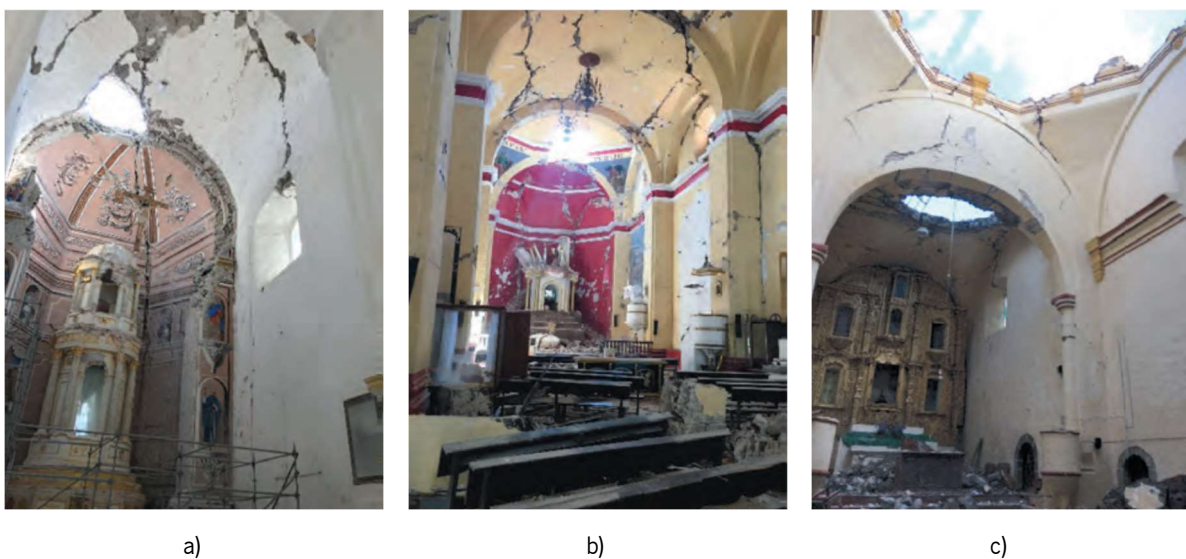
Figure 3-9. Damage in the historical heritage: a) Santo Domingo de Guzman, Tlaquiltenango; b) Santiago Apostol, Jiutepec; c) Santo Domingo de Guzmán, San Andres Hueyapan. Pictures from (Pérez-Gavilán et al., 2018).

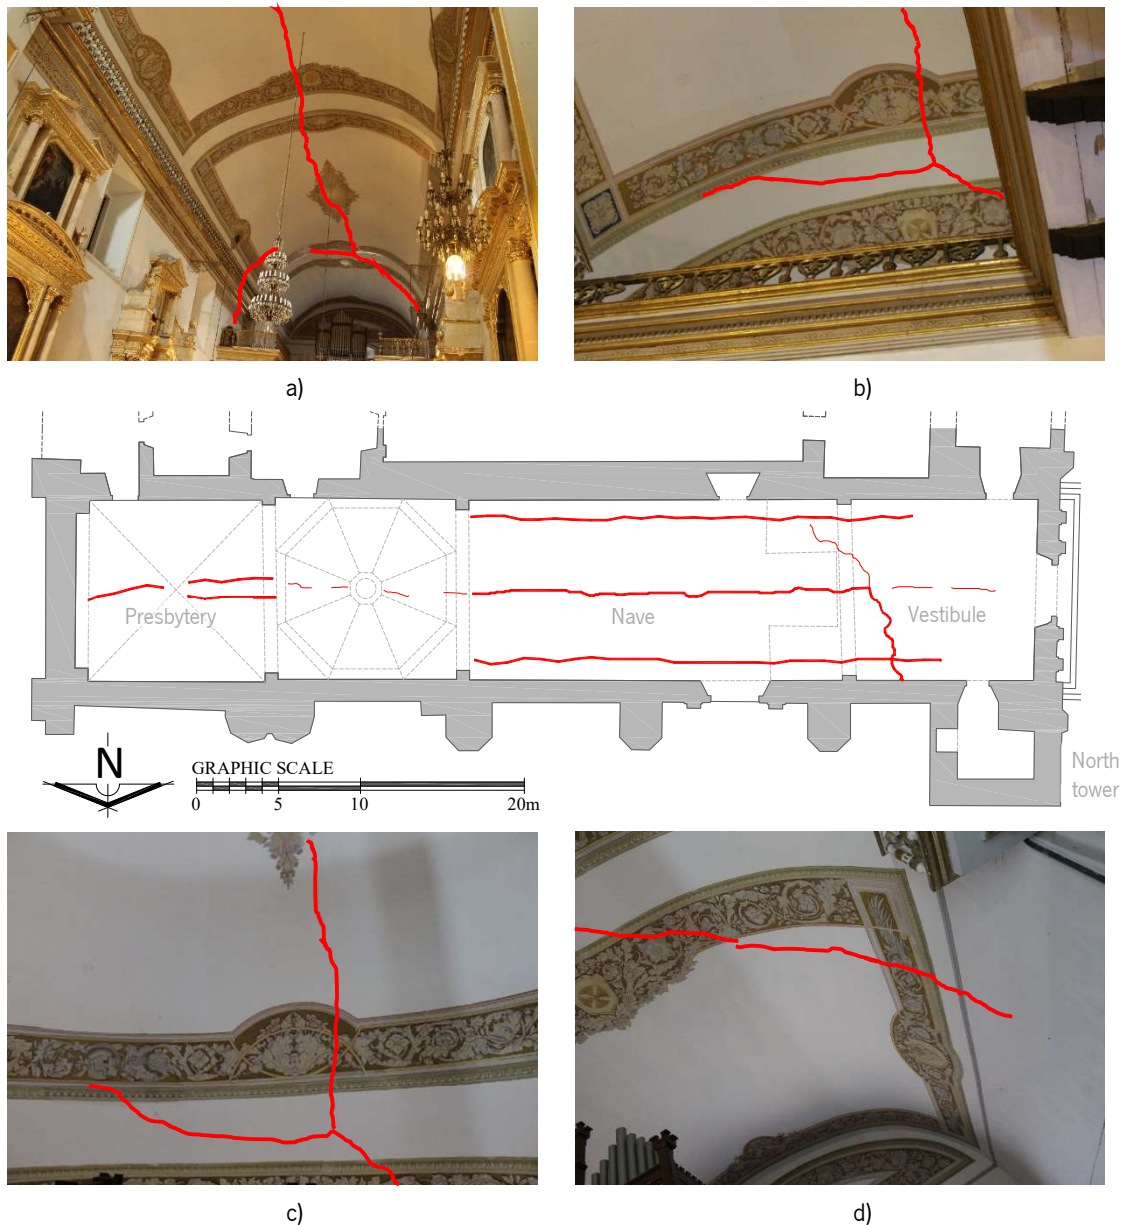
Figure 4-5. Damage at the intrados of the vaults: a) longitudinal and transverse cracking; b) change of crack direction; c) crack leading to the north wall; d) damage at presbytery's groin vault.

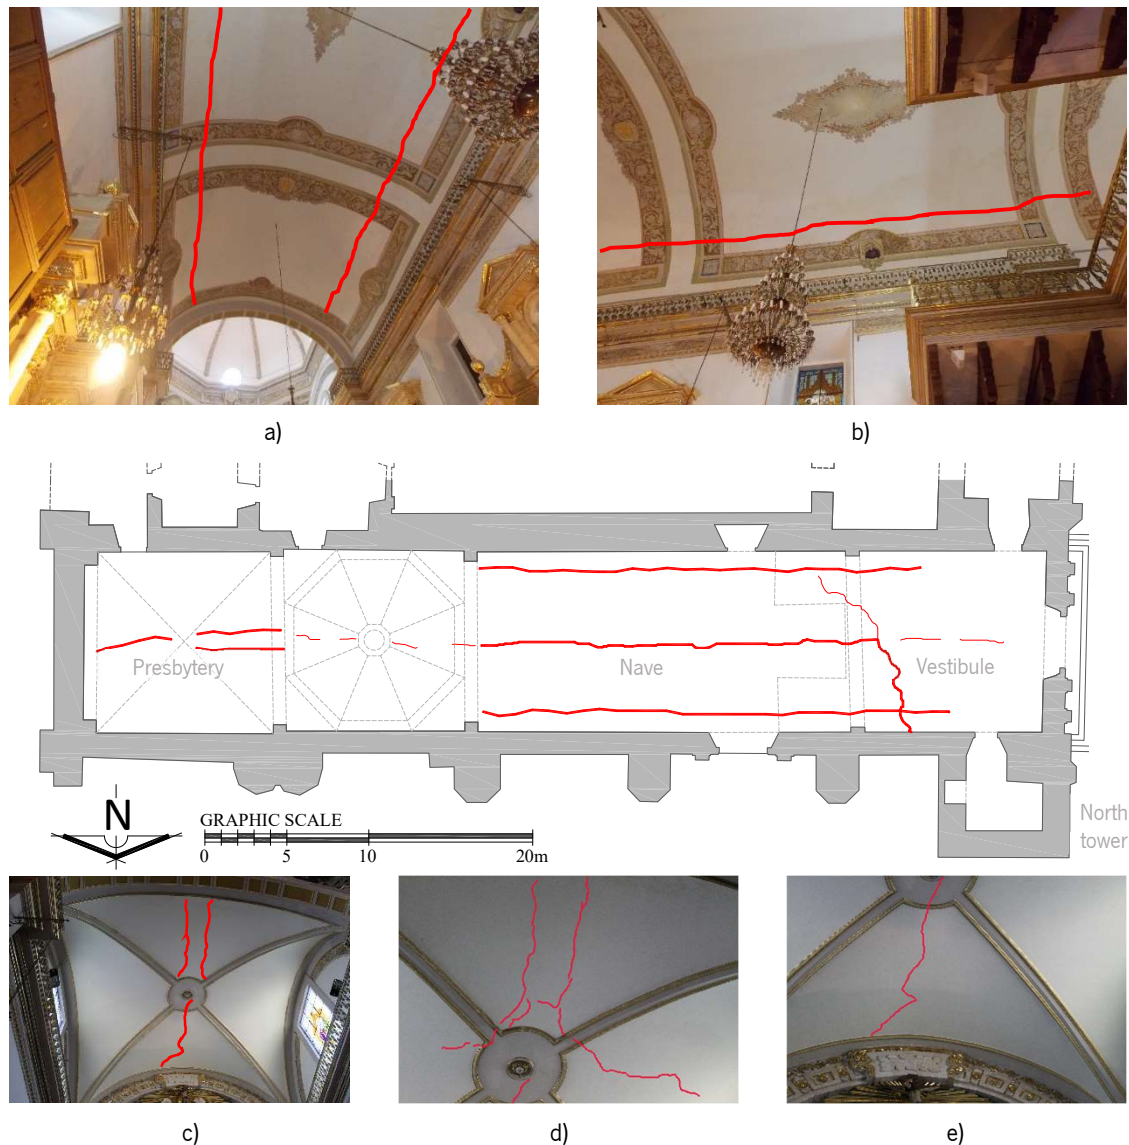
Figure 4-6. Damage at the intrados of the vaults: a) and b) nave's barrel vault; c), d) and e) presbytery's groin vault.

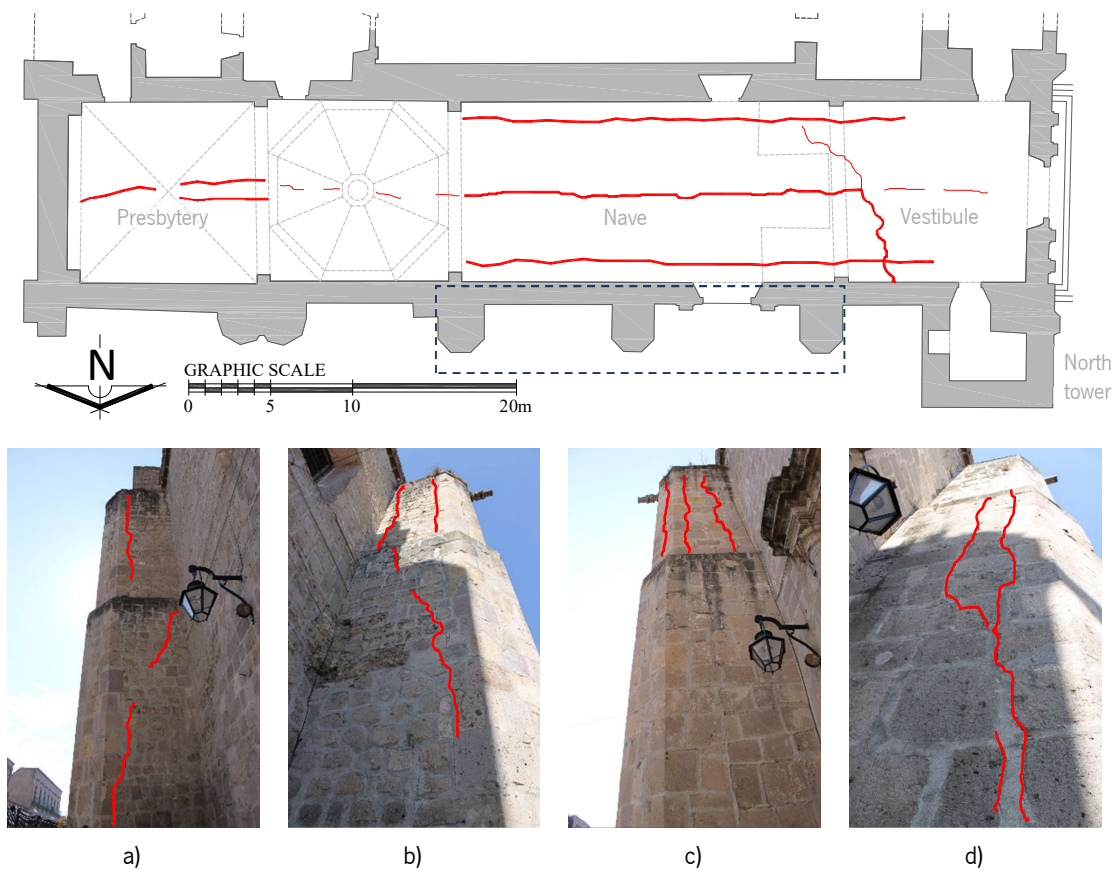
Figure 4-7. Damage at the buttresses: a) to e) vertical cracking.

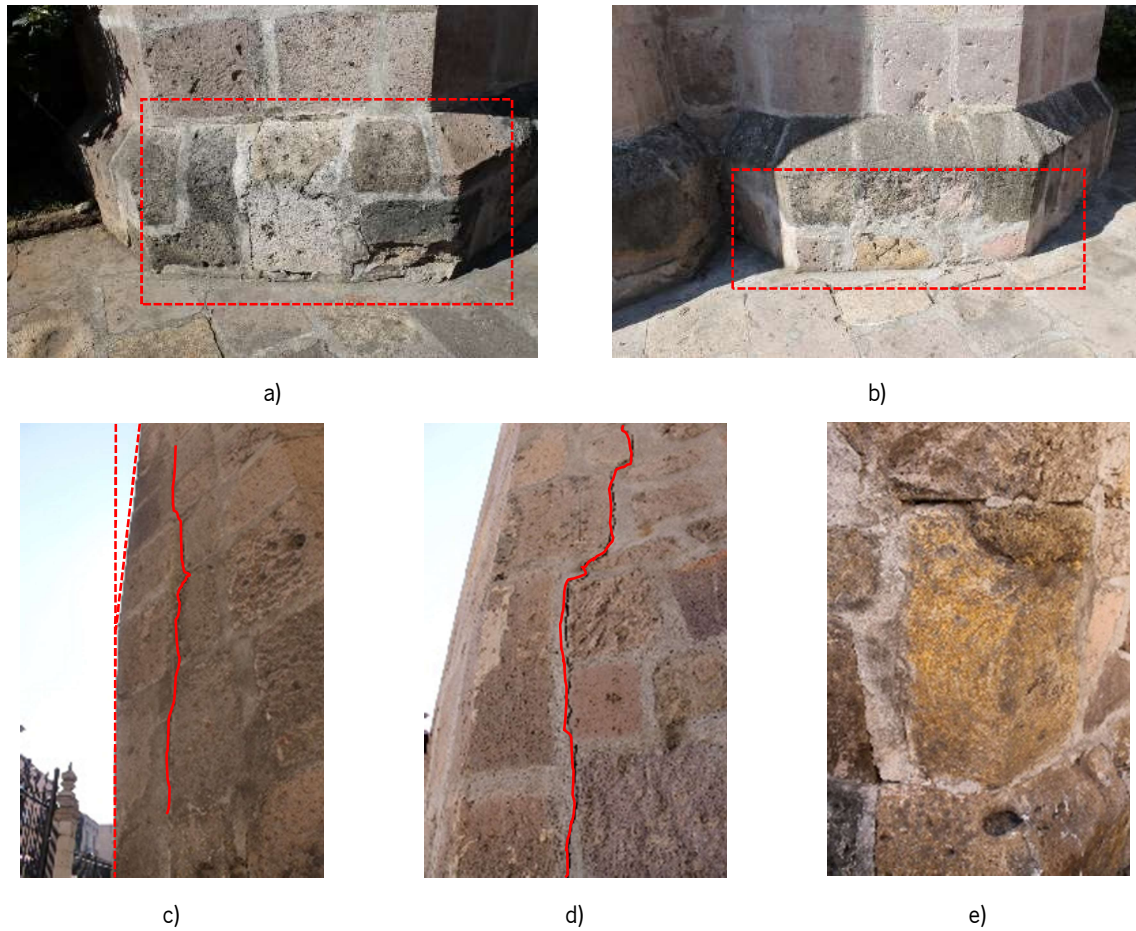
Figure 4-8. Damage in buttresses: a) and b) detachment of masonry at the basement; c) loss of verticality at the edge and vertical crack; d) vertical crack; and e) replacement of damaged units.

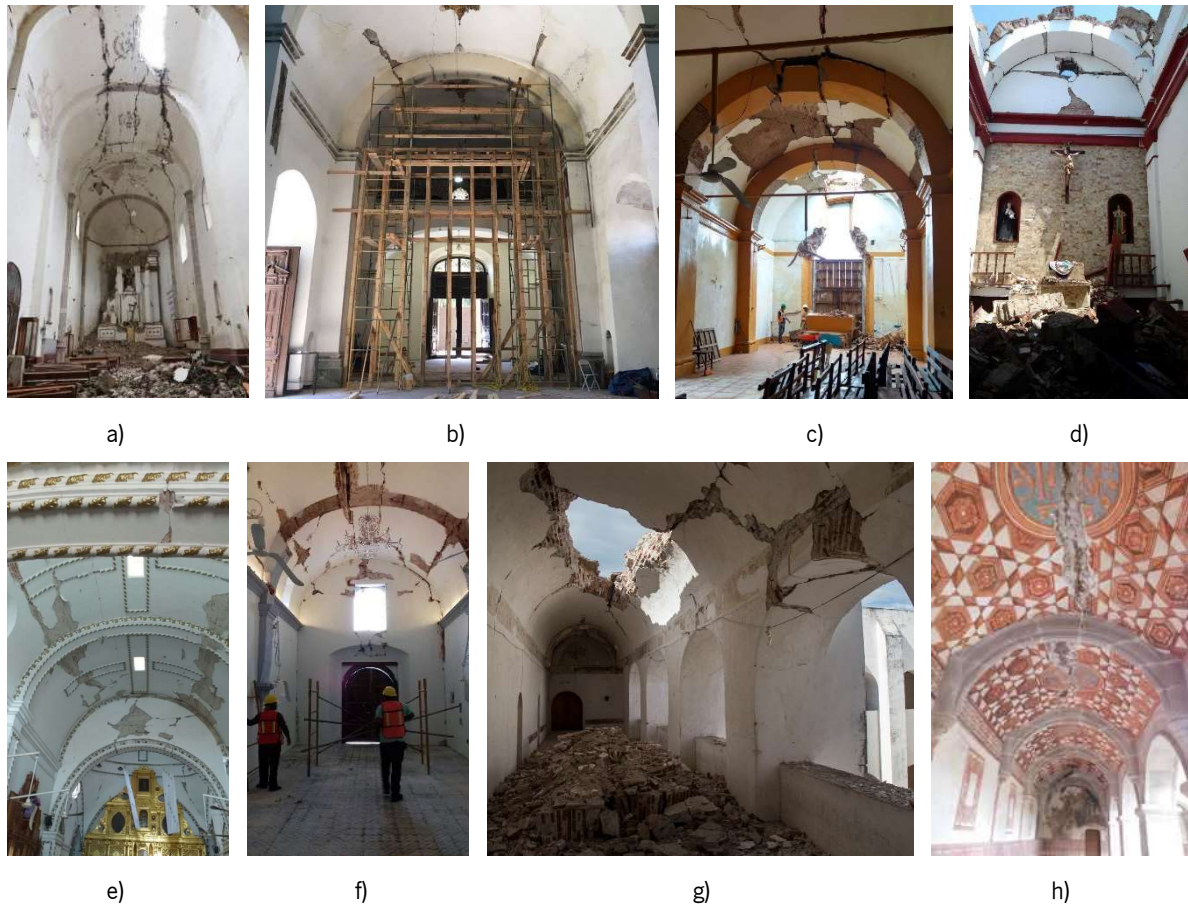
Figure 6-1. Damages at barrel vaults due to the earthquakes of September 2017: a) temple of *San Juan Bautista*, Tlayacapan, Morelos (Ojeda, 2017); b) temple of *La Virgen del Patrocinio*, Oaxaca, Oaxaca (TARES, 2017c); c) temple of *San Francisco del Mar*, Juchitan, Oaxaca (TARES, 2017b); d) parish of *Santiago Apostol*, Nliltepec, Oaxaca.(TARES, 2017a); e) temple of *San Vicente Ferrer*, Juchitan, Oaxaca (Matias, 2017); f) temple of *La Virgen del Rosario*, Juchitan, Oaxaca (TARES, 2017d); g) corridor of cloister, ex-convent of *Santo Domingo de Guzman*, Tehuantepec, Oaxaca (Sierra, 2017); h) corridor of cloister, Augustinian ex-convent of *Malinalco*, Mexico (Castañares, 2017).
