The Carmine Maggiore Bell Tower: An Inclusive and Sustainable Restoration Experience

Mariano Nuzzo ¹

and Giuseppe Faella ^{2,*}

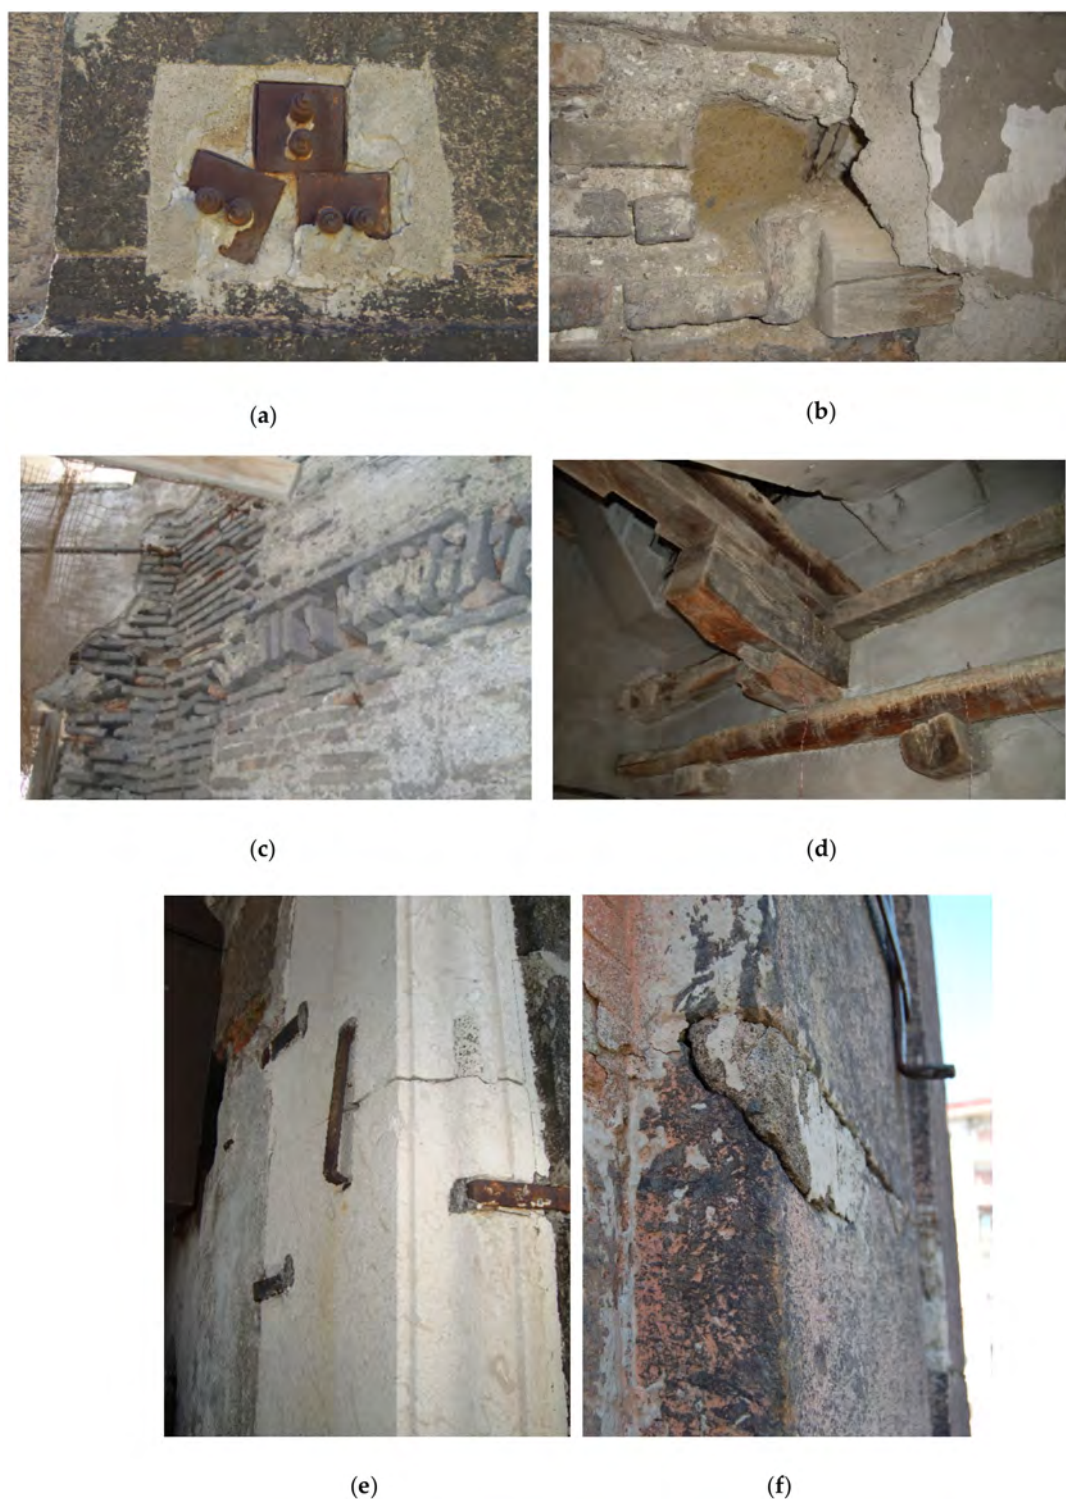
The major degradation phenomena concern (Figure 5): (a) the oxidation of tie-rods and anchor plates, especially those placed in the 1970/80s; (b) cavities in the masonry walls, which weaken structural resistant sections; (c) the degradation of the mortar joints of large portions of clay brick masonry, which sometimes also affects the bricks themselves; (d) the deterioration of timber structures, especially those supporting the main bell; (e) the oxidation of cramps and bandages anchoring cladding elements and cornices to the wall structure; (f) cracks in wall structures.

Figure 5. Degradation phenomena: (a) oxidation of tie-rods and anchor plates; (b) cavities in masonry walls; (c) degradation of mortar joints; (d) deterioration of timber structures; (e) oxidation of cramps and bandages; (f) cracks in wall structures.

- 1 The integration of the strand tie rods with new stainless steel tie rods: 30 mm diameter stainless steel tie rods were arranged, anchored to the masonry walls through stainless steel plates. Each tie rod was protected by a Teflon wrap, and the portion passing through the masonry walls was covered with a PVC tubular to allow sliding and for future maintenance.

- 3 The cracks repair: the cracks were refilled with structural mortar, sometimes improved with aggregates, to restore the masonry continuity and provide an effective interlocking. A fiber-reinforced thixotropic hydraulic lime mortar with volumetric stability, super-adhesive, compensated shrinkage, low soluble salt content (less than 10 ppm), suitable grain color, was used to avoid any risk of aggression to the existing

- 4 The filling of niches, cavities, and voids in masonry walls: the degraded stones and bricks surrounding niches or cavities were removed. The filling of niches and the masonry rebuilding were performed using elements of geometry (shape and size) and mechanical characteristics similar to the original ones, using a mortar with zero shrinkage or slightly expansive (Figure 10a).

- 5 The anti-rust treatment of the tie-rods of the late nineteenth and early twentieth century, and the replacement of the degraded steel anchoring cramps: the old cramps were replaced by injection “anchors with sock”. Stainless steel bars of 12 mm diameter were anchored for 600 mm in holes using a polyester sock, filled with a specific hydraulic mortar through an appropriate system of injection pipes. The sock, gradually filled, adapted to the geometry of the hole, ensuring the anchorage of the bar to the masonry, avoiding dispersion of material in voids and cavities, and even distribution of stresses in the masonry. Each anchorage was completed with a small stainless steel plate placed slightly under the masonry surface (Figure 10b).

- 6 The restoration of oxidized metal elements: the accessible and not notably degraded steel elements were treated by sandblasting at a pressure between 300 and 500 KPa, to remove rust until a visible metal cleaning was obtained. Subsequently, the oxidation process was inhibited through passivating chemical products, using oily inhibitors, and ferromicaceous paints (Figure 10c).

- 7 The strengthening of timber structures: degraded but recoverable timber beams were consolidated and protected by both simple impregnation and surface crack filling, using specific impregnating agents of fluid consistency and high chemical-physical compatibility with the existing wood. Where necessary, bolted stainless steel ties were arranged. The unrecoverable timber elements were replaced by elements of similar mechanical characteristics.

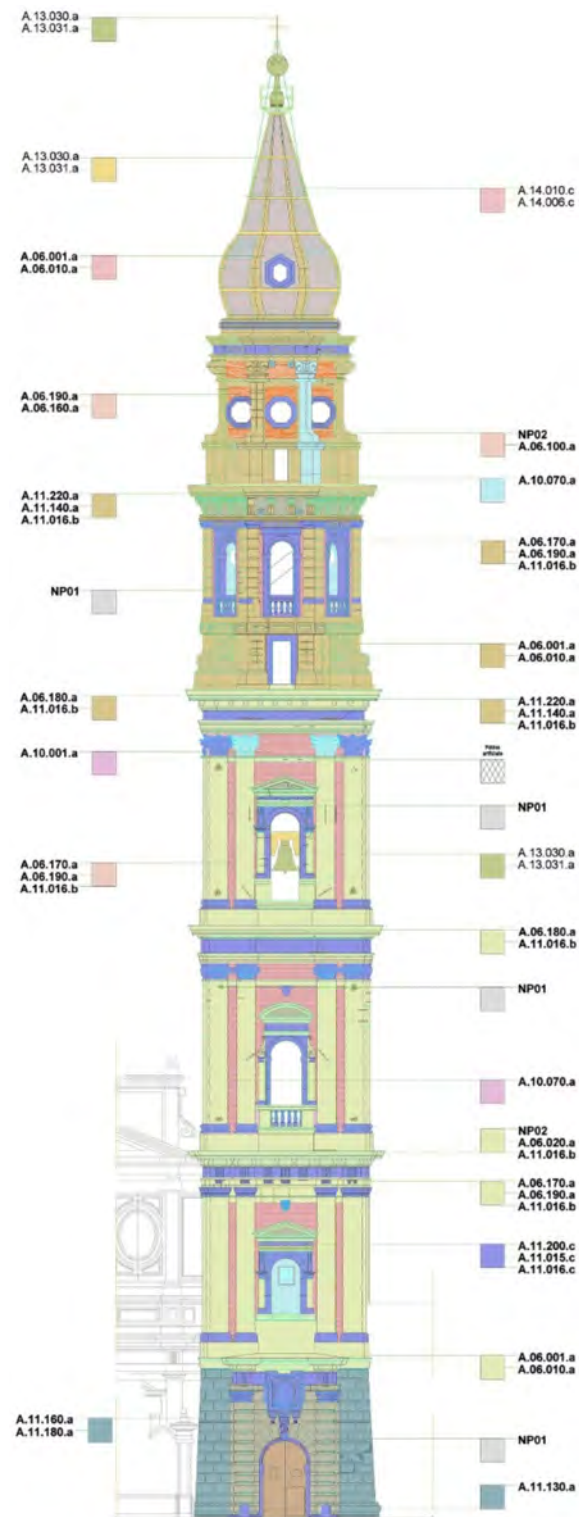
Figure 6. Restoration of west façade surfaces.

Each design solution was aimed at preserving existing materials, without altering the signs of time (Figure 6 and Table 1). The petrographic and physical characteristics of degraded stones were systematically verified for applying adequate cleaning pressures and protective mixtures, preserving the tone of stones, and improving their resistance to corrosive agents because of smog, acid rains, and bird casts. The plaster restoration was aimed at preserving the original material, reintegrating it where necessary, in full respect of their specific characteristics.

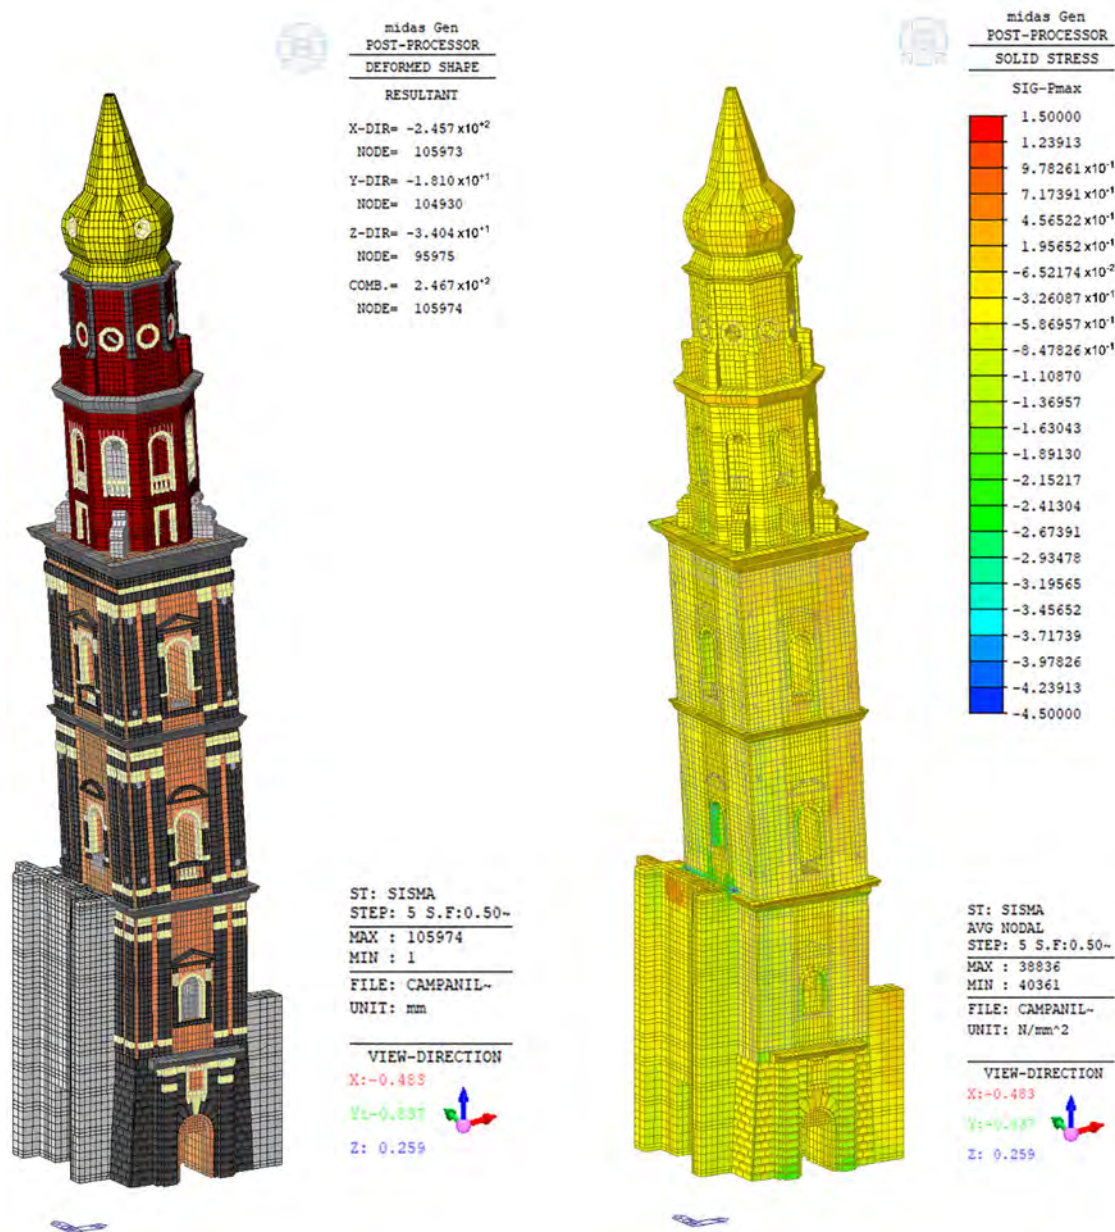
Figure 7. Non-linear static analysis: Deformed and stresses for earthquakes in North-South direction.

The non-linear static analyses allowed us to analyze both the axial and shear stresses in several cross-sections of the bell tower. Figures 7 and 8 show the maximum principle stresses in all structural and non-structural elements for the level of seismic action corresponding to the displacement capacity of the bell tower specified above. The figures show the mean “acceptable” stresses in both the tuff stone masonry and the clay brick masonry, except local concentrations in singular points (some stress peaks also affect stiffer and more resistant non-structural elements). Safety indexes greater than the unit were computed as the ratio of displacement capacity of the bell tower to the code displacement demand. Adequate margins of safety against the seismic action were identified because the smallest safety index was equal to 1.94.

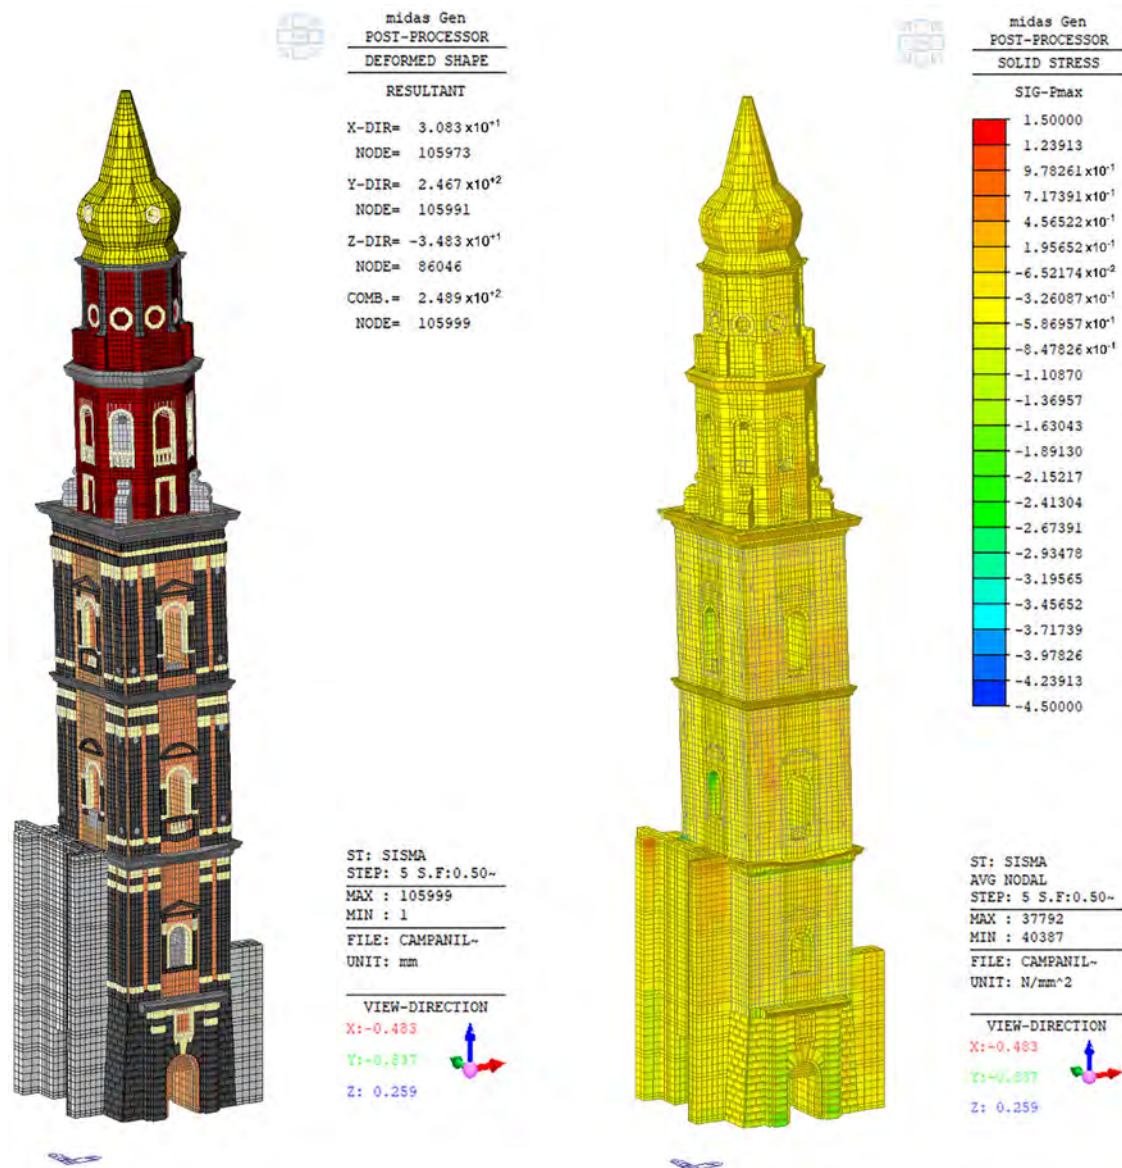
Figure 8. Non-linear static analysis: Deformed and stresses for earthquakes in the West-East direction.

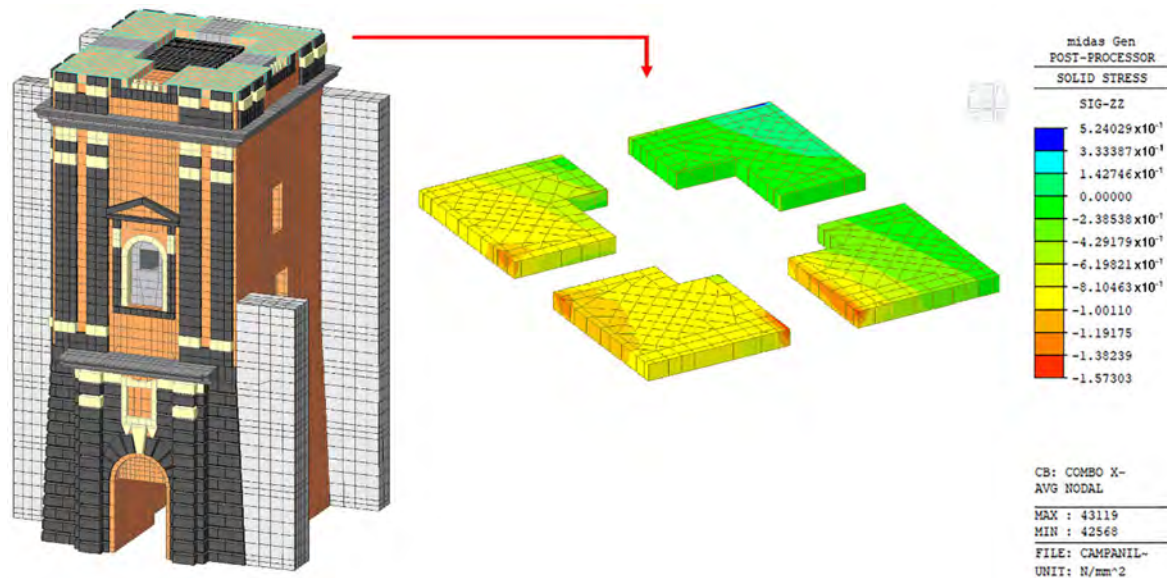
The linear dynamic analyses (modal analyses) allowed computing the design member forces (obtained through a stress integration) and comparing them with the resistant ones. Figure 9 shows, as an example, the distribution of the axial stresses in the tuff masonry alone of the section of the bell tower between 18.86 and 19.21 m (first section of reduced geometry where the bell tower is separated from the adjacent buildings), due to an earthquake acting in the North-South direction (parallel to the main façade). Subsequently, through an iterative procedure, the maximum peak ground acceleration that the structure can withstand was determined. A minimum safety index of 0.91, calculated as the ratio of capacity to demand, was computed.

Figure 9. Distribution of the axial stresses in the section of the bell tower between 18.86 and 19.21 m.

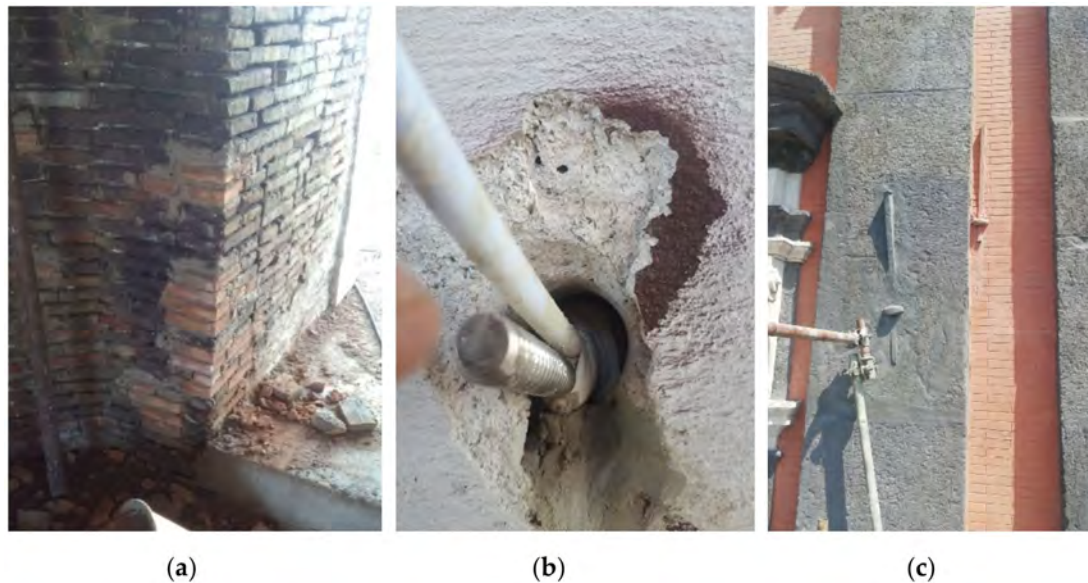
Figure 10. Masonry rebuilding (a); anchor with sock (b); restoration of oxidized metal elements (c).
