Sayano Shushenskaya 2009 Accident update

SAYANO SHUSHENSKAYA 2009 ACCIDENT UPDATE

BY FRANK A. HAMILL

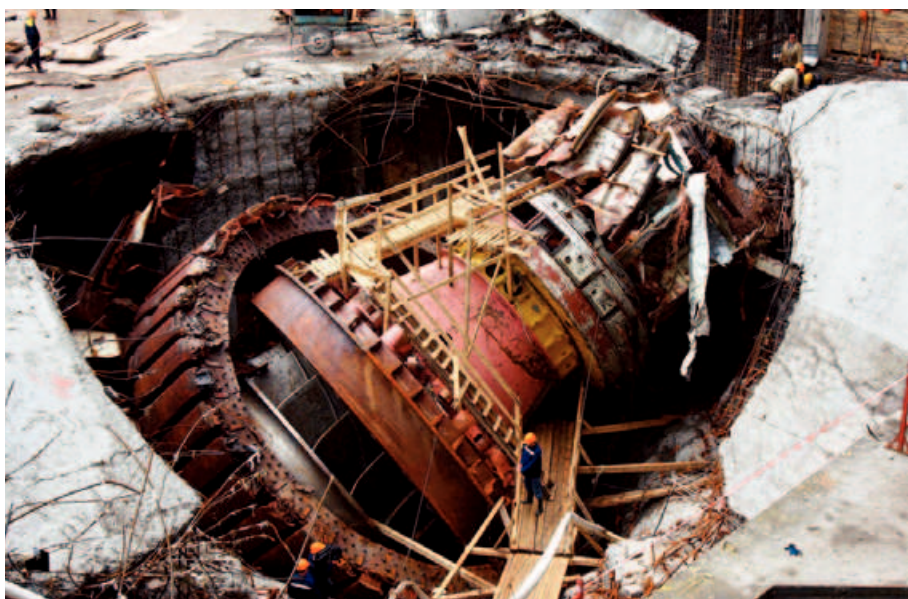
17 August 2019 marked the tenth anniversary of the catastrophic accident at RusHydro's Sayano-Shushenskaya Dam and power station (Figure 1). The accident destroyed or severely damaged all the hydraulic turbines contained in the large powerhouse located at the toe of the dam (Figure 2). The Project is located on the Yenisei River in the village of Cheryomushki, which is near the city of Sayanogorsk, Khakassia in southern Siberia. In the ten years since the event, numerous writers have expressed opinions as to the probable cause of the accident. The owner of the plant, RusHydro, and the national industrial safety agency, Rostekhnadzor, have both issued findings as to the probable cause. None of the official reports or findings have discussed the governor wicket gate closure time or its possible relation to the accident.

Figure 2. Part of the damage to the powerhouse after the 17 August 2009 accident. Unit 2 as seen on 3 September 2009 after dewatering.

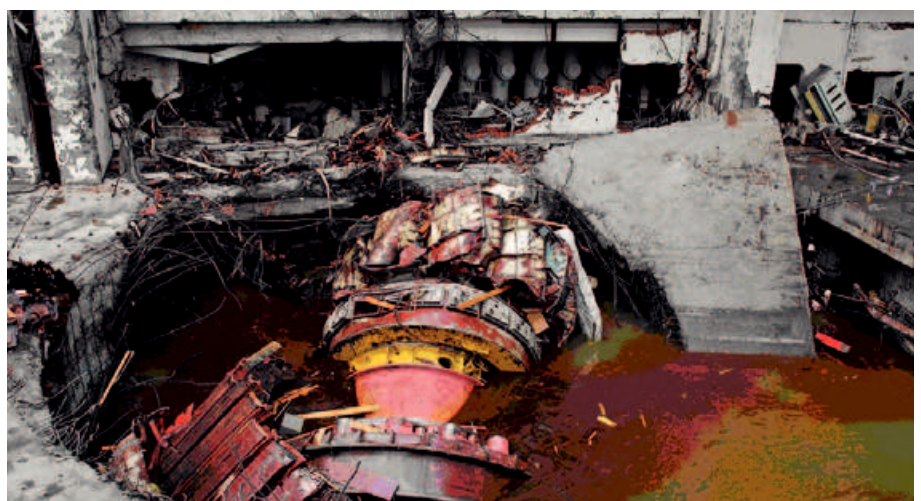
At 08:13 and 25 seconds on the morning of 17 August 2009, Unit 2 in the plant suffered a total load rejection. This was followed by a violent eruption of water in the draft tube lifting the turbine head cover, turbine runner, shaft, turbine and generator bearings upward several meters (a witness estimated three meters rise). This destroyed the generator rotor spider and permitted water to flood the

turbine pit and spill out into the powerhouse operating floor (Figure 5). The sudden failure of Unit 2 was followed immediately by similar failures of Units 7 and 9. In all, nine of the ten operating units were either destroyed or severely damaged. Only Unit 6, which was out of service at the time, was spared from severe damage, although it was flooded by water from the other failed units. In all, 75 people died and 13 were injured in the powerhouse as a result of the flooding, which raised the event to the level of a national scale disaster.

Figure 5. Unit 2 several hours after failure.
