Fatigue Behavior of Reinforced Welded Hand-Holes in Aluminum Light Poles with a Change in Detail Geometry

Cameron R. Rusnak and Craig C. Menzemer

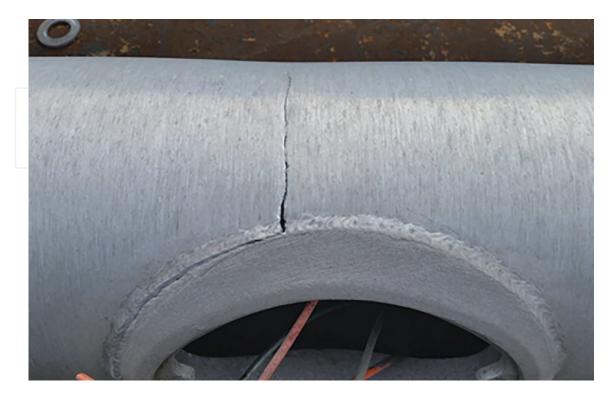
Observations have confirmed the existence of fatigue cracking associated with different hand-holes in the field. NCHRP report number 469 describes fatigue cracks found on welded steel structures near and around the hand-holes in several states. These states included New York, California, New Mexico and Minnesota [7]. In Iowa, there was a failure in a high-mast welded pole that was found to contain cracking around the hand-hole. This failure prompted further investigation into other poles and towers, in which multiple contained some form of fatigue cracking. Fatigue cracking was found in welded aluminum light poles mounted on the Mullica River Bridge after a violent storm in 2011 [8]. **Figure 1** depicts a fatigue failure associated with a hand-hole on an aluminum light pole that occurred in the field.

Figure 1. Fatigue crack in welded aluminum light pole hand-hole.

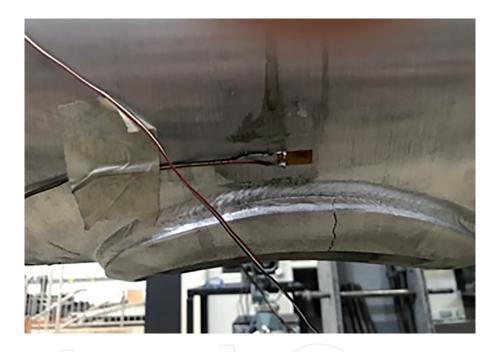
During testing, cracks were first observed in the throat of the fillet weld that joins the tube to the reinforcement ring. These cracks were first observed along the minor axis of the hand-hole at either the 3:00 or 9:00 position in Ref. to a clock. A sample of one of these cracks may be seen in **Figure 8**. These cracks would normally start at the weld root and propagate through the throat of the weld and then progress around the handhole. **Figure 9** shows an example of the crack surface after failure. Note that this

Figure 8. Fatigue crack through weld throat between reinforcement and tube.

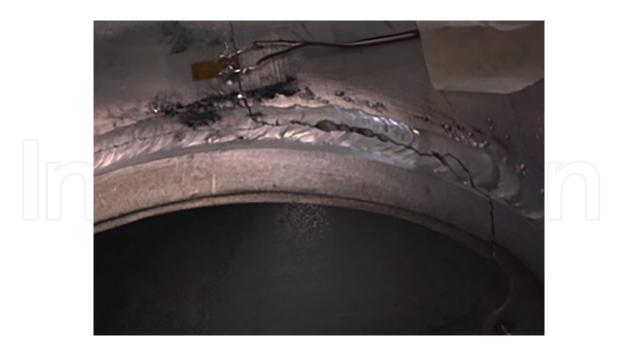
Figure 10. *Typical final failure of hand-hole details.*

Final failure typically occurred as the crack progressed through the cast insert near either the 11:00 or 5:00 position (**Figure 10**). In these cases, the fatigue cracks spent most of the cyclic life while small. In every case there was a definite transition from the time of the development and propagation of visible fatigue cracks within the fillet weld throat to the final failure. In most cases, cracks would develop and progress around the hand-hole. At this point, they would appear to stop, and only after a significant number of load cycles were applied, would failure occur.

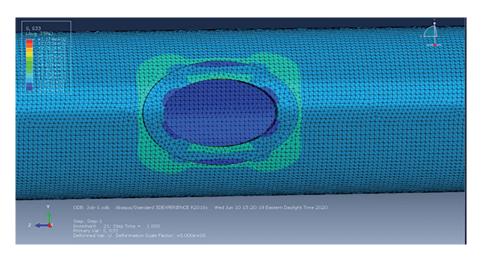
Stress "hot spots" indicate where fatigue cracking is likely to develop. **Figure 12** shows a longitudinal stress map along the "Z" axis. Under bending, longitudinal stress developed and the distribution, sense, and magnitude are affected by the presence of the hand-hole detail. This is shown in **Figure 12** with the shade of blue being a relatively low stress while elevated stress (**Figure 11**) is green. Hot spots appear along-side most of the hand-hole, maximum values between the 10:00 and 2:00 positions,

Figure 12. Contours of longitudinal stresses around the hand-holes.

as well as between the 5:00 and 7:00, indicated by a lighter shade of blue. Elevated stresses are apparent on the inside edge of the reinforcement. Stresses are larger near the junction of the inside and outside legs of the reinforcement [9]. This makes sense because, as the tube bends, the cast reinforcement attempts to elongate on the tension side. This stretches the reinforcement insert and results in transverse bending.

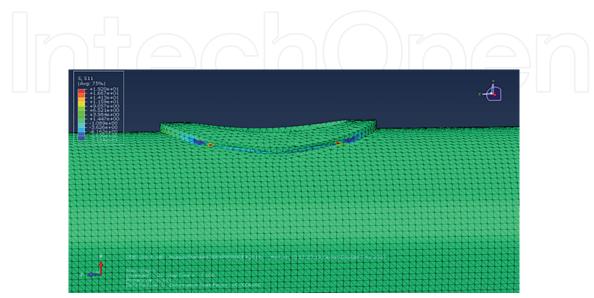
Figure 13. *Stress concentration X direction.*

Figures 13 and **14** show how a crack within the detail effects the stress hot spots. In **Figure 13**, to be precise, the stress is along the "X" axis and shows that the highest concentration of stress is located at the "end" of the crack with a red color. **Figure 14** shows this exact same phenomenon along the "Z" axis.

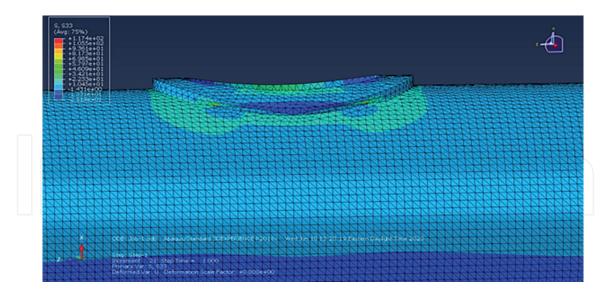
Figure 14. *Stress concentration Z direction.*
