Lessons Learned from an Emergency Bridge Replacement Project

component of the nation's transportation network, in case they are damaged or destroyed by extreme events. One of the tasks associated with this research was to conduct case studies of previous bridge replacements following extreme events. By studying these cases, the research team sought to identify and expand on lessons learned, address which actions did and did not work well given the circumstances of the incident, and incorporate lessons into the emergency response plan for highway bridges. This paper presents the findings from one of the case studies, the I-40 Webbers Falls Bridge in Oklahoma.

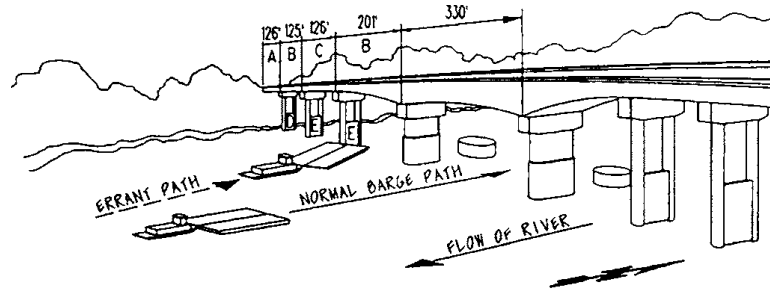
Figure 1. I-40 bridge incident sketch

- A • Damaged Span
- B • Partially Fallen Span
- C • Completely Fallen & Submerged Span
- D • Partially Damaged Pier
- E • Damaged Pier

The 20 m (64 ft) wide, 606 m (1988 ft) long, four-lane bridge was built in 1967 over the Arkansas River near Webbers Falls, Oklahoma ("Oklahoma" 2002). The original structure was a continuous haunched steel girder bridge with a 61–101–61 m (201–330–200 ft) main span combined with steel girder approach spans and a reinforced concrete deck. The steel girders were supported by 12 concrete piers. Fig. 1 shows the normal barge path and the errant barge path that resulted in a collision with the bridge. The barge was about 91 m (300 ft) outside the regular navigation channel (main channel) when it rammed into the unprotected piers of the bridge, knocking down two piers (indicated as E piers) and partially damaging another (indicated as the D pier). Four spans totaling approximately 152 m (500 ft) were also damaged. Span 1 [38 m (126 ft), shown as damage type A] was damaged, but did not fall. Span 2 [38 m (125 ft), shown as damage type B] and Span 4 [61 m (201 ft), shown as damage type B] partially fell into the river. Span 3 [38 m (126 ft), shown as damage type C] completely collapsed into the river. Fig. 2 shows the damaged bridge.

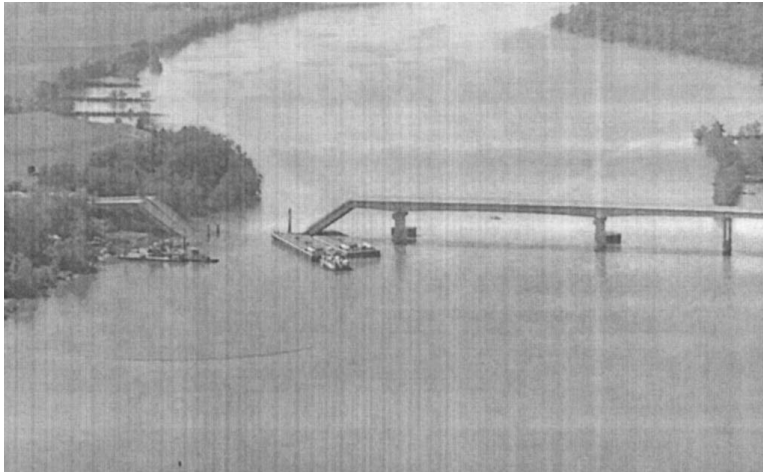
Figure 2. Overview of damaged bridge

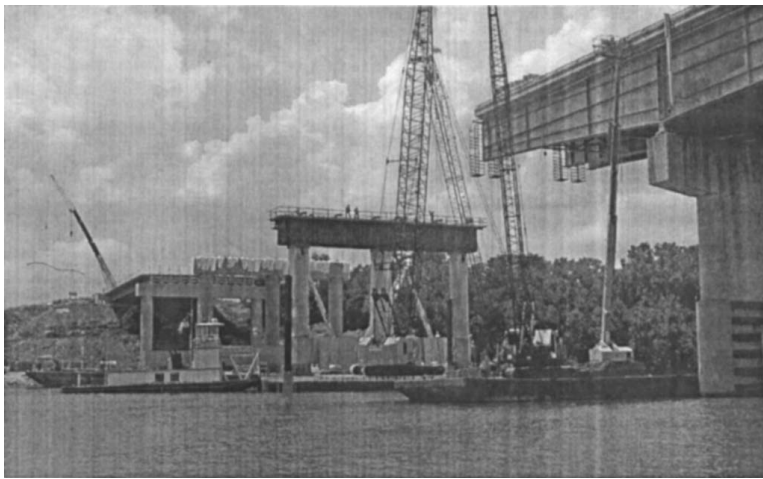
Figure 4. New pier structures under construction

The old piers had two columns supporting them. The new piers were three column structures supported by drilled shafts. Pier 3 was rebuilt at the original station. Its three columns were spaced to straddle the

existing spread footings that were left in place. The new piers were 2.7 m (9 ft) in diameter (under web wall portions), which was 0.6 m (2 ft) larger than the original. Fig. 4 shows the new pier structure under construction. The new piers were constructed with a construction joint at the top of web walls, which were full column width with some chamfering at the ends for ease of forming. Substructure concrete was permitted to be loaded at 75% of design strength.

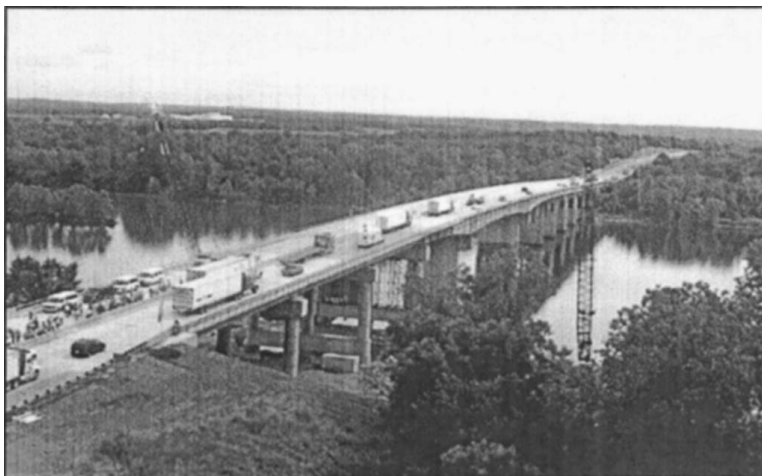
Figure 5. I-40 bridge reopened to traveling public

The major scope of repair work involved constructing a 160 m (524 ft) long combination concrete and steel girder that would tie into the undamaged four-lane bridge structure, three piers, four spans, an abutment, a 9 m (30 ft) long concrete approach slab, and a 12 m (40 ft) long roadway section. Reconstruction began on the west side of the bridge and moved toward the still-standing roadway in the center. Both ODOT and Gilbert committed the necessary resources and furnished experienced supervisors and crews to ensure that the project would be constructed as fast as possible. ODOT created a special construction residency. The assistant bridge engineer for design was on call 24 hours per day, 7 days per week. A 13-member team of inspectors was formed to oversee the reconstruction of the bridge. Some of the inspectors were retired ODOT employees. The average experience for the 13 bridge inspectors was 20 years. Inspectors were also sent to the steel fabrication shops to make sure that the steel plate girder beams were fabricated as designed and satisfied all the standards. Under normal circumstances, ODOT probably would have only two inspectors assigned to such a project.
