Moisture content changing of a historic roof structure in terms of climate effects

Mohammad Kherais^{1*}, Anikó Csébfalvi² and Adél Len^{2,3}

Pollack Periodica •
An International Journal
for Engineering and
Information Sciences

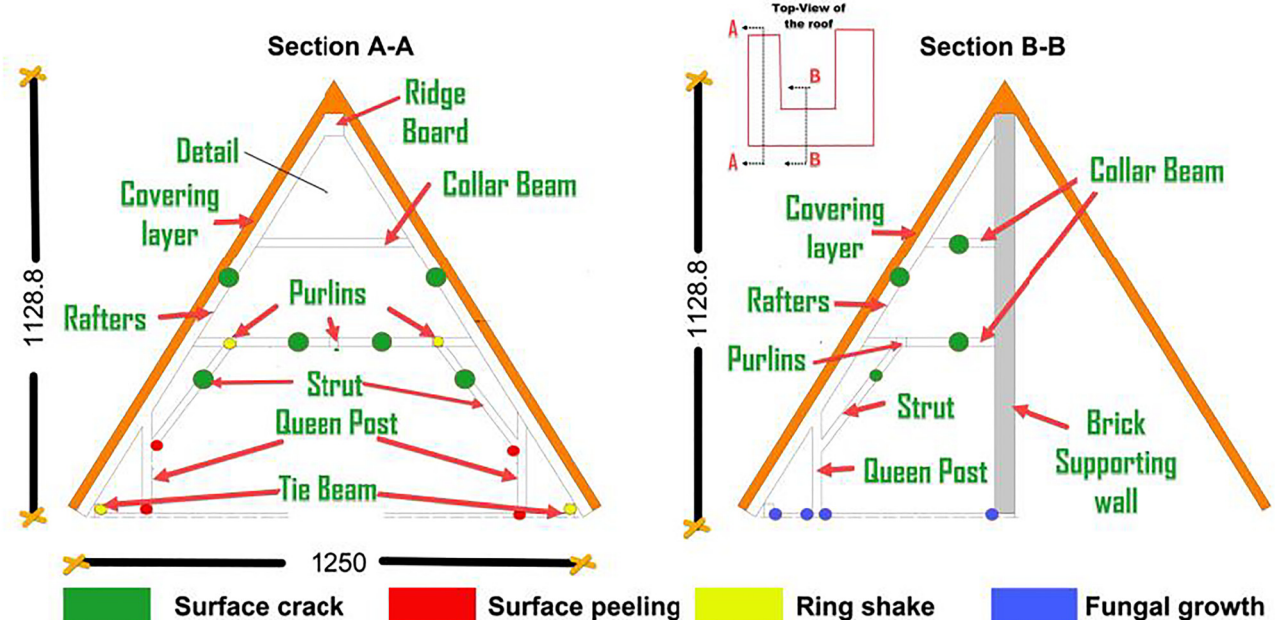
Fig. 2. Sectional view of the roof

The visual inspection of the wooden roof shows that the roof was built as queen post truss system, in order to reduce the cost and to cover the large area of the floor, which is around 190 m². The roof is supported by one brick wall in the middle; the plan view of the roof has U shape with two different sections along it as it is shown in Fig. 2. A proper ventilation system is missing. Most of the used wood is pine (*pinus silvestris*). Figure 2 shows the cracks and splits positions found in the roof on the two sectional views: A-view is a general one and B-view shows the middle supported by brick wall. Table 1 shows the results of the visual inspection. The two main reasons of the damages are the MC change and the wood ageing that can be referred to the climate change cycles and the lack of surface treatment and rehabilitation. Struts and posts are highly damaged, and the color of the elements tends to be whiter when the elements have higher elevations. The timber elements were not covered by any protective layer, and the top covering layers of the roof have passed their service life (40–50 years in average). Thus, almost all the elements are deteriorated. It can be estimated that 30–40% of the roof elements are severely deteriorated.

- double beavertail tile covering -ceiling battens 2.4 / 4.8 cm
- tilting fillet 2.4 / 4.8 cm -Bramac foil insulation 1layer
- rafters 12/15 between them fibrous thermal insulation 12cm
- waterproof sheet 2x1.5 cm

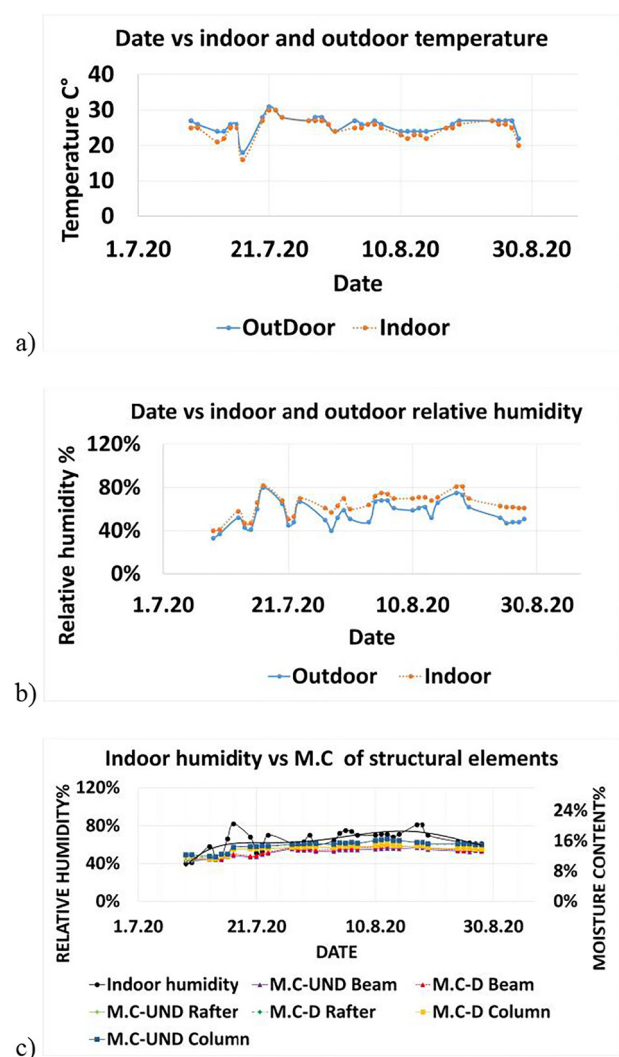
Fig. 3. On-site summer measurements: a) date vs. indoor and outdoor temperature; b) date vs. indoor and outdoor RH; c) indoor humidity vs. MC of structural elements

The measurements have been done along four seasons on different damaged and undamaged structural elements. MC values were calculated as the average of the MC values along the element (3–5 spots along the element have been measured with three measurements in the same spot). The summer measurements results are shown in Fig. 3. In the summer period the outdoor temperature ranged between 18 and 30 °C, while the indoor temperature values were always less than the outdoor values by only 1–2 °C. Outdoor RH values ranged between 35 and 80%, and the indoor values were always higher by 7–11%. The summer period T and RH values (especially between 20th of July until 18th of August) show fluctuations, however these fluctuations are followed in a much slower way by the changes of the MC values. It can be observed that the average MC values follow the T and RH very slowly (see Fig. 3c). The elements MC values range between 10 and 14%.

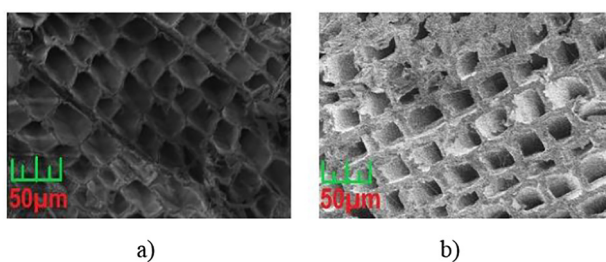
Fig. 4. Wood sample 1 analyzed with SEM, a) MC = 0%; b) MC = 12.7%

Figure 4 shows the SEM images of a wooden sample taken from a damaged girder, lightened by the sun. Figure 4a shows the sample with zero MC and a horizontal wall thickness of an average of 4.3 μm , and Fig. 4b shows the sample with a MC of 12.7% with a horizontal wall thickness of an average of 7.7 μm . The increase in the MC is translated directly into an increase in the walls thickness. It has been noticed that damaged elements were more affected by increasing the MC.

where damaged and cracked elements can absorb more water. The samples have been studied by SEM: S1 – girder, damaged, sun lightened, S9 – column, un-damaged, not sun lightened and S11 – horizontal bracing, un-damaged, not lightened by the sun. S1 had a wall thickness that kept increasing with the MC, but S9 and S11 showed that the cells reached their limit of water absorption capacity and the value of the wall thickness was approximately the same for the 2nd and the 3rd MC classes. When the volume of the wooden cells increases, new cracks develop, and the continuously absorbed water creates a humid environment for fungi growth. Both effects will have high negative impact on the mechanical, physical, and thermal properties of the wood.
