NON DESTRUCTIVE TESTING OF STRUCTURES

Part1: Masonry Arch Bridges

Zoltan Orban

APPENDIX 2: Case studies **47**

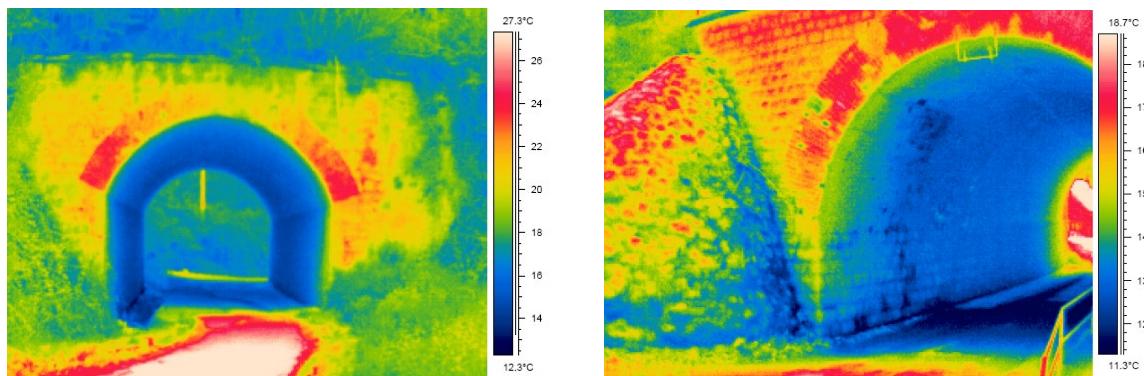
Fig. 3. Typical thermal images of masonry arch bridges. Different construction materials, patch repairs, wet areas and vegetation are clearly visible.

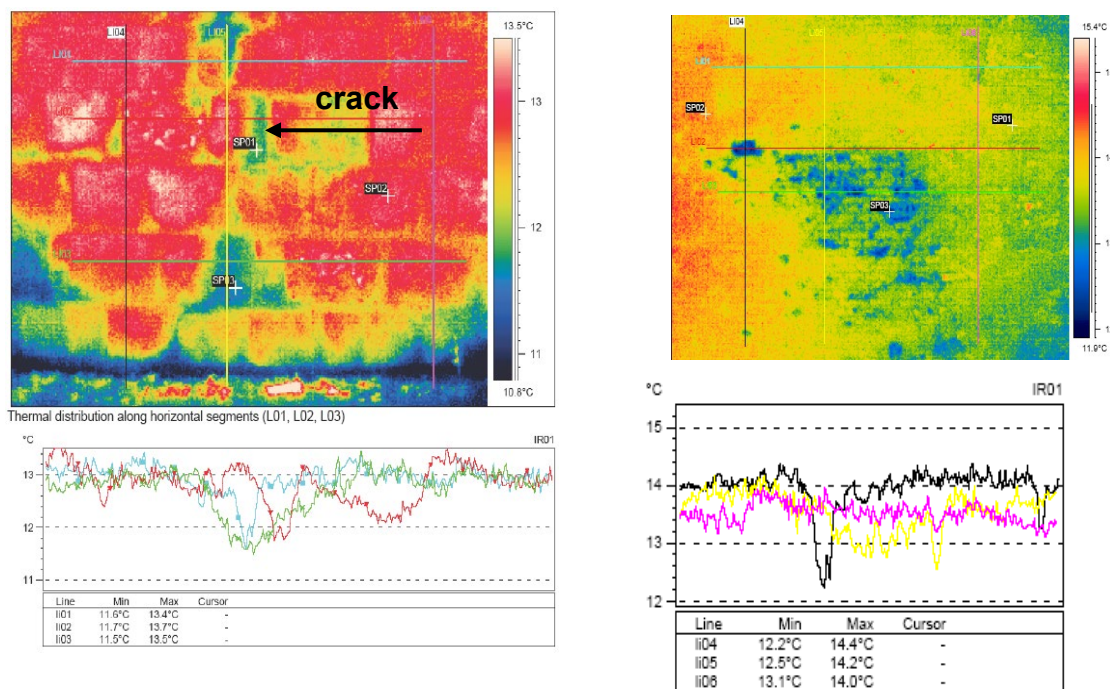
Fig. 4. Wet areas are visible on thermal images. Temperature intensity charts are represented along horizontal segments.

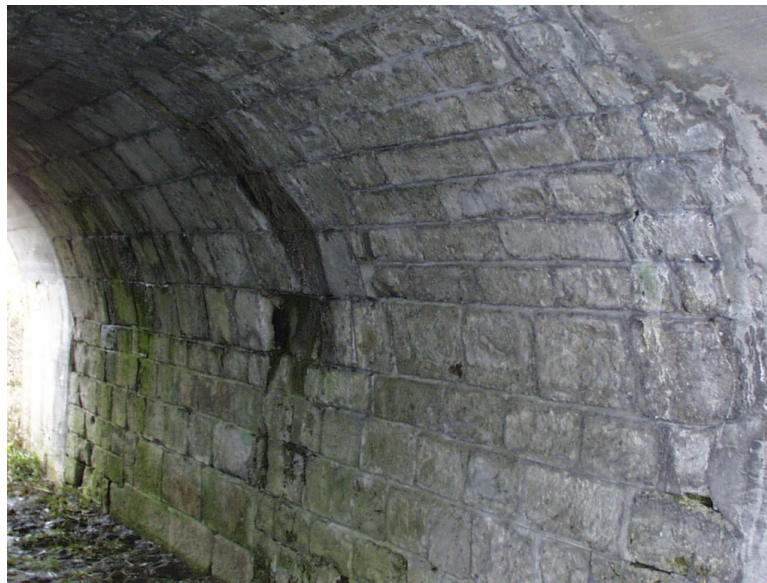
- The masonry surface is covered with moss on the abutment, along a strip above the ground level.
- Hammering of the barrel surface suggests internal voids at some parts.

Image 2: Condition of the structure. Wet spots refer to drainage problems

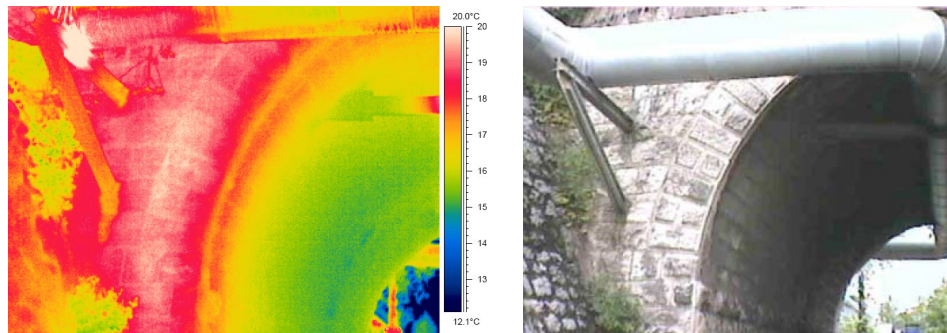
Image	Location
B1-02	Eastern abutment at ground level
<u>Comments:</u> No inhomogeneity was found on the stonework. Different construction materials can be identified (stone, mortar). A colder band is seen on the stone surface near the ground.

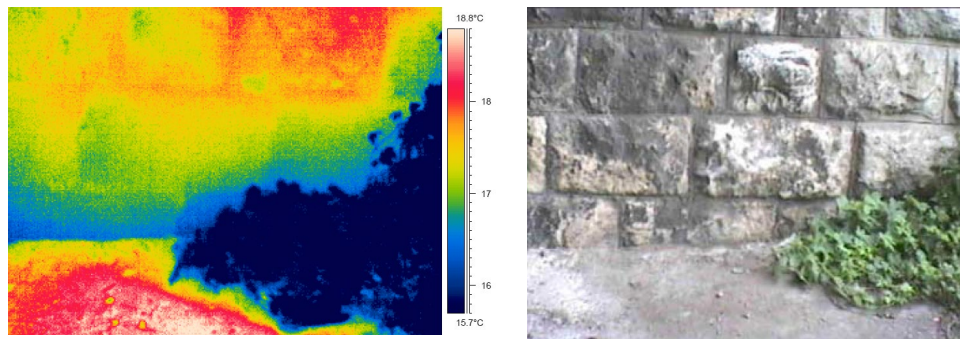
Image	Location
B1-03	Eastern abutment at middle level
<u>Comments:</u> No inhomogeneity was found on the stonework. Different construction materials can be identified (stone, mortar). The right side of the surveyed area is warmer due to the side effect.

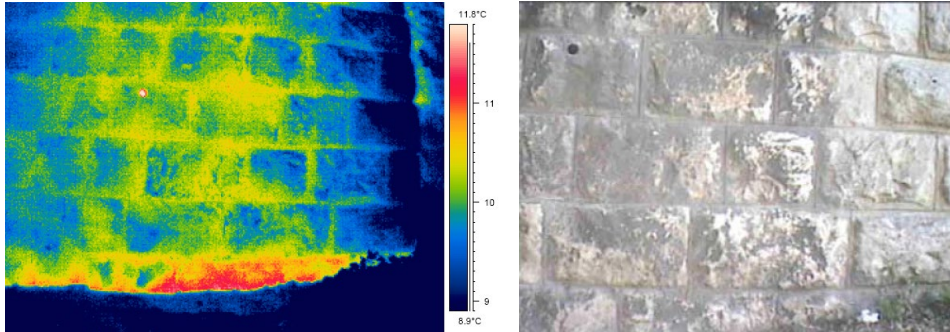
Image	Location
B1-06	Arch barrel (middle of the bridge)
<p><u>Comments:</u> No inhomogeneity was found on the stonework. Different construction materials can hardly be identified (stone, mortar). The hot spot in the middle of the image is a borehole. The surface is more or less in thermal equilibrium.</p>

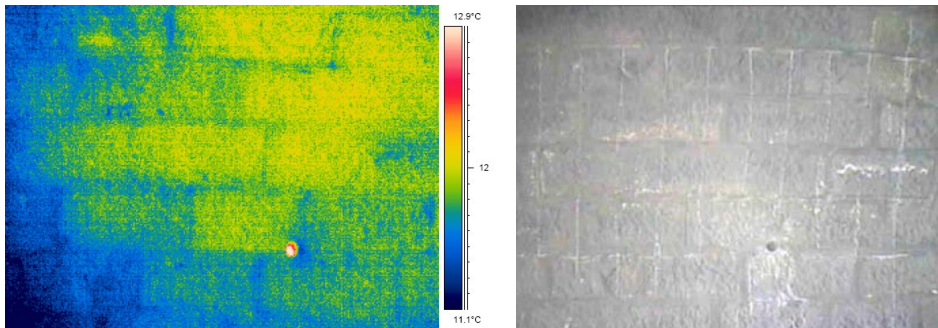
Image	Location
B1-07	Abutment and arch barrel –(eastern side, middle of the bridge)
<p><u>Comments:</u> No inhomogeneity is seen on the surface. Different construction materials can hardly be identified (stone, mortar). The surface is more or less in thermal equilibrium. Separation between the two bridge segments is clearly seen on the thermal image.</p>

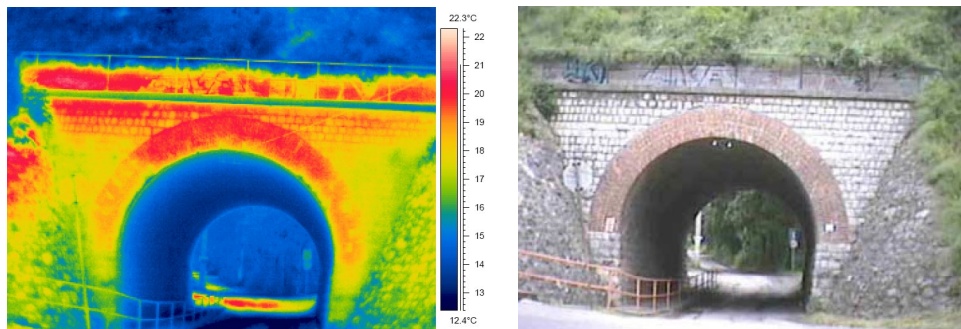
Image	Location
B3-02	Bridge front view (eastern side)
<p><u>Comments:</u> The front side of the bridge was not subjected to sunshine before and during the measurement but difference between the temperatures at the upper side and lower side can be observed. The barrel (brick material) can be distinguished from the spandrel wall (quarry stone) on the thermal image. Spots with lower temperatures on the thermal image of the barrel refer to locations of patch repairs. The area with lower temperature (deep blue spots) on the barrel and the abutment refers to the presence of wetness around a crack. This anomaly can be observed even at a distance of 15m.</p>

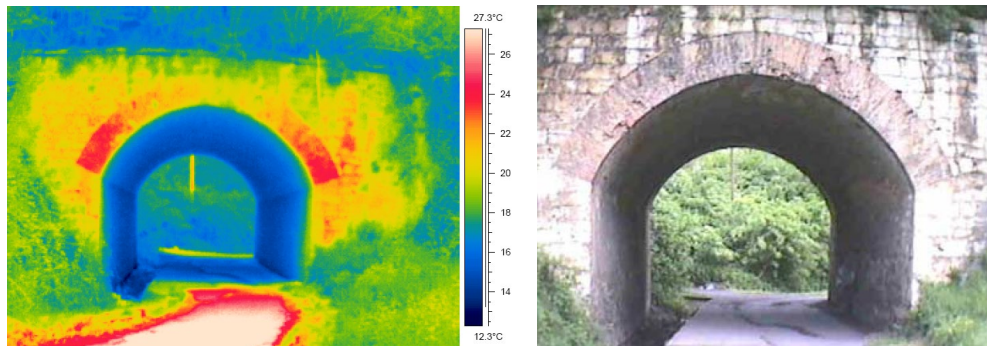
Image	Location
B4-02	Arch barrel (eastern side, at the extension of the bridge)
<u>Comments:</u> Longitudinal crack at the barrel can be identified at the thermal image.

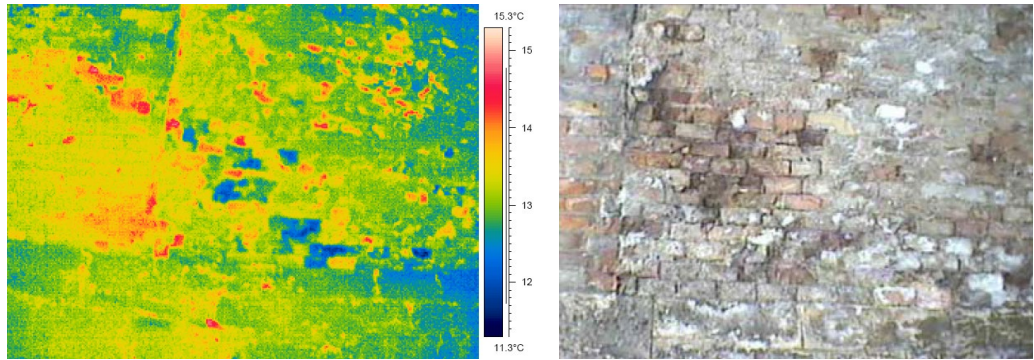
Image	Location
B4-04	Abutment (at the extension of the bridge)
<u>Comments:</u> The right part of the surveyed area on the image is covered by plaster while the left part is a stonework masonry with a highly weathered surface. The difference between the two parts can clearly be seen on the thermal image and the various construction materials can be identified. The lower part of the surface is wet that is seen on the thermal image.

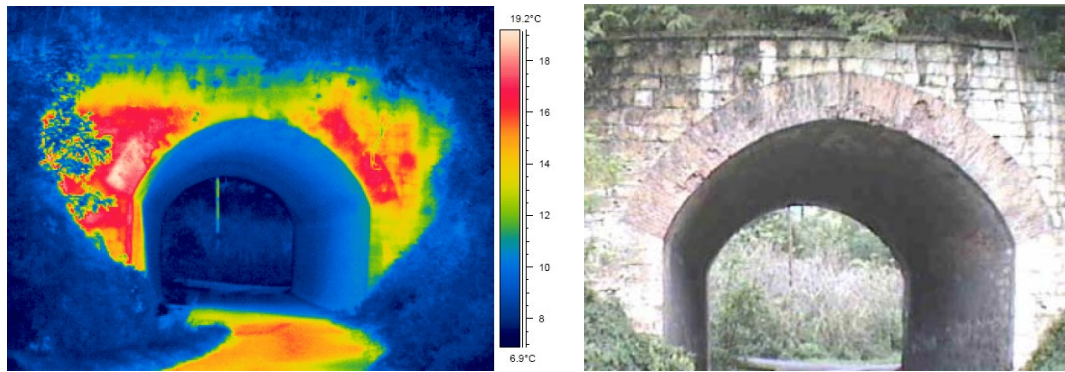
Image	Location
B4-06	Arch barrel (at the extension of the bridge)
<p><u>Comments:</u> Longitudinal crack (separation at the extension) at the barrel can be seen on the thermal image. The right part of the surveyed area on the image is covered by plaster while the left part is brickwork masonry with a highly weathered surface. However this difference between the two parts cannot be identified on the thermal image. No other anomaly can be identified.</p>
