# Technical Note

## Kinematics of a Translational/Rotational Landslide, Central Andes, Northwestern Argentina

LILIANA DEL VALLE ABASCAL

GUSTAVO GONZÁLEZ BONORINO

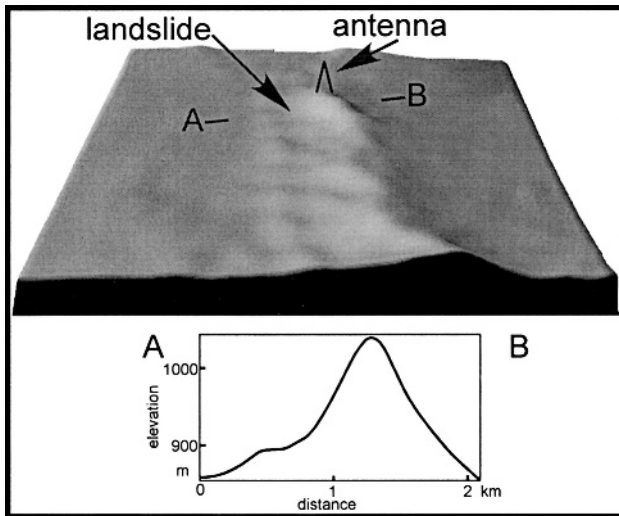
Figure 2. Digital elevation model (DEM) of the Termas Hill area and elevation profile across the site of the slide, showing the upfaulted rock ledge. This ledge partly protects base-of-slope areas from landslides generated on the western flank of Termas Hill. DEM obtained from Shuttle Radar Topographic Mission images processed with 3DEM software of the U.S. Geological Survey. View northward. The position of the communications antenna is indicated.

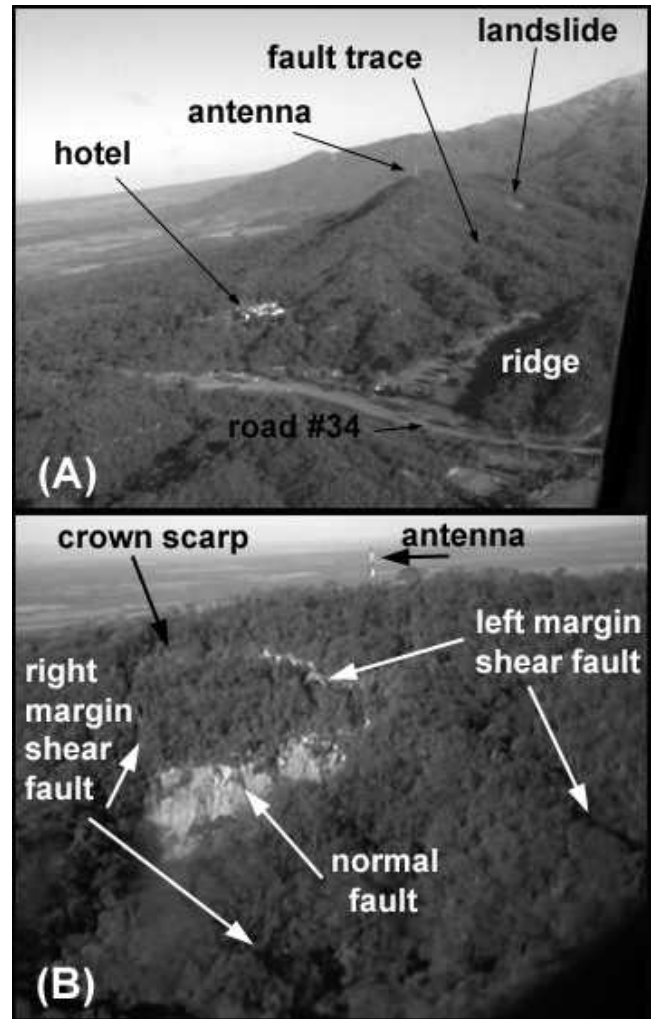
Figure 3. Aerial views. (A) View to the south-southeast showing the landslide site on the western flank of Termas Hill. Road 34 follows wind gap. (S = Saladillo Creek partly hidden by airplane wing). (B) View east-southeast showing main structural features of the Termas Hill landslide. Note the trace of shear faults in vegetated slope. Photographs courtesy of J. G. Viramonte.

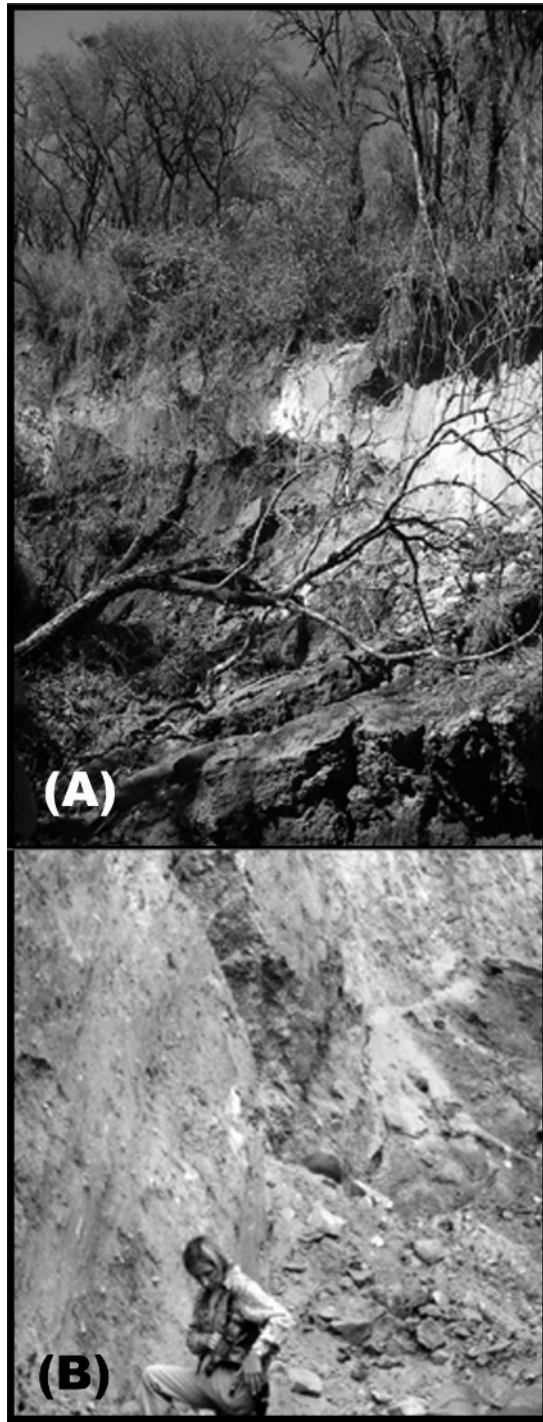
Figure 4. (A) Crown scarp. Note the shallow root zone. In the foreground is rotated slump left behind by the slide. (B) Scarp of the right-margin shear fault curves into the crown scarp in the background.

concave downslope and merges smoothly with the scarps formed by the lateral shear faults (Figure 4B). The lateral scarps severed the service road almost at right angles. Between the crown scarp and the undisturbed part of the road, the lateral scarps cut

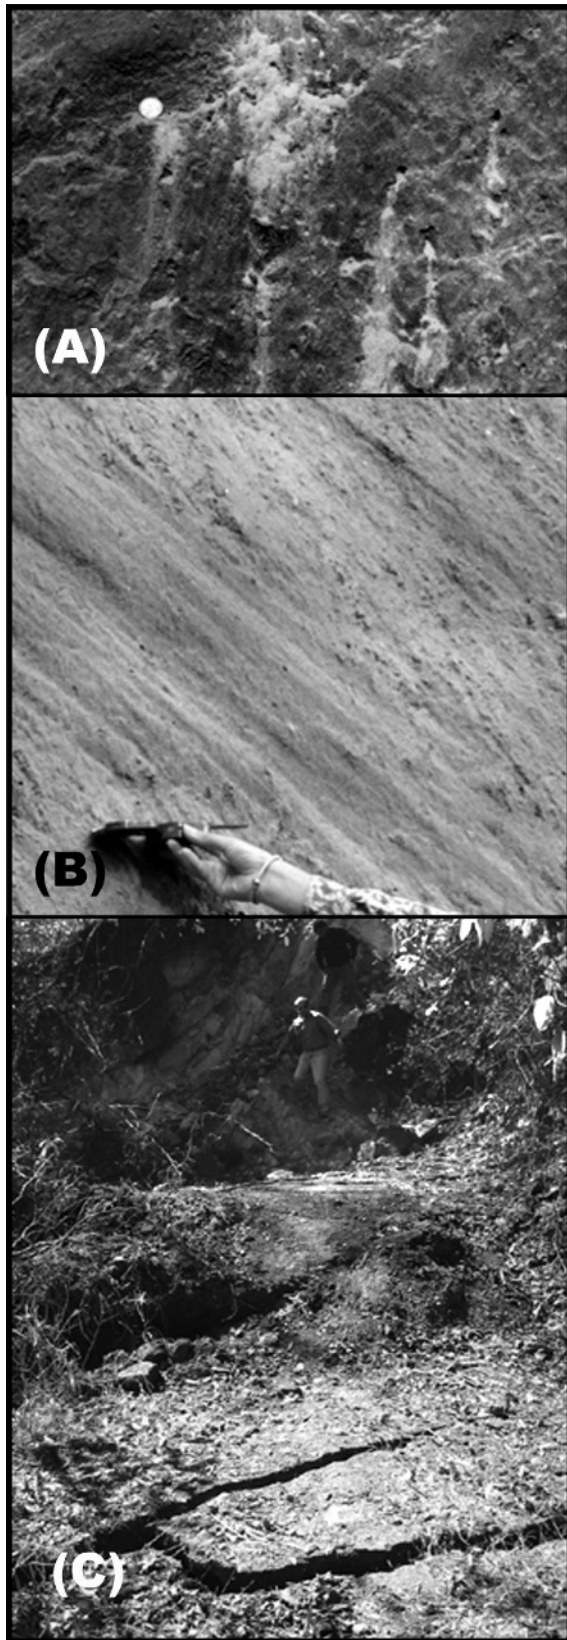
At the time of our first inspection, both lateral scarp surfaces showed well developed striations (Figure 5B); these were eroded away in succeeding months. Striations plunged downslope, on average,  $45^{\circ}$  on the right-margin (looking downslope) scarp surface and  $32^{\circ}$  on the left-margin scarp surface. In addition to the striae, the right-margin scarp surface showed pluck marks indicating displacement obliquely up the scarp of the landslide body (Figure 5A).

Figure 5. (A) Pluck marks slightly inclined downslope and downstepping up the scarp indicate initial upward movement of the slide block. Coin on pluck step measures 1.5 cm in diameter.

(B) Striations on the right-margin scarp plunge  $35^{\circ}$  downslope. (C) View toward the northern lateral fault plane exposing strata of the Anta Formation in the background and part of the displaced service road in the foreground. Note the tension cracks near the bottom of the photograph and the compression ridge in the middleground. Person for scale. Photograph courtesy of J. G. Viramonte.

Striations on the left-margin scarp surface plunge parallel to the dip of the greenish mudstone layers, indicating translational movement of the slide. Striations on the right-margin scarp surface plunge at an angle 5–10° higher than in the Anta Formation and are spatially associated with pluck marks that indicate reverse offset at this shear fault. It is tentatively suggested that plucking occurred first because of upward displacement of the slide block against the right-hand wall and that the striations developed immediately after as the slide settled downslope from a topographic position slightly higher than that of the left slide margin.

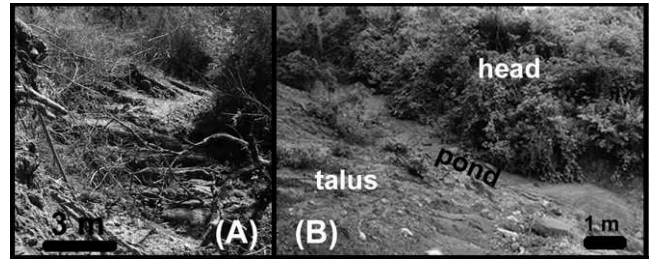
The offset road segment, presently located 30 m downslope from its original position, consists of a central 90-m-long straight segment bounded at each end by shear zones associated with the lateral faults. A narrow (about 5-m wide) shear zone adjoins the right margin scarp (Figure 6B), whereas toward the left margin closely spaced *en echelon* faults deformed the road into an arcuate trace (Figure 6A). The displaced road segment is traversed perpendicularly by tension cracks measuring up to 4 m in length and 3 m in depth (Figures 5C and 7A). In addition, a few compression ridges developed perpendicular to the road. The largest compressive ridge adjoins the right margin scarp, rising to 0.4 m above the surrounding road level (Figures 5C and 7A). A subdued ridge is present in the central reach of the displaced road segment.

The head of the slide includes the displaced road segment. The depletion zone measures about 30 m in downslope width and is largely covered by debris (Figure 7B). The head of the slide rises 3–5 m above the floor of the adjoining depletion zone, a situation that has led to ponding of rainwater and deposition of horizontal laminae of mud and fine sand over an elongate area parallel to the main scarp and about 60-m long and 3-m wide. An isolated ridge of displaced material carrying in situ vegetation is located at the northeastern corner of the slide area; the ridge crest rises 3.5 m above the level of the pond (Figure 7A). A subordinate volume of detritus occurs as talus and slumps along the foot of the main and lateral scarps. A comparison of photographs taken by other parties in October 2003 and by us in February 2004 suggests that most of the detritus accumulated during and shortly after the slide event. Approximately 150 m

Figure 6. (A) The sheared and segmented southern end of the service road. Note *en échelon* pattern of faults. Scale valid in middle ground. (B) The vegetated head of the slide has dammed running water, giving rise to an ephemeral pond; vegetation traveled with the slide. Talus from the crown scarp can be seen in the foreground. View oblique downslope.

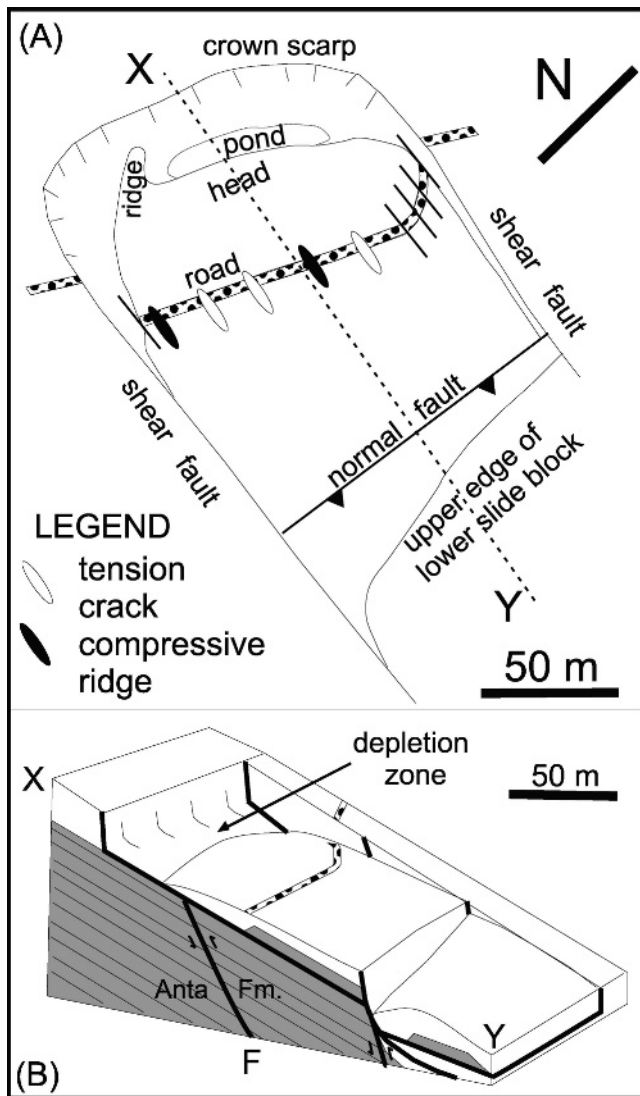
downslope from the crown scarp, a normal fault dipping  $60^{\circ}\text{W}$  severed the displaced material into two slide units of similar area. At the normal fault, the downthrown block rotated into the Termas Hill. The trace of the lateral faults bounding the lower slide unit can be recognized from the disrupted pattern of the vegetation, but the faults themselves are not exposed.

Figure 7. Schematic of the Termas Hill landslide. (A) Plan view. (B) Block diagram along dashed line XY in A (regolith in white; Anta Formation in light gray). The subsurface structure in the right half of diagram is speculative. Note the main slip surface cut by a subsequent normal listric fault. See text for description.

The slide block is cut in two by the normal fault at half length (Figure 7A). Inward rotation near the fault suggests the action of a listric normal fault. It is postulated that the translational displacement occurred first, affecting slide blocks on both sides of the normal fault and that the rotational displacement occurred immediately, or shortly, after (Figure 7B). Normal faulting probably reactivated the reverse fault upholding the rock ledge and may have been favored by a thickening of the colluvium in the lower slope of Termas Hill. The position of the toe of the slide may have been governed by the rock ledge flanking Termas Hill (Figure 2).
