International Journal of Disaster Risk Reduction

A cascading risk model for the failure of the concrete spillway of the Toddbrook dam, England during the August 2019 flooding

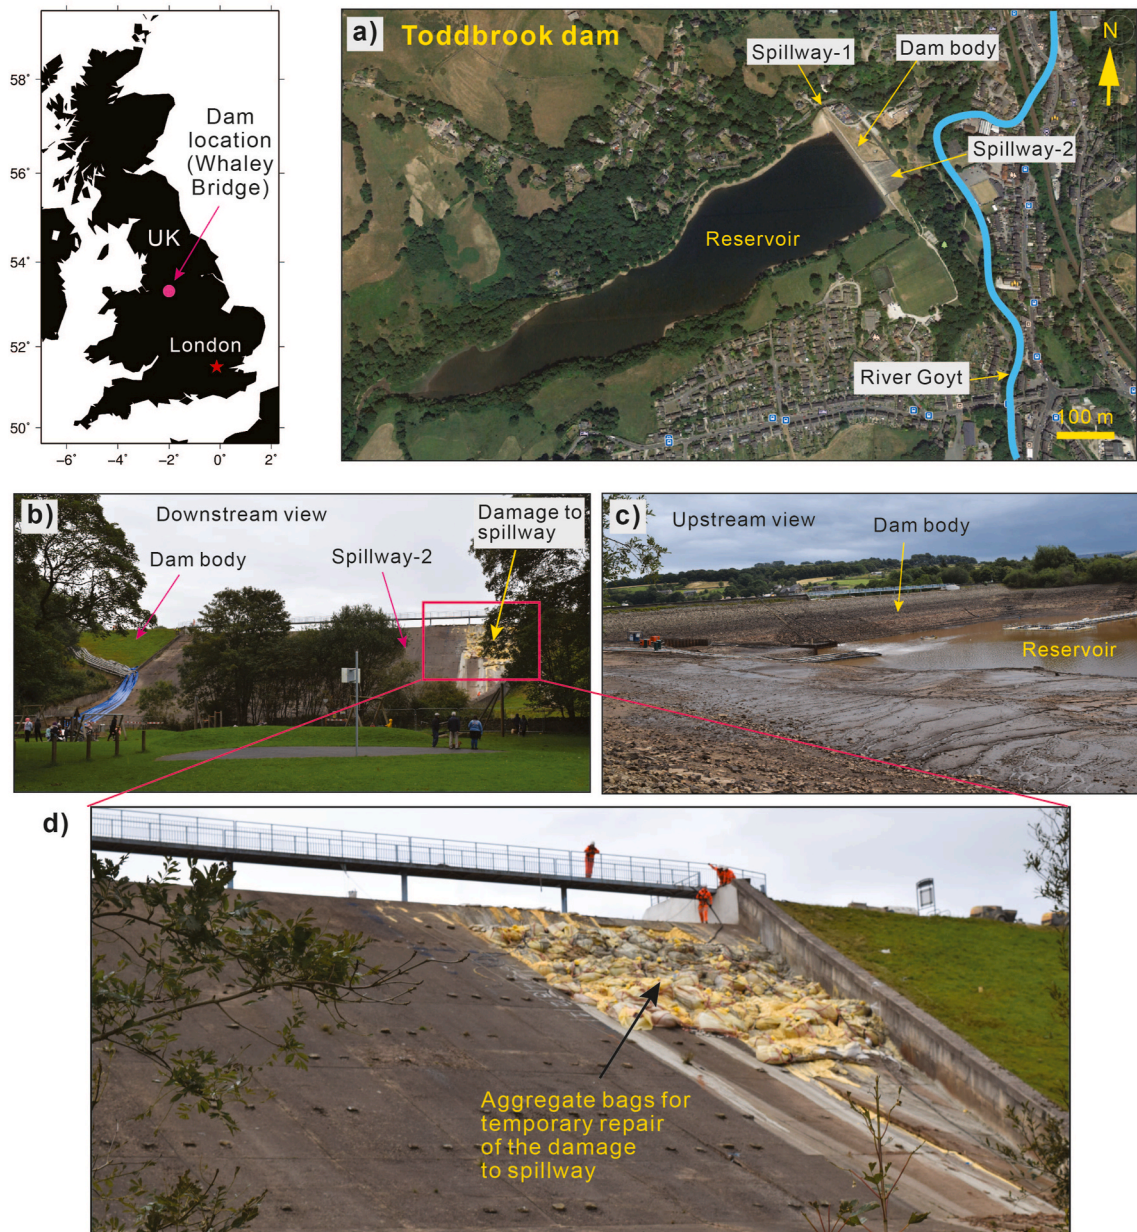
The Toddbrook earth-fill dam, England, Fig. 1, was on the brink of failure in 1–3 August 2019 following the failure of the dam’s auxiliary spillway (spillway-2 in Fig. 1a, b, d) while the reservoir was at the maximum water level due to torrential rainfall and flooding in the area. As seen in Fig. 1b,d, part of the left side of the concrete spillway was washed away by the water flow. The dam eventually survived, and the overtopping of the embankment was prevented through rapidly decreasing the reservoir water level by hiring multiple powerful pumps. Fig. 1d shows that tens of aggregate bags were employed during the incident and were placed on the damaged part of the spillway in order to prevent progressive erosion of the dam body. The aggregate bags were placed on the spillway

Fig. 1. Location of the Toddbrook dam in the UK and its dam body and two spillways. The damaged part of the spillway is shown in panels “b” and “d”. The yellow aggregate bags, shown in panel “d”, were placed at the damaged part of the spillway to stop the spread of the damage as a temporary measure. Photos in “b”, “c” and “d” are taken during our field survey in August 2019 while panel “a” is from Google-Earth (<https://earth.google.com>). The pink box in panel “b” is enlarged in panel “d”.

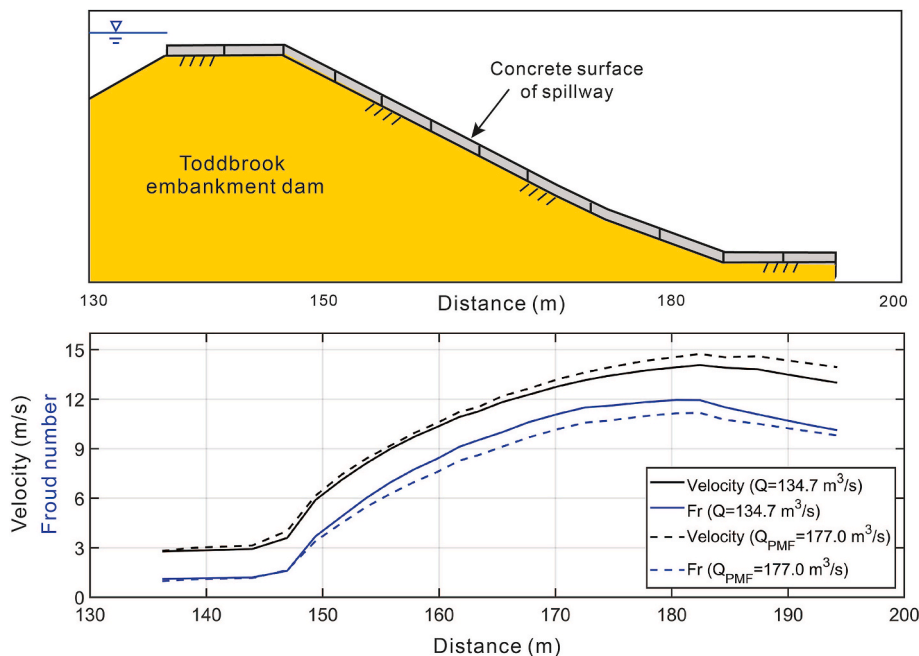
Fig. 5. Results of water velocity (black) and Froude number (blue) analyses along the concrete surface of the Toddbrook dam spillway-2 at two water discharges of $134.7 \text{ m}^3/\text{s}$ and $Q_{PMF} = 177.0 \text{ m}^3/\text{s}$. Fr in Froude number.

For the case of the Toddbrook dam, our modelling revealed that spillway-2 experiences a maximum flow velocity of approximately 15.0 m/s at the PMF (Fig. 5). The spillway-2 is made of 15-cm thick concrete slabs, which are not reinforced with rebars. Such

- We calculated a maximum flow velocity of approximately 15.0 m/s over the surface of spillway-2. Such a high-velocity flow played a major role in the failure of spillway-2 through facilitating water injection beneath the spillway slabs and cavitation forces.

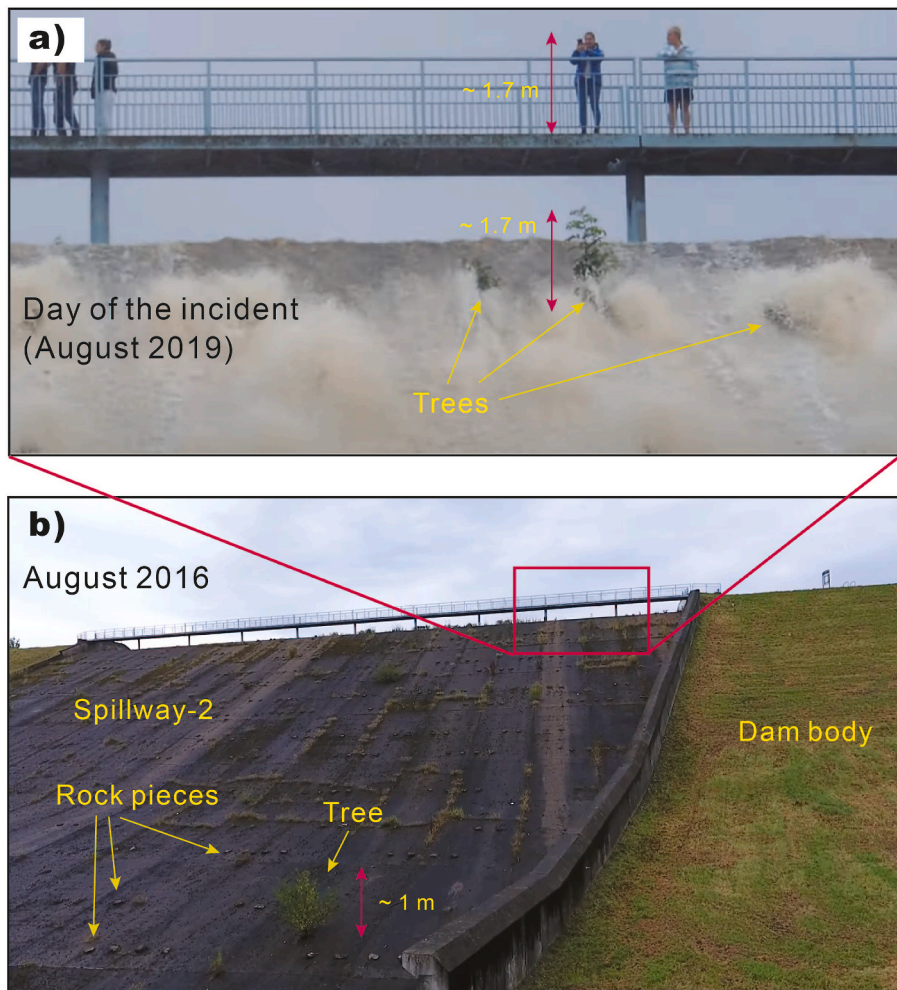
Analysis of photos and videos from the Toddbrook dam incident reveals that the concrete surface of the spillway-2 was in a poor condition at the time of the incident. Dense vegetation including a few trees were present on the surface of spillway-2 when high-speed flow was passing over it during the incident (Fig. 6a). It is noted that at least three trees, one of them approximately 1.7 m tall, are seen at the damaged part of the spillway during the incident. A review of satellite images of spillway-2 over the period of 1999–2020 (Fig. 7) reveals that the spillway surface was cleaned up of vegetations and trees from time to time. For example, the surface appears to be in a good condition in December 1999 (Fig. 7f) and December 2005 (Fig. 7b), but it is covered with vegetation and trees in other times (Fig. 7b,c,e). It is most likely that the foundation of spillway-2 has been seriously undermined due to the extensive growth of vegetation and trees over years; therefore, the concrete slabs were not resting on a solid foundation. As a result, any water injection beneath the slabs could lead to erosion of the foundation and settlements of the slabs (Fig. 8).

Fig. 6. Photos of the Toddbrook dam's spillway-2 from the day of the incident in August 2019 (a) and August 2016 (b) showing the growth of vegetation and several trees over the spillway. Photo in "a" is a snapshot from the video at: <https://www.youtube.com/watch?v=pOu5AHJ1U8&t=3s> whereas the photo in "b" is from <https://www.youtube.com/watch?v=qQNh2lhYXBM>.

In addition, the concrete surface of spillway-2 is embedded with numerous rock pieces (Fig. 6b) at certain intervals whose dimensions are approximately 22 cm (length) \times 22 cm (width) \times 22 cm (height) [16–18] and some of them were removed before or during the incident. It is not clear as why such rock pieces are placed on the spillway surface, but certainly they cannot yield the hydraulic performance of chute blocks due to their small sizes and poor connection to the main slabs. Rather, these small rock pieces could cause cavitation and damaging forces on the main slabs during the passage of high-velocity flows. In addition, removal of some of these rock pieces could lead to increased water injections beneath the slabs [16–18].

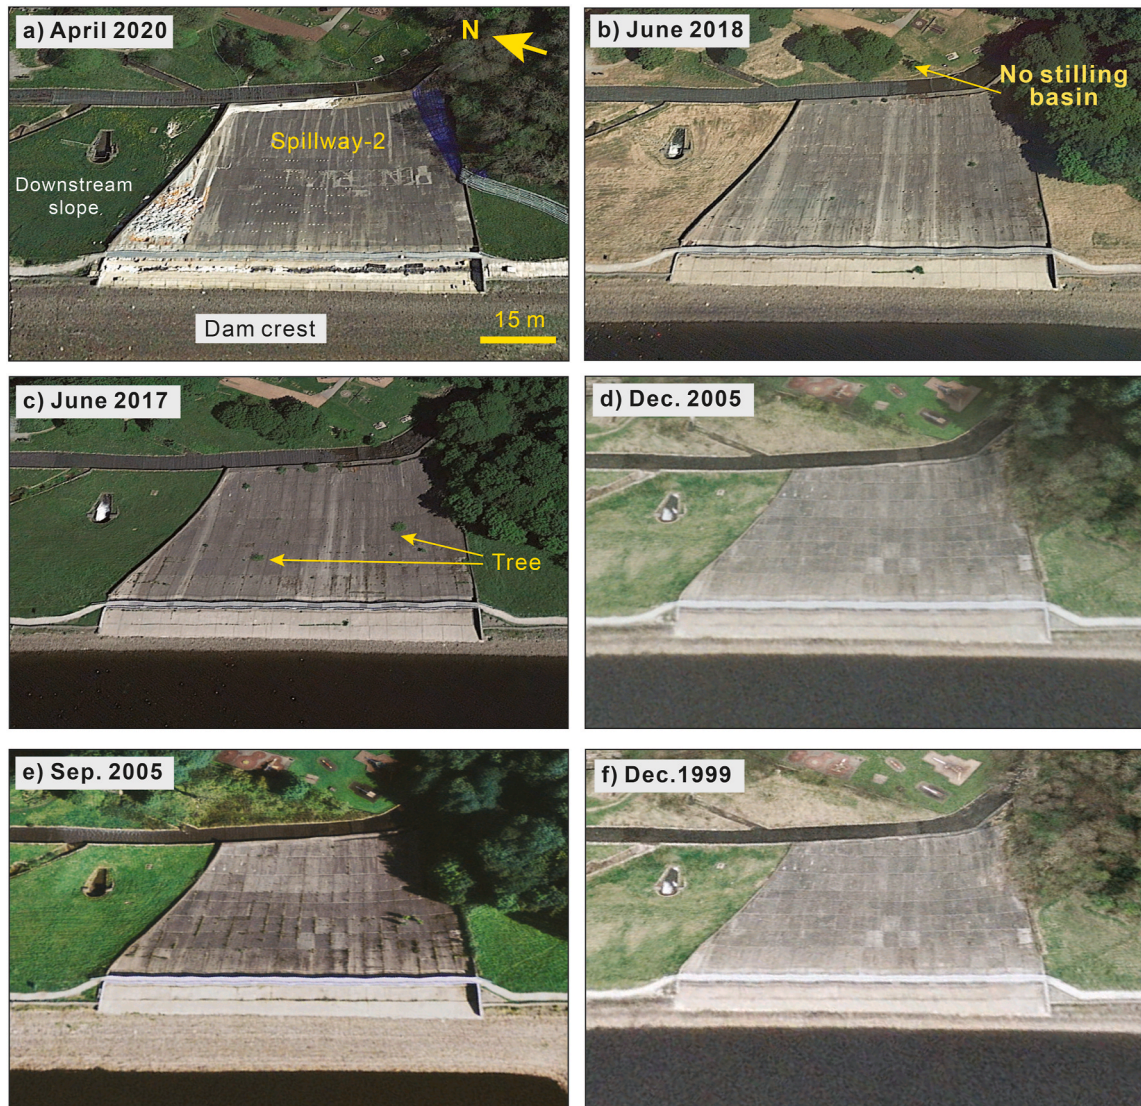
Fig. 7. Satellite images of the Toddbrook dam spillway-2 at different times before and after the incident (August 2019) based on GoogleEarth data (<https://earth.google.com/>).

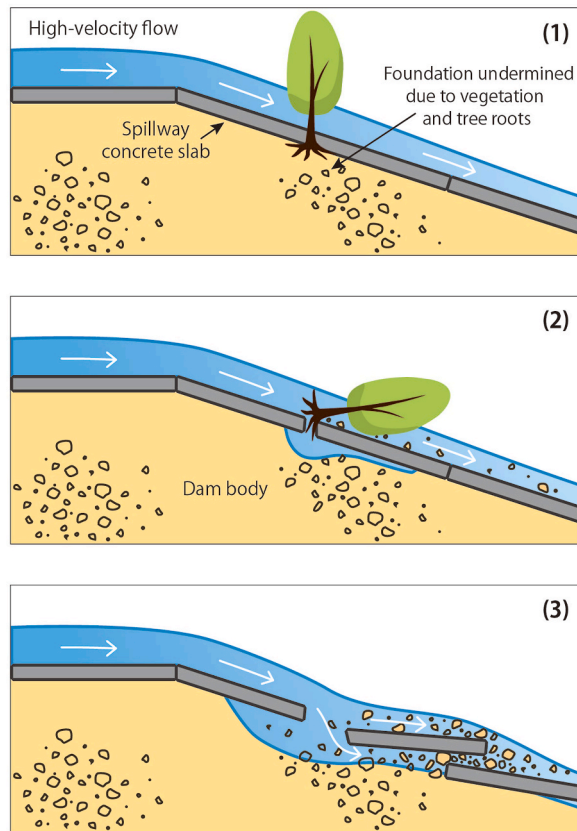
Fig. 8. Sketch showing a possible sequence of events contributing to the damage to the Toddbrook dam spillway-2 in August 2019.

water injections appear to be inevitable, at least at part of spillways during high-speed flows. In fact, the damage or failure of spillways occurs when water injection is combined with an undermined foundation as well as under-designed concrete slabs.

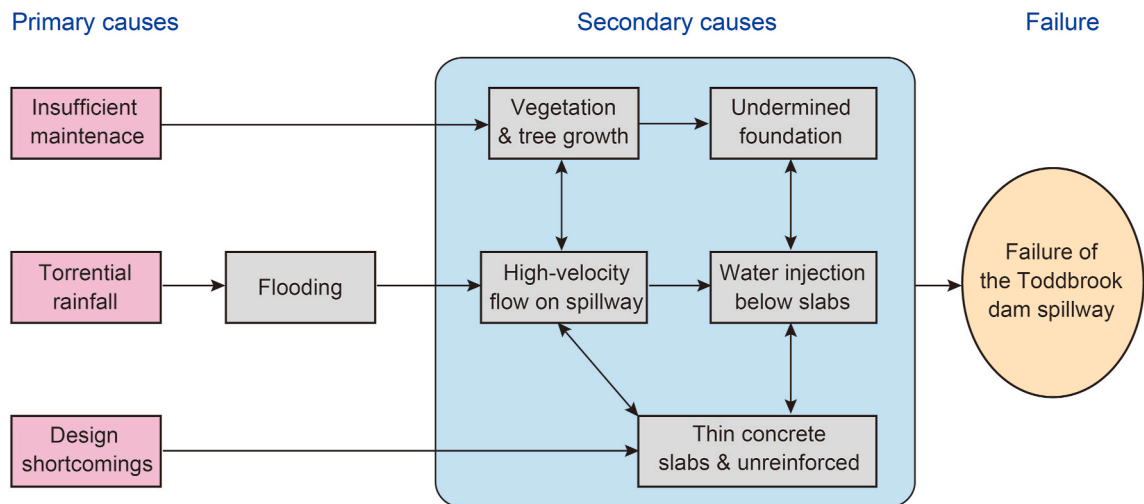
In summary, we attribute the failure of the Toddbrook dam spillway to a combination of three primary factors comprising insufficient maintenance, design shortcomings and the torrential rainfall (Fig. 9). Each of these factors interacted with each other and cascaded to other causes to produce the failure of the spillway (Fig. 9). The construction joints and cracks, generated by vegetation and tree growth, largely facilitated water injection beneath the spillway slabs. In addition, the foundation was significantly undermined

Fig. 9. The cascading risk model showing a flowchart of events and various primary and secondary causes leading to the damage to the Toddbrook dam spillway-2 in August 2019.

over years by extensive vegetation and the concrete slabs were relatively thin and under-designed (only 15 cm thick and unreinforced). It is hard to exactly determine the contribution of each factor in creating the failure, but it is very likely that the failure was the outcome of a combination and cascade of different factors (Fig. 9).

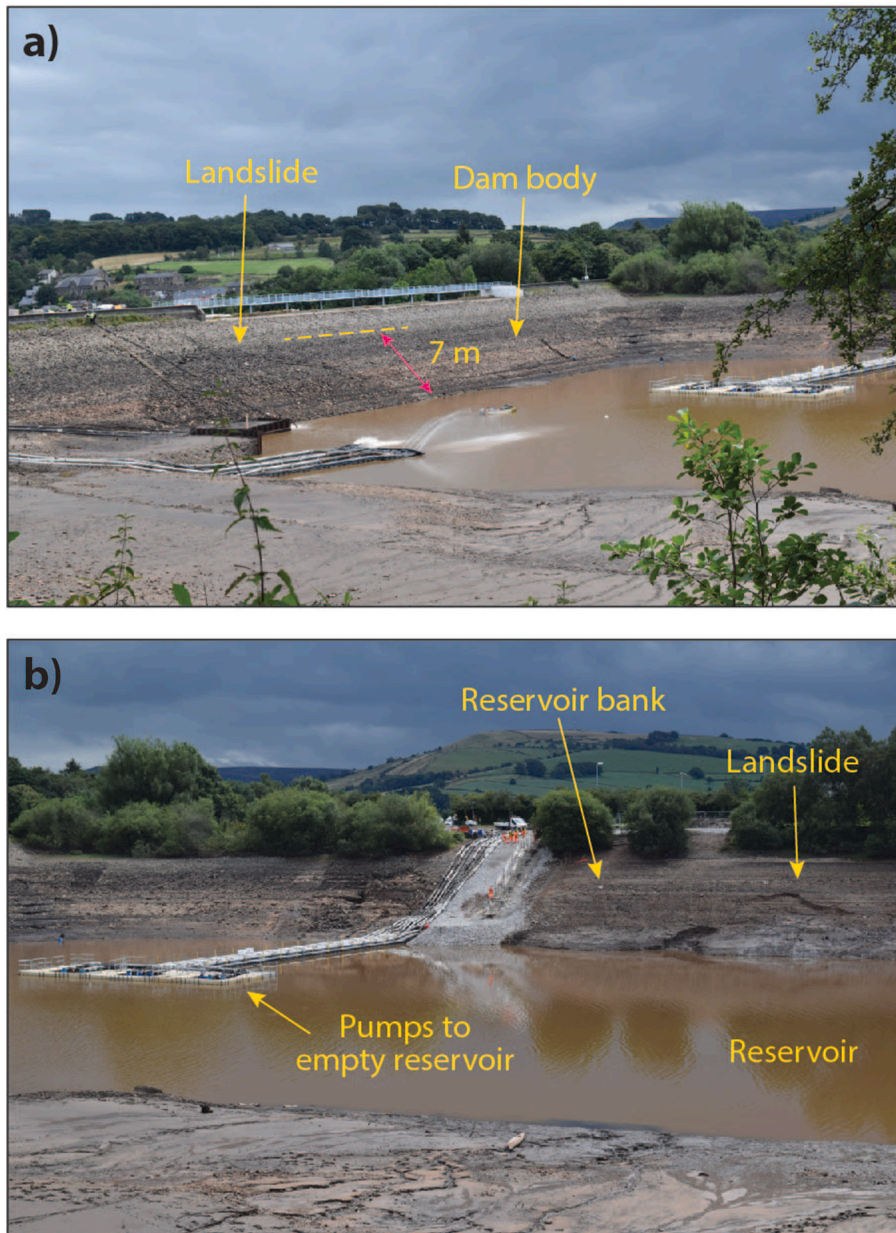
As a response to the failure of spillway-2, a rapid drawdown of the Toddbrook reservoir was conducted during the August 2019 incident as authorities rushed to empty the reservoir by employing multiple powerful pumps (Table 1, Fig. 10b). According to Table 1, the reservoir water level was dropped more than 9.0 m, and the reservoir water volume was decreased to 17% of its maximum volume in six days. As a result of such a rapid drawdown, several minor landslides occurred; the most critical landslide occurred on the upstream slope of the embankment, which has a height of approximately 7.0 m (Fig. 10a). Other landslides occurred on the reservoir banks (Fig. 10b). These landslides are evidence that the process of decreasing reservoir water level occurred at a high speed, which posed a risk for the safety of the dam. Although the landslides are minor and they did not create major risks, larger movements of the landslide on the downstream slope of the dam could result in a major damage. In addition, large landslides on the banks of the reservoir can generate large waves in the reservoir, which could overtop the dam.

Fig. 12 shows the results of dam stability analysis under the rapid drawdown situation. In case of rapid drawdown from water level of 186.0 masl to a water level of 176.0 masl, the failure mechanics is observed at the upstream side of the dam and many local failures and holes are generated resulting in a safety factor of marginally below 1.0 (Fig. 12). At the water level of 176.0 masl, however the factor of safety of the entire dam is above 1.0 indicating that the failure of the entire dam is not likely, but parts of the upstream slope of the dam are damaged (Fig. 12). This means that the dam operator will need to introduce measures to repair the damaged surfaces. The results of our PLAXIS modelling of the rapid drawdown are consistent with field observations of the dam site following the incident, which identified a landslide on the upstream side of the dam (Fig. 10a).

Fig. 10. Several landslides observed following the rapid drawdown of the Toddbrook reservoir in August 2019. a) Photo showing a landslide on the upstream side of the embankment. b) Photo of a landslide in the banks of the reservoir.

- We observed a landslide on the upstream slope of the dam as a result of the rapid drawdown, which was reconstructed through our geotechnical modelling. This implies that a slower pace must have been taken during the process of emptying the reservoir.

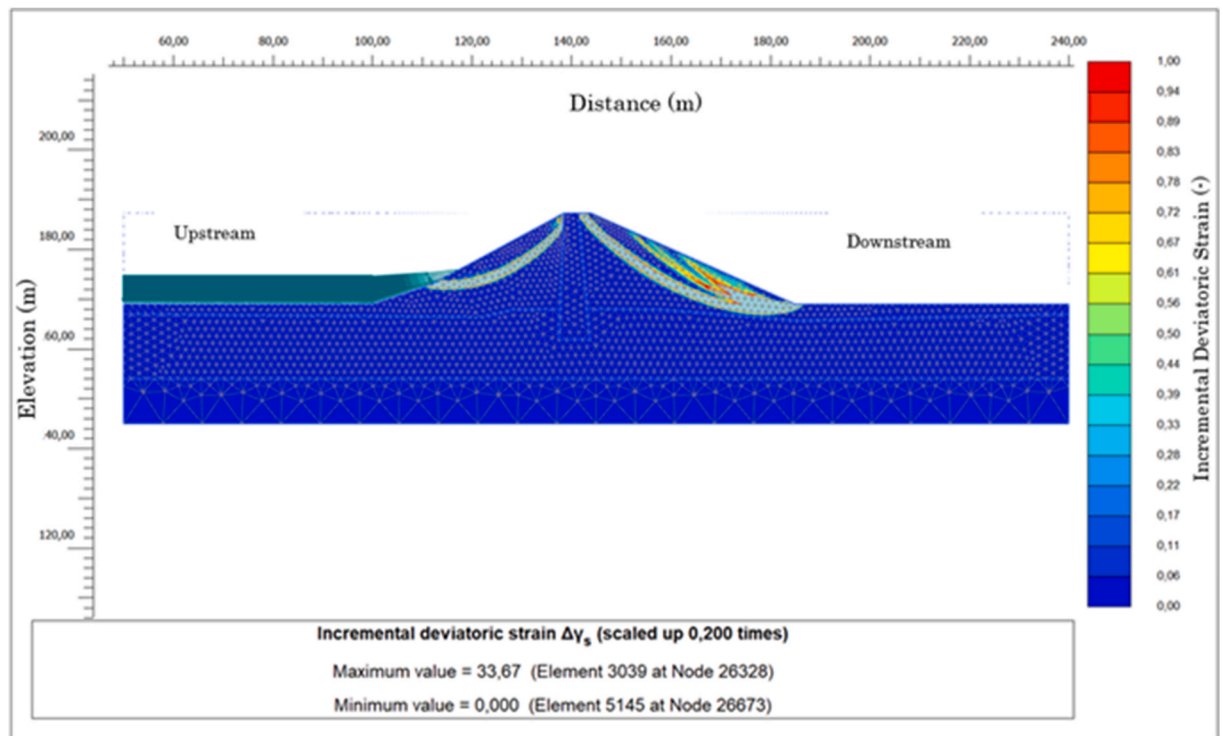
Fig. 12. The result of reservoir rapid drawdown analysis of the Toddbrook dam using the PLAXIS modelling package during the August 2019 incident.

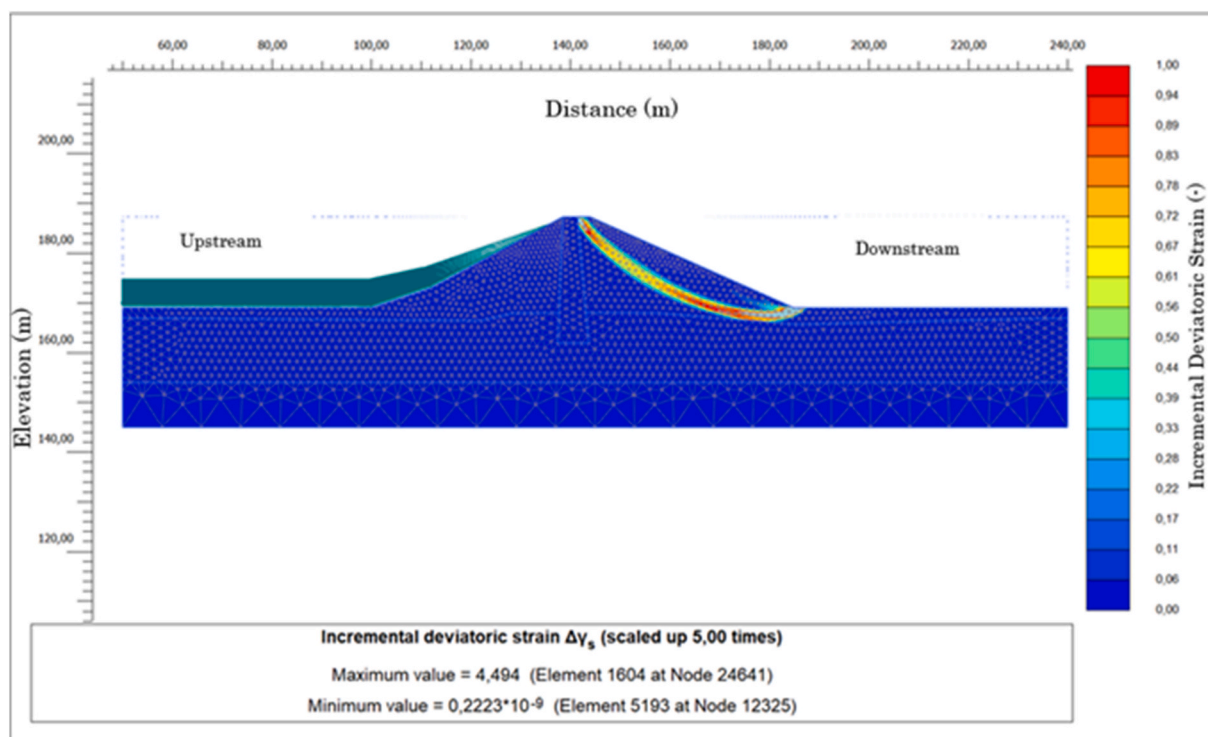
Fig. 13 shows the results of the overall dam stability when the water level is at 186.0 masl. Results indicate that, at such a high

water level (i.e., 186 masl), the water pressure makes the upstream slope of the dam more stable; therefore, the probability of occurring a failure at the upstream side of dam is low as long as overtopping of the embankment does not occur. It is needless to say that, in case of overtopping, the entire dam could be washed away in a few hours as soil embankments are very vulnerable to flowing water. Analysis shows that the factor of safety at this water level (i.e., 186.0 masl) is marginally above 1.0 and the main failure surface occurs at the downstream side of the dam (Fig. 13).

Fig. 13. General stability analysis of the Toddbrook dam slopes using the PLAXIS software during the August 2019 incident.
