Sense-B-noise: an enigmatic cause for inappropriate shocks in subcutaneous implantable cardioverter defibrillators

Received 5 April 2022; accepted after revision 30 September 2022

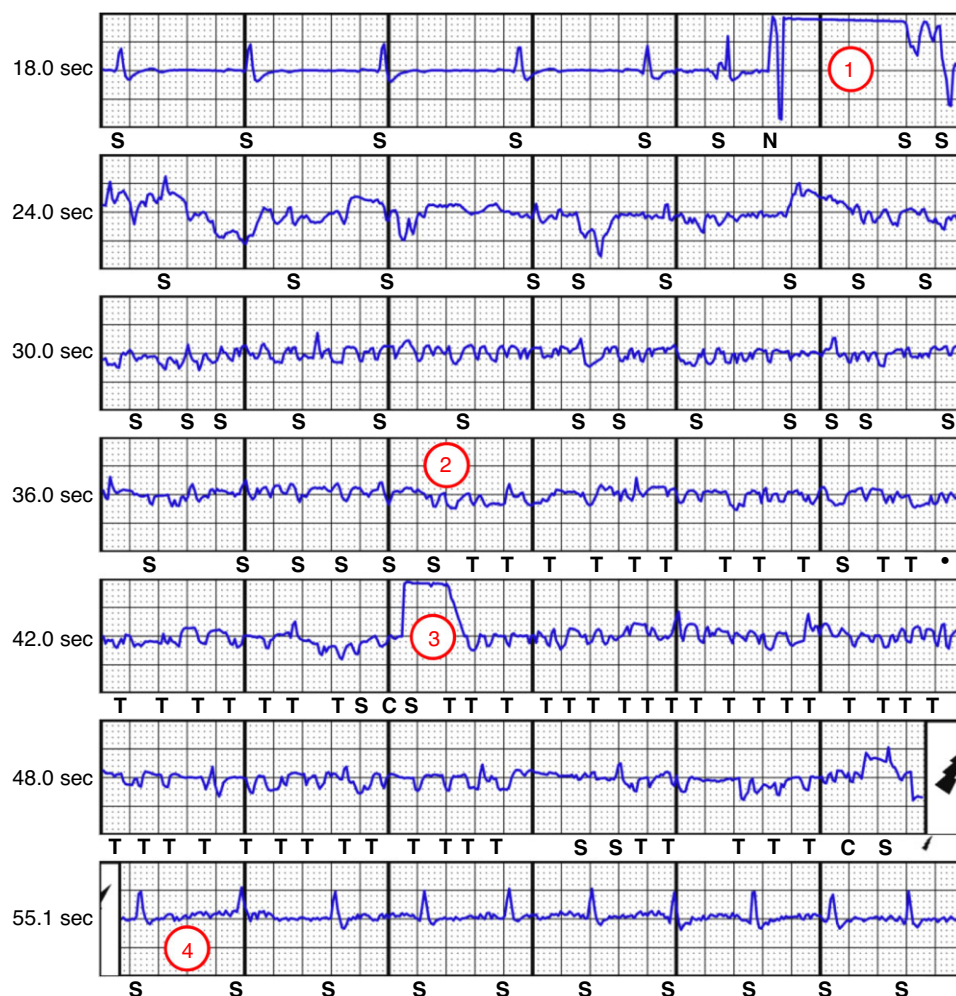
A 29-year-old male had received an Emblem A219 S-ICD with a 3501 lead (Boston Scientific, Marlborough, MA, USA) in July 2019 due to idiopathic ventricular fibrillation (VF). Two months after implantation, he received two shocks due to VF. After 16 months, while working on the computer, the patient received an IAS (Figure 1; SMART pass on, primary sensing vector, gain 2X, shock impedance 64Ω). Device manipulation and provocation manoeuvres showed no suspicious findings. The patient underwent system revision and the complete S-ICD was sent to the manufacturer for analysis. The analysis revealed that no lead defect was present. However, changes in the generator's impedance pathway of the primary sensing vector were identified, which may have caused the noise oversensing according to the manufacturer.

Figure 1 Inappropriate shock due to oversensing (Case #1). The episode begins with a sudden artefact driving the signal into saturation (1). Subsequently, the cardiac signal becomes largely unrecognizable with low-amplitude signals (2), and the S-ICD starts to charge (3, charging artefact). The shock delivery is ensued by normal QRS signal amplitudes (4).

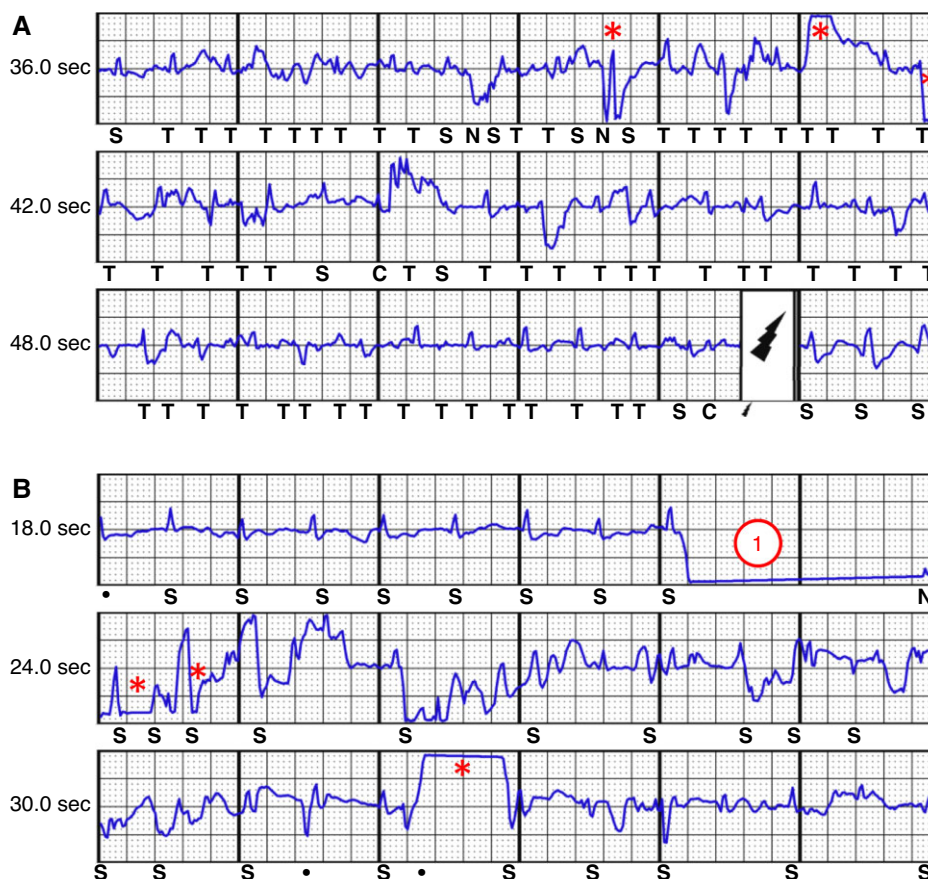
A 25-year-old woman had received an Emblem A219 S-ICD with a 3501 lead in February 2020 due to malignant mitral valve prolapse (primary prevention). Six months later, she experienced an IAS (Figure 2A). Another untreated episode had been registered two weeks prior (Figure 2B). During shock delivery (SMART pass on, primary sensing vector, gain 1X, shock impedance 59Ω), she was cleaning the floor.

Figure 2 Patient Case #2. Panel (A) inappropriate shock due to artefact oversensing. Signal saturation episodes are visible (asterisks), the low-amplitude QRS becomes better visible after the IAS. Panel (B) similar to Figure 1, the episode is triggered by a sudden artefact (1). The ensuing artefact-rich signal shows episodes of signal saturation and oversensing.

Extensive device manipulation and provocation manoeuvres at rest and during exercise could not reproduce oversensing. The X-ray showed correct connection of the lead inside the header without signs of lead fracture or kinks. Lead revision was considered but—based on the manufacturer's suggestion—we only reprogrammed the device to secondary sensing vector and installed remote monitoring. The patient was successfully rescued from VF by an appropriate shock delivered 15 months after device reprogramming. During those 15 months and until today, no oversensing was observed.

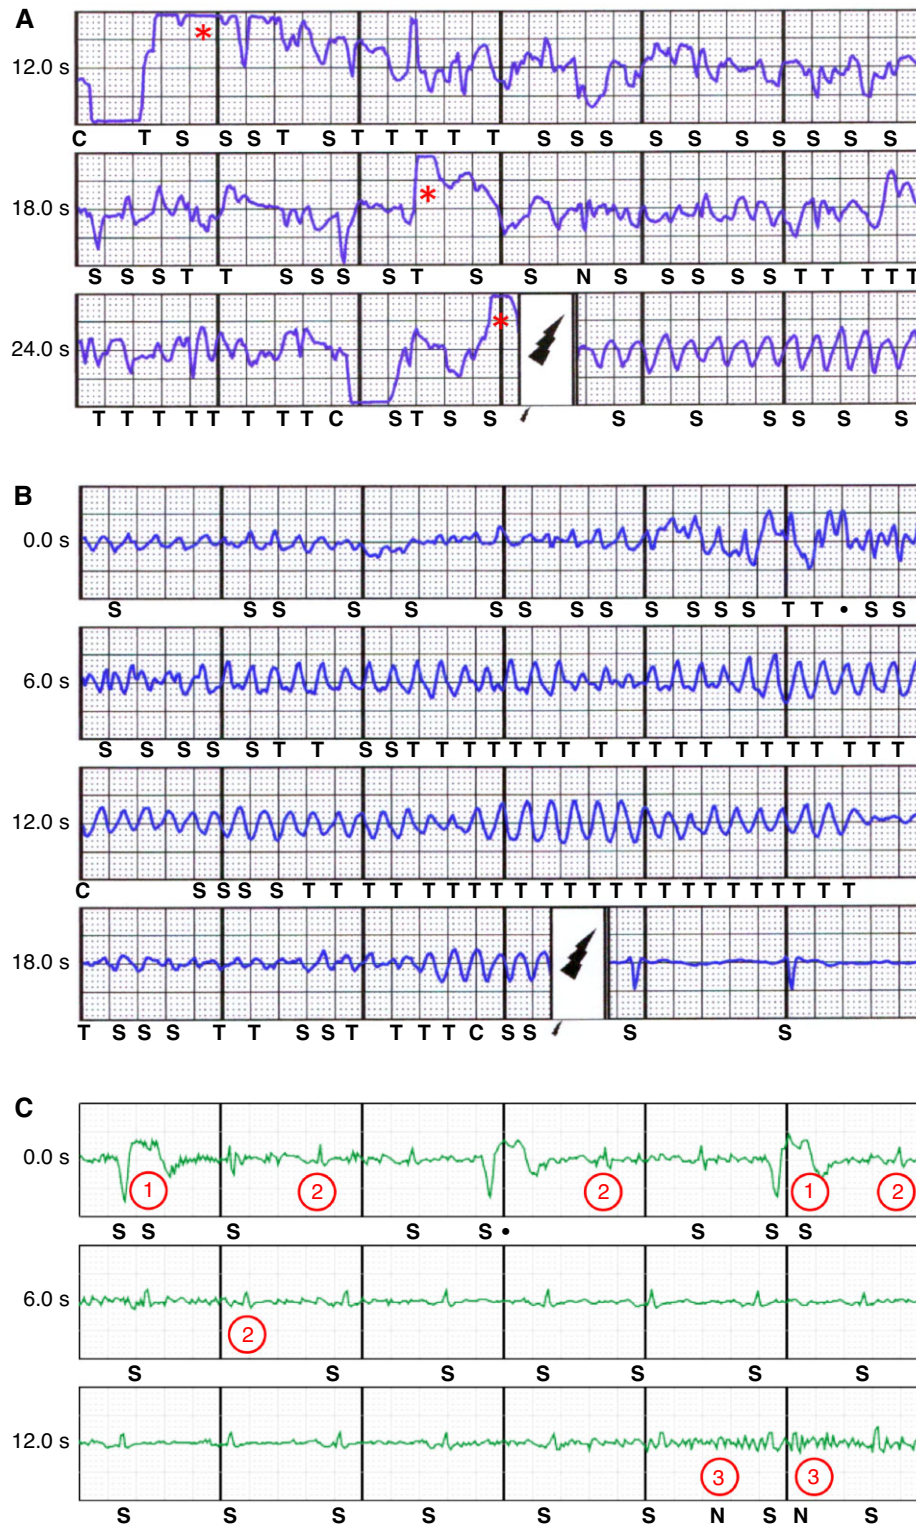
A 55-year-old female SCD survivor with long QT syndrome had received an Emblem A219 S-ICD with a 3501 lead in October 2019 after extractions of transvenous ICD systems (one due to lead fracture and another one due to superior vena cava syndrome). Twenty-seven months after S-ICD implantation, she received an IAS while being in atrial fibrillation and at rest (Figure 3A; SMART pass on, alternate sensing vector, gain 2x, shock impedance 90 Ω). The IAS induced VF, which was successfully defibrillated after 27 s (Figure 3B). The device was reprogrammed to secondary sensing vector and remote monitoring was installed. During follow-up, the SMART pass filter was automatically deactivated due to low-amplitude signals. Moreover, intermittent QRS undersensing and T-wave oversensing occurred (Figure 3C). The

Figure 3 Patient Case #3. Panel (A) patient with IAS inducing ventricular fibrillation. The shock is preceded by an artefact-rich signal with episodes of signal saturation (asterisks). Panel (B) shows the following second shock. Panel (C) remote monitoring of the patient in secondary vector. Episodes as shown in panel (A) were not registered anymore. However, intermittent T-wave oversensing (1) and QRS undersensing (2) occurred. Myopotential noise was appropriately classified by the device (3).

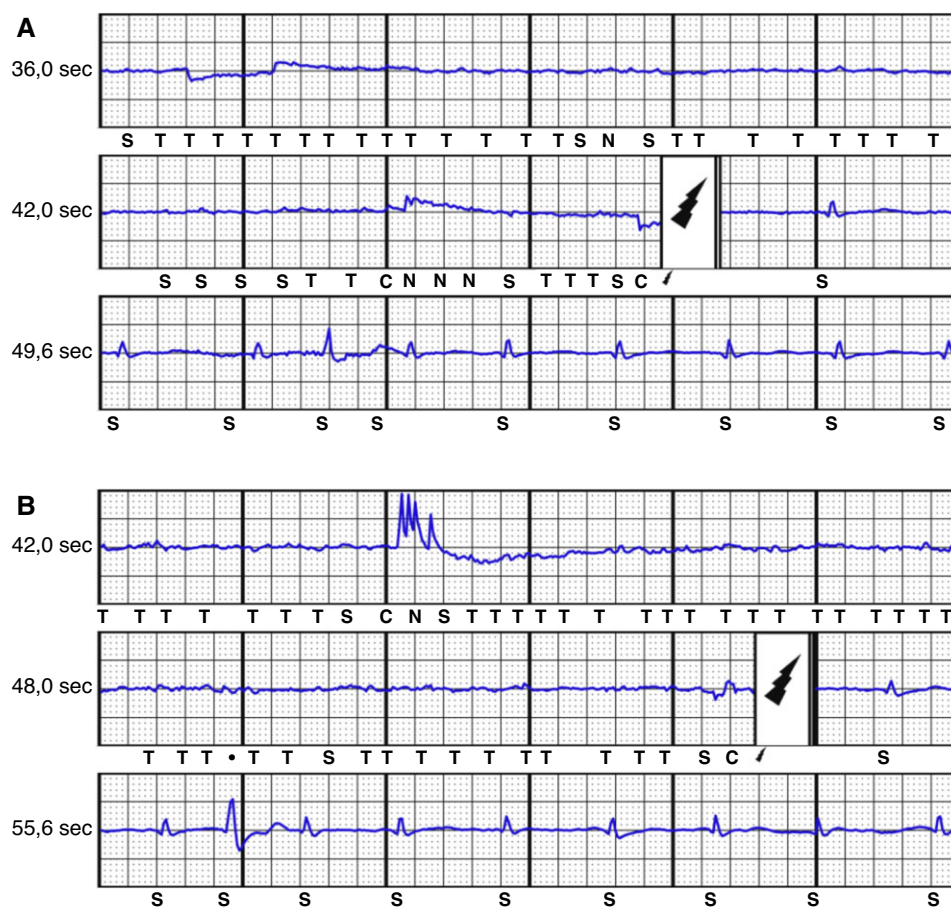
A 42-year-old male had received an Emblem A219 S-ICD with a 3401 lead in September 2016 after survival of sudden cardiac death (SCD, Chagas heart disease). Sixteen months after implantation, he received an IAS due to signal dropout (Figure 4A, SMART pass off, primary sensing vector, gain 1x, shock impedance 72 Ω). Similar non-sustained episodes with aborted shocks had been stored a minute before and on the preceding evening. Secondary and alternate sensing vectors showed low-amplitude signals, so the primary sensing vector was maintained, with re-activation of SMART pass. Two days later, the patient presented with a new IAS, again due to signal dropout (Figure 4B), again with automatic inactivation of SMART pass due to low signal amplitudes. Since there was no satisfying explanation, the patient underwent system explantation. Perioperatively, the suture sleeve was properly fixated and did not cover the proximal electrode, the lead pin was correctly inserted and showed no signs of failure. Technical analysis of the device by the manufacturer was unable to determine the root cause since the device function was unremarkable.

Figure 4 Patient Case #4. Panel (A) heavily diminished ECG signal amplitudes causing oversensing and shock delivery. Panel (B) similar episode 2 days later. Both episodes (panel B and C) showing QRS amplitude restoration after shock delivery.

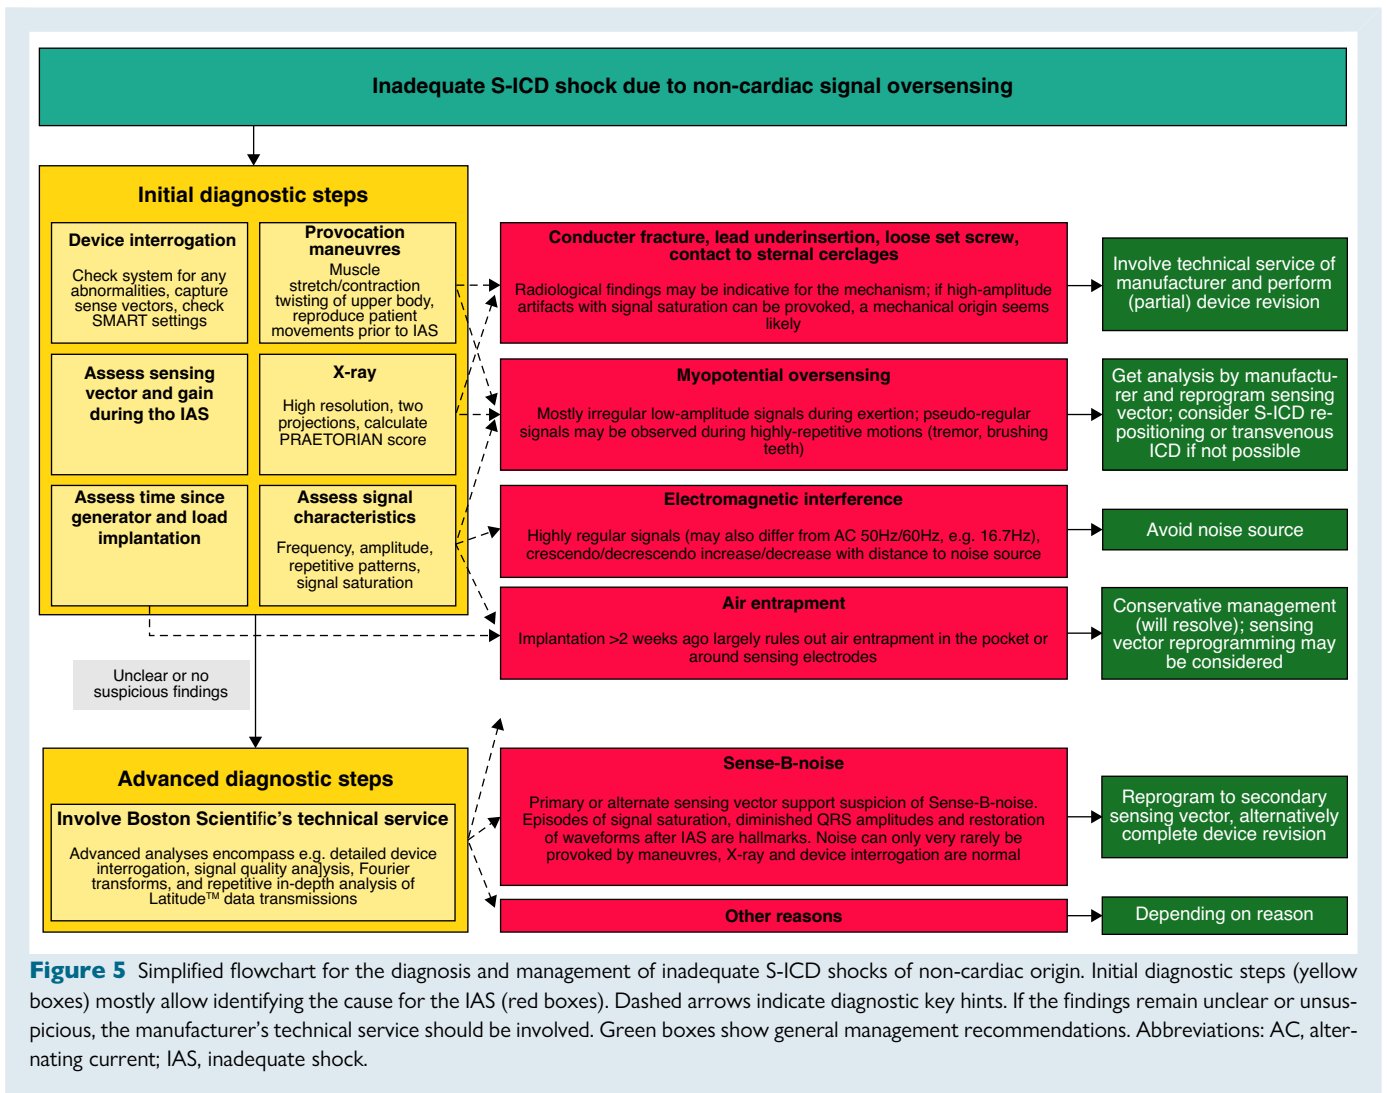
A challenging differential diagnosis is (partial) lead fracture, which may exhibit similar findings as described above.¹⁰ Lead fractures early after implantation are unlikely, but the manufacturer has released an advisory¹¹ due to lead body fractures distal to the proximal sensing ring of the model 3501, which has recently been replaced by a reinforced model.¹² When programmed in primary vector, this failure mode will not cause non-physiologic artefacts but if the device is programmed in alternate vector and only the distal sense conductor is fractured, similar artefacts with normal impedances may be seen. Chest X-ray does not necessarily reveal fracture of only some filars. Thus, if oversensing episodes can be provoked, lead or header issues have to be suspected and a system revision is required. IAS not only cause intense discomfort to patients but may result in the induction of ventricular tachyarrhythmia (Figure 3A). A flowchart summarizing the differential diagnosis and management of inadequate S-ICD shocks of non-cardiac origin is shown in Figure 5.

sensing vector accompanied by remote monitoring is an option in case of true Sense-B-noise if other causes of device failure have (largely) been ruled out after discussion with the manufacturer's technical support. The technical service of the manufacturer may provide additional information in the form of advanced remote monitoring or quantitative signal analyses. Whenever the secondary sensing vector cannot be used due to poor signals [Cases #3 (Figure 3C) and #4], device revision is recommended. However, Boston Scientific has not yet released specific general management recommendations.
