Dynamic Behavior of Connected Structures

Ahmad Fahmy Kamarudin^{1*}, Shahrul Niza Mokhtar¹, Seyed Jamalaldin Seyed Hakim¹, Zainah Ibrahim², Azmi Ibrahim³, Ade Faisal⁴

Abstract: The effect of connected structure on SMK Bukit Tinggi building was investigated based on their dynamic behaviour. The structure was constructed with four main buildings are interconnected. Ambient vibration testing (AVT) was used to predict the dynamic response and characteristics by using triaxial 1Hz seismometer and CityShark data logger. The AVT signals were analysed using GEOPSY software for Fourier Amplitude Spectral (FAS). All predominant frequencies (f_0) and mode shapes were identified and verified with previous research finding using similar testing approach on the same building, but with different instrument of accelerometer sensor and ARTeMIS software processing tool. Five modes of f_0 were found from the FAS curves from this research, but only four f_0 were obtained from ARTeMIS analysis. The highest deviation percentage was indicated at the 5th mode of building frequency at 9.5 %, but 0 to 2.5% to the rest frequencies mode (1st to 4th frequencies mode). Ununiformed buildings response behaviour

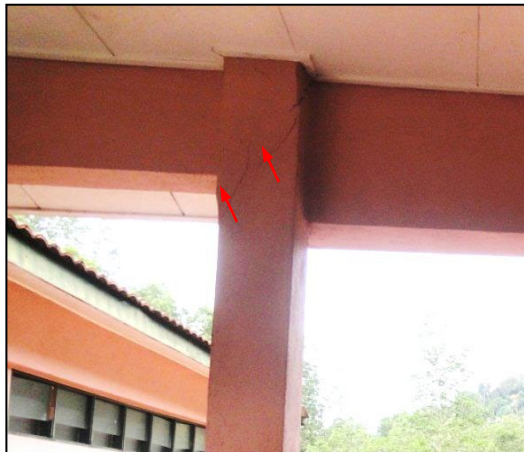
To avoid for any casualties, the building is sealed for further investigation and rehabilitation. Fig. 4 shows the damages observed in 2013 of Building C and cracking images of structural and non-structural components. A point of worth noting is most standard schools in Malaysia are absent of the expansion joints between adjacent buildings, to induce the undesirable strain and movement hence leading to structural damage especially in seismicity region. Ununiformed buildings response behaviour was believed as the main factor which initiated to progressive shear cracking on the slab panels, columns and beams that concentrated at the reentrant corners between laboratory and

academic buildings triggered by previous earthquakes. Besides, the shear cracks on the brick wall also can be seen along the access (void) at the center of the laboratory building, at every floor level. From visual observation made on the connecting academic buildings (Building A, Building B and Building D) are free from any damages.

Shear crack at column
(photo was taken from the 3rd floor)

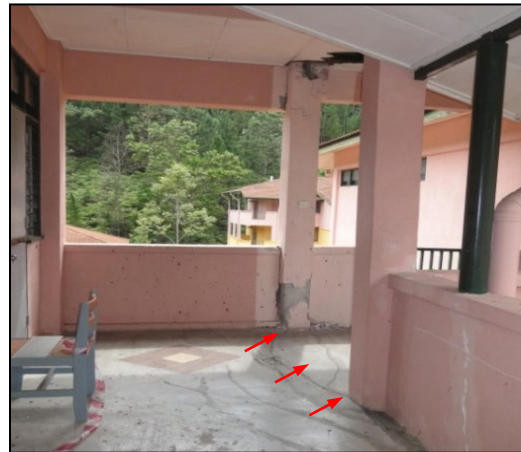
Slab cracks at joint to adjacent building
(photo was taken on the 3rd floor)

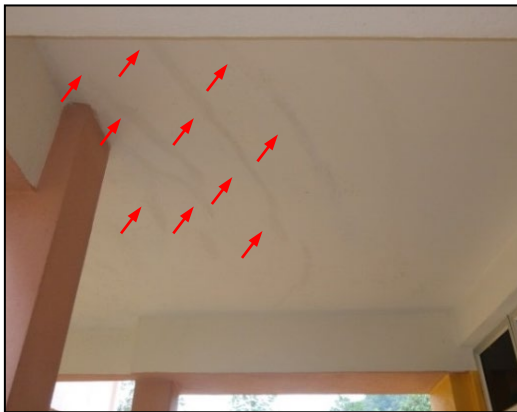
Sealed slab
(photo was taken from the 2nd Floor)

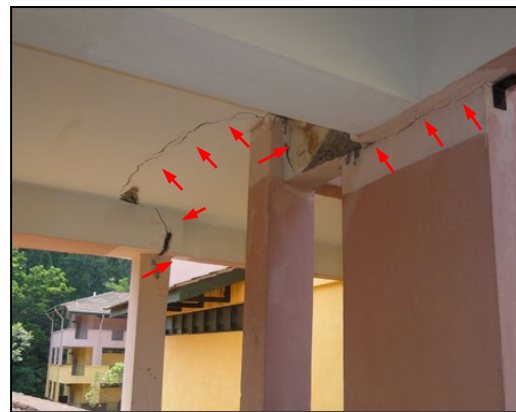
Cracking failure of slab, beam and column
(photo was taken from the 2nd Floor)

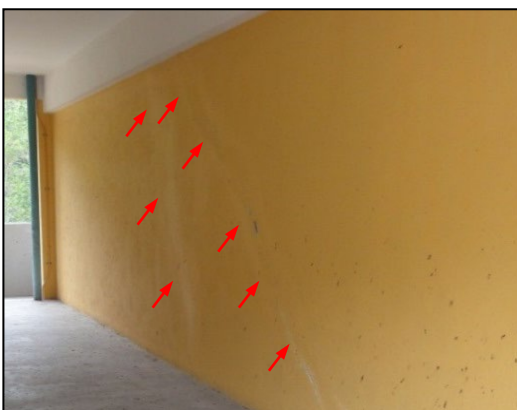
Cracks and sealed brick wall
(photo was taken on the 1st floor)

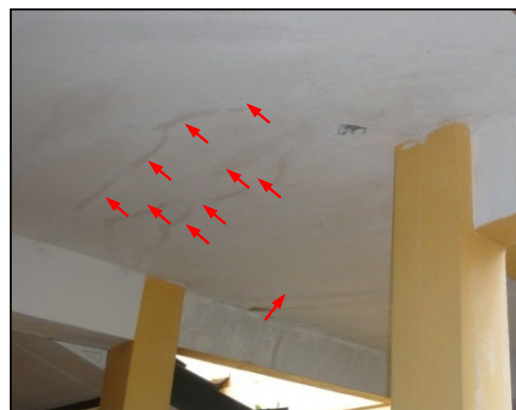
Sealed slab
(photo was taken from the 1st floor)

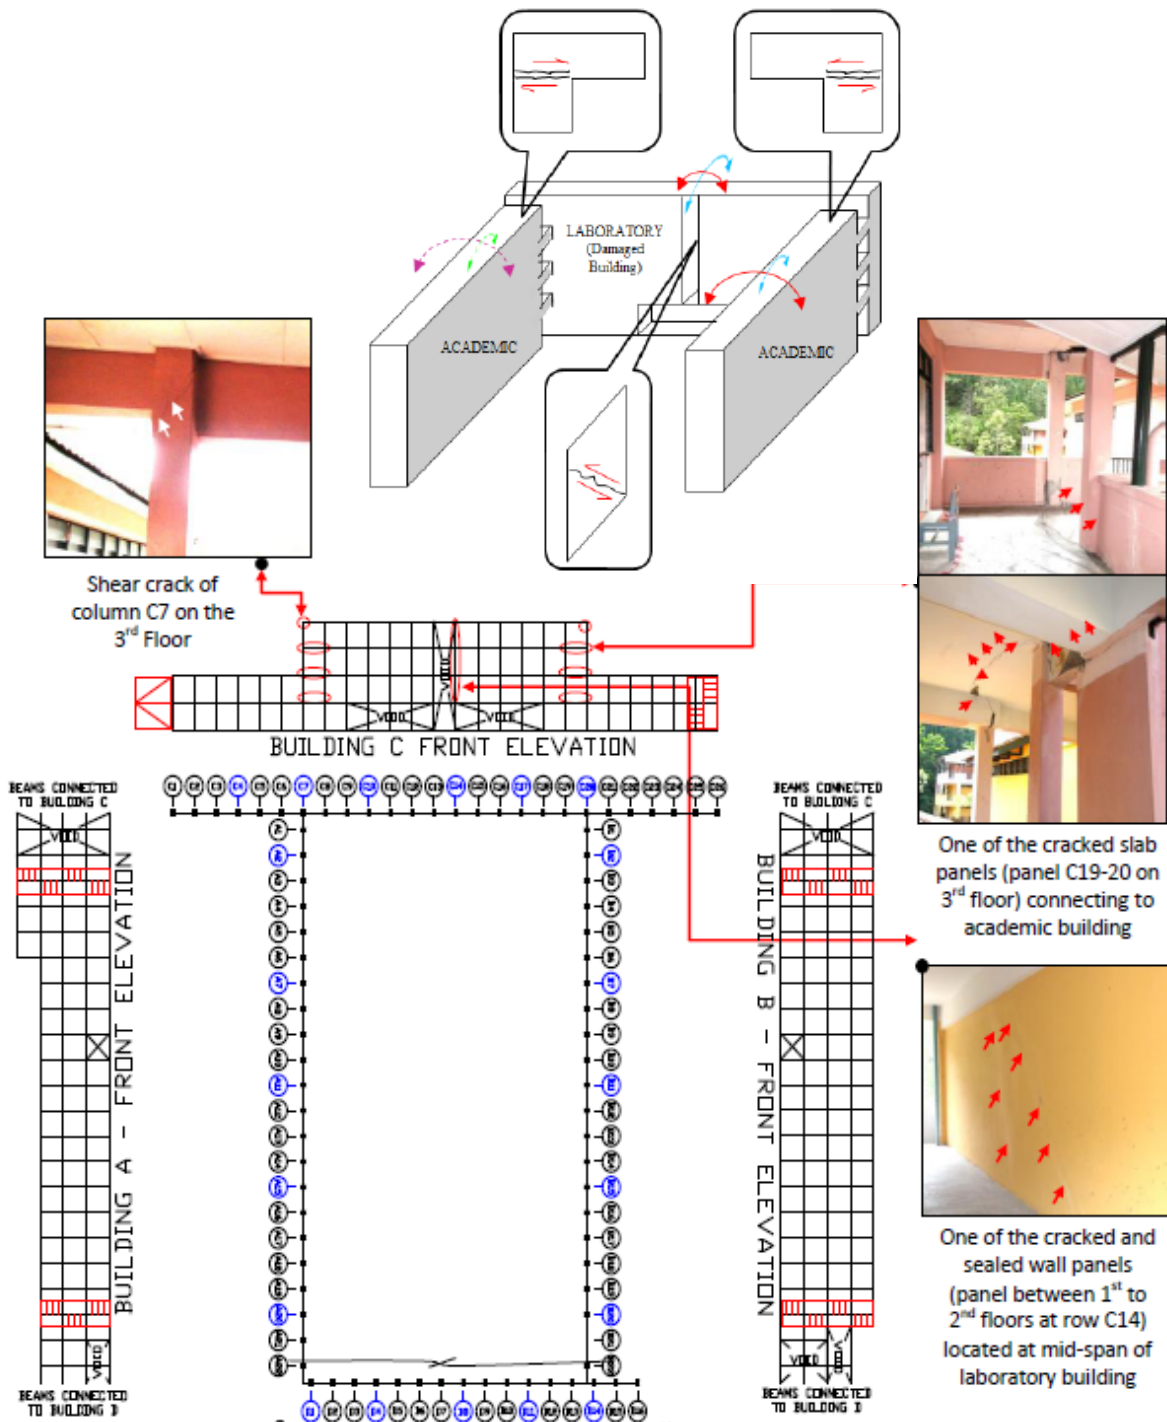
Fig. 13 - Location of structural damages and oscillations of Building A, Building B and Building C, SMK Bukit Tinggi

Structures are never perfectly regular; hence the designers routinely need to evaluate the likely degree of irregularity and the effect of this irregularity [15]. Multiple vibration modes are clearly observed from the FAS curves obtained on the measured building in SMK Bukit Tinggi. Difference configurations in terms of floor level and number of bays of Building A, Building B, Building C, and Building D create multiple building responses on respective f_0 . Difference oscillations of Building C against respective motions of f_0 by Building A and Building B created the unsynchronized movement between each building. In this case, Building C is more vulnerable due to the weaknesses of its building configurations (presence of soft storey and irregular mass concentration) compared to the adjacent buildings resulting in higher structural damages (see Fig. 13).

Most of the damages are also concentrated at the reentrant corners between Building C and adjacent buildings (Building A and Building B), as well as at the partition wall located at the mid span of building. Continuous frame between the laboratory (Building C) and both academic buildings (Building A and Building B) without provision of separations (expansion joint) does not allow the buildings to behave independently. The types of failures on columns, beams, slabs panels and brick walls are identified as shear failure. It is desirable to use seismic separation or expansion joint to divide the buildings into independent parts which may provide a regular seismic behaviour [17]. According to FEMA 454 [18], stress concentrations can be created by both horizontal and vertical stiffness irregularities, whereby in plan configuration the reentrant corners is the most likely subjected to produce higher stress concentrations.
