JRC2015-5793

TRACKING OF SPALL DETERIORATION ON TAPERED ROLLER BEARINGS

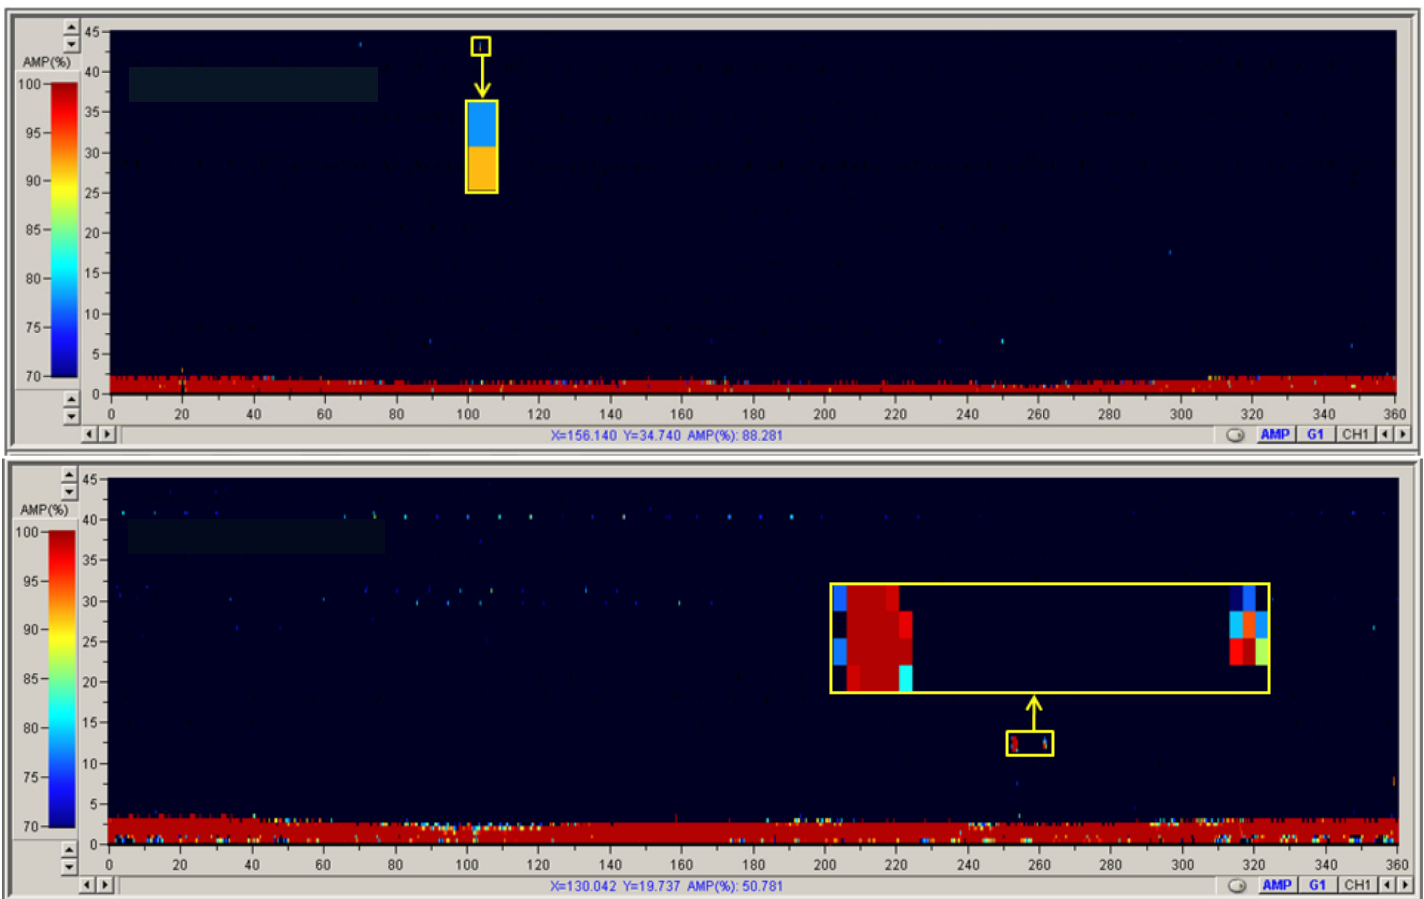
An example of the UT surface wave scan performed at UNL is provided in Figure 2. The x -direction of the scan represents the circumferential θ -position of the raceway (inboard or outboard) in degrees ($^\circ$), and the y -direction represents the z -location in millimeters (mm). The high amplitude indications along the bottom of the UT scan image in Figure 2 should be neglected as they represent the onset of the flat portion depicted in Figure 1(b). Note that, defect-free cups were used in the first service life test, and defect-free cones were used in the second and third service life tests. This was done in an effort to confine any possibility of premature failure to the bearing components that contained subsurface inclusions within the raceways.

Figure 2: Ultrasonic (UT) wave scan images of Test Cup A, which indicate the presence of three high amplitude subsurface inclusions detected on the IB raceway (top) and OB raceway (bottom) – 7.5 MHz transducer (400 μ m depth from raceway surface)

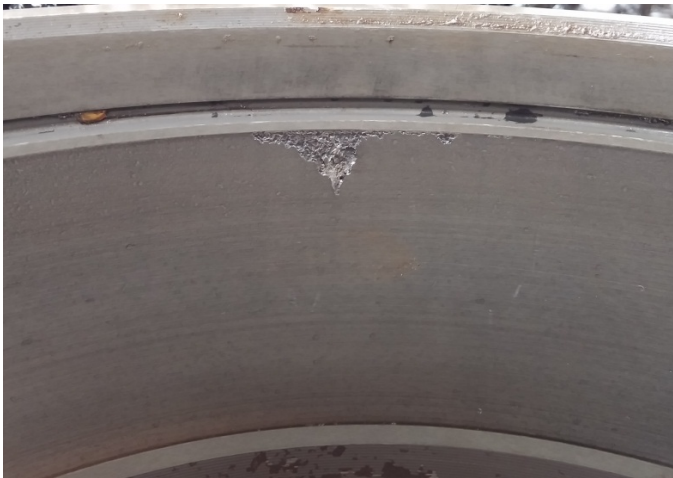
Upon teardown and inspection of Bearing 3, a spall was discovered on the IB raceway of Test Cup A, as shown in Figure 4. The total spall area was calculated to be approximately 0.175 in.². The spall formed at a location $\theta = 104^\circ$ and $z = 43$ mm, which coincided with an inclusion listed in Table 1 for Test Cup A. Interestingly, the high amplitude indication of the subsurface inclusion as detected by UT surface wave scans at 7.5 MHz (400 μ m) was not detected at 15 and 10 MHz (200 and 300 μ m, respectively). As previously mentioned at the beginning of this paper, cups and cones reach maximum shear stress 200 μ m beneath their contact surfaces [7], yet this spall initiated at an inclusion site 400 μ m beneath the contact surface of the inboard (IB) raceway of Test Cup A, signifying that inclusions at depths below the maximum shear stress region can initiate spalls.

Figure 4: Photograph of spall formation discovered on the IB raceway of Test Cup A after 51,420 miles of operation – 2nd Teardown

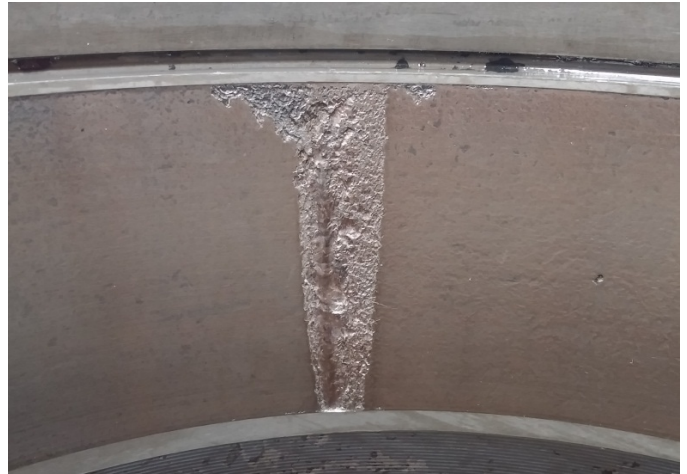
Subsequent to stopping the tester and pressing off the bearings, Bearing 3 was disassembled after running a total of 63,678 miles. Visual inspection of Bearing 3 revealed deterioration of Spall 1 (depicted in Figure 5), which was previously discovered during the second teardown inspection.

After only 12,258 miles of additional operation, the spall had expanded along the entire width of the raceway for a total spall area of about 1.050 in.²; i.e., the spall grew in size six times its original area.

Figure 5: Photograph of degradation of the existing spall found on Test Cup A after running an additional 12,258 miles – 3rd Teardown

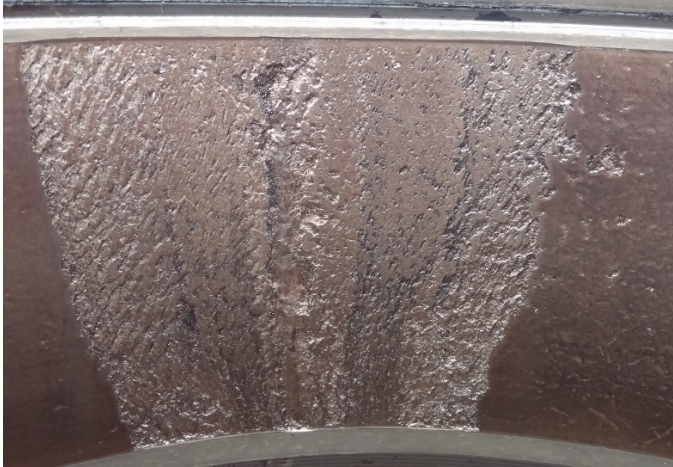
Upon teardown and inspection of all bearings, it was found that Spall 1 of Bearing 3 had drastically deteriorated and covered about 4.418 in.² of raceway area, as can be seen in Figure 6. Hence, after only 26,086 miles of additional operation since the second teardown, the spall grew approximately 25 times its original size, from an area of 0.175 in.² to 4.418 in.². The drastic growth rate of this spall provides clear evidence of the detrimental effect of subsurface inclusions and the importance of bearing steel cleanliness.

Figure 6: Photograph of further deterioration of Spall 1 on Test Cup A after operating an additional 13,828 miles — 4th Teardown

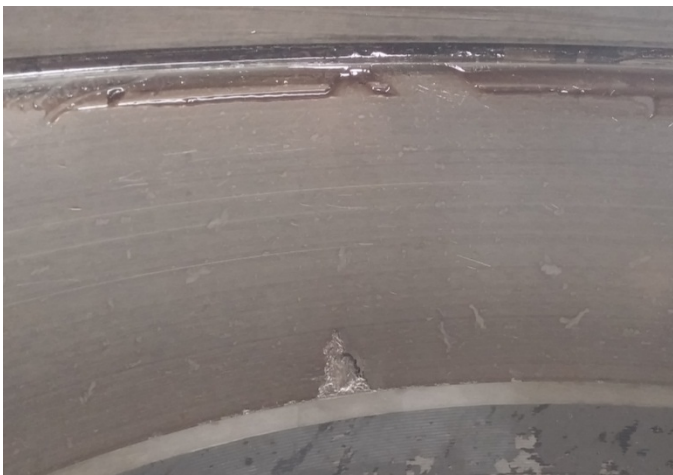
Additionally, visual inspection of Test Cup A also revealed the existence of a second spall (Spall 2) on the outboard (OB) raceway, pictured in Figure 7. The position of Spall 2 was located at $\theta \approx 262^\circ$ and $z \approx 7$ mm, which matched exactly the location of a subsurface inclusion detected by the ultrasonic surface wave scanning, listed in Table 1. Spall 2 seems to be at the early stages of spall initiation with a total area of about 0.0734 in.². However, based on the severe damage exhibited by Test Cup A, it was removed from this service life test to prevent possible catastrophic bearing failure, and was replaced with a control (defect-free) cup. Visual inspection of the other bearings revealed no signs of any spall initiation.

Figure 7: Photograph of a second spall (Spall 2) that developed on the OB raceway of Test Cup A of Bearing 3 after a total of 77,506 miles of operation — 4th Teardown

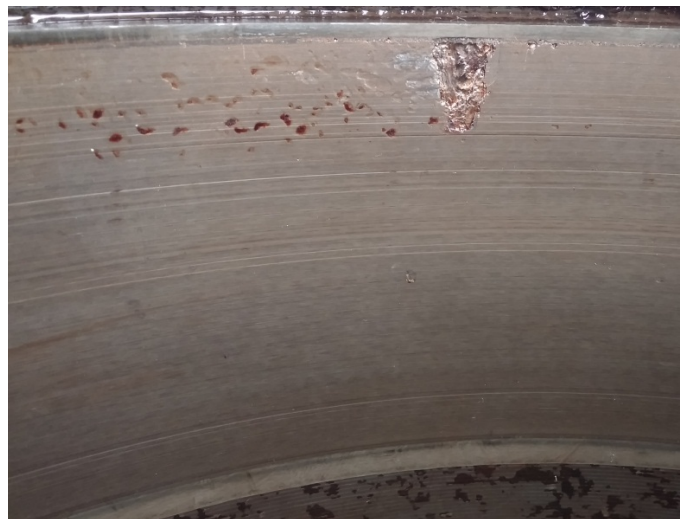
Upon teardown and inspection, a newly developed spall was discovered on the IB raceway of Test Cup B of Bearing 3, pictured in Figure 8. The dents observed to the left of the spall (direction of rotation) are most likely caused by the debris from the formed spall. Due to the severity of the dents, they were considered as part of the spall area which was measured as 0.669 in.². The position of the spall on the IB race was located at $\theta = 86^\circ$ (measured from the center of the deepest region of the spall) and $z > 45$ mm, which did not coincide with any of the subsurface inclusion locations detected by the UT surface wave scans as listed in Table 1 for Test Cup B. However, it should be noted that the ultrasonic surface wave equipment at UNL can only scan up to $z = 45$ mm, leaving the remaining top 5 mm portion of the raceway unscanned. The latter implies that there is a possibility that a subsurface inclusion existed in the region where the spall initiated, but since the surface wave scans do not cover the top portion of the raceway, this inclusion was not identified. Efforts are underway to ensure that the entire cup raceway can be scanned for future testing.

Figure 8: Photograph of a spall that developed on the IB raceway of Test Cup B of Bearing 3 following 174,448 miles of operation — 5th Teardown

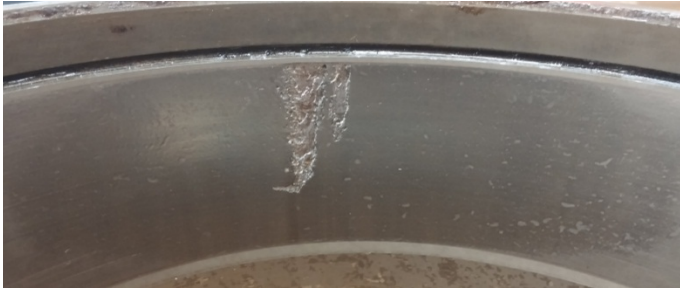
Following teardown, visual inspection of Bearing 3 revealed noticeable deterioration of the existing spall previously discovered on the IB raceway of Test Cup B, as can be seen in Figure 9. The spall has grown in size and it is accompanied by numerous indentations along the width of the raceway. The spall size is now approximately 2.600 in.², which means that the initial spall that developed on Test Cup B has grown four times its original size after running an additional 10,757 miles.

Figure 9: Photograph of the deterioration of the existing spall discovered on Test Cup B of Bearing 3 after running an additional 10,757 miles – 6th Teardown

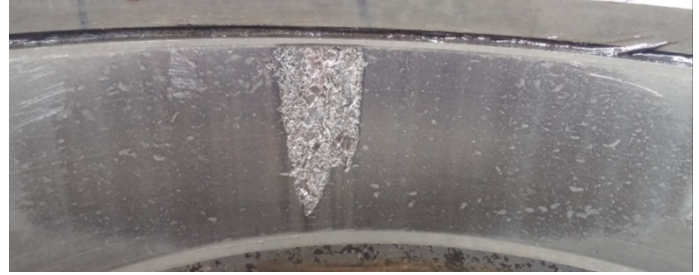
Upon inspection of Bearing 3, the existing spall on Test Cup B was observed to have further degraded, as depicted in Figure 10. The indentations increased in frequency and severity and spanned over a significant portion of the inboard (IB) raceway. The total spall area including all regions of severe indentations was calculated to be 8.292 in.², which is approximately 3.2 times the previous spall area (measured after the sixth teardown) after only running an additional 4,769 miles, and about 12.4 times the original spall size (measured after the fifth teardown) after operating an additional 15,526 miles. The abovementioned spall growth rates demonstrate how fast spalls can deteriorate once they have initiated, which highlights the importance of bearing steel cleanliness.

Figure 10: Photograph of further degradation of the existing spall found on IB raceway of Test Cup B of Bearing 3 following an additional 4,769 miles of operation – 7th Teardown

Based on the severity of the spall degradation on Test Cup B, Bearing 3 was removed from this service life test and was replaced with another ultrasonically scanned cup sent from UNL. Inspection of the other three bearings did not indicate the presence of any other spalls. Hence, the bearings were rebuilt, pressed onto the test axle, and the test was resumed. After running a total of 214,452 miles, Bearing 2 (Test Cup C) exhibited slight indications of abnormal operation, which called for an eighth teardown.

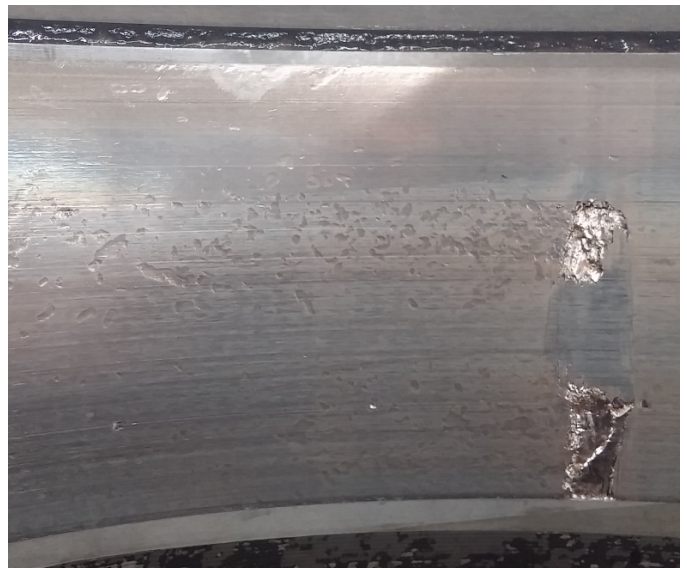
Visual inspection of Bearing 2 revealed the presence of two spalls on the IB raceway of Test Cup C. The two spalls are connected by two crack lines on either edge of the widths of the spalls, as pictured in Figure 11. Similar to the spall discovered on Test Cup B in the fifth teardown, each of the two spalls was accompanied by dented regions caused by the debris from the formed spalls being wedged between the raceway and the rollers. The total spall area was calculated to be approximately 1.880 in.². The position of the developed spall is at a location $333^\circ < \theta < 337^\circ$, and $0 < z < 33$ mm. According to Table 1, the spall location did not coincide with any of the listed subsurface inclusion locations for Test Cup C. It is possible that this spall developed on a site of subsurface inclusion that lies deeper than 400 μ m.

Figure 11: Photograph of the spall that developed on the IB raceway of Test Cup C of Bearing 2 after running a total of 214,452 miles – 8th Teardown

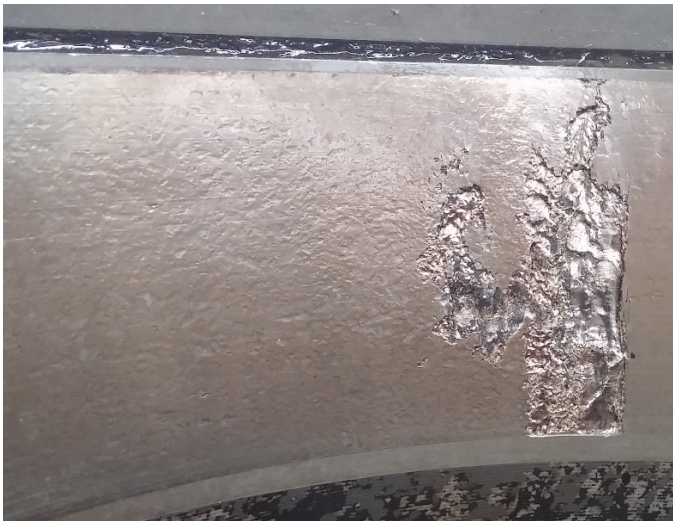
After 7,805 additional miles of operation (222,257 miles of total operation), the service life test was stopped and a ninth teardown ensued. Upon visual inspection of Bearing 2 (Test Cup C), it was found that the previously developed spall had deteriorated and was accompanied by regions of severe indentations, as shown in Figure 12. The indentations were observed on the left side of the spall, which is consistent with the axle rotation. The spall area including the regions of severe indentations was measured to be roughly 4.044 in.², which is about 2.2 times the original spall area.

Figure 12: Photograph of the deterioration of the existing spall located on the IB raceway of Test Cup C after an additional 7,805 miles of operation – 9th Teardown

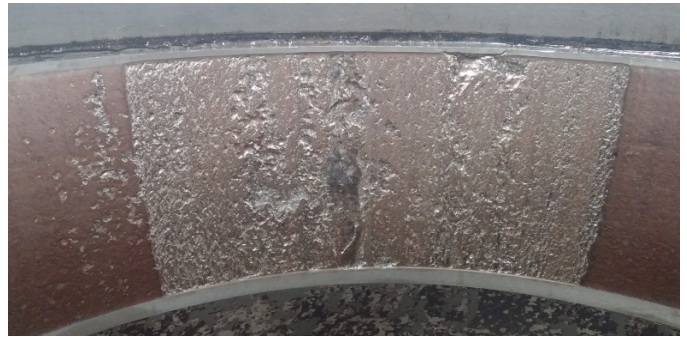
After running a total of 250,059 miles, Bearing 3 (Test Cup C) exhibited further signs of deterioration, which prompted a tenth teardown. Upon disassembly and inspection of Bearing 3 (formerly Bearing 2), it was observed that the spall deterioration was drastic, as pictured in Figure 13. The degraded spall encompassed nearly half of the loaded region of the IB raceway of Test Cup C. The total spall area measured roughly 8.986 in.², which means that this spall grew about 2.2 times its size from the previous teardown after 27,802 miles of operation, and approximately 4.8 times its original size (8th teardown) in the span of 35,607 miles of operation. Based on the severity of the spall, and since the bearing reached the 250,000 milestone, it was removed from this service life test and was replaced by another ultrasonically scanned test cup

Figure 13: Photograph of the extensive spall degradation of the existing spall found on Test Cup C (Bearing 3) after running an additional 27,802 miles of operation – 10th Teardown
