Failure Analysis of Steam Generator Tubes

Gonzalo Diego and Susana Merino

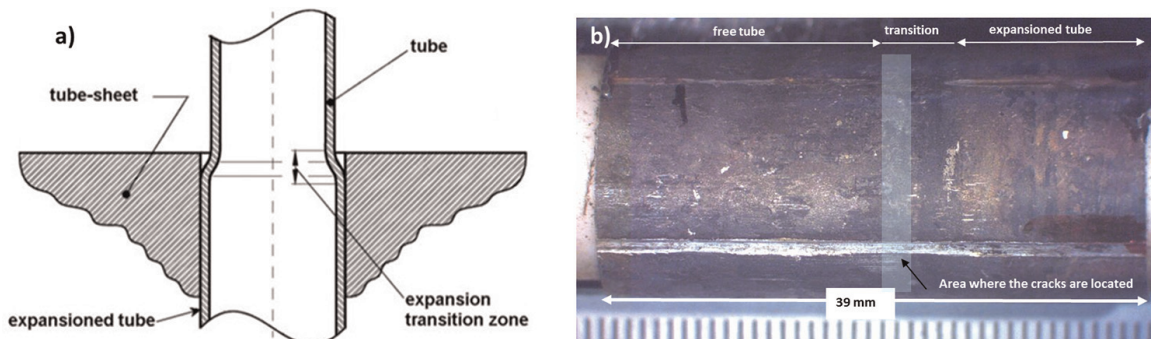
Multiple circumferential small cracks separated by ductile ligaments in an area of 5 mm width are shown in Figure 5b. These cracks were located at 3 mm from the last contact point between the tube and the tube sheet. Damage as "wastage," pitting or other has not been detected. Different color is observed among these areas. The expanded region shows a red coloration (tube sheet contact) while the transition zone presents a dark gray color because this area has been covered by sludge.

Figure 5. a) As-reception segment tube extracted in the area of the sketch. b) Image analysis to detect the expansion end of the tube by stereoscopy microscopy.

Destructive examination of the expansion transition zone has revealed a 5 mm wide band with multiple circumferential cracks separated by small ductile ligaments. These cracks were located 3 mm from the last point of contact between the tube and the tube sheet. No other type of damage such as "wastage," pitting or others has been detected.

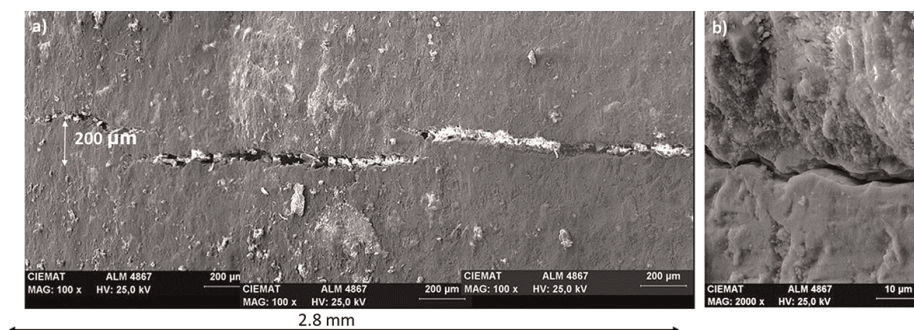
Figure 6a) shows the cracks detected on the OD side of the tube. Cracks have a circumferential orientation with corrosion deposits and they were detected in an area around the tube located above the last point of contact between the tube and tube sheet. The highest density of the cracks was located at 5 mm of this last point.

Figure 6b) shows the intergranular morphology of the cracks at high magnification and the aspect of the corrosion deposits on the tube surface. EDX analyses show important amounts of Na, Si, S, and Cl in these areas. Also, the presence of Cu and traces of Pb and Zn were also detected in five analyses.

Figure 6.
 a) Circumferential cracking on OD transition zone. b) Detail of the intergranular morphology of the cracks.

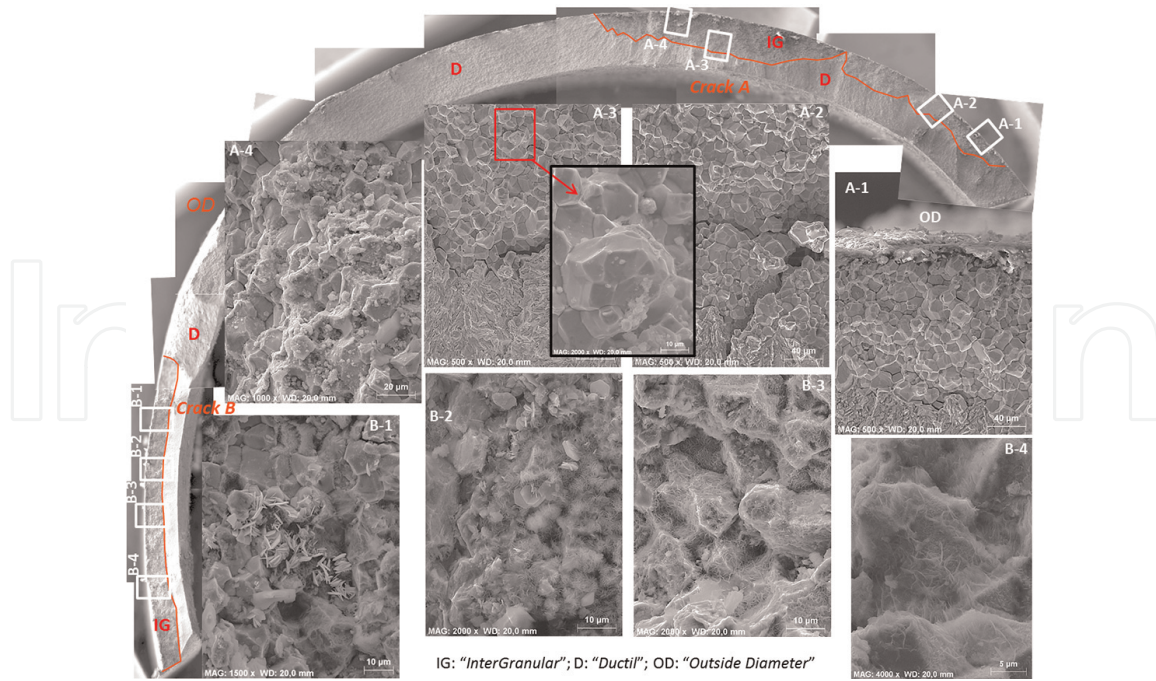
Morphology of the fracture is shown in **Figure 7**. Crack A presents an intergranular morphology with several ductile ligaments. Maximum depth of the intergranular crack was 937 µm, 82% of the tube thickness. Crack B, also of intergranular

Figure 7.
 Fracture surface with details of the intergranular crack and deposits morphology (A and B).

Intergranular morphology of the two fractures showed some different aspects between them (**Figure 7**). Fracture surface of crack B was covered by a continuous gelatinous film, while the fracture surface of crack A showed corrosion deposits only in the initial area, near the outer surface, while the remainder of the fracture was completely clean.

Two cracks have been characterized during the fractographic examination both of intergranular morphology, which at first glance presents different aspects. Crack B's fracture surface was completely covered by a viscous morphology film while crack A was covered with deposits in the initial area, near the external surface of the tube, the rest of the fracture was apparently clean.

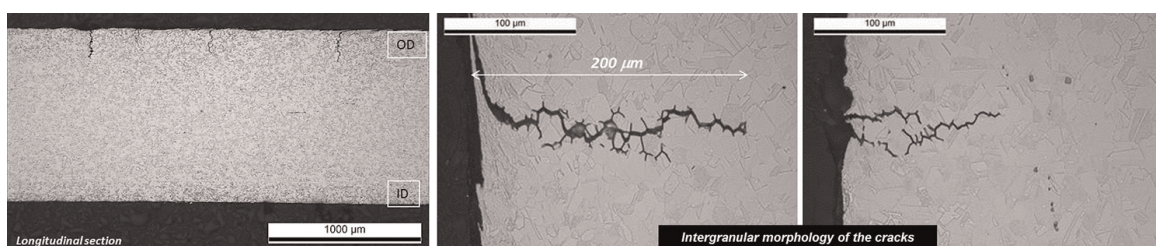
Metallographic characterization of selected cracks by stereoscopy microscopy was prepared in the thickness plane of the other half segment tube. **Figure 8** shows the morphology of the crack in the metallographic samples. The maximum depth detected

Figure 8.
 Intergranular cracks in metallographic samples.

was 210 μm , being in all cases of intergranular morphology. In one of them, it can be observed that the crack initiation is parallel to OD surface, possibly due to the existence of a hardened surface (shot peening process). In other areas, the cracks propagated with normal orientation to OD surface.

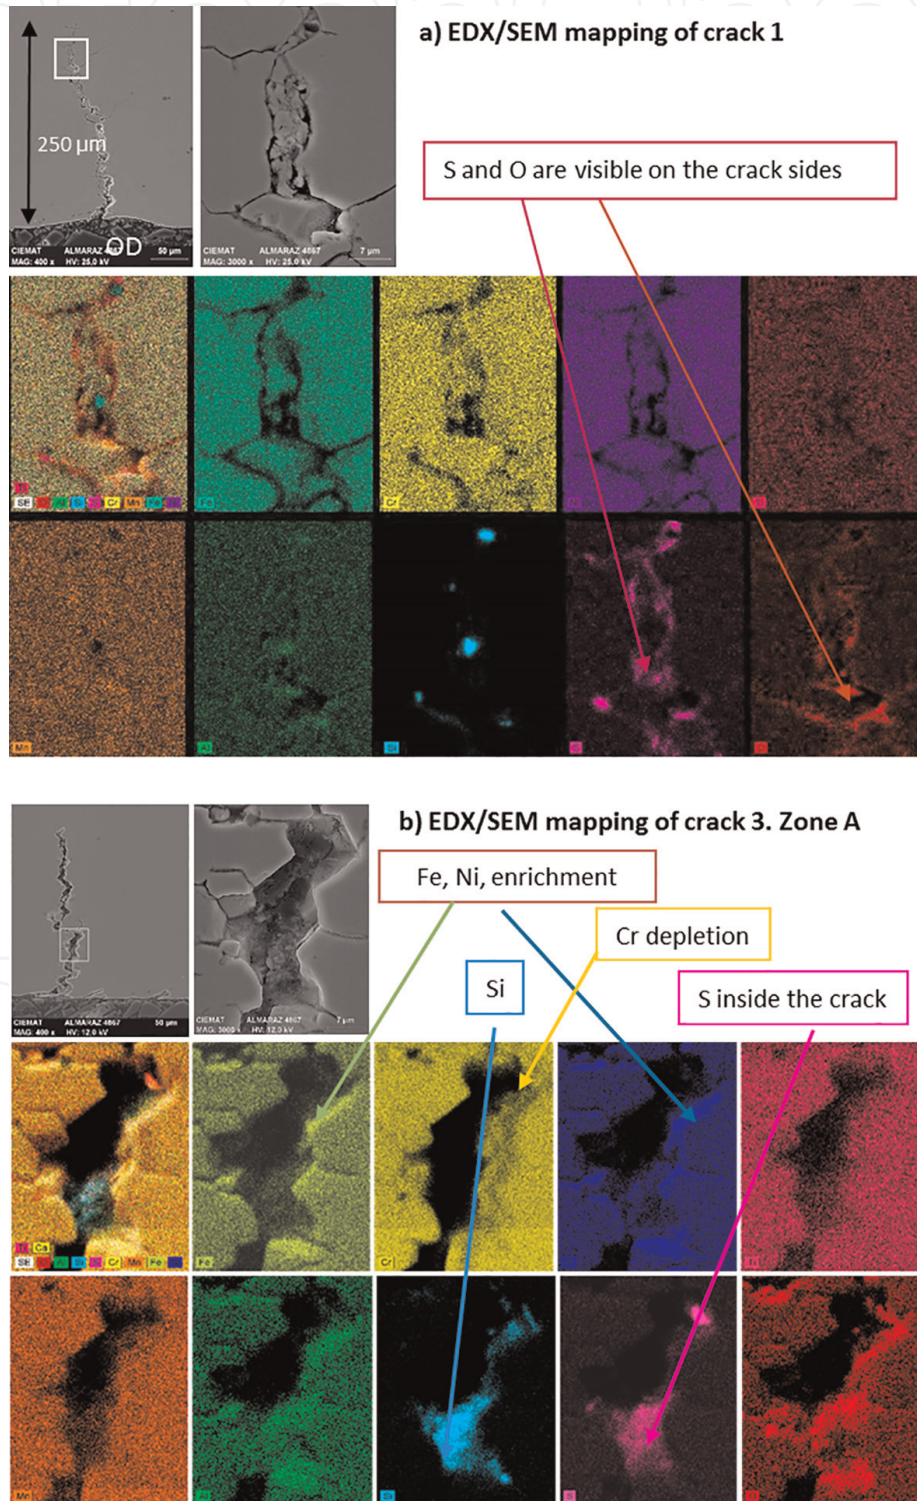
Figure 9a shows the sulfur distribution inside the cracks by x-ray mapping. In some cases, S seems to be associated with Ni or Cu and not with oxygen. It is very possible that these elements are in sulfide form. A Fe and Ni (Cr depleted) rich layer

Figure 9.
a) EDX/SEM mapping of crack 1. b) EDX/SEM mapping of crack 3.

can be observed in **Figure 9b**. Besides, Si and oxygen have been detected in very internal areas of the crack. Also, the presence of S is remarkable in this area.

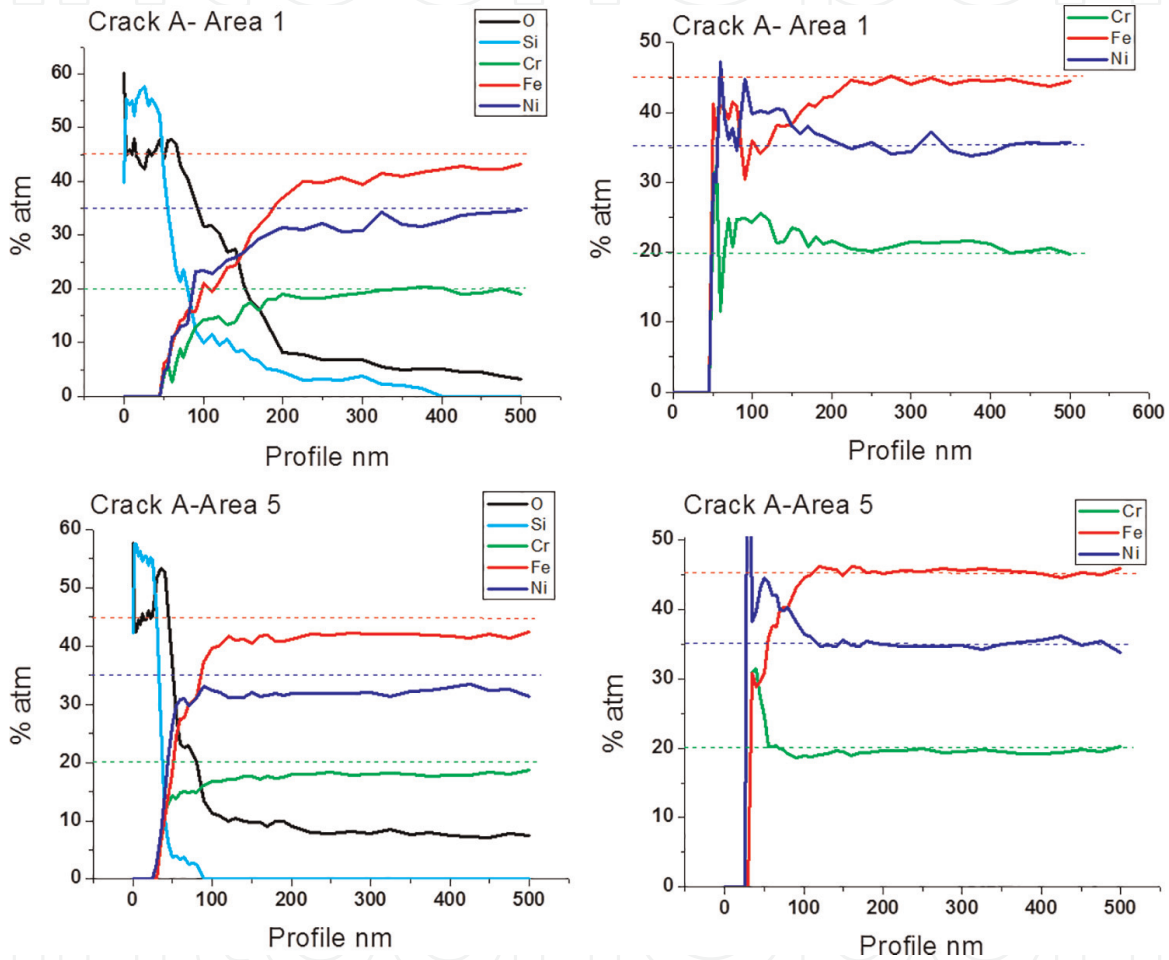
Figure 10.
 Auger profile concentration for O, Si, Cr, Fe, and Ni and Cr, Fe, and Ni. Areas 1 and 5 of crack A.

Concentration profiles at crack A (area 1), show a thicker silicate layer around 400 nm. This point is the closest to OD. In the other points, far from OD (area 5), the silicate layer is thinner (<100 nm). Ni enrichment is always detected at the five points of the analyses. Fe is always depleted in all cases, even though in the first layers this depletion is less pronounced. Cr is enriched in the first nm and after it is stabilized with a concentration corresponding to the base material or slightly depleted.

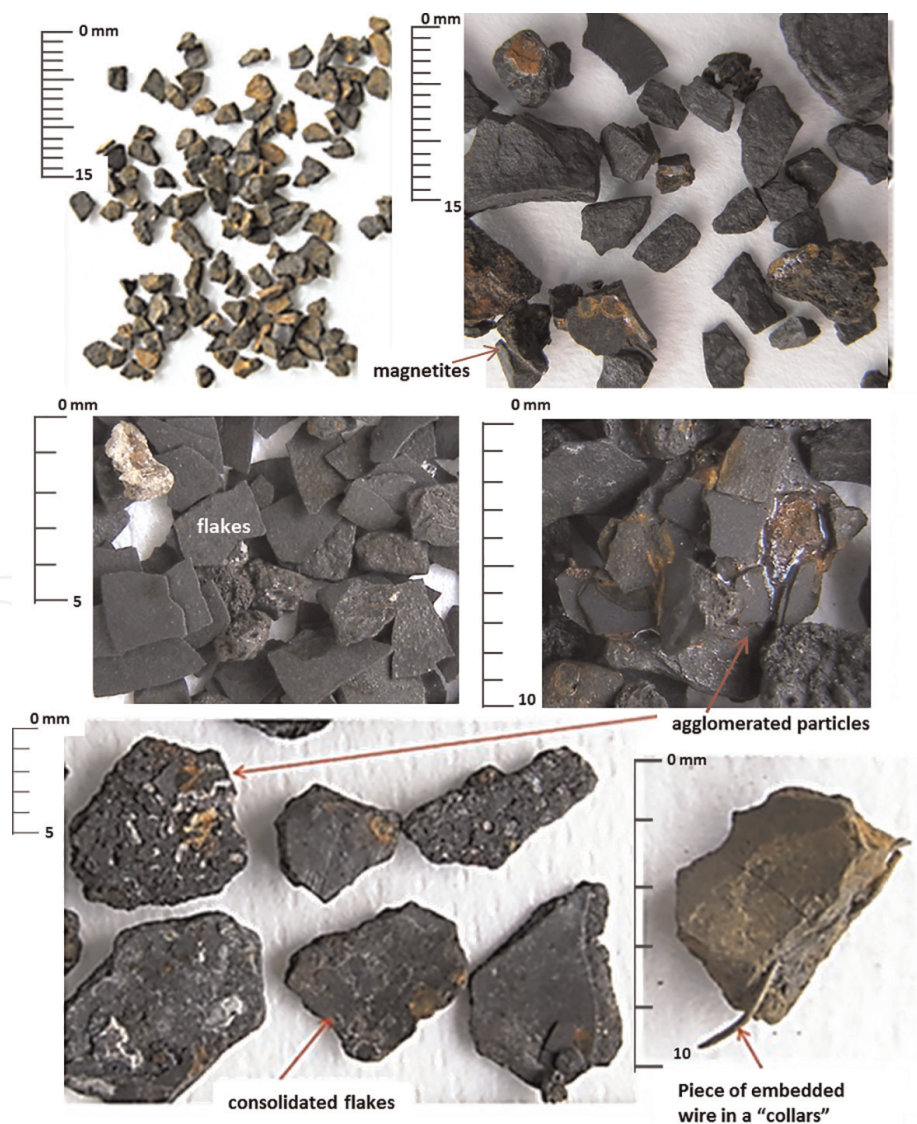
Figure 11.
Different morphology of deposits collected from steam generator.

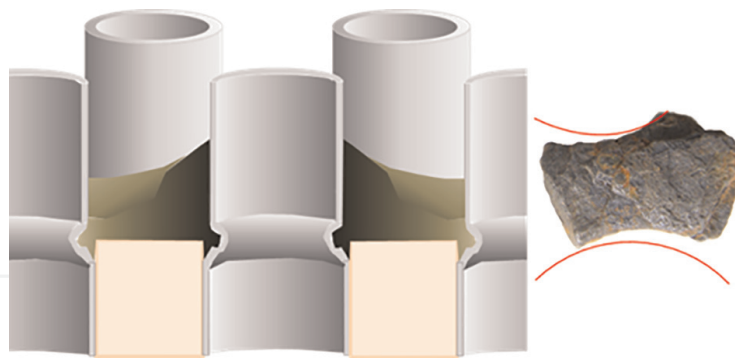
Figure 12.
Individual particle from tube-sheet SG. Dimensions fit the space between the tubes of tube sheet.

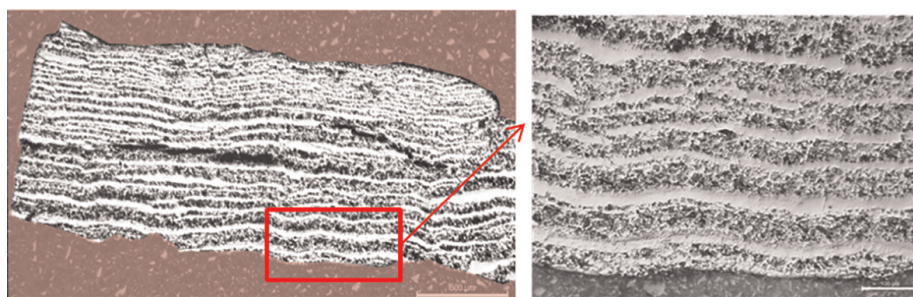
Figure 13.
Cross-section of magnetite layered particle. Optical and SEM images.

Magnetite layered pieces of several mm of thickness presented very high hardness values (876 Hv maximum). On the other hand, “flakes” present moderate hardness values (533 Hv maximum). “Collars” showed hardness slightly lower and heterogeneous values.

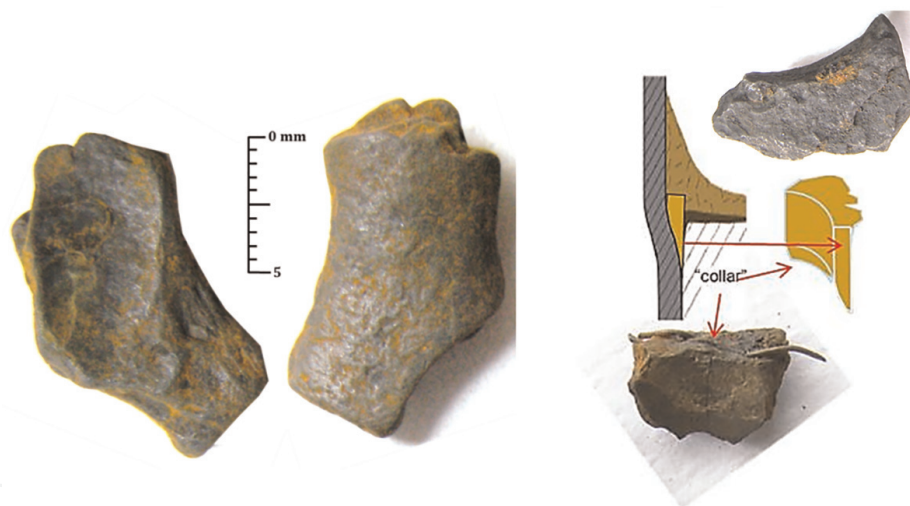
As discussed at the start of this section, “collars” pieces were detected Spanish NPPs (**Figure 17**). Cross-sections of these samples are formed by a number of metallic inclusions embedded in a matrix of Al and Si species (**Figure 18** and **19**). These last elements were enriched preferably near the interface with SG tube surface. Si/Al ratio is higher when the silicates are the binding agents.

Figure 17.
 Morphology of "collars" removed from NPPs.

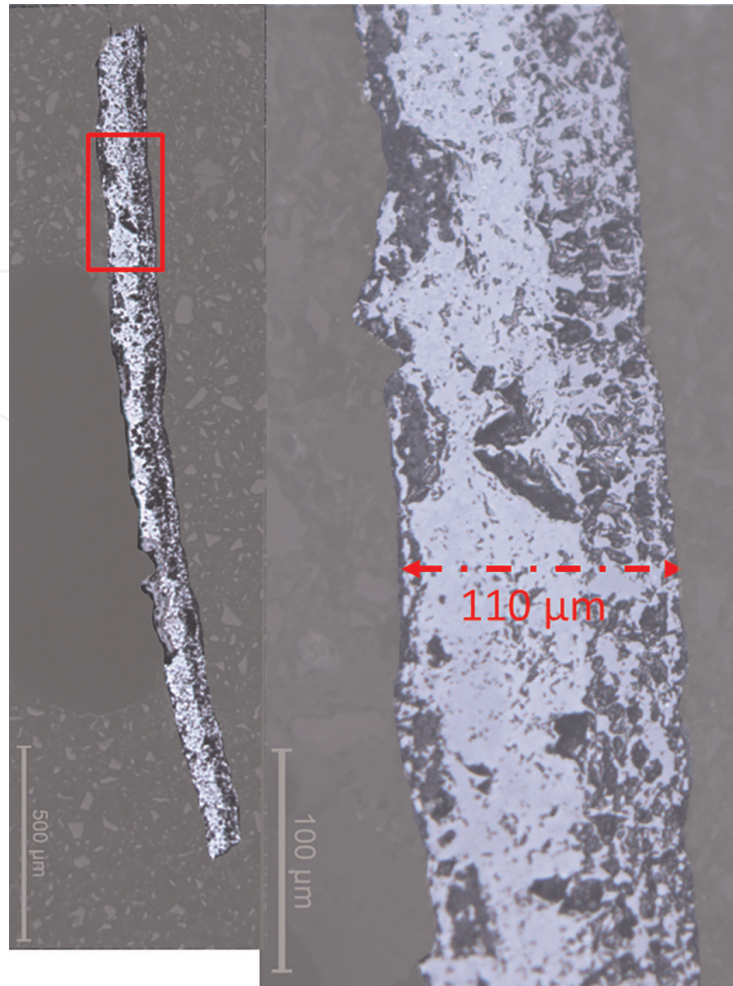
Normally, flakes are formed by an inner layer in contact with the tubing surface and an outer layer with high porosity (**Figure 20**).

Figure 20.
Cross-section of “flake.”

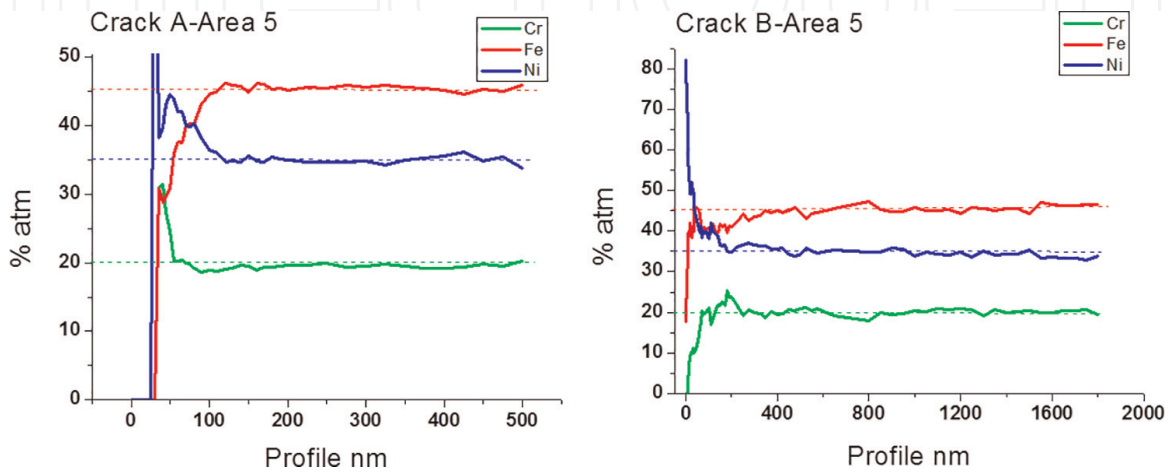
If we compare these results with the concentration profiles obtained at the bottom of cracks A and B (**Figure 21**), we observe that the main difference between these curves and those of the laboratory sample is the existence of nickel enrichment in the latter, which, as shown in **Figure 23**, is the typical trace left by alkaline environments.

Therefore, we can conclude that the cracks have been formed in a neutral or slightly alkaline environment. Alkaline environments with pH > 10 can be discarded due to the presence of silicates. Sulfur presence would suggest acidic environments, although this evidence is not fully conclusive in all performed analyses. However,

Figure 23. Concentration profiles obtained in the segment of the tube on the fracture surface of cracks A and B in the area near the bottom of the crack.
