# Inspection of open-pit mine drainage characteristics with a horizontal borehole camera

C Perdigão<sup>1</sup>, A Dyson<sup>1</sup>, M Yaghoubi<sup>1</sup> and T Baumgartl<sup>1</sup>

<sup>1</sup> Geotechnical and Hydrological Engineering Research Group, Federation University Australia

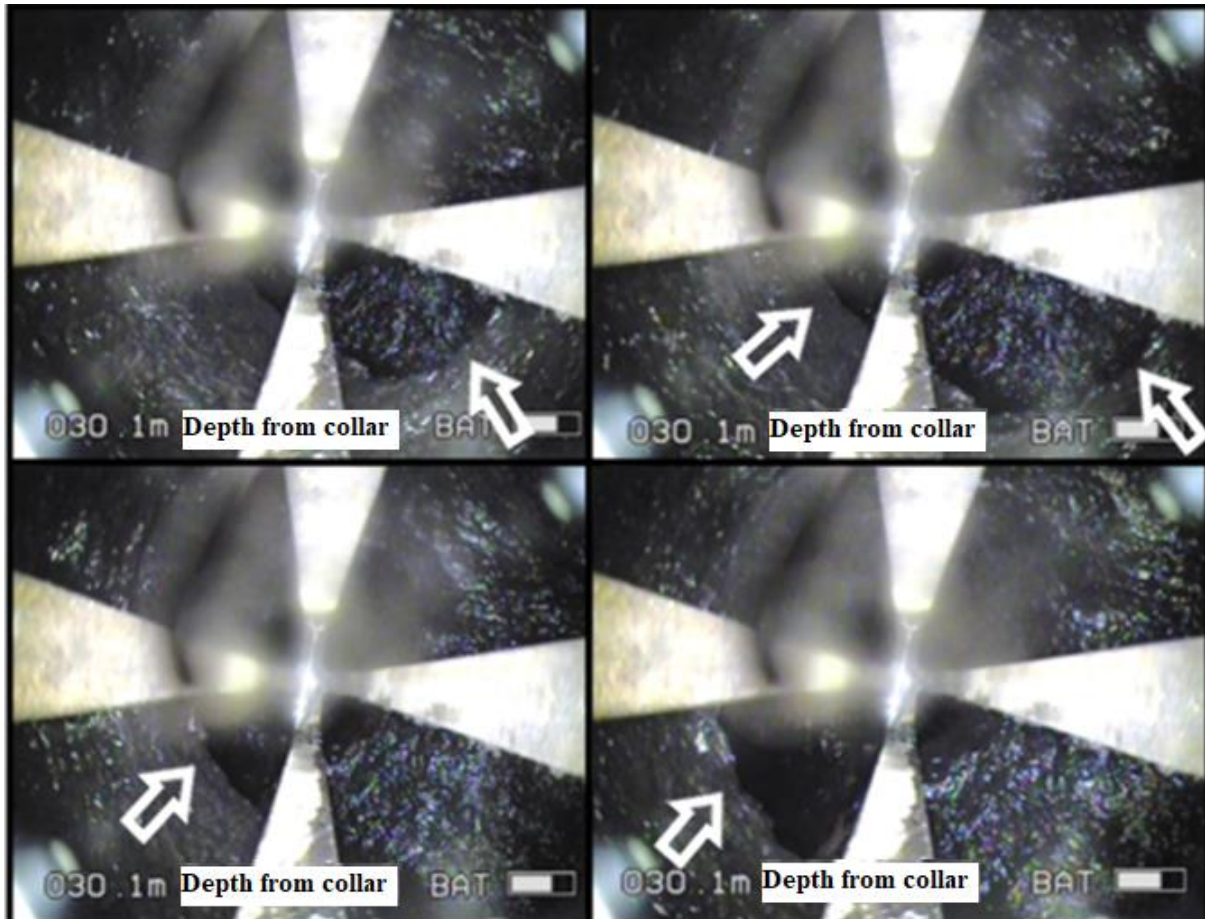
Joints could be observed inside the bores as expected (Figure 6) as the geological structure and, in particular, the natural jointing and faults of the brown coal govern the macro-permeability in the Latrobe Valley coal seam [11]. Joints are the most numerous and obvious structural features in the brown coals in this specific region and are of particular significance to the stress of the region [7].

**Figure 6.** Joint observed from inside a horizontal bore through the camera inspection pointed by white arrows.

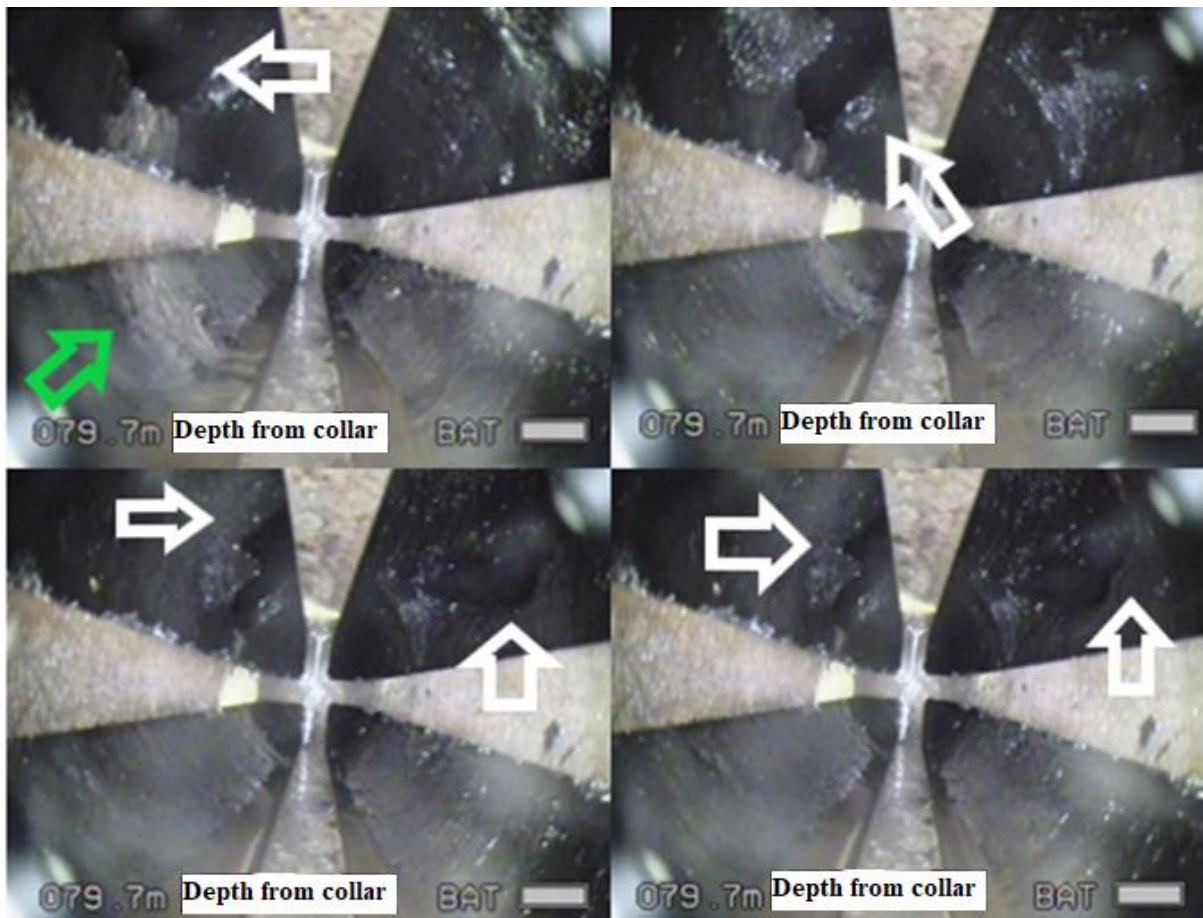
A visual inspection was also carried out in a bore located next to the one cited previously and another joint could be observed as shown in Figure 7. The flow of water through a joint into the borehole can be observed in the top left photo.

**Figure 7.** Joint observed through the camera inspection inside the bore located next to the previously investigated bore pointed by white arrows. Flow of water through a joint into the borehole can be observed in the top left pointed by the green arrow.

As it is known that joints in the brown coal batters are typically sub-vertical and comprise two sub-orthogonal sets and penetrate the full depth of the coal seam [9], it is reasonable to assume that these two identified joints inside the two bores are the two joints observed from surface mapping as highlighted in Figure 8. Therefore, it might be possible to link boreholes internal properties to those observed on the surface.

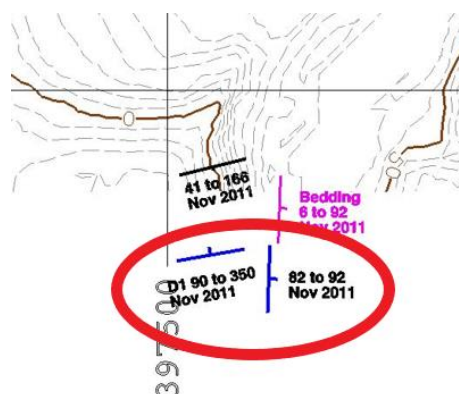
**Figure 8.** Yallourn mine defect mapping.

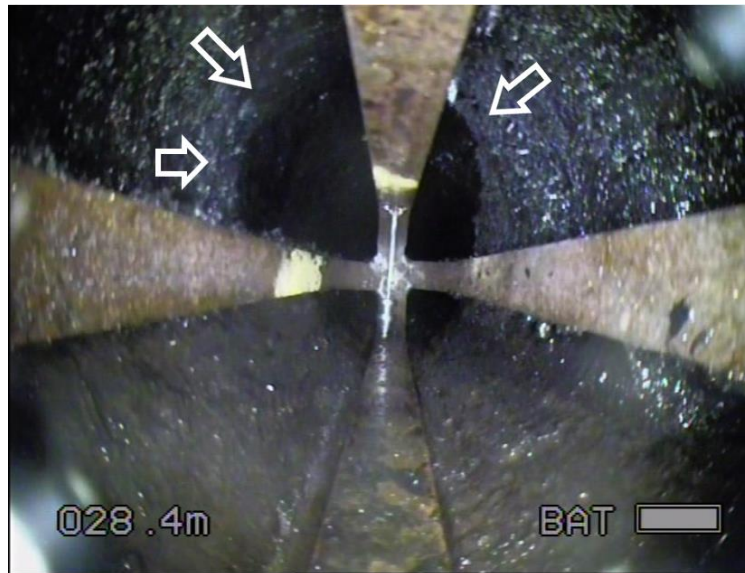
Changes in the bore diameter were observed through the visual inspection (Figure 9). The reason behind it is unknown. One assumption is that internal stress releases within the coal may cause some coal block movements along horizontal drains. A second assumption is sediment accumulation. The geometry in this particular instance may also have been altered due to the drilling method as sometimes it can be challenging to control the drilling angle as well as the bore shape.

**Figure 9.** A change in the borehole diameter is observed

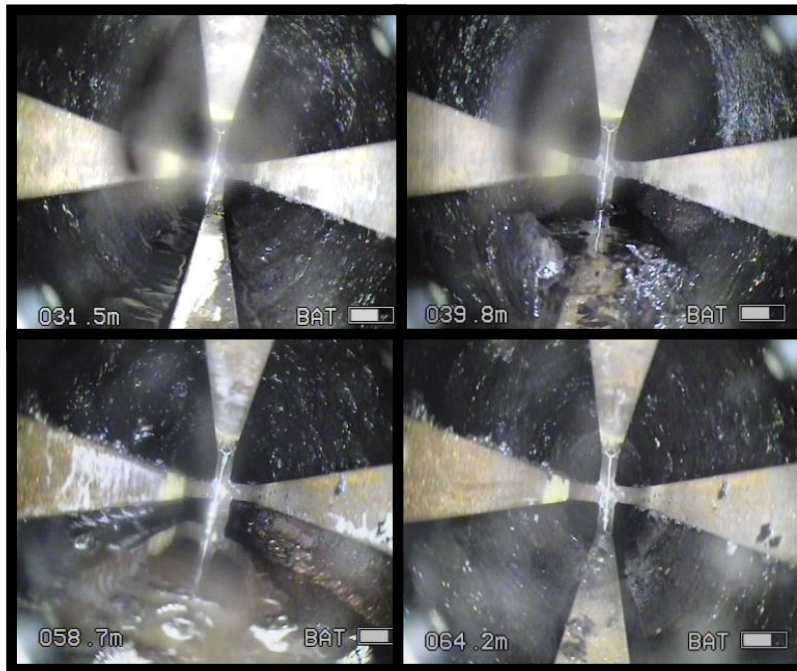
The camera inspection showed a variation in water flow along the bore length, which can be observed in Figure 10. In some instances, after an evident joint, the flow of water is significantly reduced as the open coal joint intersected in the drain hole works as a preferential path for water. As boreholes that are a short distance apart can intersect different numbers of joints, further investigation can be carried out for a better understanding of the water flow dynamic in between bores sharing the same joint network.

**Figure 10.** Variation of water flow along the bore

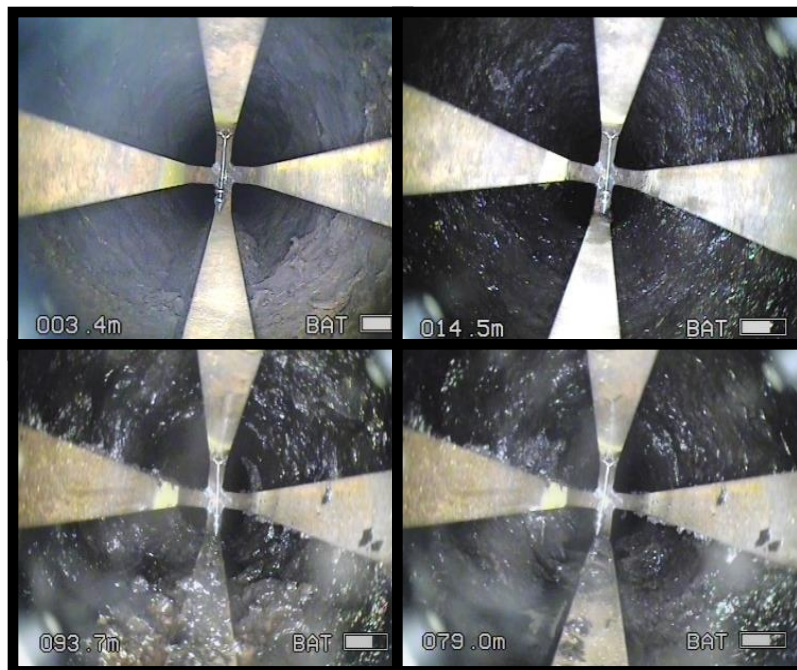
The camera also allowed the observation of different materials along the bore with different surface roughness seeming to be coal and clay (Figure 11).

**Figure 11.** Different roughness along the bore.
