### A photographic essay on landslides across southeastern New South Wales triggered by the rainfall events of 2022

Phil Flentje

# **A PHOTOGRAPHIC ESSAY ON LANDSLIDES ACROSS SOUTHEASTERN NEW SOUTH WALES TRIGGERED BY THE RAINFALL EVENTS OF 2022**

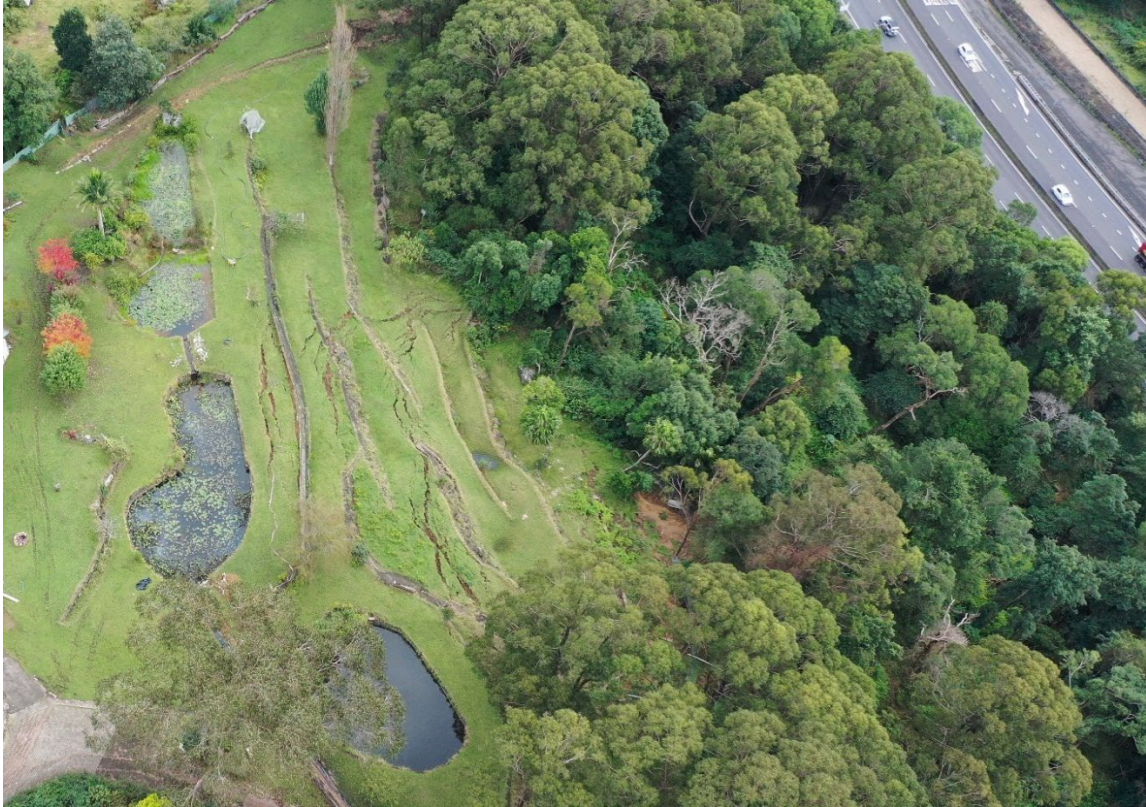
The first three landslides shown below (in Figures 4, 5 and 6) were noted along the terrace underlain by the Stanwell Park Claystone and above the cliffline of the Scarborough Sandstone in private properties above (on the western side of) MOR from early March between the north end of Parrish Avenue and the accessway known as McCoys Right of Way. Upper tributaries to Cabbage Tree Creek flow in an easterly direction through this terrace. Figure 4 includes three garden ponds, each with a footprint smaller than or up to the size of a small domestic swimming pool. During heavy rainfall, the ponds were overflowing (with natural ground water and uncontrolled overland flow) and saturating the slopes below. With significant tension cracking of the area immediately down slope of the ponds, including right across the berm of the central pond, the concerned resident called the NSW State Emergency Services during the afternoon of the 7th March. Initially the north bound lanes of MOR were closed for fear of debris flow inundation. In the light of day, the closure was reduced to one north-bound lane for a further 24 hours and a series of concrete Jersey Barriers were installed to mitigate debris flows reaching the northbound carriage way. A series of debris flows did indeed occur over the next month or so but they have all travelled less than half the distance through the steep and densely vegetated terrain, stopping on a lower gentler sloping terrace adjacent to the road (not visible in the photo).

**Figure 4. The three ponds area showing arcuate cracking on the 5<sup>th</sup> May 2022 superimposed on landscaped terraces and retaining walls sculpted prior to 2011. The upper scarps of several debris flows can be seen along the tree line. RPA photo by Flentje.**

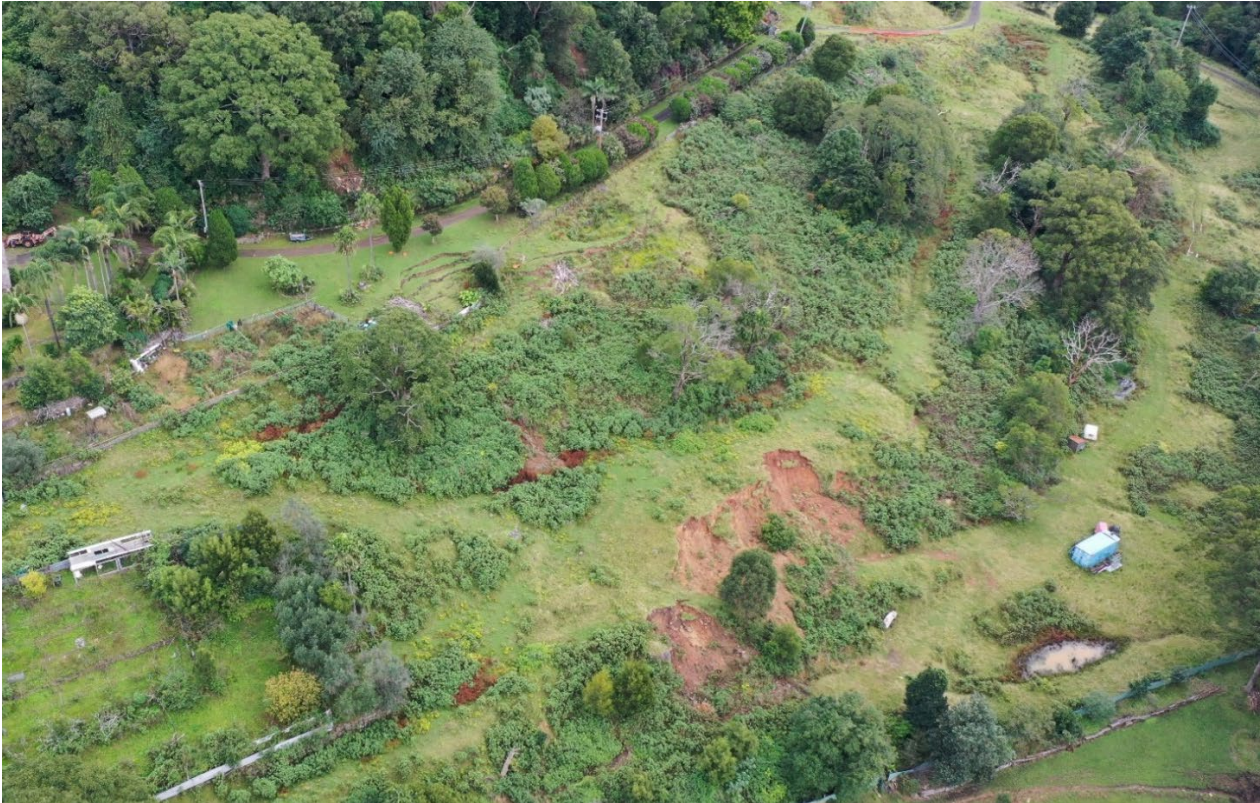
The site shown in Figure 5 is immediately to the north of that shown in Figure 4 and also on the uphill side of MOR (and almost directly west of the southbound mid-level arrestor beds which are on the downhill side of MOR). During observations for the pond tension cracks, numerous quite large and extensive slide/flow scarps were observed from a distance across this site. Over several days walking over the site, with a Trimble 7X GNSS device and flying a small upper level recreational drone, the extent of this large slide was determined. The large slumps evident in the lower central area of Figure 5 are located across the toe heave of this site whilst the upper rear main scarp is located along the hedge row and access road at the top of the photo, and an area of arcuate cracks are also evident in the upper left. Just visible in the top right is a tension crack along the access road, in places 1m high. This site covers an area of 1.65 hectares and has an approximate volume of 70,000m<sup>3</sup> as an average depth of the failure has been estimated at 7m.

**Figure 5.** This site is immediately north of the area shown in Figure 4. Several walkover inspections of this site with a Trimble Geo 7X has identified a large slide category landslide with an area of 16,500m<sup>2</sup> and with an assumed maximum depth of 7m, a volume of approximately 70,000m<sup>3</sup>. RPA photo by Flentje.

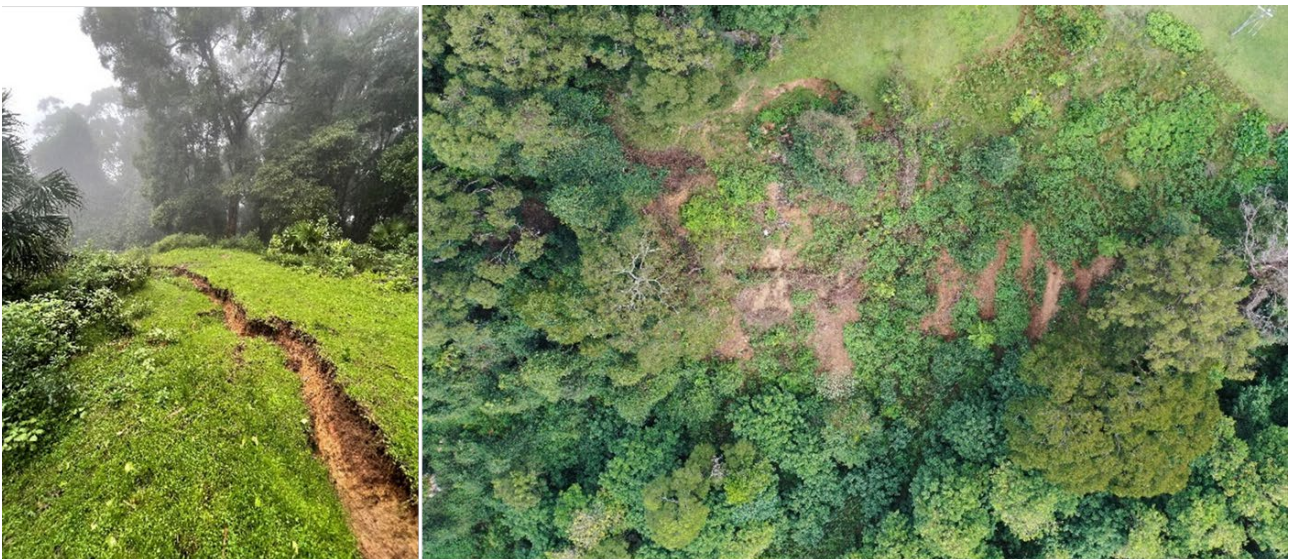
The site shown in Figure 6 is again north of that shown in Figure 4 and is separated from that site by an upper tributary of Cabbage Tree Creek. The owner of this property called the TfNSW roads staff and alerted them of this crest line tension crack and movement of the colluvium towards the steeper slopes immediately above MOR. This pre-emptive notice by owners and residents has been very much appreciated by the authorities.

**Figure 6.** At the eastern edge of the Stanwell Park Claystone Terrace, the colluvium breaks away and slides over steepening slopes. This crack was reported by the owner and mapped on the 7<sup>th</sup> March at up to 600mm, with a backscarp at ~75°. After 4 weeks this scarp had grown to over 2m in several locations and was observed on the ground and by RPA on the 5<sup>th</sup> May. The toe of this slide had by then flowed over the Scarborough Sandstone cliff face as a number of debris flows, stopping short of MOR. (RPA photo by Flentje).

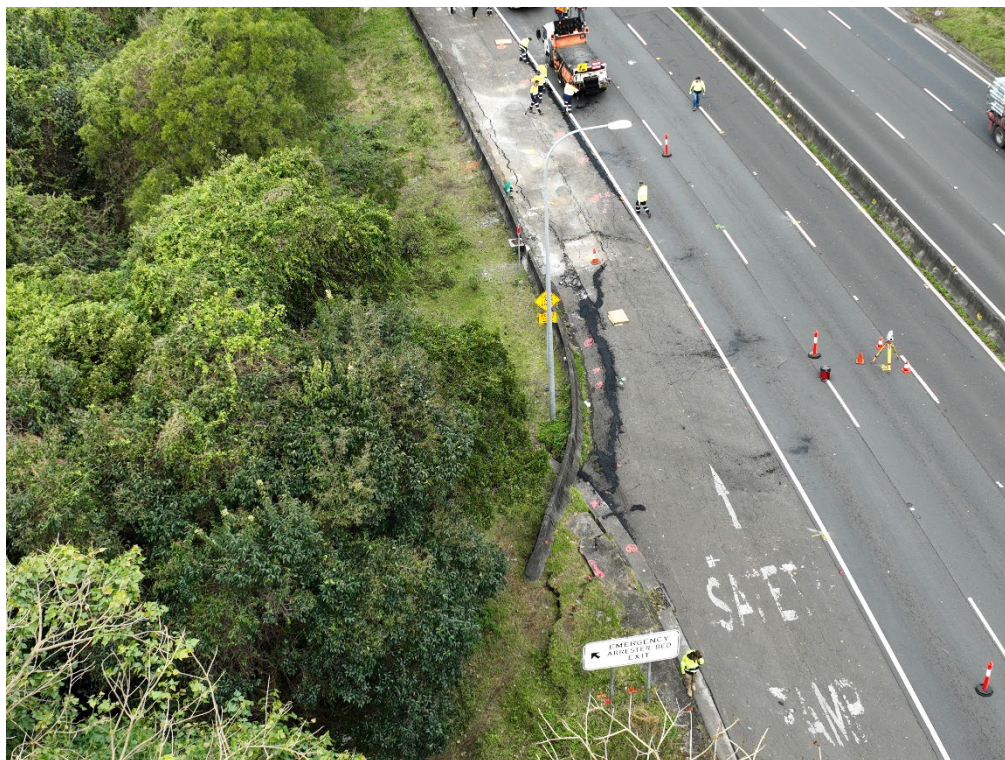
Figure 7 and 8 show the movement of the southeastern portion of the very large Site 141 slide (which MOR traverses) and the impact of this movement on the pavement of Mount Ousley Road. Inclinometers across the site have shown small movements of up to 1cm or so across the entire site. However, the dewatering pump system which is aligned along the western side of the northern half of the site, has largely saved the northern half of the site with only minor movement occurring there. In addition to the manual inclinometers, three reliable movement sensor types have been installed across Site 141 (Figure 8). Opposite the Pump Station (Flentje et al., 2017), in the northern half of this site, a Shape Accelerometer Array (SAA) and two Geokon Long Range Displacement (extensometer) Sensors are operational in addition to two long serving and reliable inclinometer casings. The inclinometers have shown displacement at between 20.5m and 25.5m depth, with up to a total of <10mm of displacement during this event. The SAA (Figure 2, 5<sup>th</sup> X-axis up) shows that segment 13, at 24m below the ground surface, reported 1.5mm displacement over 2-3 days starting on about the 8<sup>th</sup> March, with another 24 hours or so of accelerated movement of 1mm of total displacement on the 8<sup>th</sup> April and yet another period of acceleration commencing on the 4<sup>th</sup> July for 3-4 days with another 3.5mm of total displacement.

**Figure 7. The southeastern quarter of the 810,000m<sup>3</sup> volume Site 141 landslide was reactivated between 1am to 3am on the 7<sup>th</sup> of July 2022. Photo by Cox, 13/7/2022 at 11am during a southbound carriageway closure.**

The south-eastern quarter of the Site 141 landslide was reactivated between 1am to 3am on the 7<sup>th</sup> of July 2022, outside the immediate zones covered by the displacement instruments reported above. However, because of the movements reported in near real-time by these instruments, the road was already under 24 hour geotechnical inspections. It was during one of these inspections that a previously unknown series of tension cracks were observed in the southbound roadside verge and entrance lane to the emergency stopping arrestor beds at 3am on the morning of the 7<sup>th</sup> of July 2022. In the following couple of days extensive tension cracks, ranging from hairline cracks in the asphalt and up to 600mm in height were identified and mapped for lengths of up to 250m in the slopes to the east of the carriageway as shown by the solid and dashed red lines in Figure 8 with the aid of a Trimble Geo 7X GNSS device. Figure 7 shows how the tension cracks appear in the southbound lanes on the 17<sup>th</sup> July. The toe heave of this landslide was exposed for the first conclusive time, and 20 to 50m further downslope than previously expected. A new high resolution professional drone based lidar DEM was collected during a southbound carriageway closure on the 13<sup>th</sup> July and a preliminary data set has been provided in

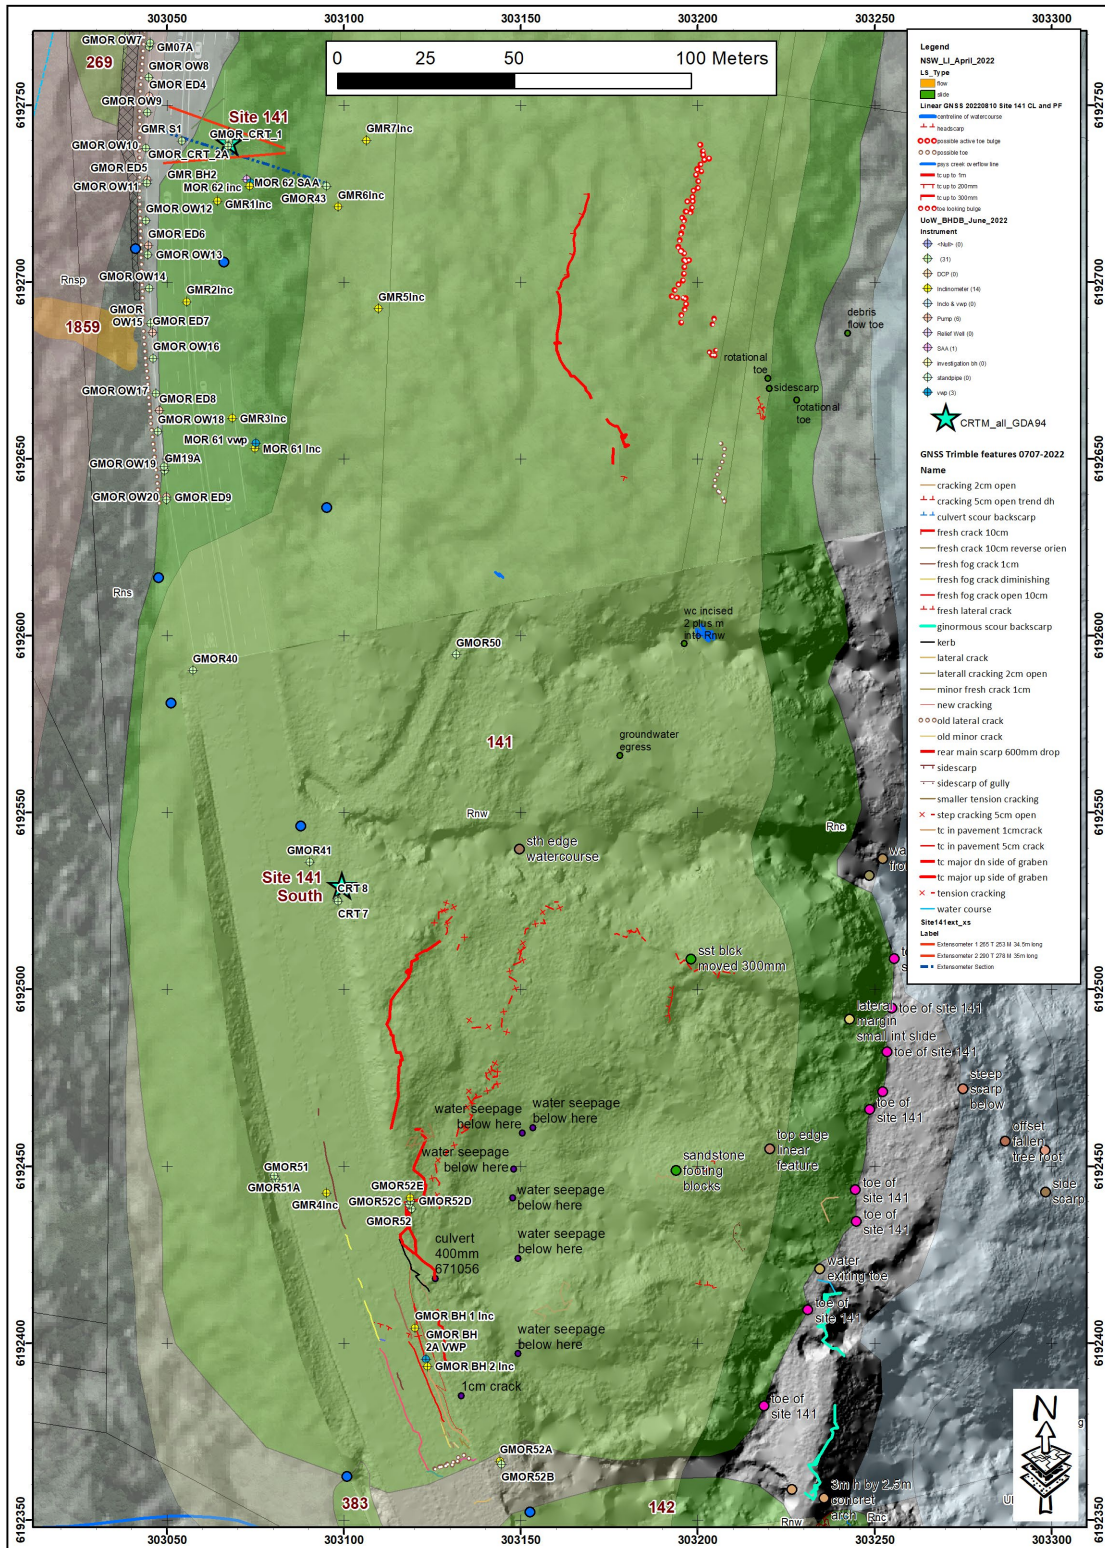
At the southern end of Site 141, 220m south of the Site 141 monitoring system, another monitoring station, Site 141 South (Figure 8) has been installed with one inclinometer casing housing a 2.5m long GeoFlex Array (DGSI, 2019) between 8.41m and 10.91m depth). Segment 4 between 9.9 and 10.4m depth has shown 3mm of displacement in the first two weeks of March, although the array was having connectivity issues from late 2021 and the complete instrument array was replaced on the 4<sup>th</sup> April and the new connection was established on the 7<sup>th</sup> April as movement was occurring for the second time in this event. The new array showed 2mm of displacement between the 7<sup>th</sup> and 14<sup>th</sup> April and 2.5mm of displacement between the 3<sup>rd</sup> and 10<sup>th</sup> July (see the top plot in Figure 2).

advance of the completed full dataset and this early hillshade data is shown in the background of Figure 8. With the detailed mapping aided by the keen eyes of many colleagues, the new high resolution lidar data, and many RPA photos, the landslides boundaries and dimensions have been revised as shown in Figure 8. The revised dimensions indicate a larger volume of approximately 810,000m<sup>3</sup>.

**Figure 8. Map of Site 141 following exposures mapped during the July 2022 event at this site. The solid and red dashed lines in the central region of the figure are the tension cracks that developed during early July. This event has exposed the toe bulge as shown by the labelled pink dots. Figure includes DioSpatial high resolution lidar.**

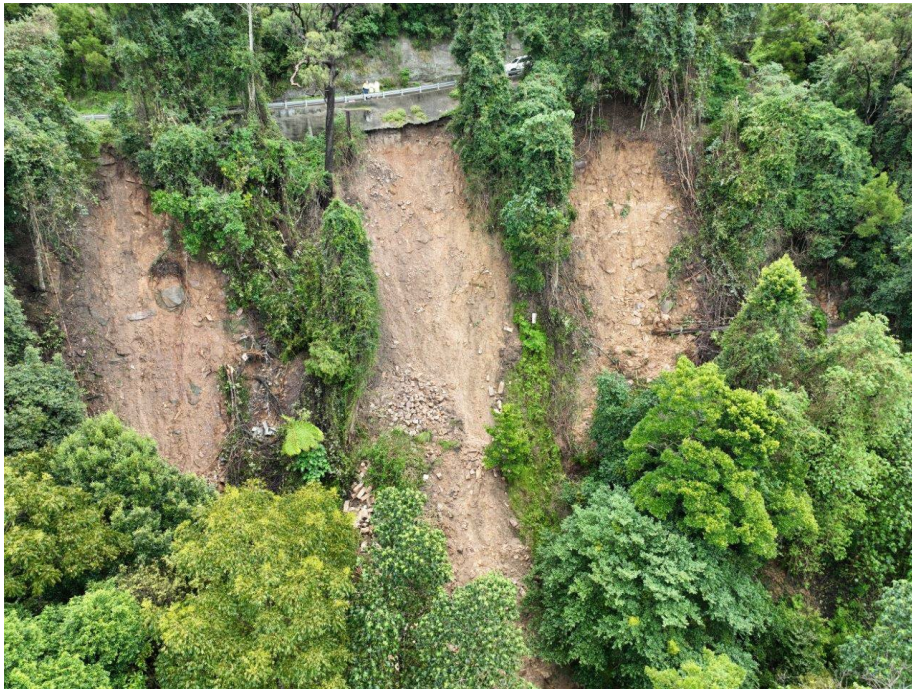
Bulli Pass is a steep and narrow section of the Princes Highway, linking the town of Bulli to the top of the Illawarra escarpment, at Bulli Tops. It was built in the 19<sup>th</sup> century for use by loggers and by locals who transported goods to and from Sydney. To this day it remains an important arterial road linking the northern Illawarra suburbs to the top of the Illawarra escarpment, the main north-south M1 Princes Motorway and importantly to the south-western Sydney region and freight hub. During the rainfall events, the upper three kilometres of the road experienced several scours, and small landslides within the downslope fill embankments and the collapse of at least two old dry-stacked stone walls (Figure 9) together with slightly extended failures of the very steep natural slopes below the road. Lower down on the Pass, near the bend known as Greens Pinch, a portion of an existing 1970's red shotcreted cut batter on the south side of the road has also failed. There are also numerous areas where existing areas of tension cracking in the pavement have progressed which will require further investigation as priorities and opportunities progress.

**Figure 9. Very steep, approximately 75 degrees, downslope fill embankment slopes including the collapse of at least two old dry-stacked stone walls previously supporting Bulli Pass.**

Lane closures were implemented in two locations along with a vehicle load limit, with heavy vehicles above 5 tonne having to use alternate routes. Temporary emergency repair works were carried out, while more permanent repair solutions could be investigated and designed. Emergency repair works are ongoing and it is anticipated the repairs will be sufficiently complete in order to remove the vehicle load limit in the coming weeks. Further design and repair works will likely be ongoing for the remainder of 2022.

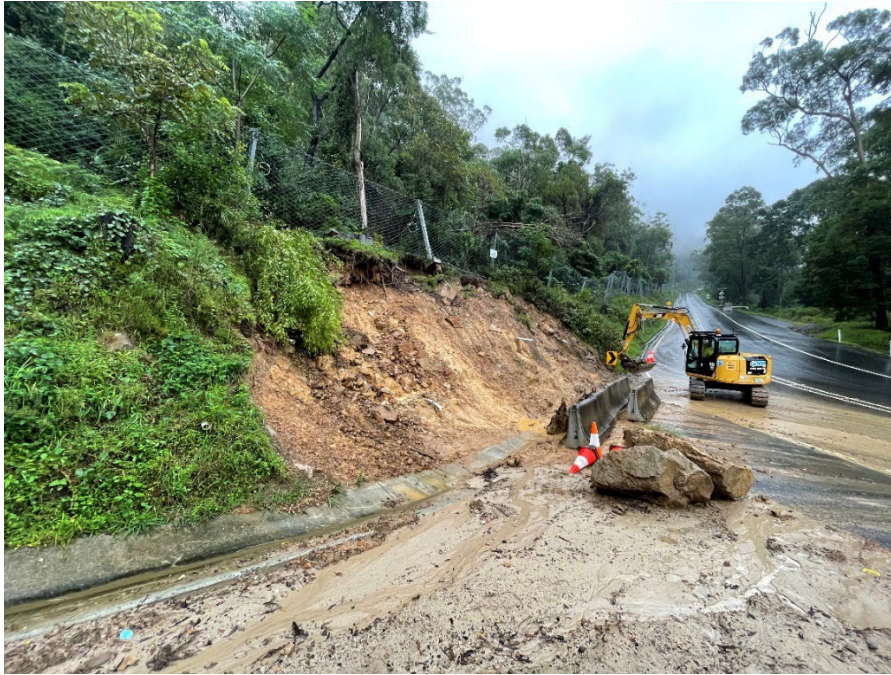
**Figure 10. Bulli Pass failure on about day 4 of its activity, 5<sup>th</sup> March during a day closure of the road.**

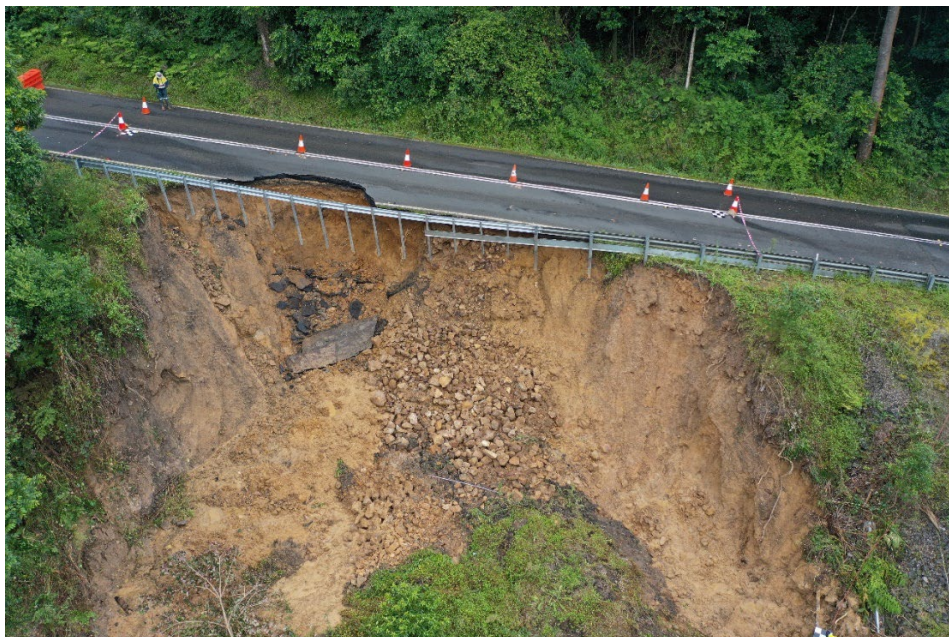
embankment failure was reported to TfNSW on the morning of the 8<sup>th</sup> of March 2022 following in excess of 550mm of rain in the previous 7 days. The affected area was approx. 25m long, with the critical central scour zone being approx. 20m long. The landslide regressed from the pavement edge line to the centre of the westbound lane, undermining the road in part and creating an overhanging slab which can be seen in Figure 11. There was a 5m scour zone where the pavement had started to develop a thin tension crack in the outer wheel path. There was also a longitudinal crack forming on the centre line. The embankment slope was composed of sandstone fill material in the central portion, which is anecdotally believed to be rockfill from a previous smaller repair. The failure material was saturated, due to recent heavy rainfall and active seepage was noted emerging from the face at numerous locations. The failure extended approximately 20m down the slope from the edge line, with primary damage in the upper 3 to 4m. The slope angle either side of the scour was approximately 33°.

**Figure 11. Barrengarry Mountain Road, close in view from a RPA aircraft showing the collapsed rockfill material, the unsupported Armco barrier and the flow like behaviour of the debris.**

The slide was mapped by Flentje and Larkin on the 16<sup>th</sup> of March (to add to the LI) with the Trimble GNSS 7X device and was estimated to have a volume of 600m<sup>3</sup>. RPA imagery identified a smaller landslide further down the valley which can be seen in Figure 12. Further downslope again these both coalesced into an alluvial fan deposit on a terrace area (out of view in Figure 12). Drilling investigation of the site did not encounter bedrock with boreholes terminating at 10m. The site was remediated by progressively removing material from the westbound lane that was affected by the slide, and soil nailing at 1m increments as the excavation proceeded. At each 2m interval the near vertical face of the excavation was shotcreted, prior to further excavation. Excavation continued to 5m below the existing surface where firm footing were expected. However, due to the continued rainfall and difficulty protecting the site from water (rainfall and seepage) the foundation was softer than expected. The base of the excavation was sloped to enhance runoff. Rock intended for the bridging layer was then pushed into the soft floor to stiffen up the foundation to provide the required support for the rockfill, with the final remediation shown in Figure 13. The remediation work was completed over several months and the road was reopened to traffic on the evening of the 1<sup>st</sup> of July. The cost of the project was approximately \$1 million.

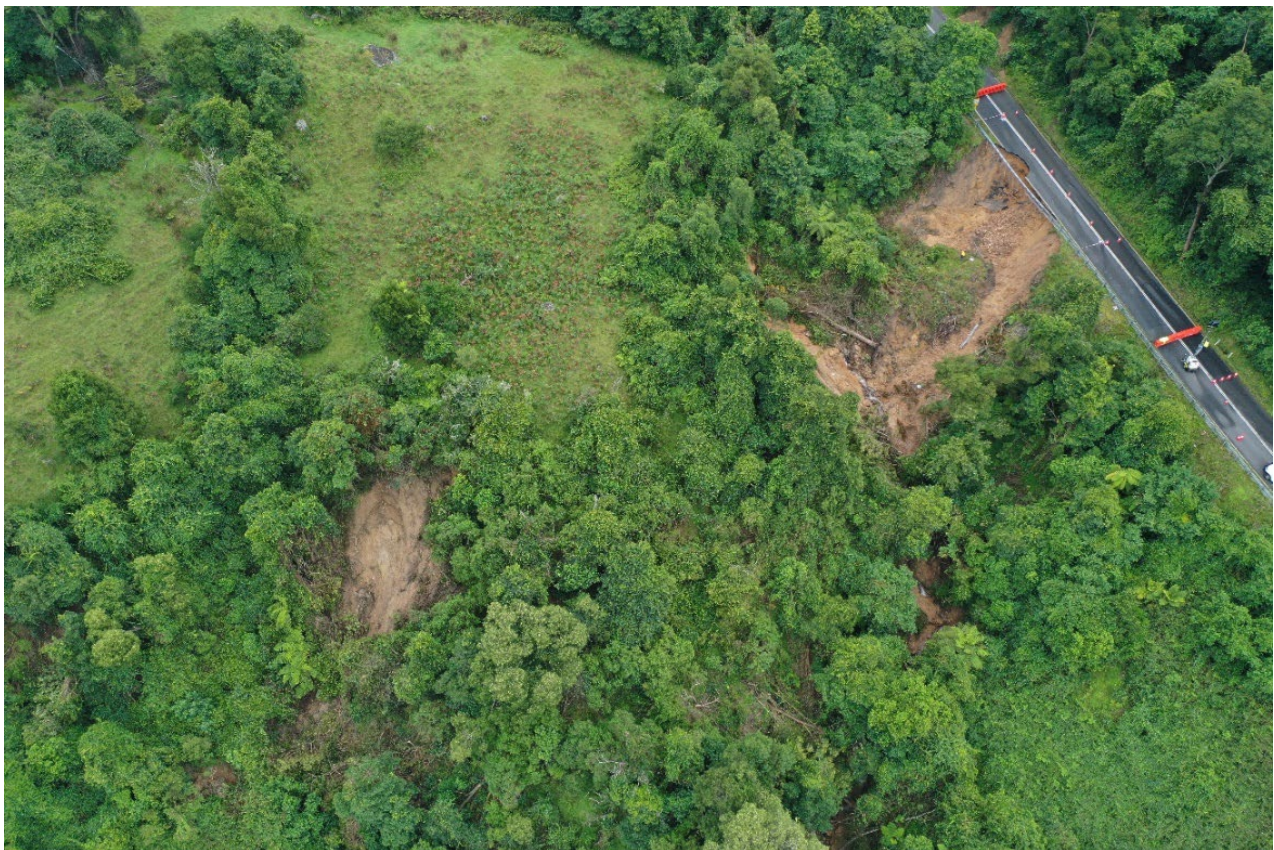
**Figure 12. Barrengarry Mountain Road showing the extended flow component of the landslide and an adjacent debris flow.**

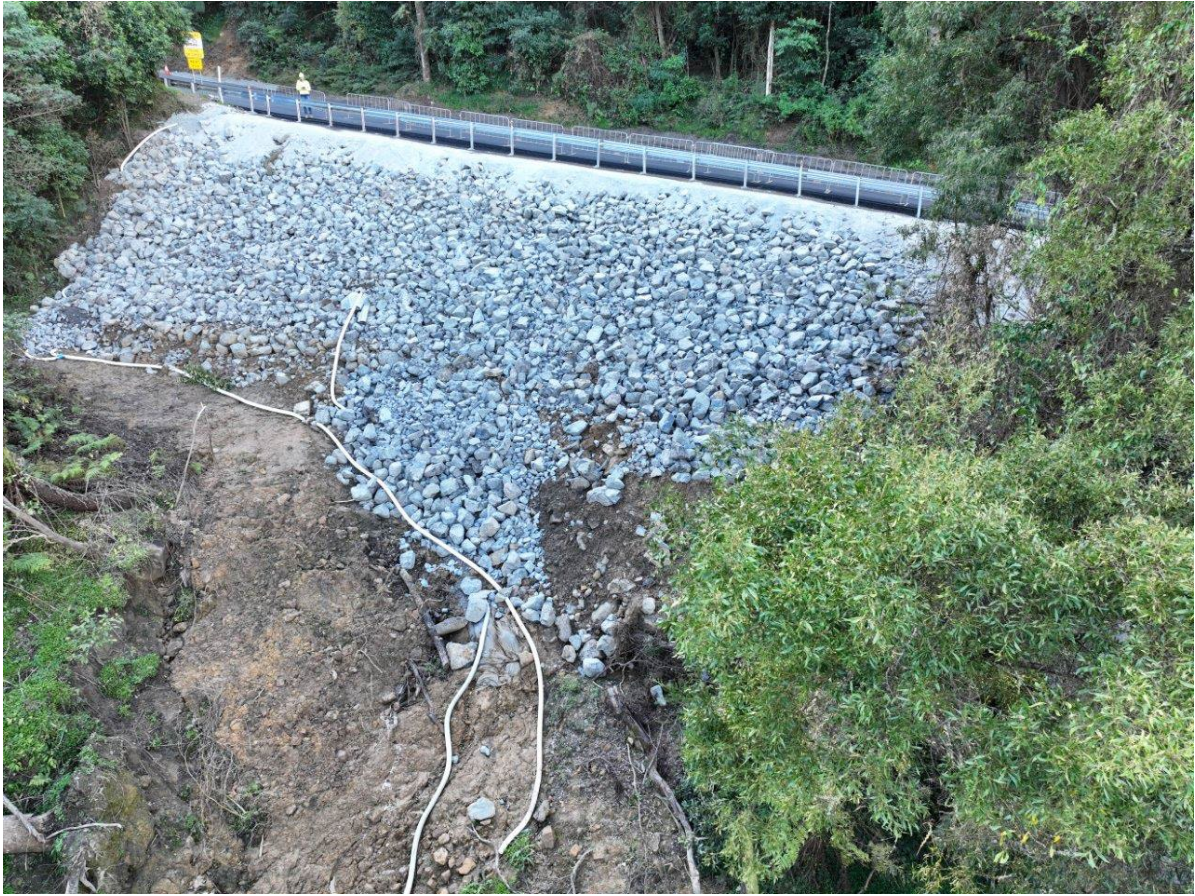
**Figure 13. Barrengarry Mountain Road rockfill. RPA photograph by Horan, late July 2022.**

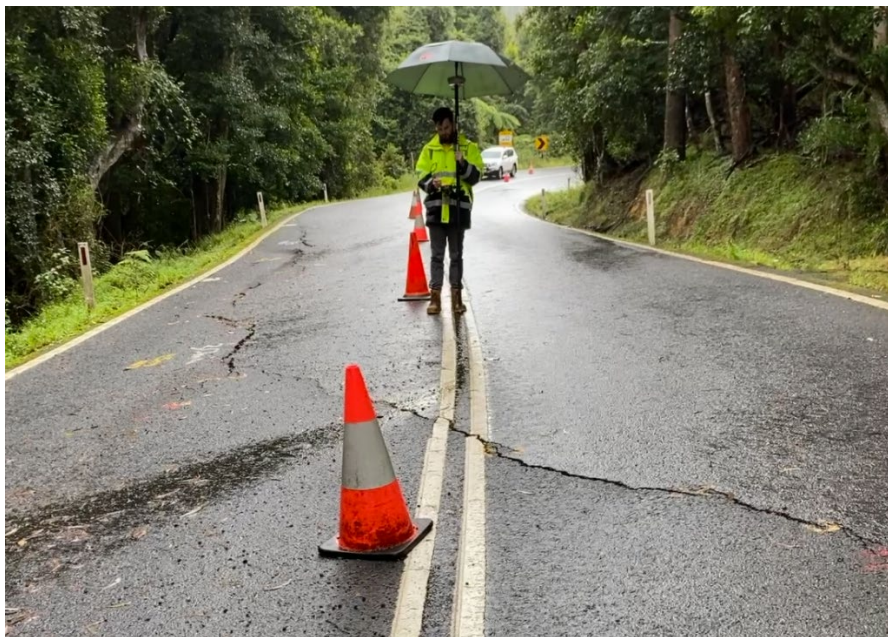
**Figure 14. Macquarie Pass Trimble GNSS mapping of tension cracks and other relevant site features. Photo by Flentje, March 2022.**

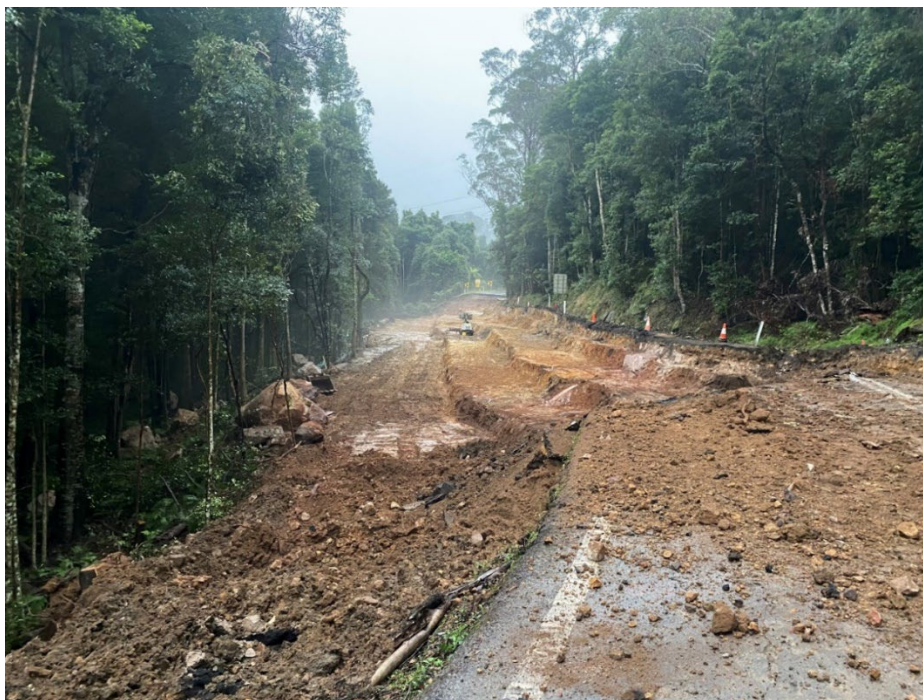
**Figure 15. Benched excavation of landslide affected area at Macquarie Pass nearing completion. Photo by Boys, late April 2022.**

The Illawarra Highway crosses the Illawarra escarpment 10 kilometres west of Albion Park at Macquarie Pass. This 7.5-kilometre stretch of road between Tongarra Mine Road and Mount Murray Road is steep, narrow, and winding as it ascends 550 metres in altitude. On the night of Wednesday the 9<sup>th</sup> of March 2022, following over 1,000mm of rain in the previous 30 days, pavement cracking such as that shown in Figure 14 was observed, with vertical displacement, in a section of Macquarie Pass. As the cracks and displacement grew in size, investigative drilling works were carried out on the 15<sup>th</sup> and 16<sup>th</sup> of March, which interestingly did not encounter bedrock (with all holes drilled to 8-10m depth). The road was closed at 7:30pm on the 26<sup>th</sup> of March 2022 after the damage to the pavement became a safety concern. The landslide was mapped with the Trimble GNSS 7X device by Flentje and Larkin on the 31<sup>st</sup> of March and the landslide is estimated to have a volume of 2,000 cubic metres. Remediation of the site began in early April with mass earthworks to remove nearly 4,000m<sup>3</sup> of the affected embankment and to bench the slope, as shown in Figure 15. In late April, work began on rebuilding the road by draping the excavation with a sturdy geotextile then back-filling and compacting layers of coarse

graded basalt with a nominal diameter of 150mm. The embankment and pavement reconstruction was completed in May with the road open to traffic again on the 20<sup>th</sup> of May, at a total cost of near \$3 million.

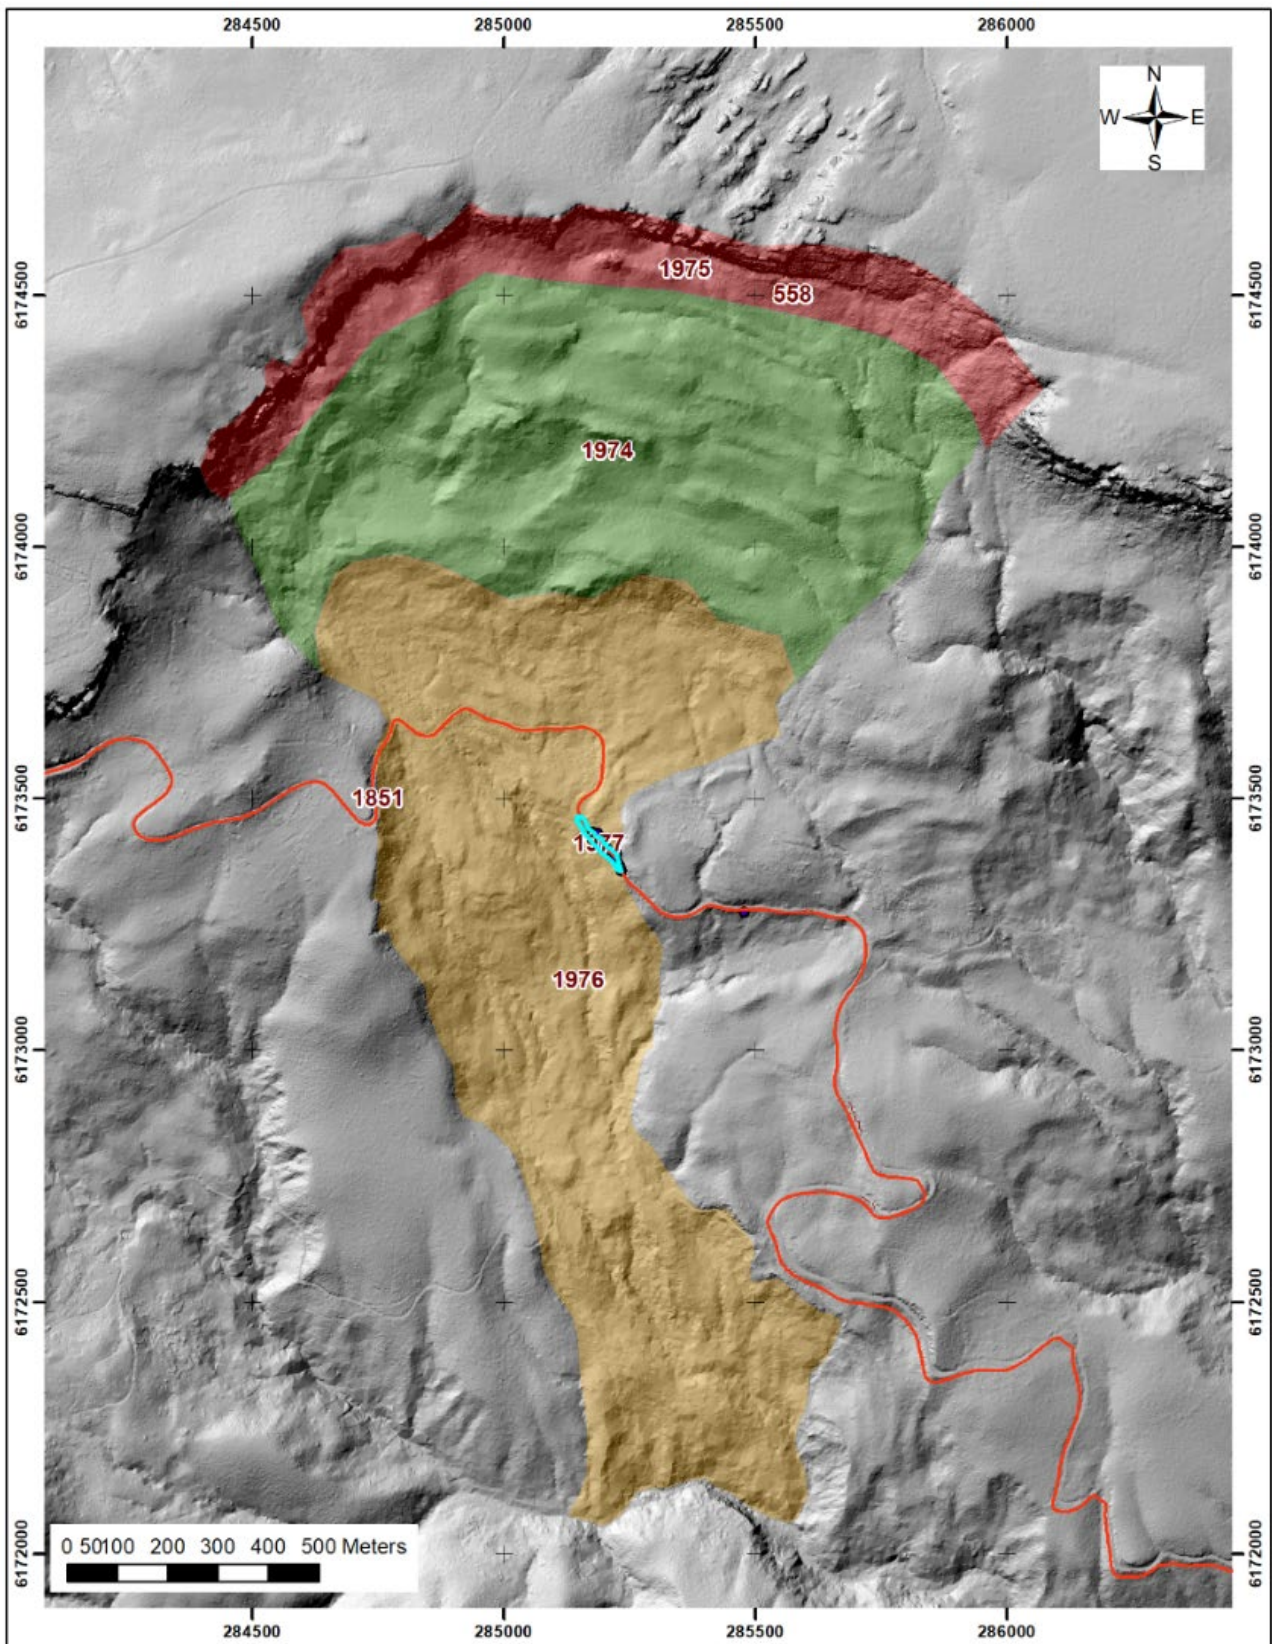
In the process of converting the field-based Trimble GNSS mapping data to a site within the LI, Flentje and Larkin used NSW Spatial Services Lidar data (May 2014) to create a hillshade image to assist in identifying landslide boundaries, as can be seen in light blue in Figure 16. Upon further GIS-based review of the Macquarie Pass site as a whole, the hillshade signature of a ‘prehistoric’ (Hamel, et. al., 2022) or very old, very large complex landslide became clear. Highlighted in red, green and orange the approximate boundaries of the slide can be seen with three distinct features. The red shaded area represents the head scarp of the failure where the landslide first separated from the escarpment, likely as a series of rockfalls, or more likely at this scale, escarpment collapses. The green shaded area represents the massive translational slide component of this failure, at approximately 1400 metres wide, 800 metres from the escarpment, and potentially 20 metres deep - this slide component could have a volume of 10 million cubic metres. The orange shaded area highlights an extensive debris flow over 1.5 kilometres long that reached Macquarie Rivulet at the bottom of the valley. Approximately 150 metres could have failed to create this debris flow, at 800 metres wide and 15 metres deep this component could have a volume of 800,000 cubic metres. A landslide of this magnitude is likely to have impacted waterways and altered the course of the rivulet in the valley below. As seen in Figure 16 the landslide impacting the road was on the eastern boundary of this ancient slide, which possibly saw movement as a result of the high rainfall and was likely a contributing factor of the smaller slide.

Figure 16. Lidar DEM hillshade model of a portion of Macquarie Pass showing the clear signature of a 'prehistoric' landslide and the location of the 9<sup>th</sup> March failure.

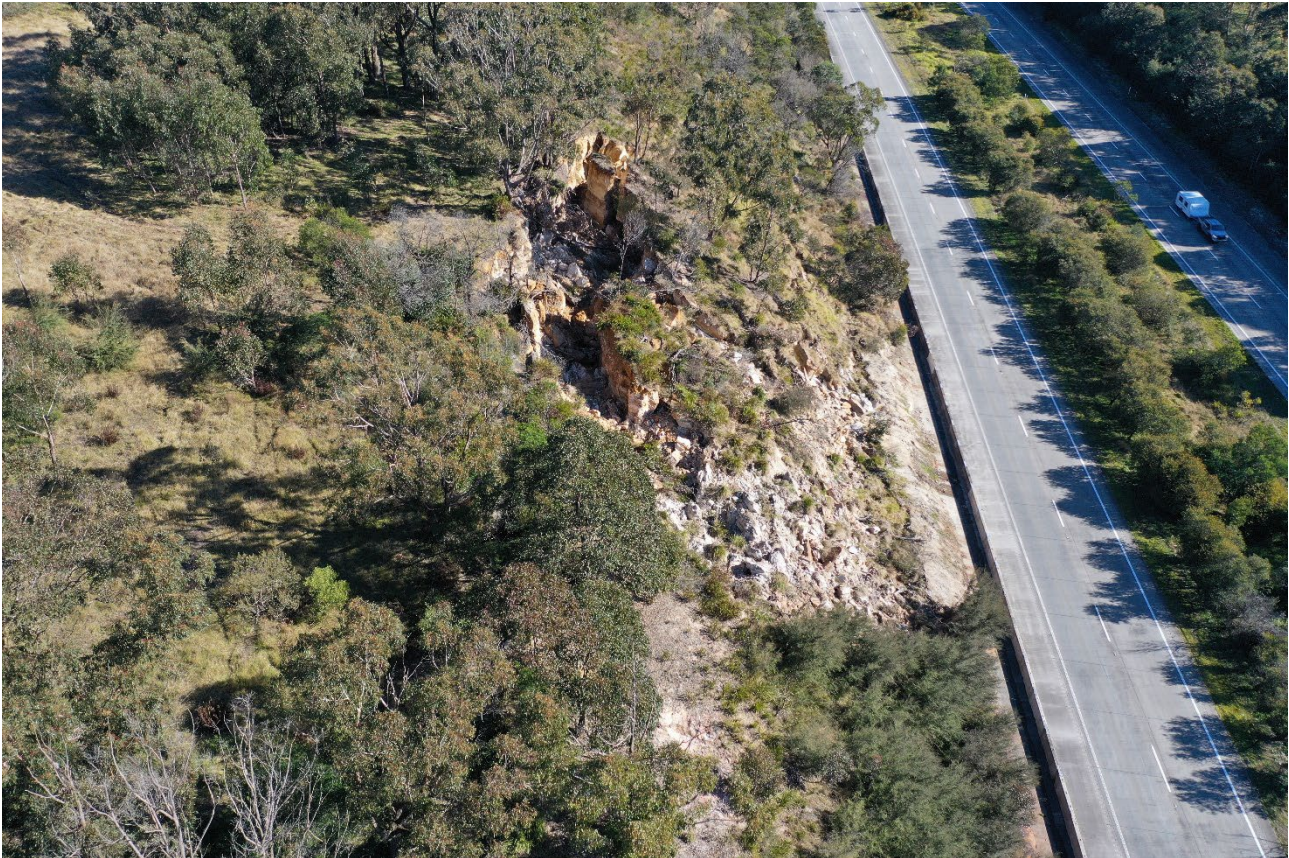
Figure 17 shows a significant cutting failure on the Hume Highway near Berrima. The slope was inspected on March 7th, during the first week of the March rain event. Initially reported as a small debris and mud slide onto the shoulder and slow lane of the highway, with some toppled trees and rocks on the face of the cutting of some concern. A Geotechnical inspection was carried out 21st March, which identified the large translational slide failure towards the top of the 15m high cutting. The main slide was found to have a 60m long tension crack/graben structure which was up to 10m deep and 8m wide. The arcuate tension cracks beyond the main graben structure extend for at least 120m total length as they curve back towards the highway both north and south of the site. There are higher cracks along near-vertical bedrock discontinuities that are open up to 40mm. The volume of the displaced Hawkesbury Sandstone material is approximately 10,000m<sup>3</sup>. Drilling investigations behind the slide encountered 18m of sandstone with occasional siltstone and conglomerate lenses, and siltstone layers from 18m. A concrete lined catch drain above the slide has failed into the graben structure exacerbating the failure due to the prolonged rainfall events. Remediation has commenced with the removal of the displaced sandstone material a priority. In the long term, the slope will be remediated with a rock berm and a capping

**Figure 17. A Hawkesbury Sandstone cutting failure on the Hume Highway near Berrima. Initial inspections on the 7<sup>th</sup> March were followed by geotechnical inspections on the 21<sup>st</sup> March when the wider scope of the 10,000m<sup>3</sup> translational failure was acknowledged. Remediation has recently commenced. RPA photo by Flentje, 15 June 2022.**

of rock to minimise further regression combined with an upgraded catch drain directing surface water well away from the failure and cutting face.

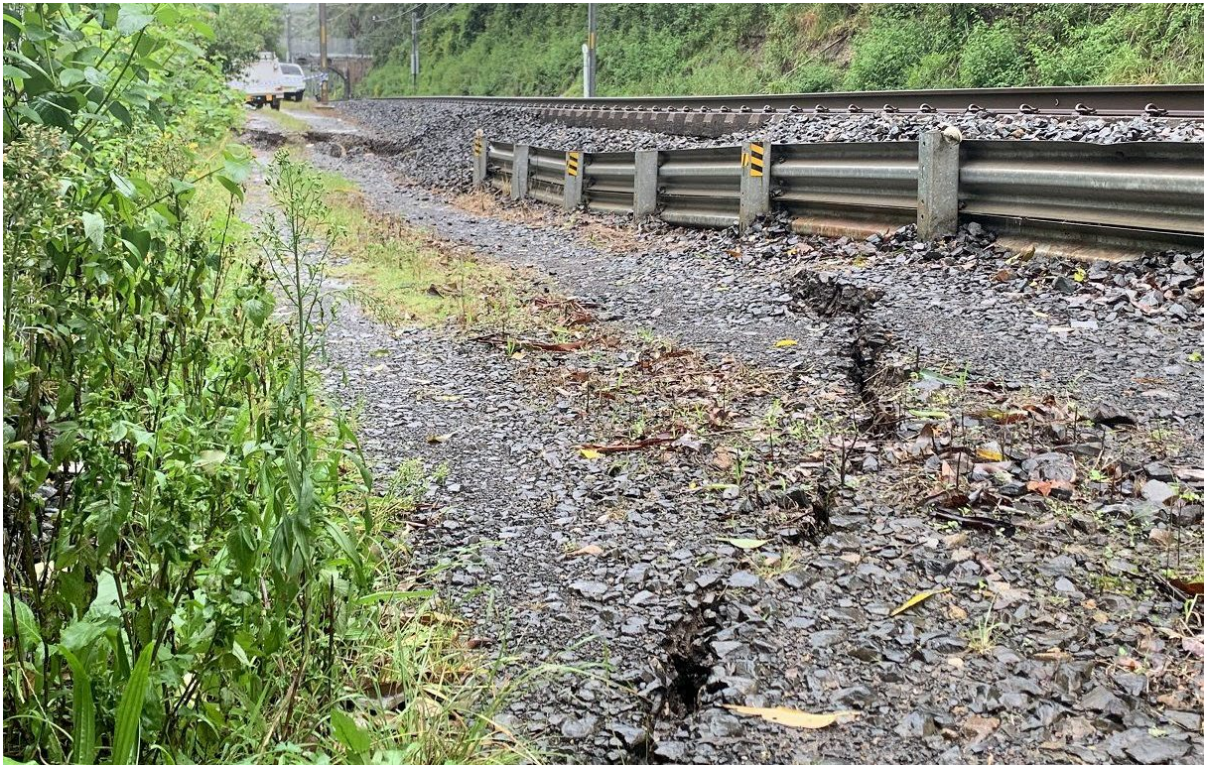
A slide failure in Otford at chainage 53.535km (from Sydney), as shown in Figure 18 and 19, resulted in closure of the line for 18 days. Several smaller failures have also occurred in Otford, both to the south and north of this main site although these have not directly affected rail operations. Train movements ceased on Wednesday 6<sup>th</sup> April as a result of the heavy rainfall and with the rainfall monitor alarms, hydrological issues with culverts and as landslides were expected. Highrail on-track patrols commenced from Thirroul at first light on Thursday 7<sup>th</sup> April and the Otford landslide was promptly identified. Sydney Trains very quickly commenced the drilling boreholes on the site and engaged consultants SMEC for investigation and remedial advice.

The Figure 18 failure occurred at the site of a previous failure documented by a sketch in the Illawarra Line Drainage Plans (1964). An intact solid mass concrete 2m high 30m long wall along the toe of this earlier failure, as shown in the earlier plans, still exists along the bank of the Hacking River. The date on the older plans is almost illegible but it may read 29.7.55. The location of this concrete retaining wall was mapped by Flentje with the Trimble GNSS in May 2016 for a small earlier culvert related failure along the southern margin of this site. Trimble GNSS mapping on site by Flentje, escorted by rail staff during this closure, confirmed the site dimensions as having a length of approximately 72m, and a distance from the crest to the toe of approximately 32m and a midpoint depth of about 8m which suggest a landslide volume in the order of 8,400m<sup>3</sup> of material. The benched excavation (Figure 19) was no doubt considerably larger. This excavation was lined with a sturdy geotextile and backfilled with coarse basalt in the order of nominal diameter 200mm. The cost of these works has been reported as approximately \$5.2 million (Milling, pers. com, July 2022). The work was

**Figure 18. View towards Sydney (UP) at kilometerage 53.53km on the 7<sup>th</sup> April 2022 at 3pm. Track, formation and Armco sag is clearly evident. Photo courtesy of S. Milling.**

completed by the TfNSW-Sydney Trains Major Works Division (MWD) over a two week track possession. Following the failure on the 6<sup>th</sup> or 7<sup>th</sup> April, this segment of the South Coast Line was fully reopened to rail traffic late on Anzac Day, Monday the 25<sup>th</sup> March, ready for the Tuesday morning peak.

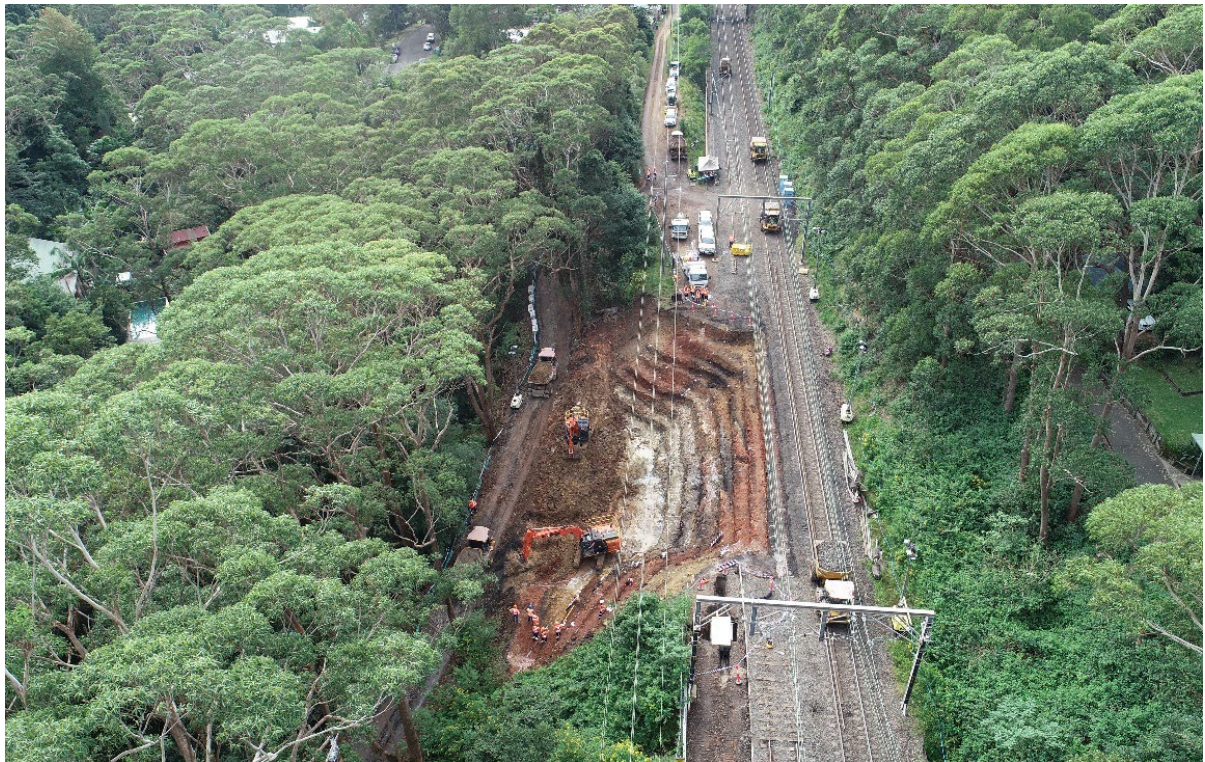
**Figure 19. Looking towards Sydney above 53.7km on the 16<sup>th</sup> April. The benched cut is near completion and lining with geofabric commenced in the same afternoon. RPA photo by Flentje.**
