### A photographic essay on landslides across southeastern New South Wales triggered by the rainfall events of 2022

Phil Flentje

# **A PHOTOGRAPHIC ESSAY ON LANDSLIDES ACROSS SOUTHEASTERN NEW SOUTH WALES TRIGGERED BY THE RAINFALL EVENTS OF 2022**

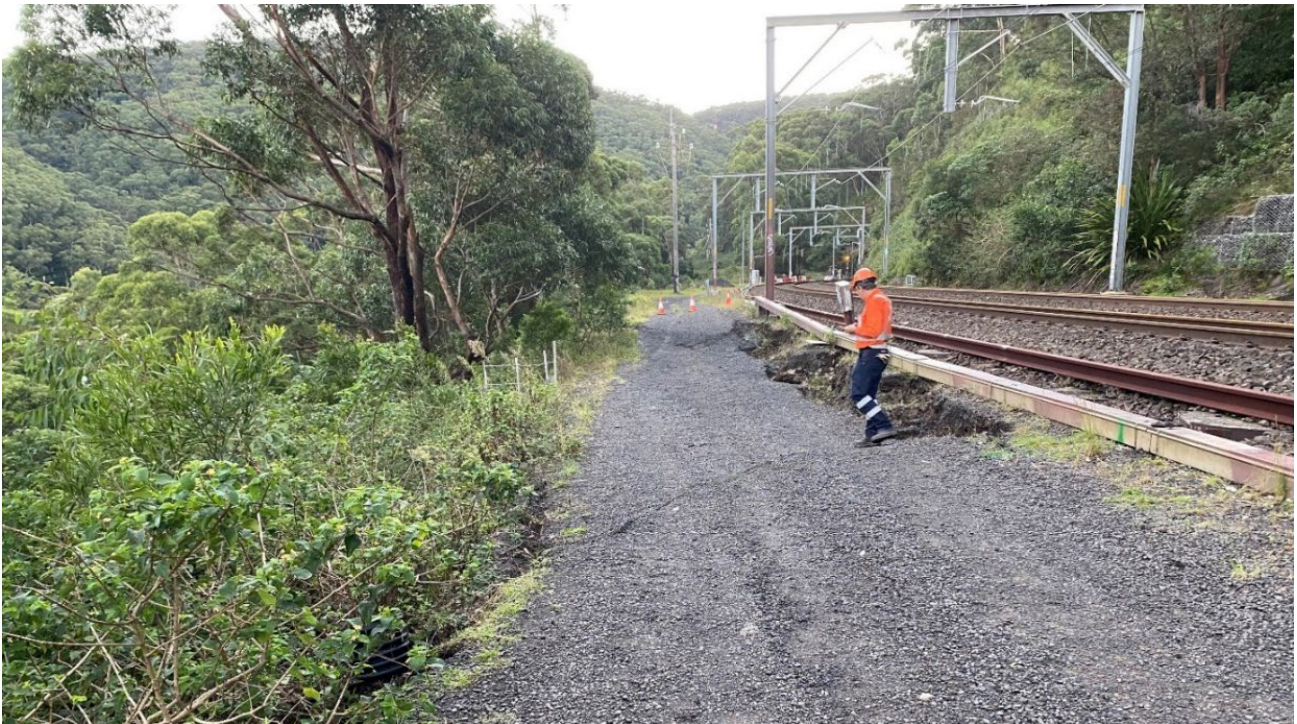
Another Illawarra Line embankment slide failure occurred in Stanwell Park, just south of the station at chainage 56.300km on the DN side. Flentje and Larkin, with the aid of TfNSW engineer Mr. Milling, have mapped the downslope extents of this slide with the Trimble GNSS device during several visits in April and June 2022. At this site, the line sits upon the “top” of a large landslide that extends downslope for approximately 180m to the banks of Stanwell Creek. When considering the current dimensions of this site (180m long by 120m wide) with a conservative depth estimate of 10m, a volume of approximately 100,000m<sup>3</sup> is determined. This site has quite a history as described by Stone (2012) and that reference includes several good photographs of failures in April 1989 and August 1990, and references to earlier failures at this site from 1950 onwards (Smith, 1964) and also in 1987 – see Stone (*ibid*) Figures 18-23 therein for images of the 1990 situation. The design philosophy for track safety in 1990 was to independently support the track with a discrete anchored pier wall system, a system not reliant upon the presence of the landslide mass in front of the wall, thereby isolating the track from the landslide hazard. The discrete anchored pile wall system consists of some 20 piles of 1m diameter and nominally 15m deep over a 40m length to isolate the track from the landslide – see the top of the line of piers between the track and access road in Figure 20, and a RPA view of the slide headscarp area in Figure 21. The piles were installed during the 1990 January shut-down and the cable anchors were installed the following year. During the recent event, the access track, independent of the railway, followed the landslide movement down from the railway, consistent with the design. Due to a major restoration project scheduled for the Viaduct, south of this site and which is accessed via this track, a new remedial solution is currently being sought for this site. The current design philosophy includes lowering the access road several metres across the failure, but not so much as the remove too much of the passive support for the existing piles provided by the embankment itself.

**Figure 20. View southwest over the headscarp of the Stanwell Park rail embankment failure at 56.300km. Photo by Flentje, 14 April 2022.**

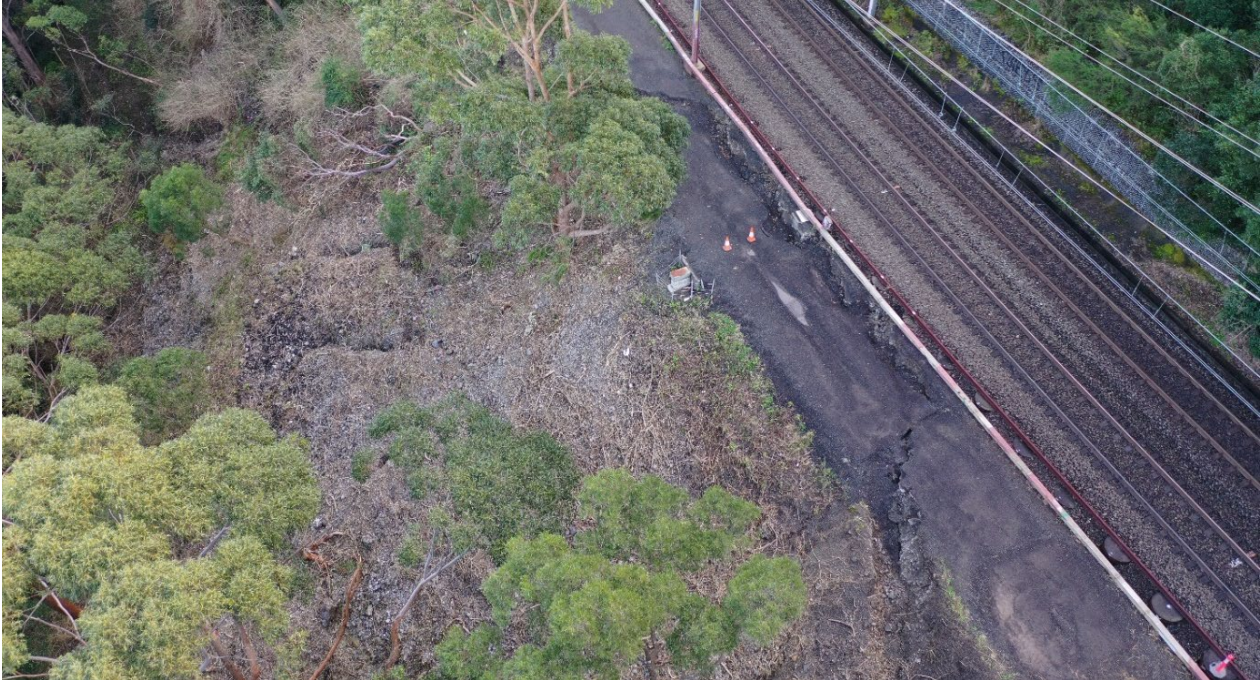
**Figure 21. View to the west over the distorted upper slag embankment and headscarp of the Stanwell Park rail embankment failure at 56.300km. RPA photo by Flentje, 5 August 2022.**

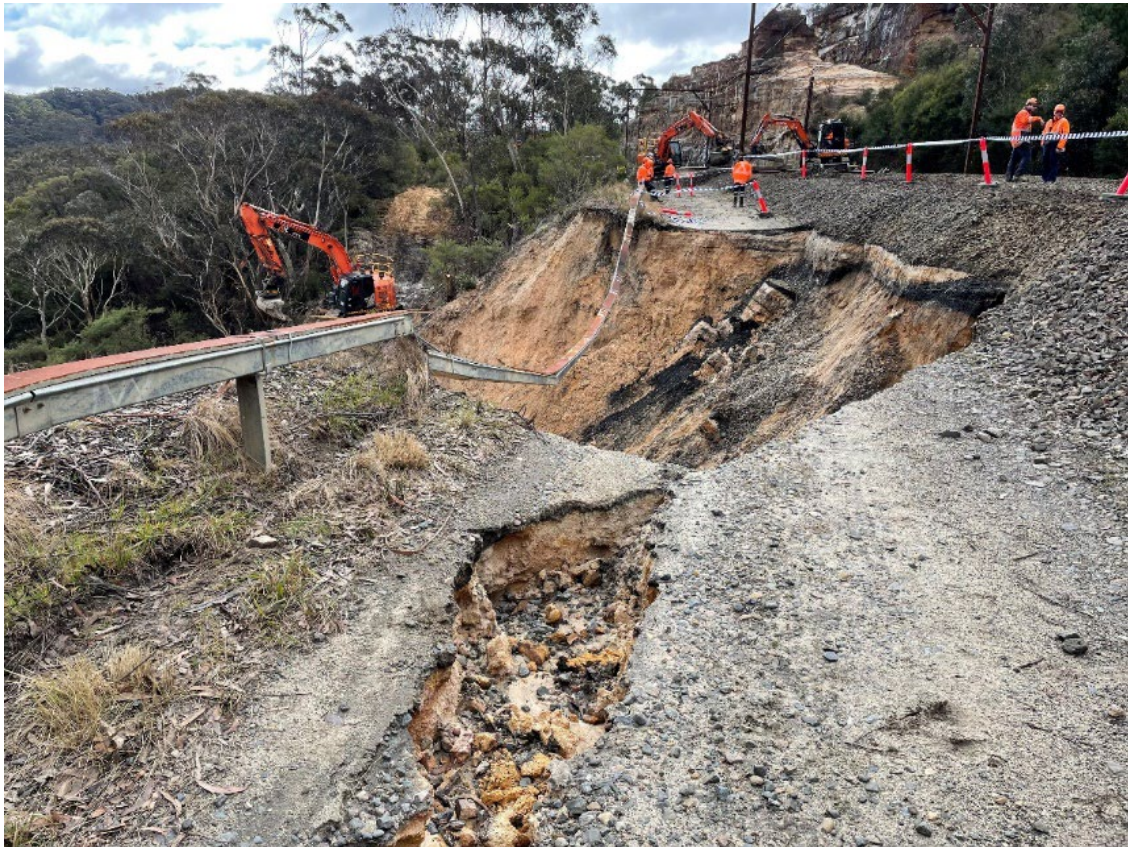
The main western railway line takes a winding route as it traverses the Blue Mountains, through large rock cuttings and deep embankment fills, generally across quite steep terrain. A section of this line between Blackheath and Mount Victoria (chg. 124.32km) passes along a sandstone cliff line near Mount Boyce. In the late hours of July 4<sup>th</sup>, following over 600mm of rain in less than 7 days, a landslide took out the access road and undermined the down track (DN from Sydney) closing the line to all traffic. The site, approximately 2.3 kilometres southeast of Mount Victoria, is located in a large gully between sandstone cuttings. Figures 22 and 23 show the extent and damage of the estimated 5,000 cubic metre failure which is characterised by large rotational slide in the fill embankment and a debris flow extending into the bushland below. The landslide was first mapped by Larkin on the 8<sup>th</sup> of July, for the purposes of adding the site to our LI. Clearly the site has been suitably mapped by TfNSW and consultants prior to our work. The site has been promptly remediated

**Figure 22. Major slide which closed Main West at Blackheath around 11pm July 4. Photo by Larkin 8 July 2022.**

by Major Works Division (MWD) with the benched removal of a reported 30,000 tonnes of material from the landslide site, down to and into bedrock. The benched excavation was lined with heavy geotextile to permit reconstructing the embankment with the importing of 40,000 tonnes of basalt material, placed in compacted layers. The line was reopened on July 30, just 25 days after the failure occurred.

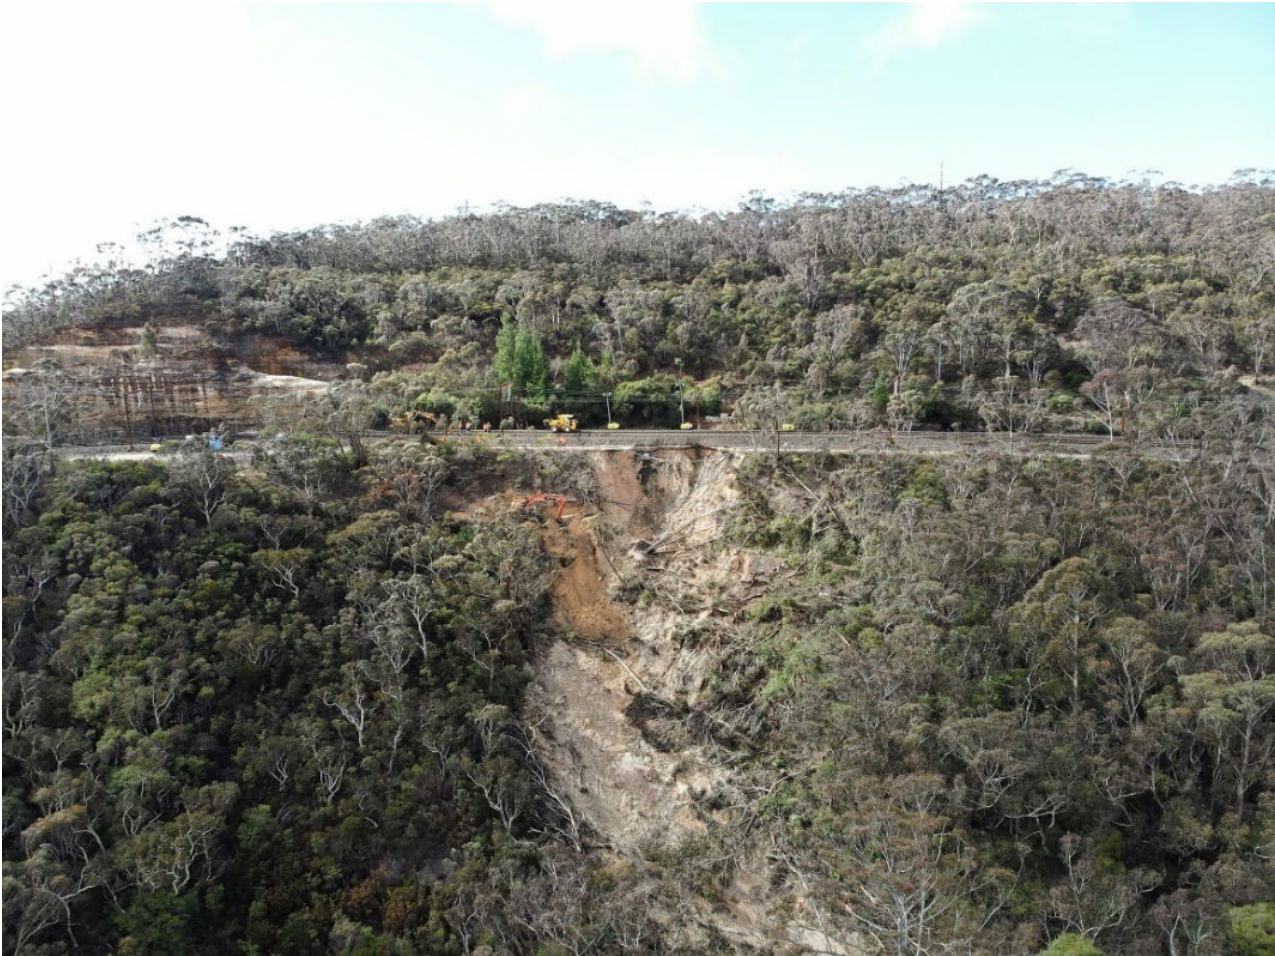
**Figure 23. RPA oblique photograph of the Blackheath site. Photograph sourced from TfNSW Facebook post.**

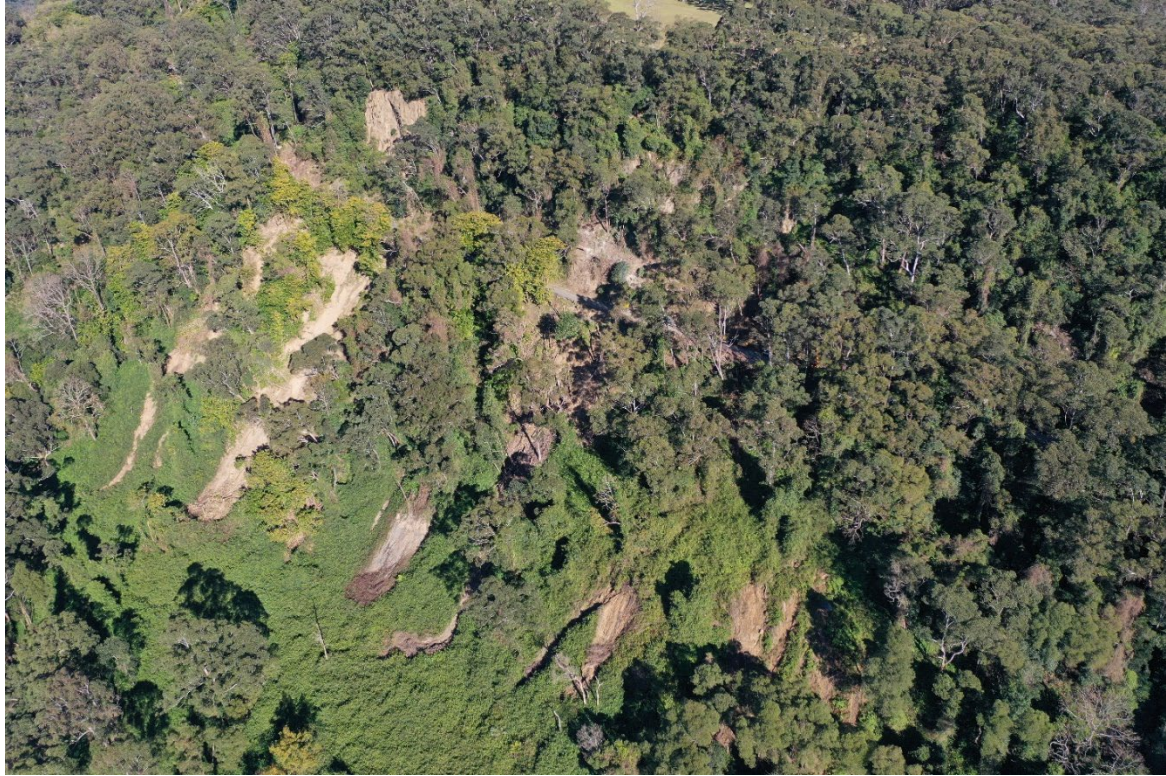
Harry Graham Drive (HGD) traverses the Illawarra escarpment just north of Mount Kembla and has been impacted significantly by rainfall since February 2022. A 1.5-kilometre section of this road runs along a narrow colluvium mantled terrace upon the Wombarra Claystone immediately beneath the Scarborough Sandstone cliffs. The slopes to the east drop steeply into the Kemira Valley below. The road was closed on March 1<sup>st</sup> 2022 due to severe weather conditions and inspections on the 10<sup>th</sup> of March revealed significant damage to the road as a result of landslide movement. The road received 500mm of rain in the 7-days prior to inspection which revealed large rotational failures, debris flows, scours, rock falls, and tree falls. Figure 24 is a RPA image of a 300-metre section of HGD (just visible above centre) with multiple failures both above and below the road. Figure 25 is taken from the ground in the middle of this section showing a near 2-metre backscarp of one of the largest downslope failures along the road. This landslide has an estimated volume of 4,000 cubic metres and this has site continued to move since March.

**Figure 24. RPA oblique photograph of Harry Graham Drive. Photo by Flentje 15/06/2022.**

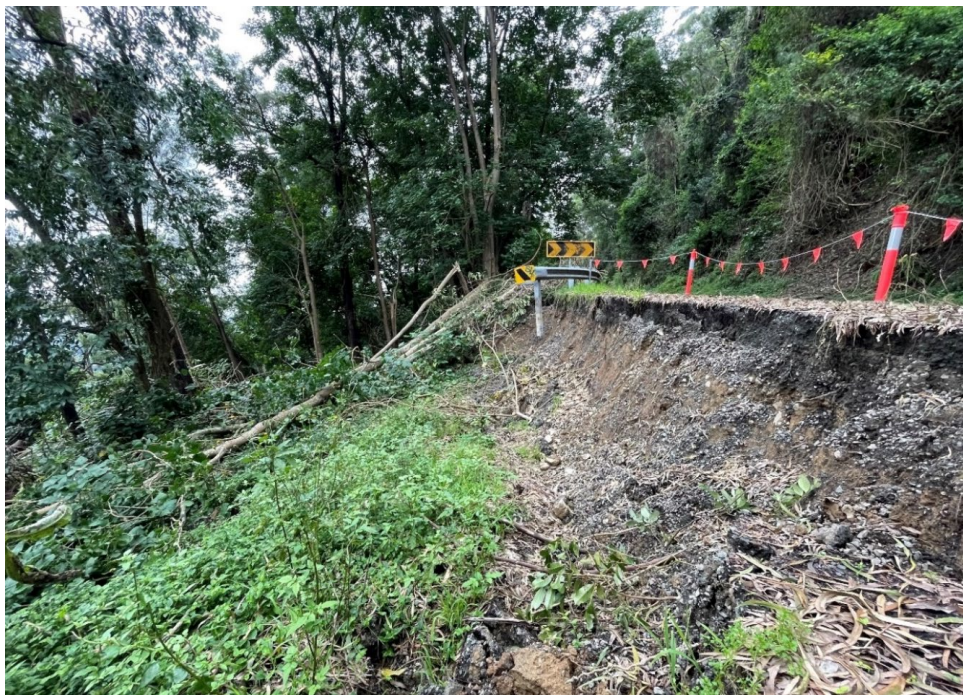
**Figure 25. Major downslope slide on Harry Graham Drive. Photo by Larkin 30<sup>th</sup> March 2022.**

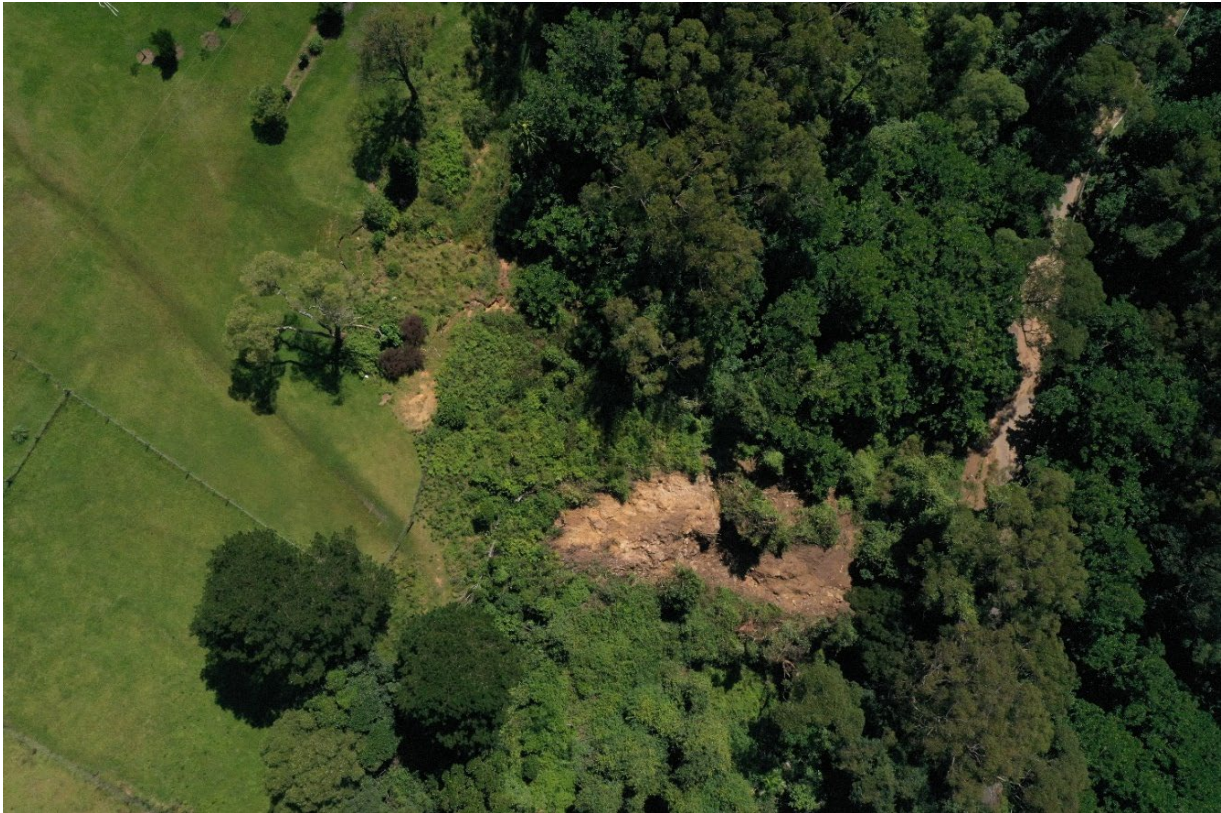
Figure 26 shows an aerial view of a 400m<sup>3</sup> upslope failure on Harry Graham Drive that originated as a slide type failure along the edge of the terrace and resulted in a debris flow that reached and travelled along the HGD road pavement. Tension cracks can also be seen in the figure, slightly above the debris flow scarp and these delineate another significant slide extent. This site is just to the south of a significant complex slide and debris flow failure that became almost a ‘signature’ photograph event of the August 1998 rainfall event, a photo that showed a house close to a large failure scarp draped in yellow and green plastic. The failures on Harry Graham Drive have been mapped on multiple occasions since the 10<sup>th</sup> of March 2022 by Flentje and Larkin with the Trimble GNSS 7X device. Wollongong City Council has commenced multiple types of remediation along the road including removal of debris, earthworks, installing rockfall protection barriers, soil nailing, rock bolting, and shotcreting. A sheet pile remediation treatment has also been implemented in an area where landslide movement has caused pavement deformation and displacement. This solution

**Figure 26. RPA photograph of debris flow above Harry Graham Drive. RPA photo by Flentje 10<sup>th</sup> March 2022.**

involves steel sheet piles driven into the ground at several inclinations (pseudo ‘pali-radice’ micro-pile approach) at the edge of the road and tied with a concrete capping beam to stabilise movement whilst also forming the roadside edge beam. All of these works have been expedited and are still ongoing at present in order to reopen the road in early September. There is considerable pressure on the timeline as this road segment is to be used as a stage in the Union Cycliste Internationale (UCI) cycling world championships on the 24<sup>th</sup> and 25<sup>th</sup> of September 2022, when cameras of the world will be turned on Wollongong similar to that experienced in France during the Tour de France.

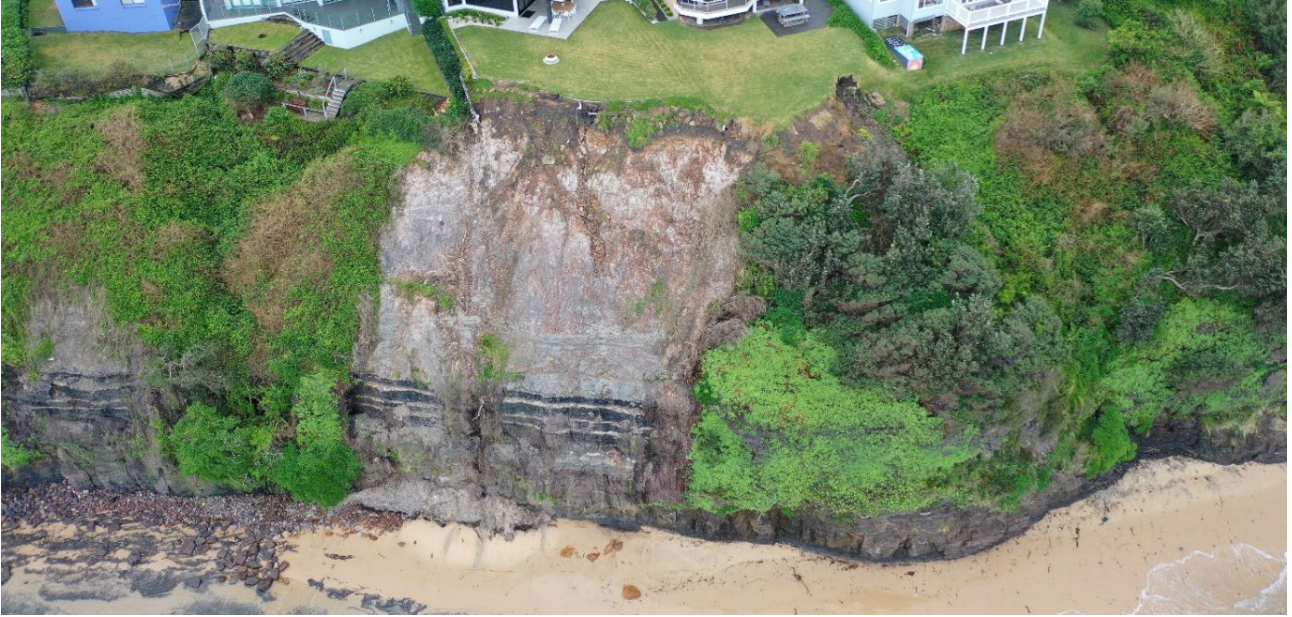
As noted in the Introduction of this paper, coastal landslides have affected infrastructure and properties in the regions northern suburbs as many sea cliffs were damaged during the prolonged combination of very heavy rainfall and at times large destructive waves coupled with low atmospheric pressures driving higher sea levels. Figures 27 to 30 are four of many such examples. The landslides shown in Figure 27 and 28 are very close together physically and show failure of steep slopes above cliffs that expose the Tongarra Seam and the overlying Bargo Claystone interval of the Illawara Coal Measures. The upper steep slopes include a sequence of mottled grey and red-brown colluvium, and an upper variable layer of fill has also very clearly been placed to provide the level grassed rear terraces of the properties. Importantly, both sites show no evidence of retaining structures or slope failure mitigation works. Figure 27 shows there remains a horizontal buffer between the rear scarp of the failure and several residences. In Figure 28, on the other hand, there is a very narrow buffer of less than several metres between the rear main scarp and at least one residence. The failure hazard is real and there is a high likelihood that at least one dwelling will require management. Remediation of the site, considering workplace safety concerns together with other issues, with the house remaining will be challenging.

Figure 27. Fill and colluvial failure of coastal cliffs, northern suburbs. RPA photo by Flentje 22<sup>nd</sup> July 2022.

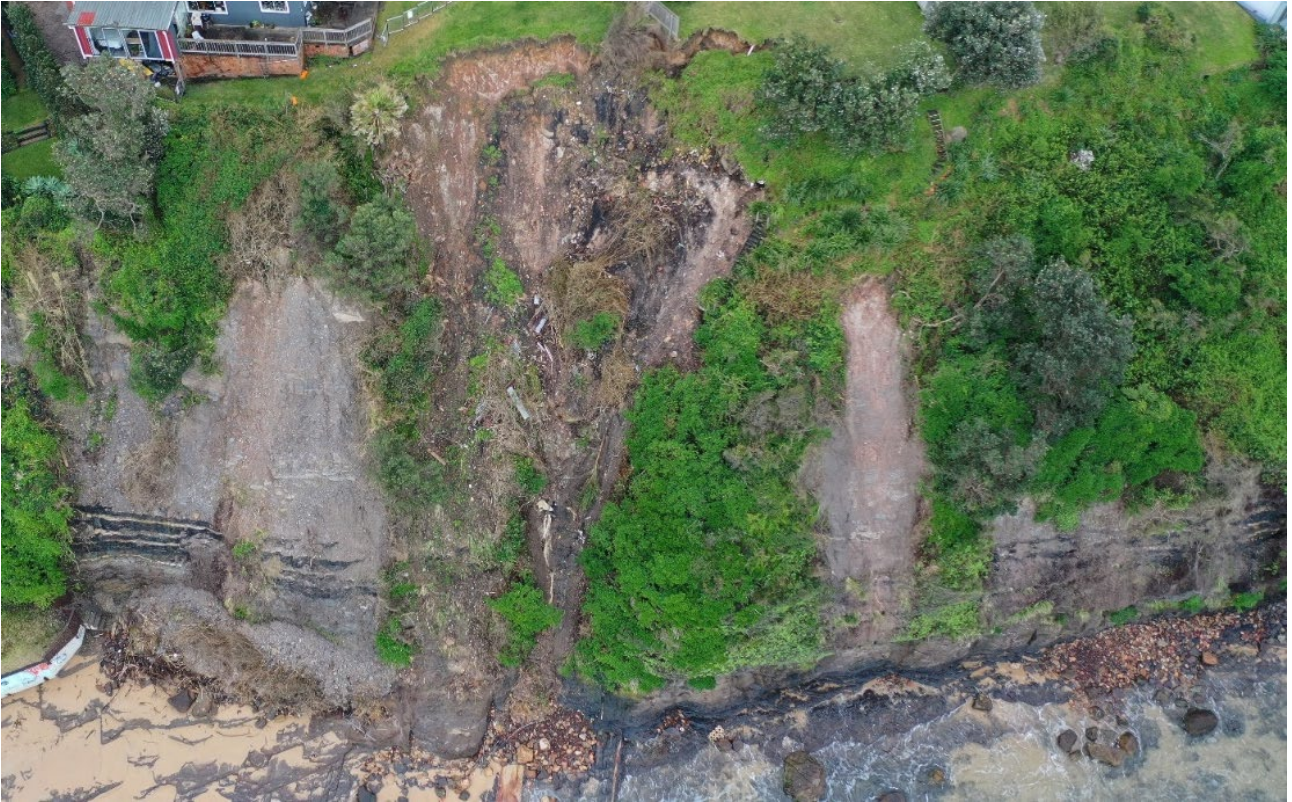
Figure 28. Fill and colluvial failure of coastal cliffs in the northern suburbs. In this section, the failure hazard is visibly apparent. RPA photo by Flentje 22<sup>nd</sup> July 2022.

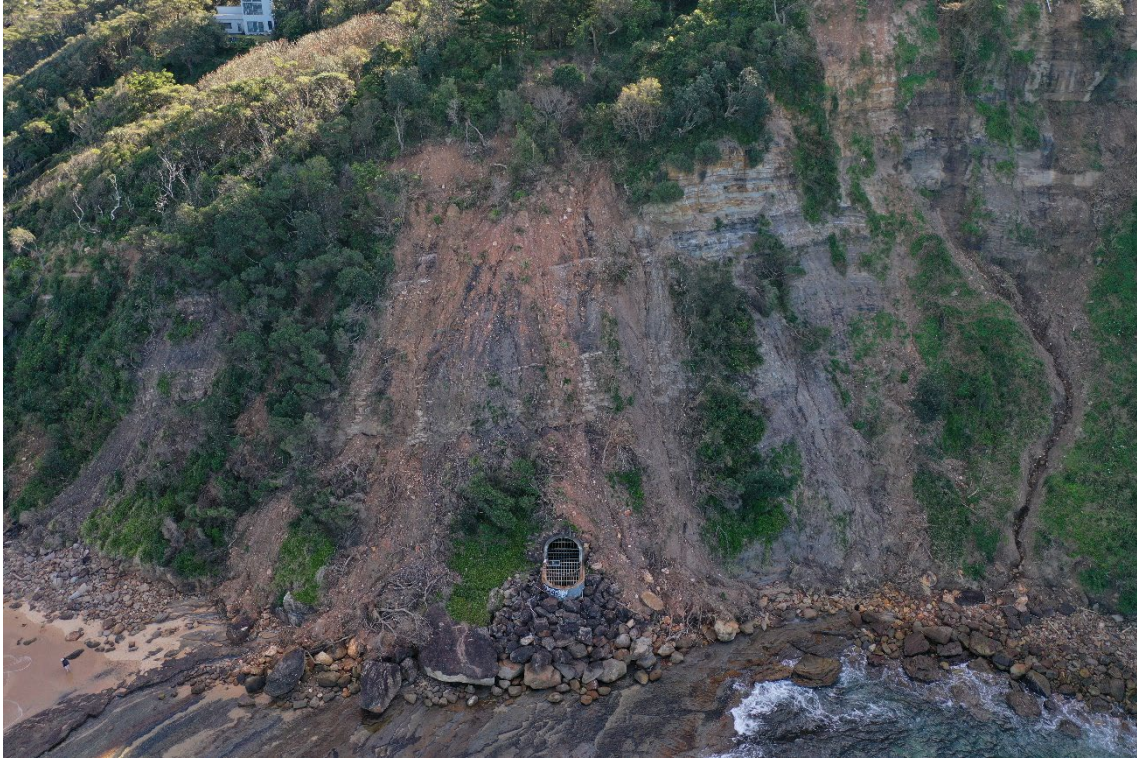
Figure 29 shows a similar coastal setting whereby the eastern edge of the upper terrace has failed. The first author is quite familiar with this site and the failure material is from a colluvium slope and, at about 30m behind the slope the side scarp of another landslide exists (moving downslope to the left), on which a continuous monitoring station has been installed. The original coast road historically traversed the outer edge of the terrace, not far above the failure shown in this image. The orange material shown in the upper failure area is littered with boulders, as is the draped colluvial debris that has flowed down the slope and onto the rockshelf along the toe of the slope. The portal structure shown in the bottom centre of the figure is the outlet for the Wombarra Drainage Tunnel.

**Figure 29. Failure of the colluvium mantle along the top of the coastal cliffs has resulted in debris flows and rockfalls onto the outlet of the Wombarra Drainage Tunnel, which is at the base of the cliffs in mid photo, at the north end of Wombarra Beach. RPA photo by Flentje 5<sup>th</sup> August 2022.**

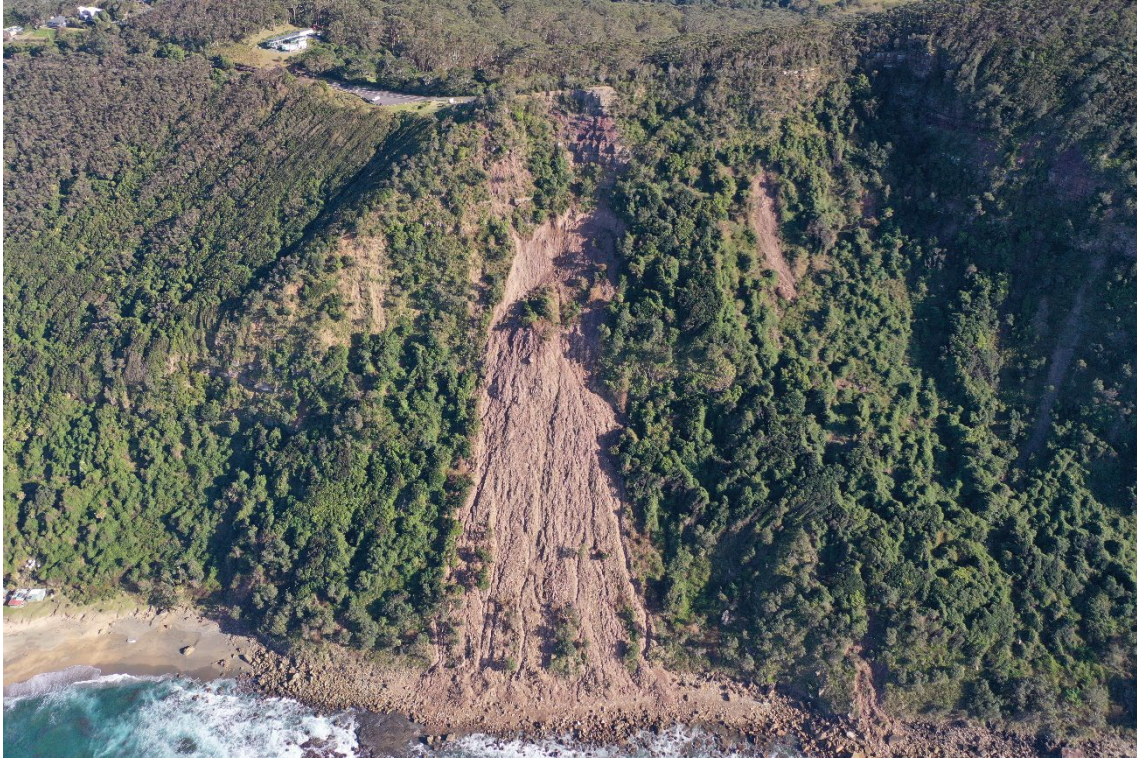
Figure 30 shows quite a dramatic failure on the coastal cliffs at the south end of the Royal National Park on the eastern side of the cliffs below the Otford Lookout. This image also shows four small failures (above, to the left and right, and another bottom right) around the main debris flow trail, and quite a large deep landslide headscarp of the main slide. With reference to a digital elevation model and a hillshade terrain in ArcGIS for this area, the main slide area may be around 60m wide and 30m from the headscarp out to the where the debris flow would have commenced, and the slide may be 10-15m deep - which suggests a conservative volume estimate of 10,000m<sup>3</sup>. There does not appear to be significant consequence of this failure, to humans. It is in the NPWS Royal National Park Estate and it has clearly done extensive damage to the coastal forest ecosystem. Whilst not a recognised walking track, one can walk from Bulgo Beach on the left, along the rock shelf to Hell Hole beach off to the right of this photo.

Of note, here are several shacks in the bottom left of the photo. These are the northern most dwellings of the Bulgo Beach Shack community. The northern most shack (assumed to be similar in position then as it is now) was inundated by debris on January 24<sup>th</sup> 1933 during a significant rainstorm. The shack at the time had a family of 10 asleep across two bedrooms. All were awoken by the event, and one bedroom was engulfed with 4 children buried. The other family members, in another bedroom, escaped and raised the alarm. Three of the missing kids were recovered, but Roy Burns (15 years old) was found still in his bed smothered by mud and boulders, and a 14 year old sister was taken to the Coledale Hospital with serious injuries (Sydney Morning Herald, 24 Jan 1933, page 11). On the same day, 7 campers were drowned in nearby Stanwell Park, so the rainfall at the time must have been extraordinary. The main point here being that the northern the shacks, at least, are in a similar geomorphic setting to the slopes where the flow has travelled.

**Figure 30. Bald Hill Claystone and Bulgo Sandstone cliff face below Otford lookout at the south end of the Royal National Park. RPA photo by Flentje 8<sup>th</sup> August 2022.**

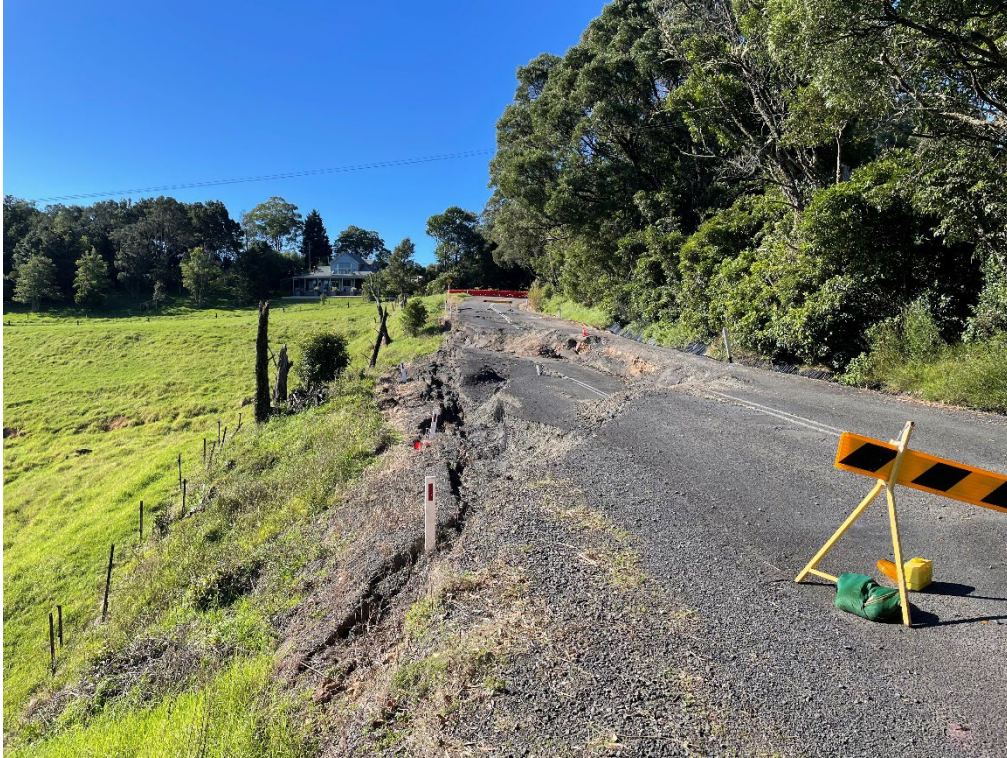
Wattamolla Road traverses the colluvial foothills of the Illawarra escarpment as it descends from Woodhill Mountain into the Brogers Creek arm of Kangaroo Valley. Kangaroo Valley has seen an anomalous depth of rain in the first half of 2022 with 7-day totals exceeding 800mm in the February-March rainfall event, resulting in the closure of Wattamolla Rd on March 2<sup>nd</sup> – see again Figures 1 and 3. Located 130 metres west of the intersection of Wattamolla Rd and Woodhill Mountain Road, Figures 31 and 32 show the landslide extent and pavement damage. Features of the landslide were first seen as settlement and cracking in the road pavement followed by significant vertical and horizontal displacement, indicating a large rotational slide with the head scarp encompassing both travel lanes. Further features were noted in nearby farmland with tension cracking on either side of an undulating gully depression indicating the side scarps of the slide - extending approximately 120 metres to the northwest. This movement is a reactivation and regression of an existing landslide which has caused damage to the road in the past (as reported by passing residents as mapping the site was taking place). The slide was initially mapped by Larkin on the 19<sup>th</sup> of May and then again by Flentje and Larkin on the 26<sup>th</sup> April. It is estimated to have a volume of 20,000m<sup>3</sup>. Shoalhaven City Council have completed interim works including the reconstruction of one lane of the road which is now open to traffic with a 4.5 tonne load limit. Long-term remedial solutions are currently being investigated including embankment support and the consideration of pumped water wells.

**Figure 31. Major slide which closed Wattamolla Rd on March 2. Photo by Larkin 19<sup>th</sup> May 2022.**

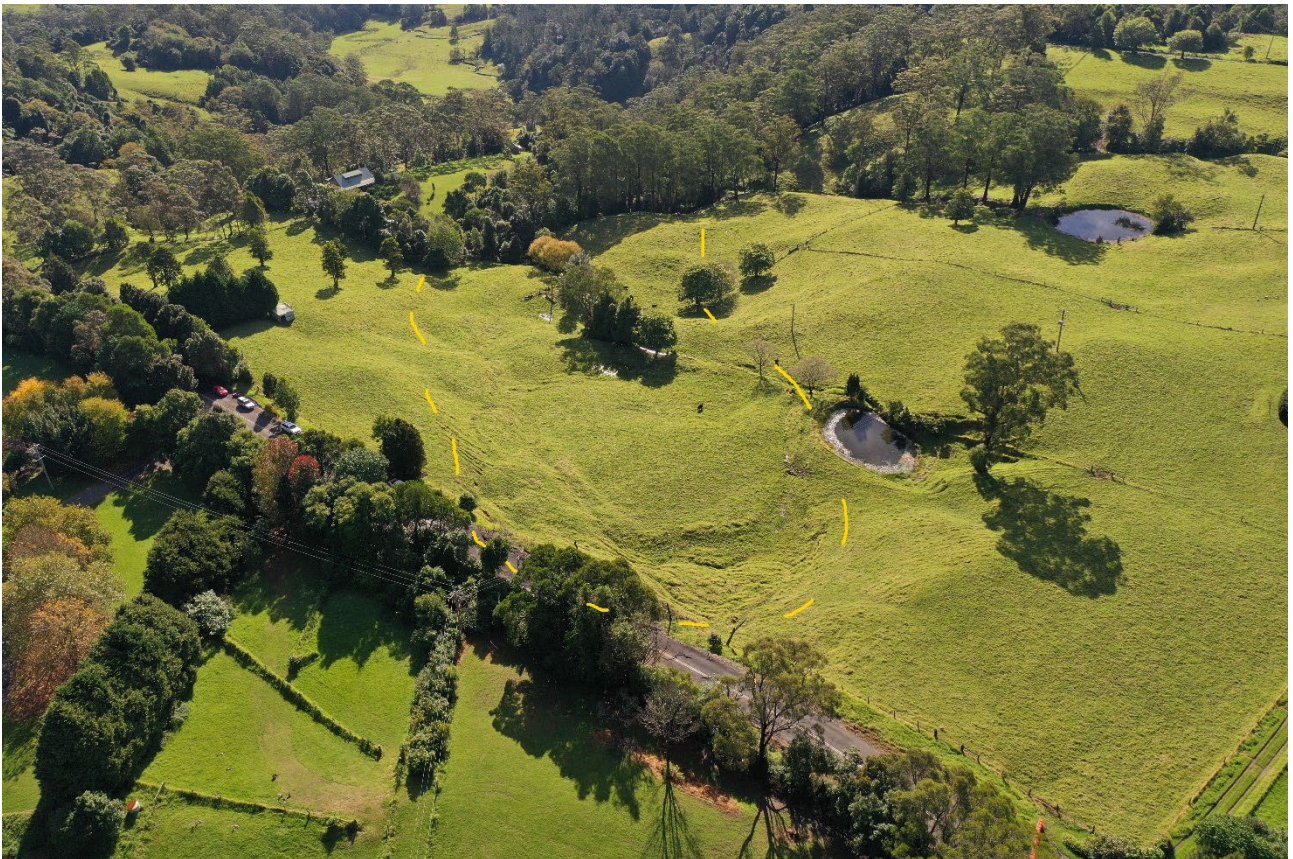
**Figure 32. RPA oblique photograph of Wattamolla Road. Approximate landslide boundary outlined in yellow. Photo by Flentje 26<sup>th</sup> April 2022.**

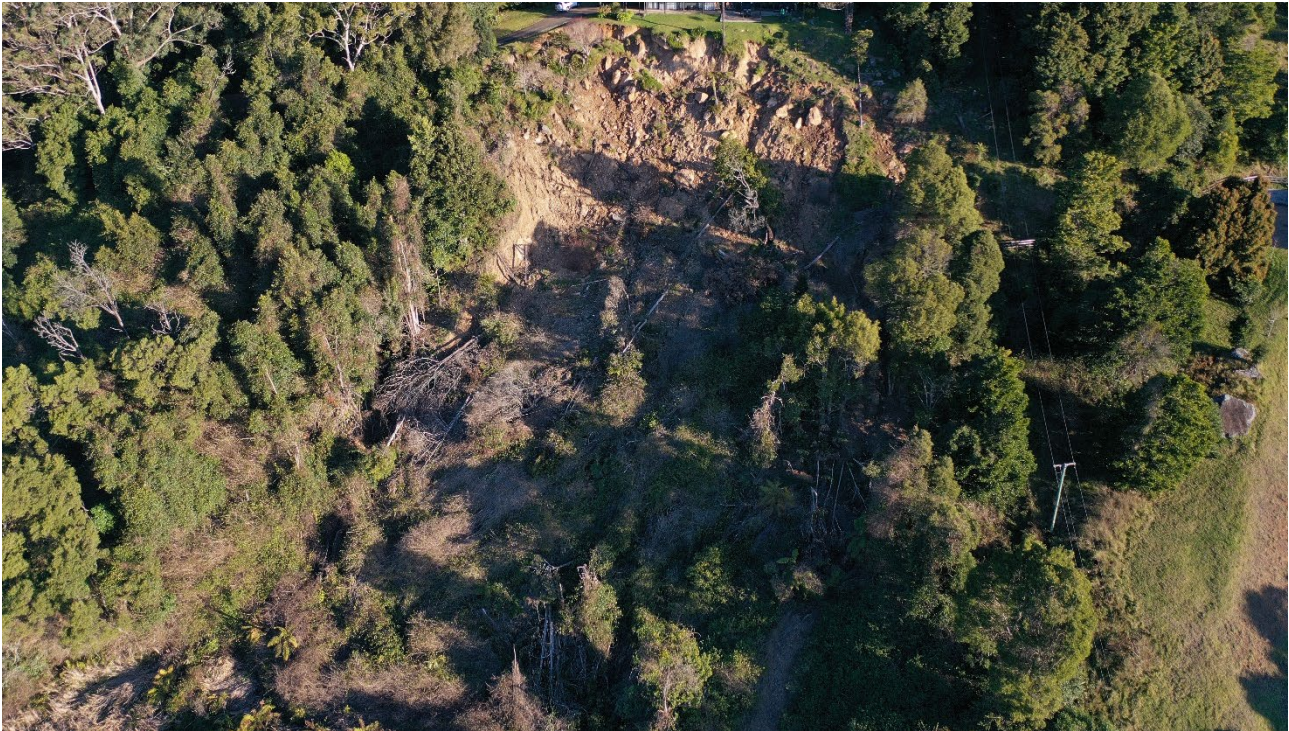
Located approximately 5.5 kilometres northwest of Berry on the NSW south coast, Figure 33 shows a large colluvial landslide in the foothills of the Kangaroo Valley. This failure is believed to have occurred in the early March rainfall event - investigation into a more precise timing of the slide is ongoing. The approximately 10,000m<sup>3</sup> slide occurred on a large, boulder filled colluvium deposit along a gully line. This location is likely a prehistoric landslide with material originating from the escarpment cliff line directly above. The slide was mapped and photographed by Flentje and Larkin on the 1<sup>st</sup> of August. For scale reference, the properties access way can be seen near the top centre of the photo, and the main scarp is approximately 60m wide.

**Figure 33. Slide flow category landslide in Kangaroo Valley. RPA photo by Flentje 1<sup>st</sup> Aug 2022.**

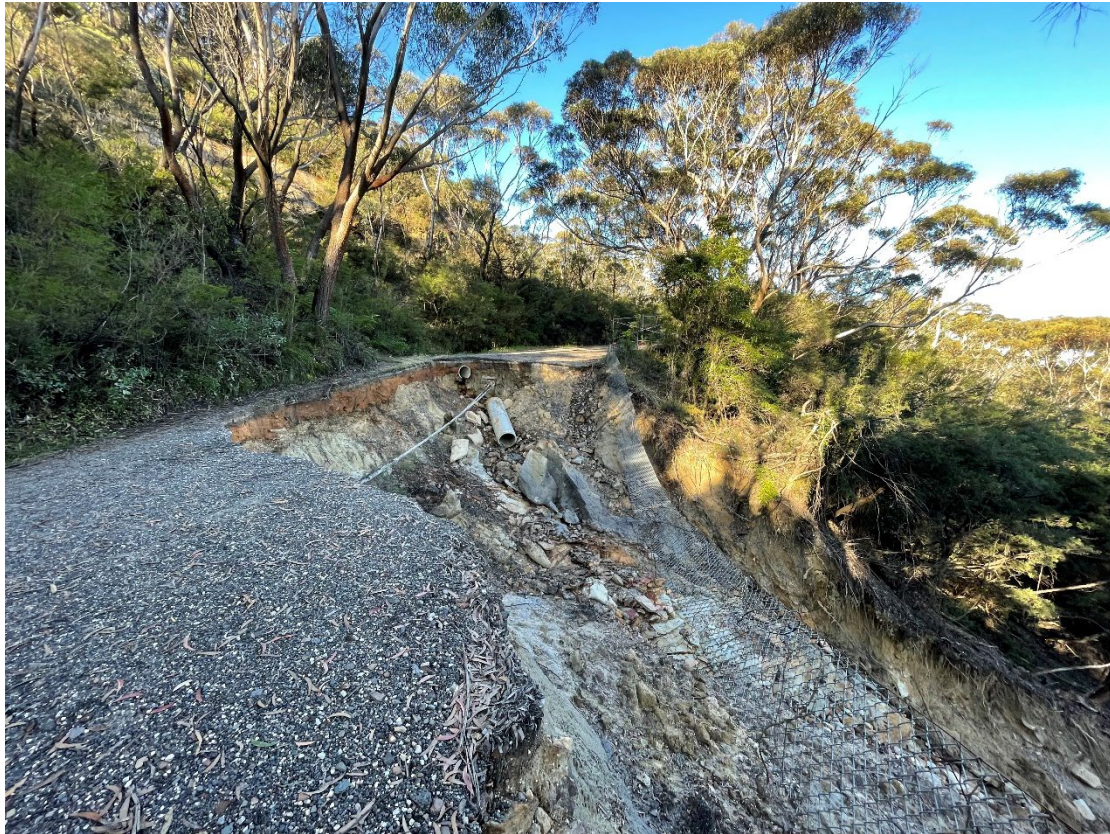
Glenraphael Drive traverses the sandstone cliffs south of Katoomba along the head of the Jamison Valley in the Blue Mountains National Park. The road traverses steep undulating terrain as it leads to the Narrow Neck Trail, a popular tourist destination. Glenraphael Drive was closed on March 6<sup>th</sup> after a landslide failure damaged the road embankment following rainfall that exceeded 600mm in a 7-day period in the late February to early March event. Located 500 metres from the road's intersection with Cliff Drive, the failure has since regressed and has now taken the full width of the road. Figure 34 shows the extent of the rotational slide which transitions to a debris flow that extends approximately 80 metres into the national park below the road. A small culvert can be seen feeding directly into the backscarp of this failure and is highly likely to have contributed to the failure, along with the very high rainfall totals. The slide was mapped by Larkin on the 8<sup>th</sup> of May with the Trimble GNSS 7X device and the failure is estimated to have a volume of 400m<sup>3</sup>.

**Figure 34. Slide on Glenraphael Drive, March 6. Photo by Larkin 8<sup>th</sup> May 2022.**
