# Appraising the Seismic Response of a Retrofitted Adobe Historic Structure, the Role of Modal Updating and Advanced Computations

**Figure 1.** The Church of Kuñotambo: plans at choir loft level and at base floor level, east façade and longitudinal section at nave, presbytery and altar, from 2015, before retrofit [13].

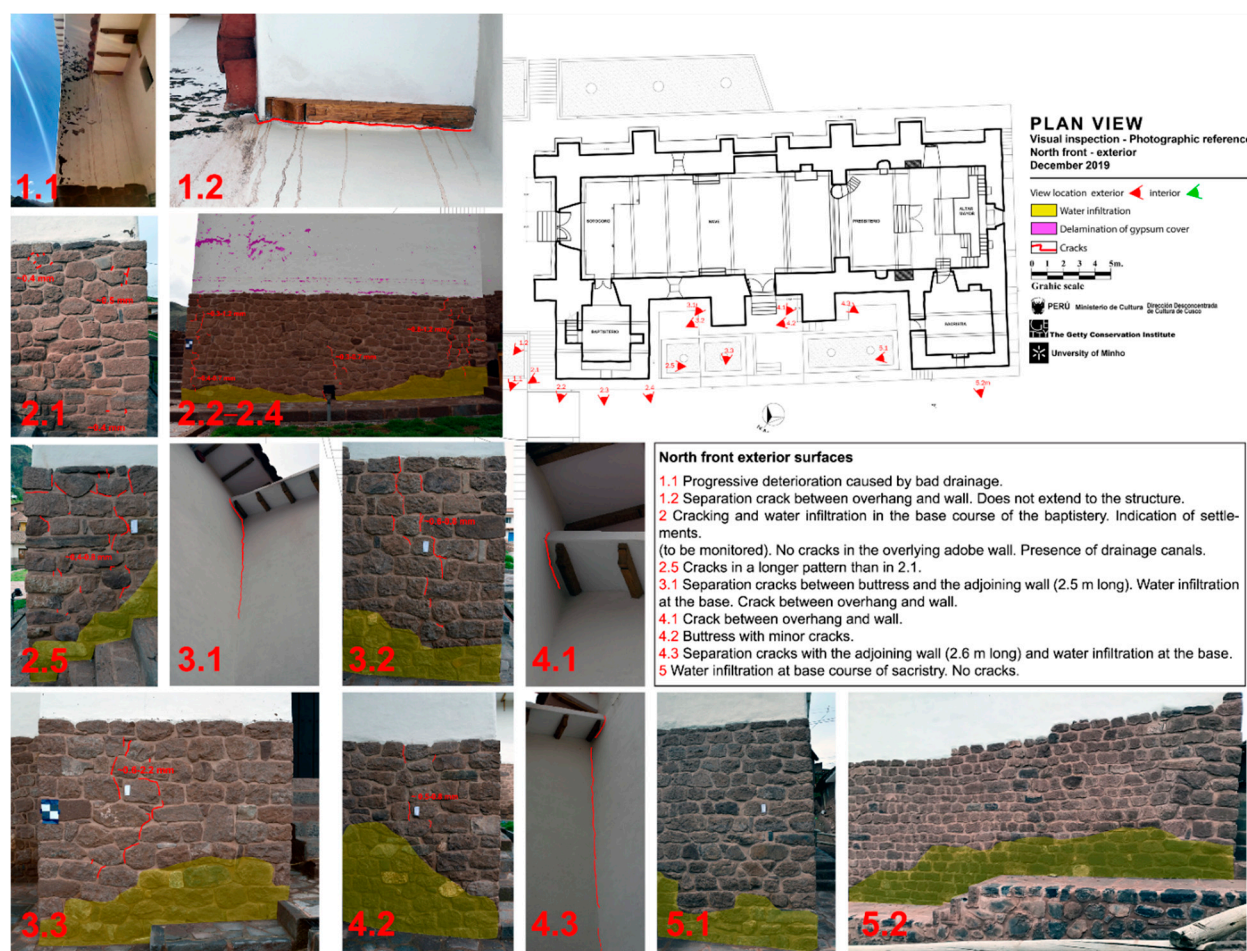
**Figure 7.** Set of documented damages comprised at the exterior surfaces of the south elevation. Note the photo references.

Signs of inadequate drainage were found (1.1–1.2 in Figure 7). Due to deficient roof waterproofing, rainwater ingress was observed in the staircase leading to the choir loft (15.3 in Figure 9). Moisture-driven damage was also observed along the base of the north façade (2.2–2.5, 3.2–3.3, 4.2 and 5.1–5.2 in Figure 7). This is possibly due to the action of wind-driven rain, in combination with the capillary rise of ground water and condensation.

Vertical cracks (medium to wide, with a thickness of 0.3–1.2 mm) were noted at the stone plinth on both corners of the baptistry (2.1–2.5 in Figure 7). These indicate the separation of the reconstructed exterior leaf of the stone masonry which has weak interlocking with the existing wall's core. Damage can be associated with cracking at the staircase compartment (15.1–15.3 in Figure 9) and may be related to differential settlements.

Regarding the condition of the new roof system, several cracks were identified at the interface between the roof and the gable ends, and at the transition with the *quincha* arch (16.1–16.2 in Figure 9). Similar cracks were identified in the interfaces of the roof at the baptistry and sacristy (12–14 and 18.1–18.2 in Figure 7).

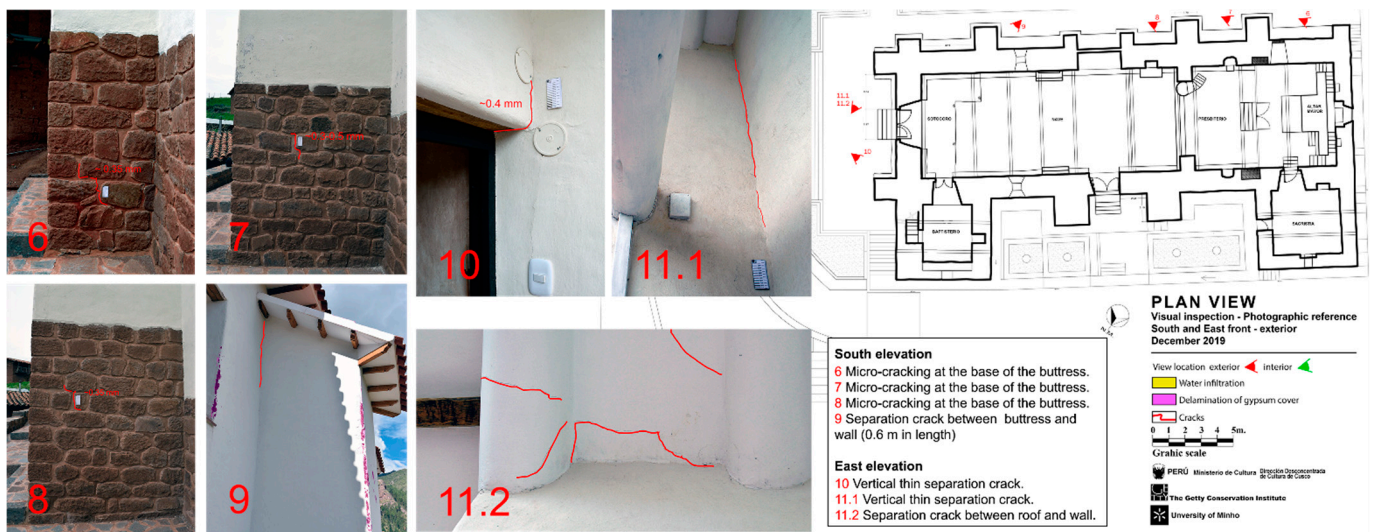
On the east façade, narrow cracks were present at the intersection between the gable wall and the nave (11.1 in Figure 8). These cracks indicate poor interlocking of the walls and out-of-plane deflections due to the flexible roof diaphragm. Narrow cracks were also present on the interior surfaces of the gable end (19.1–19.4 in Figure 9) and near the abutments of some roof rafters (11.2 in Figure 8). Such cracks may have been triggered by thermal variations, wind actions, small earthquakes or wet–dry cycling of adobe masonry.

**Figure 8.** Set of documented damages comprised of thin cracks, at wall intersections and the base course of the new buttresses. Note the photo references in the plan view.

Cracks were also identified at the top of the buttresses (3.1, 4.1 and 4.3 in Figures 7 and 9 in Figure 8). These were narrow continuous cracks, 0.6–2.6 m long, that ran vertically along one corner of the buttresses at the interface with the adjoining lateral nave walls. Moreover, the horizontal interface with the overhang appeared cracked.

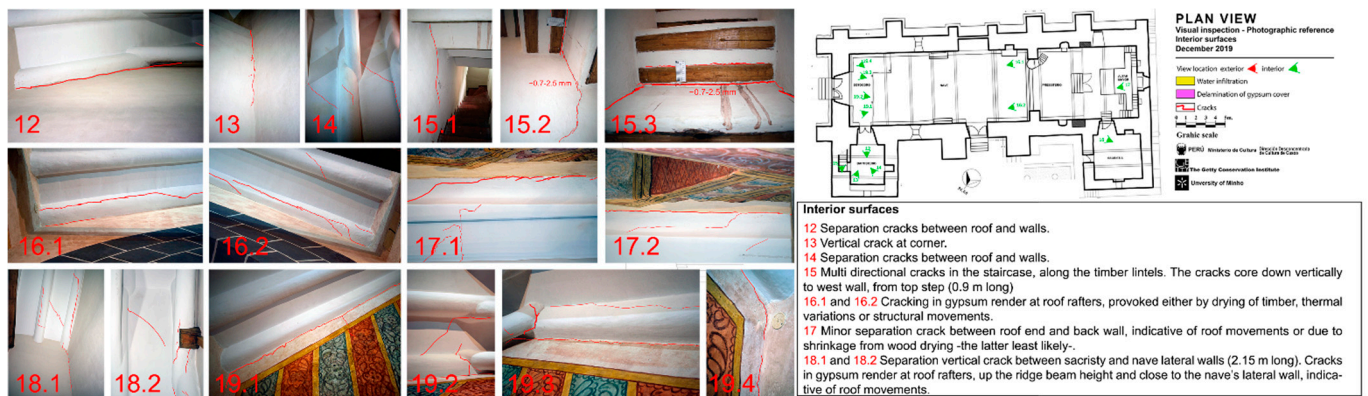
**Figure 9.** Set of documented damages comprised of thin cracks, at wall intersections, and for the roof's gypsum finishing in the interior surfaces. Note the photo references in the plan view.

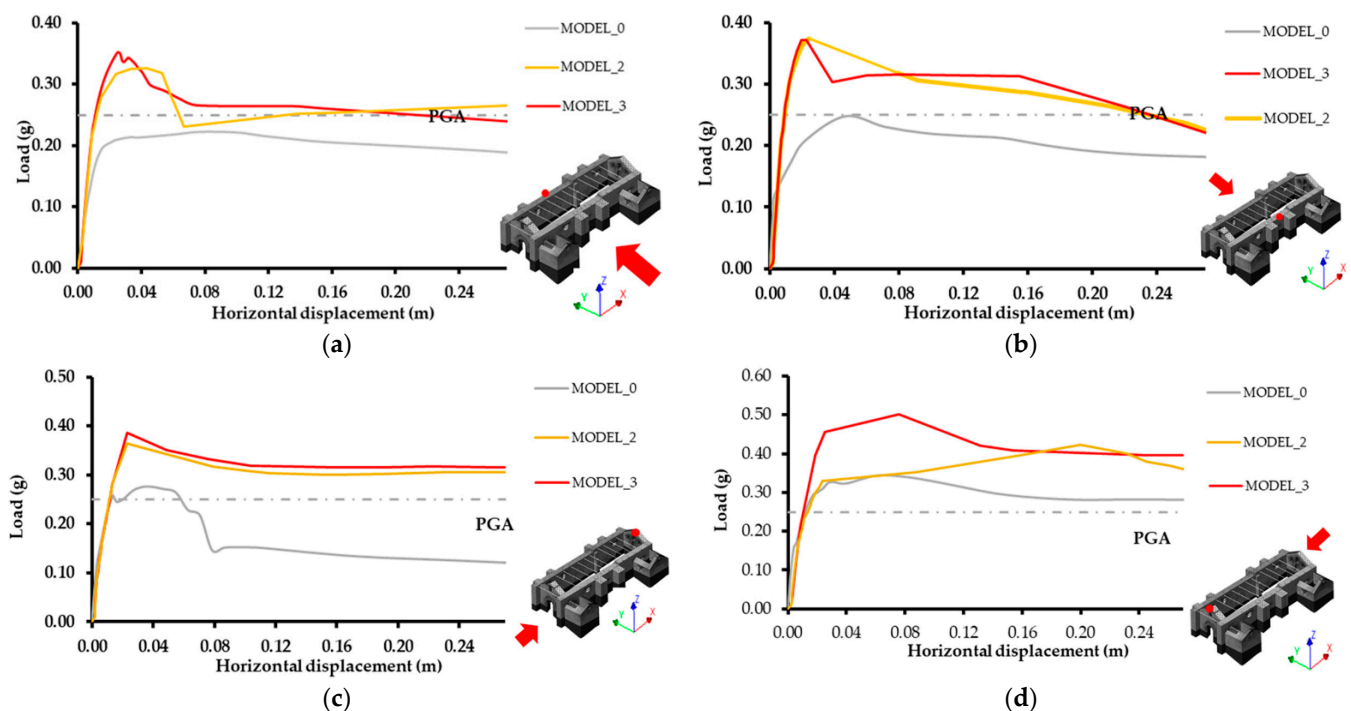
As shown in Figure 18a, the capacity of the un-retrofitted church in the +YY direction, is less than the region's 0.25 g design peak ground acceleration [14]. The maximum estimated capacity of MODEL\_2 is equal to 0.33g, which surpasses the capacity demand for the region. From the plots of the maximum principal tensile strains, presented in Figure 19a, it is evident that the strengthened structure presents a more global failure mode, which consists of out-of-plane bending of both lateral walls, together with diagonal and vertical shear cracks in the side walls of the baptistery, the sacristy and the east façade. The more homogenous structural response is mainly the result of the bracing timber elements. These prevented the early separation and out-of-plane overturning of the south lateral wall that occurred in MODEL\_0.

**Figure 18.** Pushover curves of Models 0, 2 and 3 in (a) +YY, (b) −YY, (c) +XX and (d) −XX directions. Note that the displacements in the pushover curves correspond to the displacements of the control nodal points, indicated here with red dots.

The pushover curves in the negative  $-YY$  direction (Figure 18b) indicate that the un-strengthened MODEL\_0 barely reached the capacity of 0.25 g, while both strengthened models MODEL\_2 and MODEL\_3 attained a capacity of approximately 0.37 g. This clearly evidences the effectiveness of the strengthening. MODEL\_3 and MODEL\_2 exhibit similar behavior, despite the actual difference in the values of elastic stiffness at interfaces. In fact,  $-YY$  is the weak direction for out-of-plane behavior in the south lateral wall of the nave, presbytery and altar. Thus, considering the lower counteracting resistance of the south buttresses, the south wall in both models fails mainly under the same diagonal in-plane flexural cracks and a tensile rotation failure zone at the base, and hence the stiffness of the assigned interfaces presents a lower influence in the resultant lateral capacity.

In the  $+XX$  direction (Figure 18c), the capacity of MODEL\_0 marginally exceeds the limit of 0.25 g, but a sharp post-peak reduction of lateral resistance occurs. The capacities of MODEL\_2 and MODEL\_3 were both approximately equal to 0.37 g. Referring to Figure 19c, failure in MODEL\_0 consists of out-of-plane rotation of the entire west façade after it disconnects from the nave walls. Instead, the corresponding failure mode in MODEL\_2 also involves the east façade, with cracking at the corners to a lesser extent and vertical bending fragmentation at both gable ends.

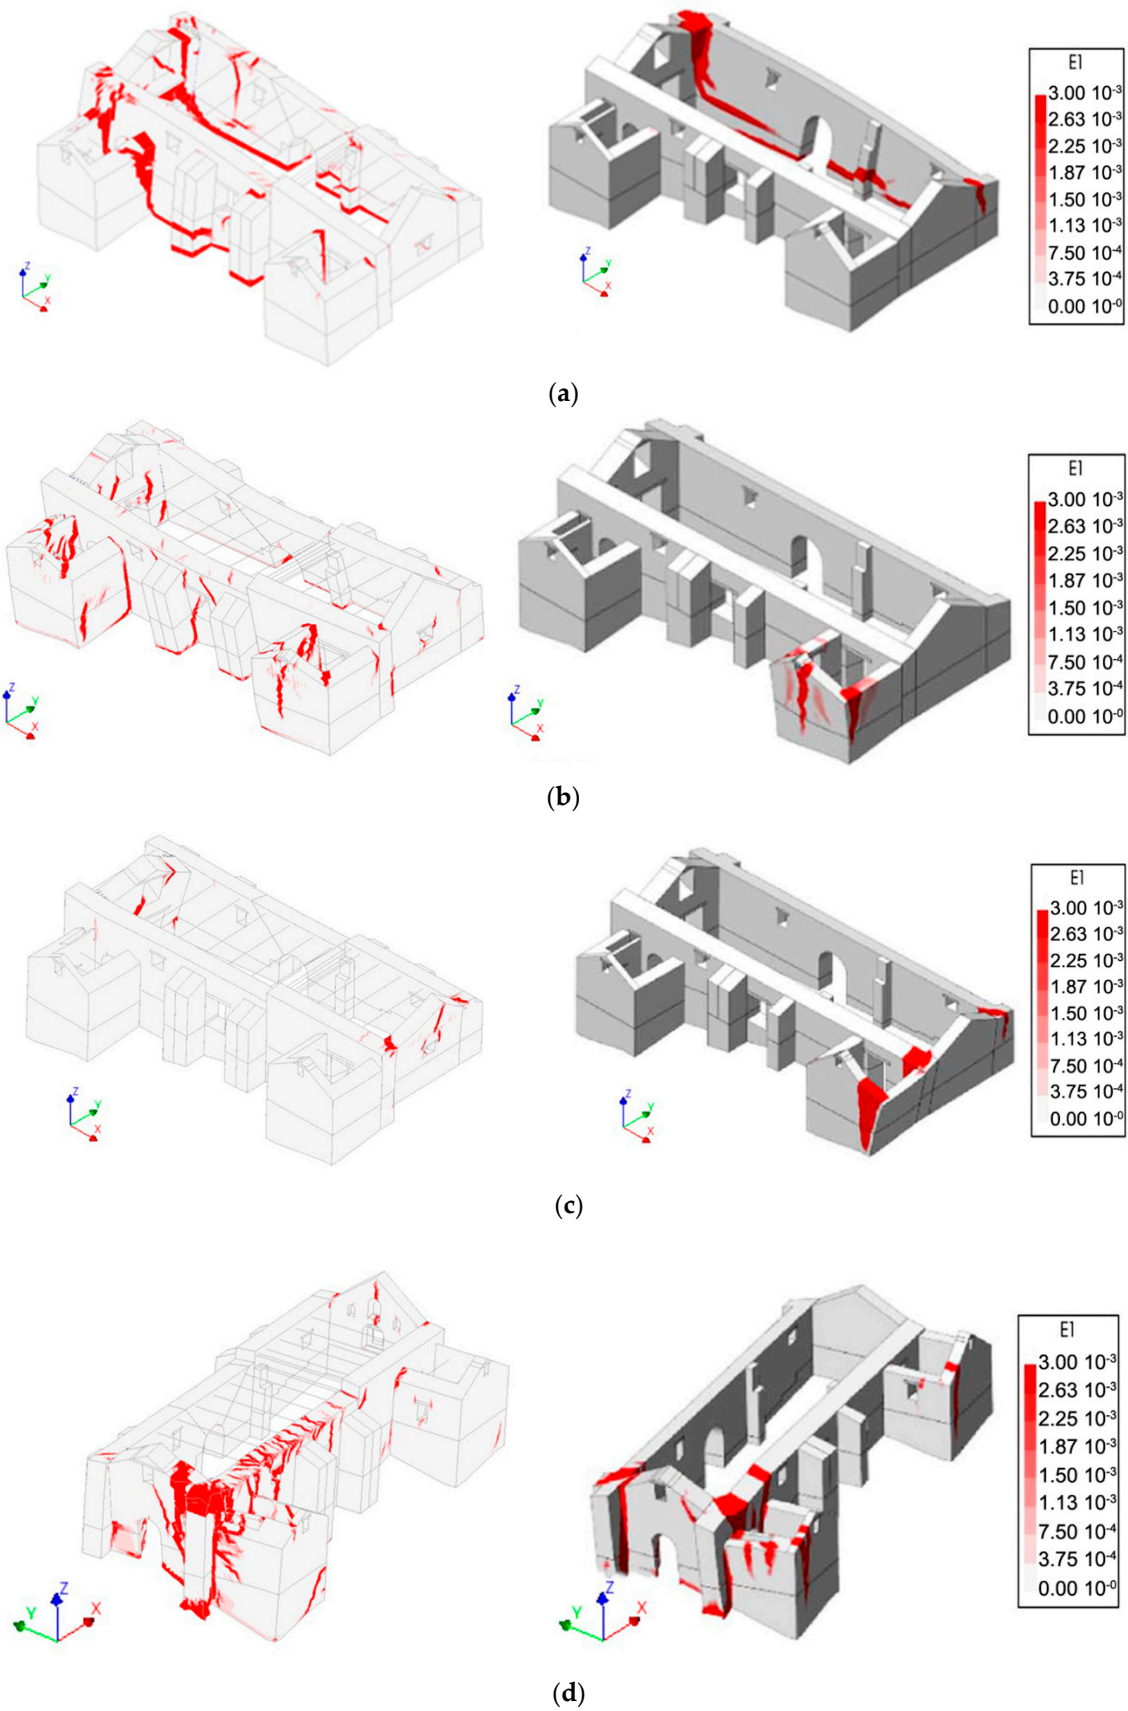
**Figure 19.** Distribution of maximum principal tensile strains at maximum capacity for MODEL\_2 (left) and MODEL\_0 (right) in (a) +YY, (b) -YY, (c) +XX and (d) -XX directions.

The computed distribution of maximum principal tensile strains plots (Figure 19b) indicates that in MODEL\_0, failure in the  $-YY$  direction is characterized by out-of-plane rotation and vertical bending fragmentation of the gable wall of the sacristy. The presence of the timber strengthening elements in MODEL\_2 results in a global failure mode, which involves out-of-plane bending of the lateral walls, together with the development of in-plane shear cracks in the side walls of the baptistery and sacristy, and the east façade. It is noted that the vertical cracking shown in the side base course walls of the sacristy is identical to the documented damage in situ (2.5 in Figure 7).

According to the contours of Figure 19d, the failure of MODEL\_0 involves out-of-plane rotation of the east façade and vertical shear cracking of the nave's lateral walls. This is consistent with that observed in the damage assessment of [4]. After strengthening, the damage is mostly concentrated in the north end of the east façade, due to the asymmetric distribution of stiffness within the plan of the building and the presence of an opening and lintel on the north side. In addition, parallel vertical cracks occur at the top of the north lateral nave wall, indicating the axial elongation of the bond beam that was installed. The damage at the peak capacity, in this case, is rather extensive but it is also more widely distributed.
