FAILURE THRESHOLDS FOR RCC CREST CAPS

TONY L. WAHL¹, BRYAN J. HEINER¹ AND JACOB F. KEPLER²

Keywords: RCC overlays, overtopping protection; failure modes

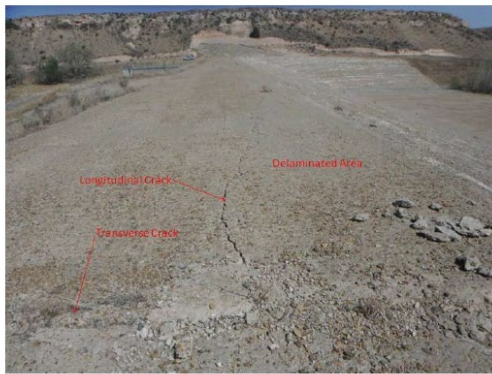
13. Transverse crack (foreground) in dam crest at STA 6+50 in foreground, looking left. Longitudinal crack extends from transverse crack about 20 feet to left. Top lift is unbonded left of transverse crack and downstream of longitudinal crack.

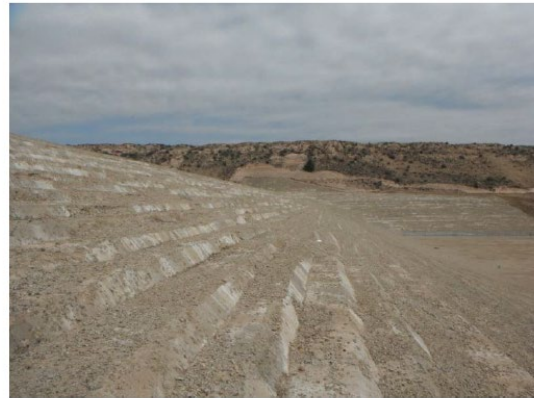
15. Downstream slope, looking left from near STA 7+50.

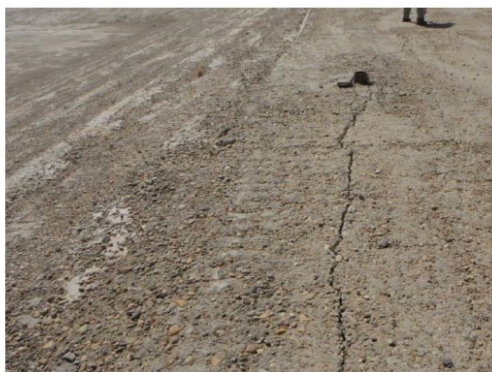
14. Longitudinal crack in dam crest near STA 8+50 and B-103, looking right from STA 8+60. This crack is about 0.25 to 0.5 inches wide and 25 feet long.

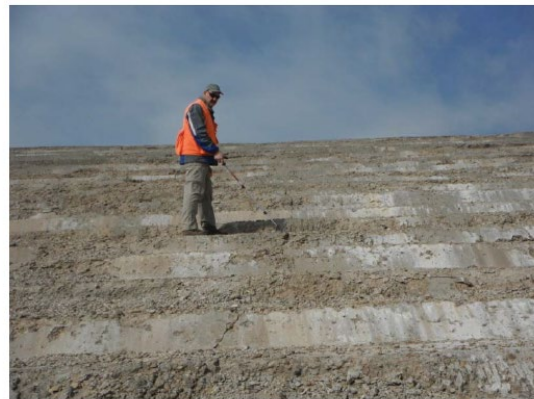
16. Downstream slope near STA 6+50, looking upstream. Note typical transverse crack.
