Seismic damage assessment of school buildings after 2012 Emilia Romagna earthquake

Antonio Formisano*

SUMMARY – In the paper the usability checks performed on precast RC gyms and masonry school buildings, located in the Municipalities of San Pietro in Casale (BO), Bomporto (MO) and Bondeno (FE) after the seismic events occurred on 2012 May 20th and 29th, are reported and discussed. First, the main features of surveyed buildings have been identified. Later on, on the basis of the detected damages, their seismic deficiencies have been recognized. Finally, the indication of some appropriate simple interventions for retrofitting studied buildings has been given.

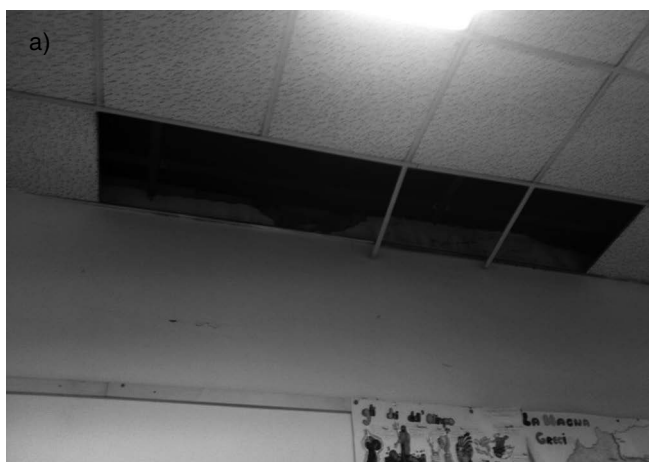
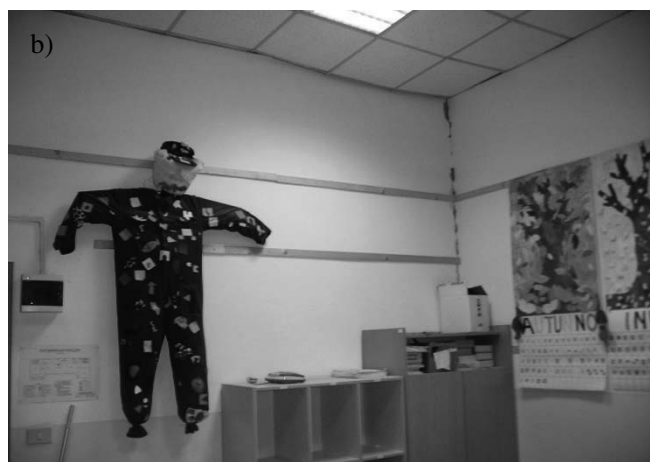
The building has shown few damages in the external part of the load bearing vertical structure. Instead, inside, at the first level, vertical cracks between masonry walls and internal ones, together with damages and failures of some ceiling panels, are noticed (Fig. 2).

Fig. 2. Failure of ceiling panels (a) and vertical crack between masonry wall and internal one (b).
Crollo di pannelli del controsoffitto (a) e fessure verticali tra parete in muratura e divisorio interno (b).

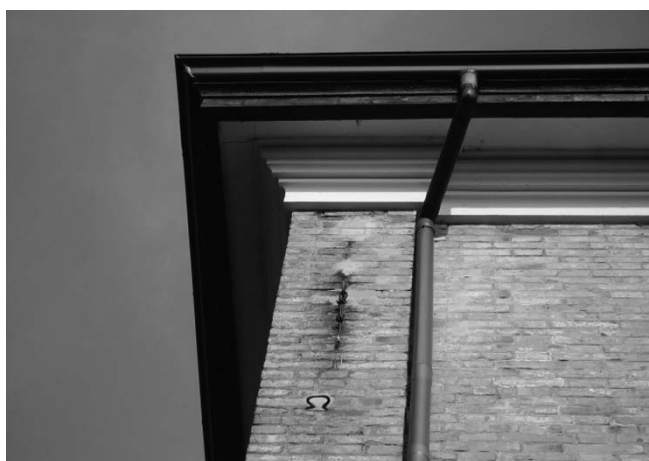
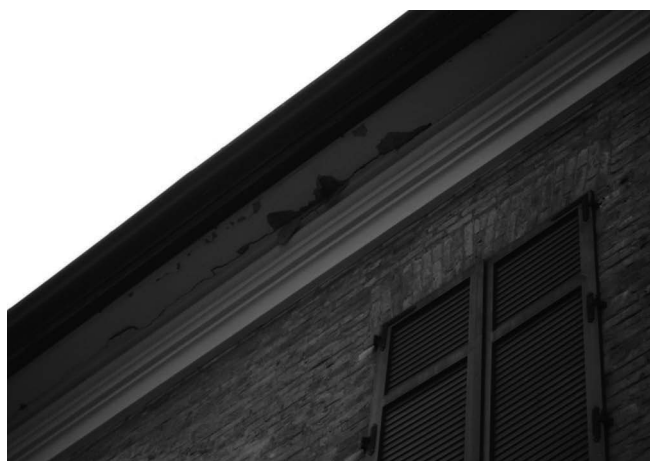
On the façade, some horizontal cracks along the intersection zone between masonry wall and cornice roof have been recorded (Fig. 3).

Fig. 3. Horizontal cracks along the roof cornice.
Fessure orizzontali lungo il cornicione di copertura.

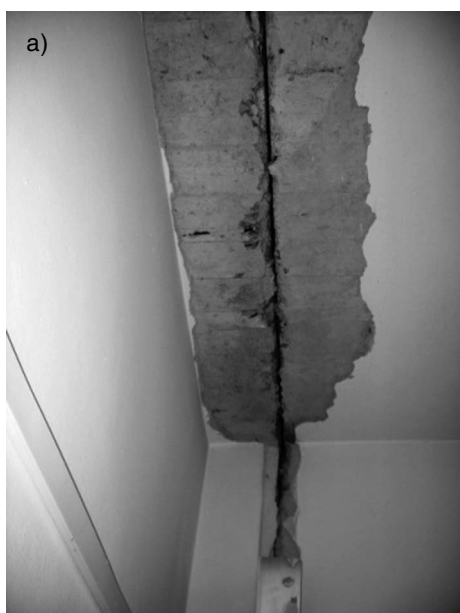
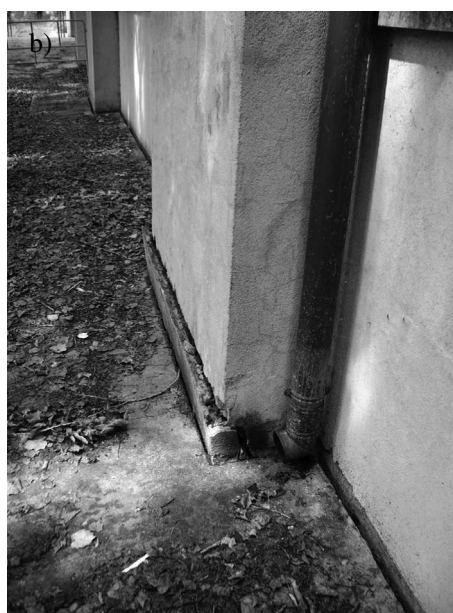
Fig. 5. Vertical crack corresponding to the joint zone (a) and a slight foundation subsidence at the building base (b).
Fessure verticali in corrispondenza del giunto (a) e leggero cedimento della fondazione (b).

A significant damage has been detected in the contact zone among buildings, since the “rules of art” have not been followed in the joint design and hammering of two structural parts have produced the detachment of large parts of plaster (Fig. 5a). One of the two buildings has shown a foundation relative displacement which has produced both displacement and rotation of the precast panel used to close the ventilation space around the building (Fig. 5b).

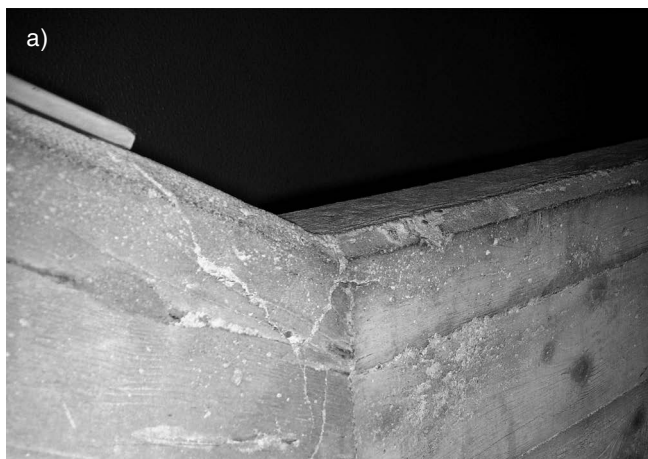
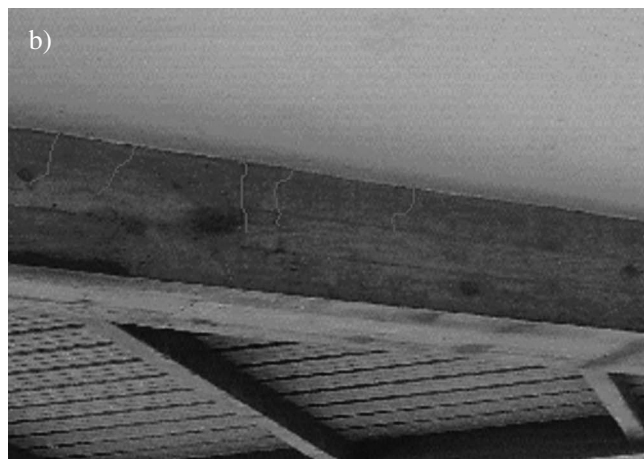
Inside the building, some damages in the staircase (Fig. 6a) and in a ground storey beam (Fig. 6b) have been detected, the latter showing few but diffused cracks due to vertical seismic accelerations. Other non-structural damages are cracks into plaster in the

Fig. 6. Cracks in the staircase beam (a) and in a ground storey beam external to the school (b).
Fessure in una trave delle scale (a) e in una trave a piano terra esterna all'edificio (b)

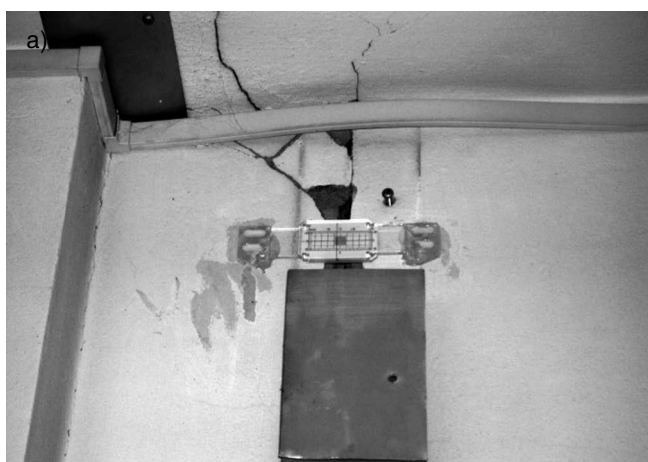
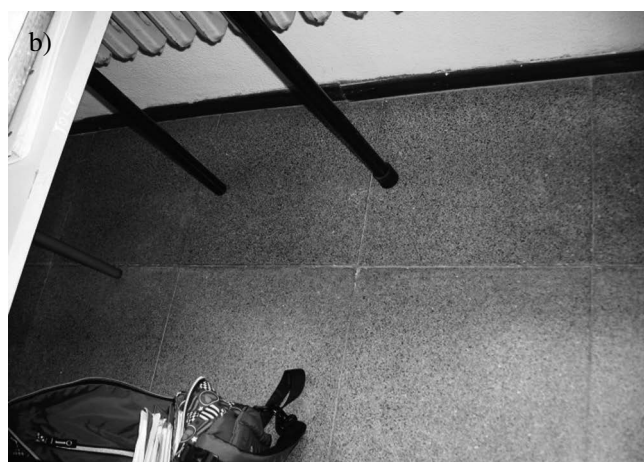
area close to the joint (Fig. 7a), as well as a horizontal crack on the pavement of a first level classroom (Fig. 7b).

Fig. 7. Non structural damages: plaster cracks (a) and a pavement horizontal crack (b).
Danni non strutturali: fessure nell'intonaco (a) e una fessura orizzontale nel pavimento (b).

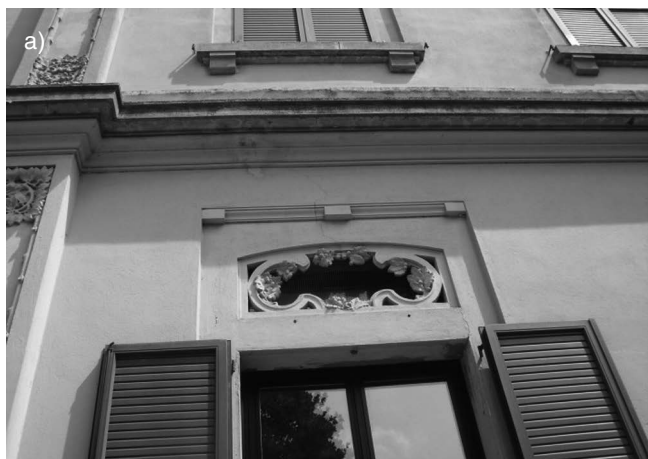
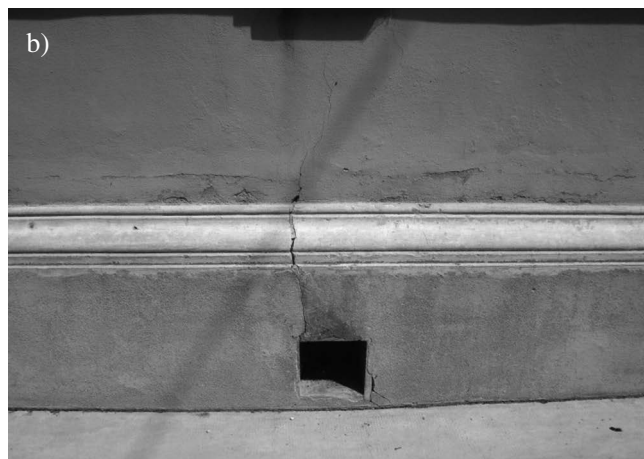
Vertical cracks into door architraves and diagonal cracks in the masonry spandrels above the same doors have been recorded inside and outside the building (Fig. 9). In addition, horizontal cracks between masonry walls and floors due to the deficient connection grade among them has been noticed.

Fig. 9. Vertical cracks into architrave (a) and at the building base (b).
Fessure verticali nell'architrave (a) e alla base dell'edificio (b).

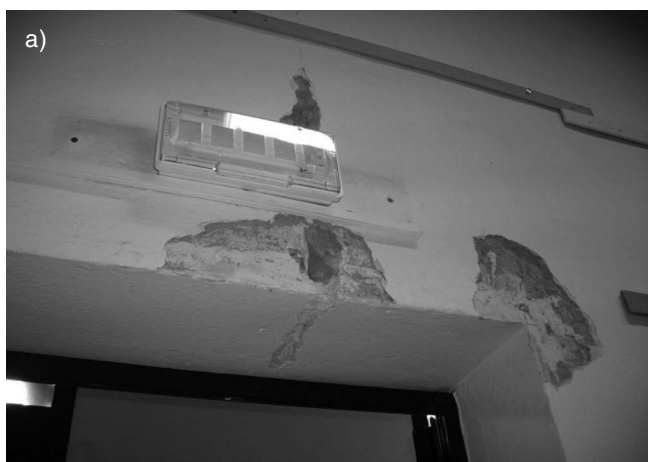
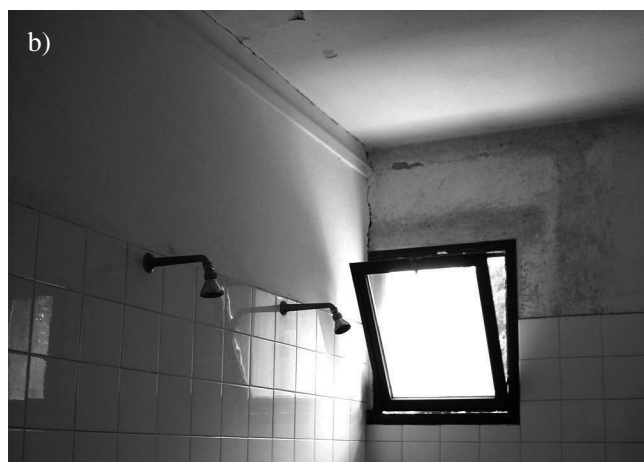
Also in this case, slight damages consisting of cracks into architraves and masonry spandrels have been detected (Fig. 10a). Moreover, horizontal cracks between

Fig. 10. Architrave (a) and wall-floor (b) cracks.
Fessure nell'architrave (a) ed all'attacco parte-solaio (b).

masonry walls and intermediate floors have been seen (Fig. 10b).

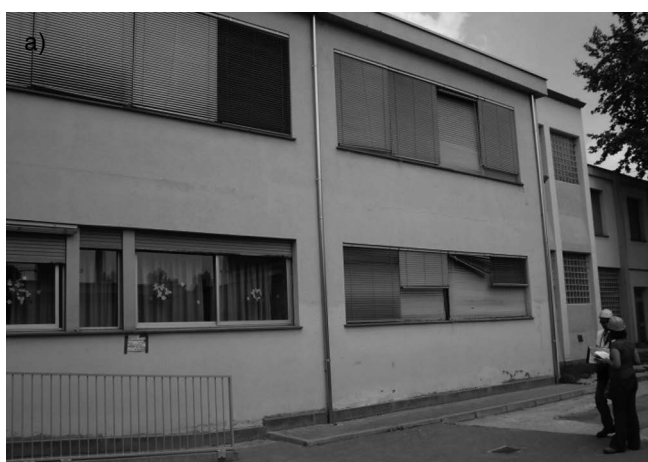
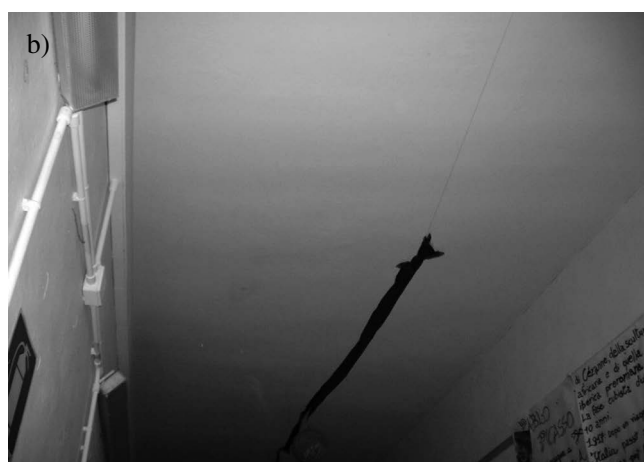
The building has suffered slight damages to non-structural parts, such as internal walls, plaster and ceiling panels (Fig. 14b). Even if a rather good building seismic response has been recorded, lack of transverse connections among frames makes the building very vulnerable towards earthquakes.

Fig. 14. The central r.c. structural unit of the school building "Menotti": external view (a) and ceiling damages (b).

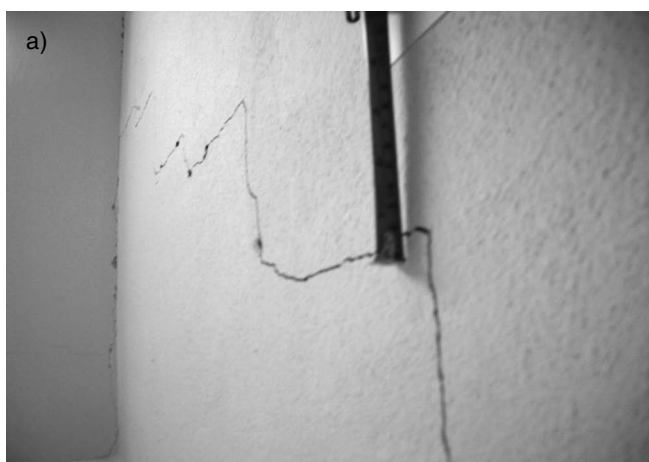
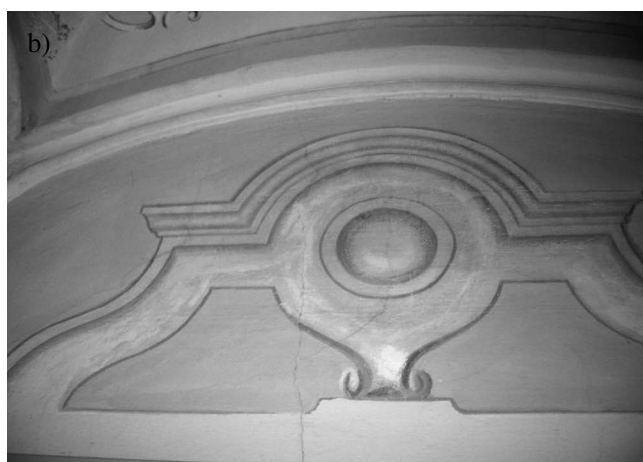
In the building few damages among walls and not significant floor-wall cracks have been recorded. Diagonal cracks into masonry piers and horizontal cracks in vaults are very diffused (Fig. 18).

Fig. 18. Details of some cracks detected in the “Sorelle Luppi” school building.
 Dettagli di fessure osservate nella scuola «Sorelle Luppi».

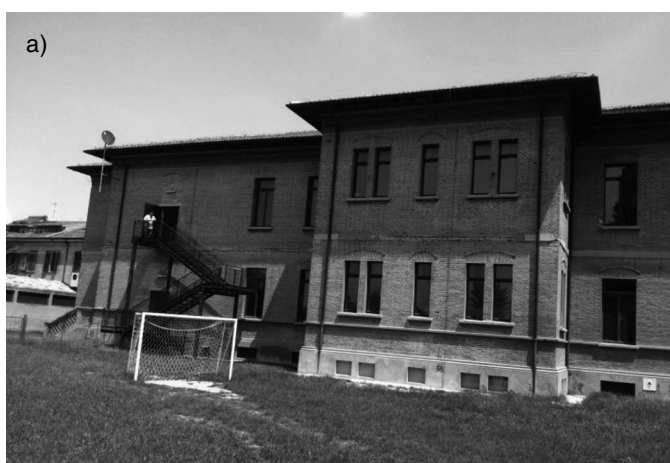
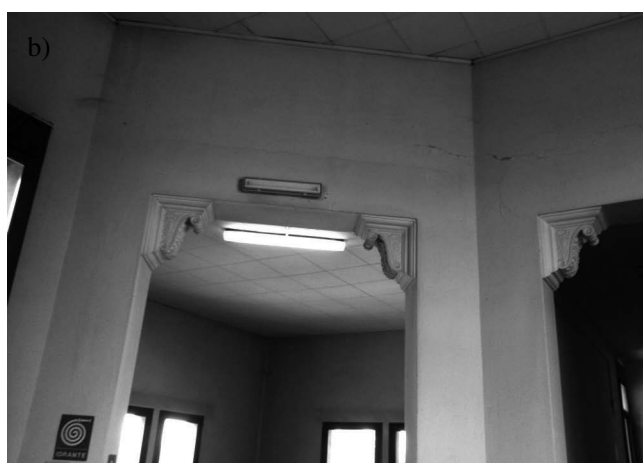
Slight structural damages, namely vertical cracks in door and window architraves (Fig. 19b), horizontal cracks at the floor-wall intersections and diagonal and vertical cracks into masonry walls (Fig. 20), have been noticed. However, a very heavy damage has been detected at the intersection of two masonry walls, which were completely separated (Fig. 21a).

Fig. 19. The primary school “Battisti”: external view (a) and architrave cracks (b).
 La scuola elementare «Battisti»: vista esterna (a) e fessure in un architrave (b).

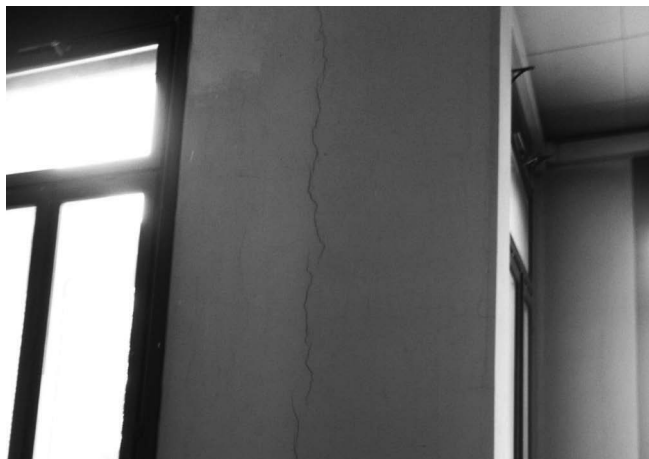
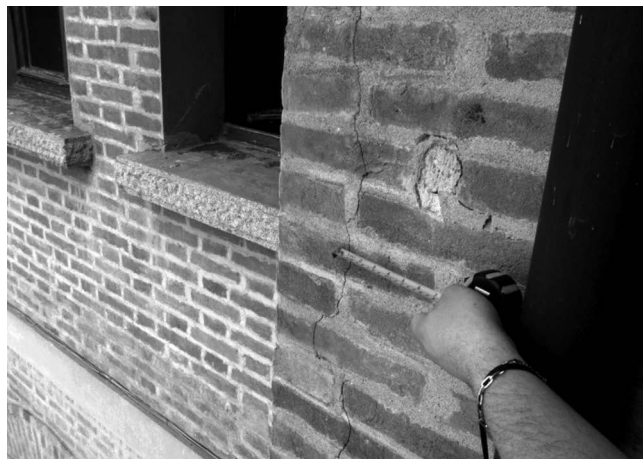
Fig. 20. Vertical cracks in masonry piers of the primary school “Battisti”.
Fessure verticali in maschi murari della scuola elementare «Battisti».

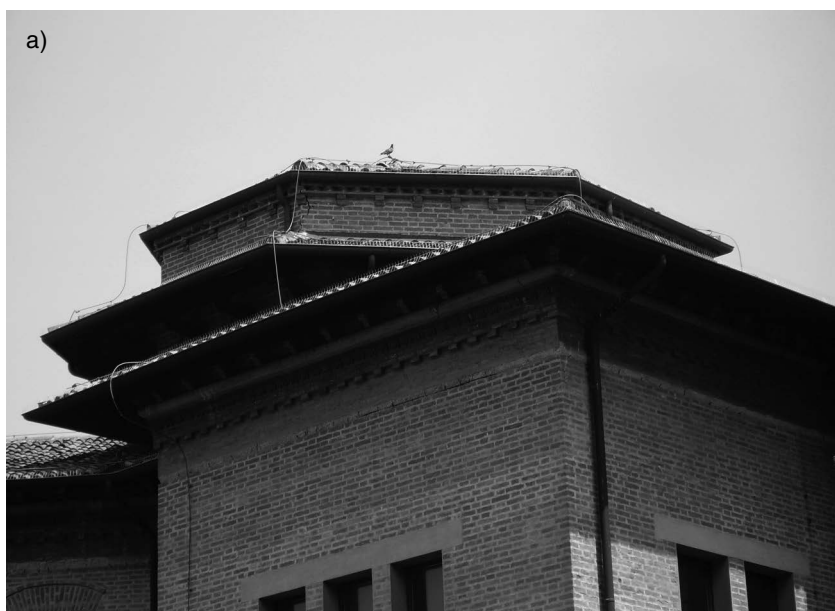
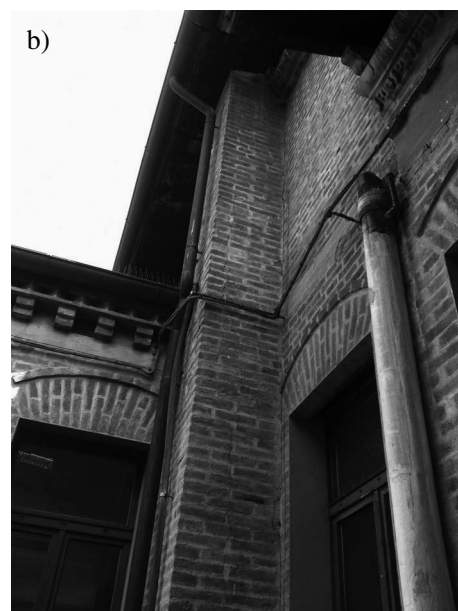
About non-structural components, a medium-heavy crack in the intersection zone between the facade and a masonry chimney has been noticed (Fig. 21b). Also, significant damages into ceiling have been observed, they producing the collapse of some covering panels.

Fig. 21. A very large crack between two masonry walls (a) and a vertical crack between the chimney and the façade (b) of the primary school “Battisti”.

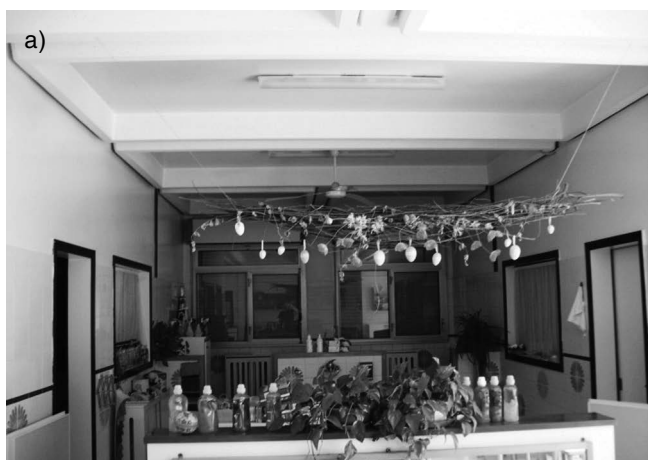
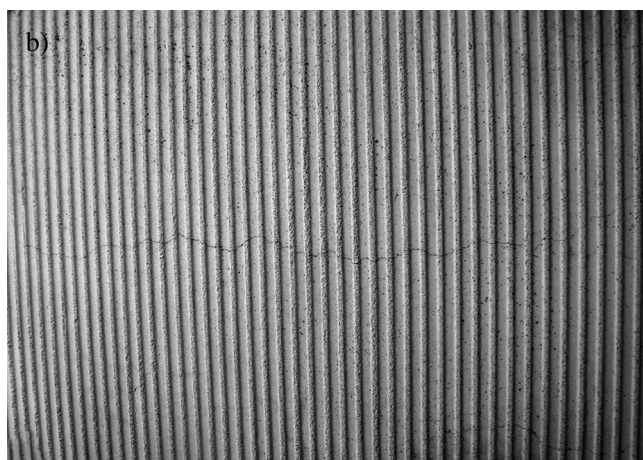
of precast r.c. panels which has shown light and diffused damages after earthquake. In particular, horizontal cracks in masonry walls (Fig. 24b) and vertical cracks at the interaction zones among walls and between walls and floors (Fig. 25) have been recorded.

Fig. 24. Internal view of the nursery (a) and horizontal cracks into a precast r.c. panel (b).
Vista interna dell’asilo (a) e fessura orizzontale in un pannello in c.a. prefabbricato (b).

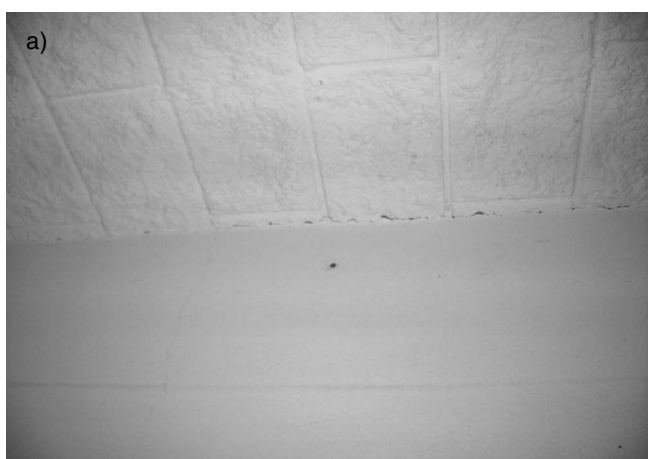
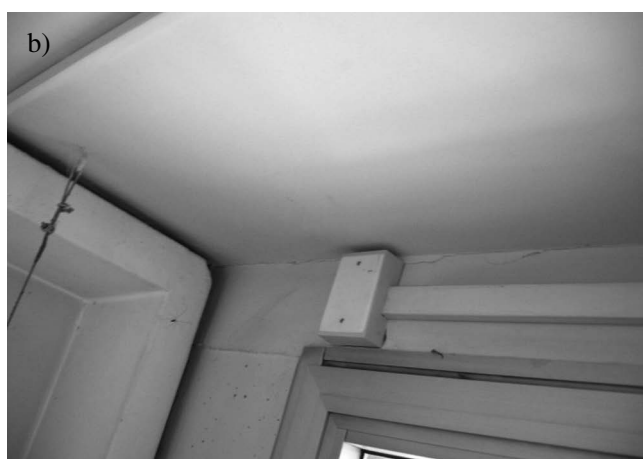
Fig. 25. Wall-floor cracks (a) and small vertical damage between orthogonal walls (b).
Fessure parete-soffitto (a) e leggero danneggiamento tra pareti ortogonali (b).

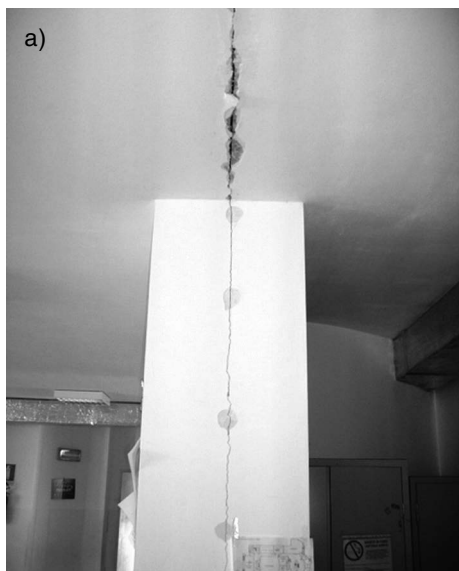
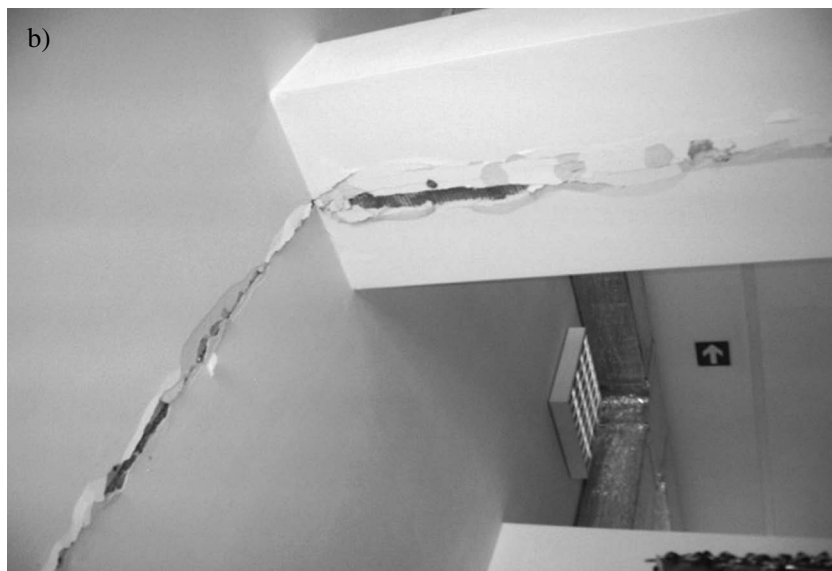
distance among two adjacent buildings, the main damages have been detected there. In fact, important plaster cracks have been observed both among adjacent col-

umns (Fig. 29) and on the floor (Fig. 30a), as well as horizontal cracks have been recorded on the classroom pavement (Fig. 30b) close to the structural joint.

Fig. 29. Vertical crack along the structural joint.
Fessura verticale lungo il giunto strutturale.

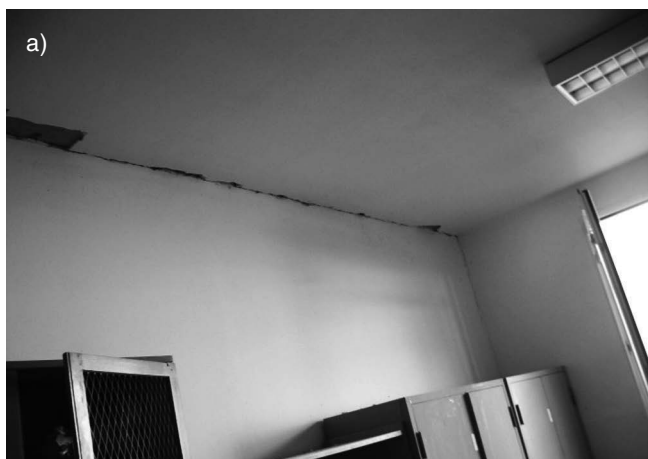
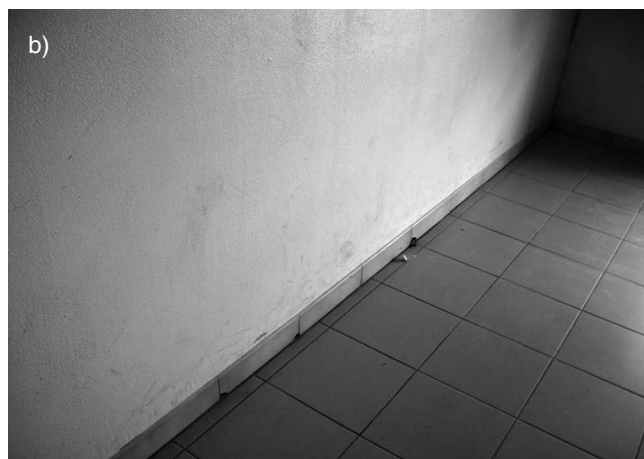
Fig. 30. Cracks on the floor intrados (a) and extrados (b).
Fessure all'intradosso (a) ed all'estradosso (b) delle solette.

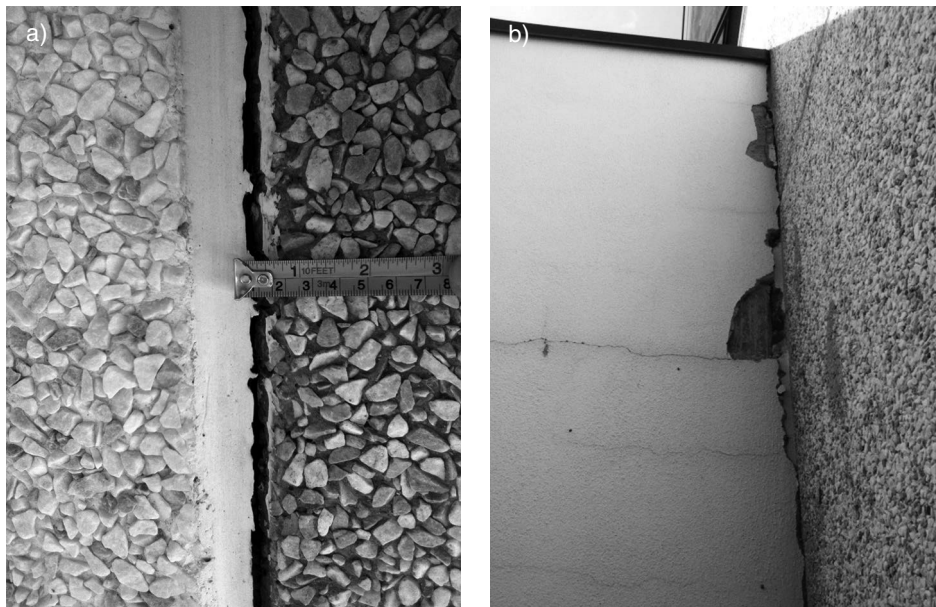
Fig. 32. Column-panel detachment (a) and vertical crack due to hammering effect among adjacent buildings (b).
Distacco colonna-pannello (a) e fessurazione verticale dovuta a martellamento tra edifici adiacenti (b).

of them, badly connected to columns, have suffered an overturning out-of-plane mechanism which has produced detachment of panels from columns (Fig. 32a). In particular, a vertical crack developed along the entire building height at the panel-column interaction zone has been noticed. Also the hammering effect between gym and the connection structural body with the school building has been recorded (Fig. 32b).

As a whole, the observed damages, due to the absence of beam-to-column connections and the inefficiency of panel-to-column ones, make building susceptible to undergo severe damage under future earthquake, so to require appropriate seismic retrofitting interventions able to improve their global behaviour.
