***Effect of geological structures, rock weathering,
and clay mineralogy in the formation of various
landslides along Mugling–Narayanghat road
section, Central Nepal Himalaya***

Amar Deep REGMI*¹ and Kohki YOSHIDA*²

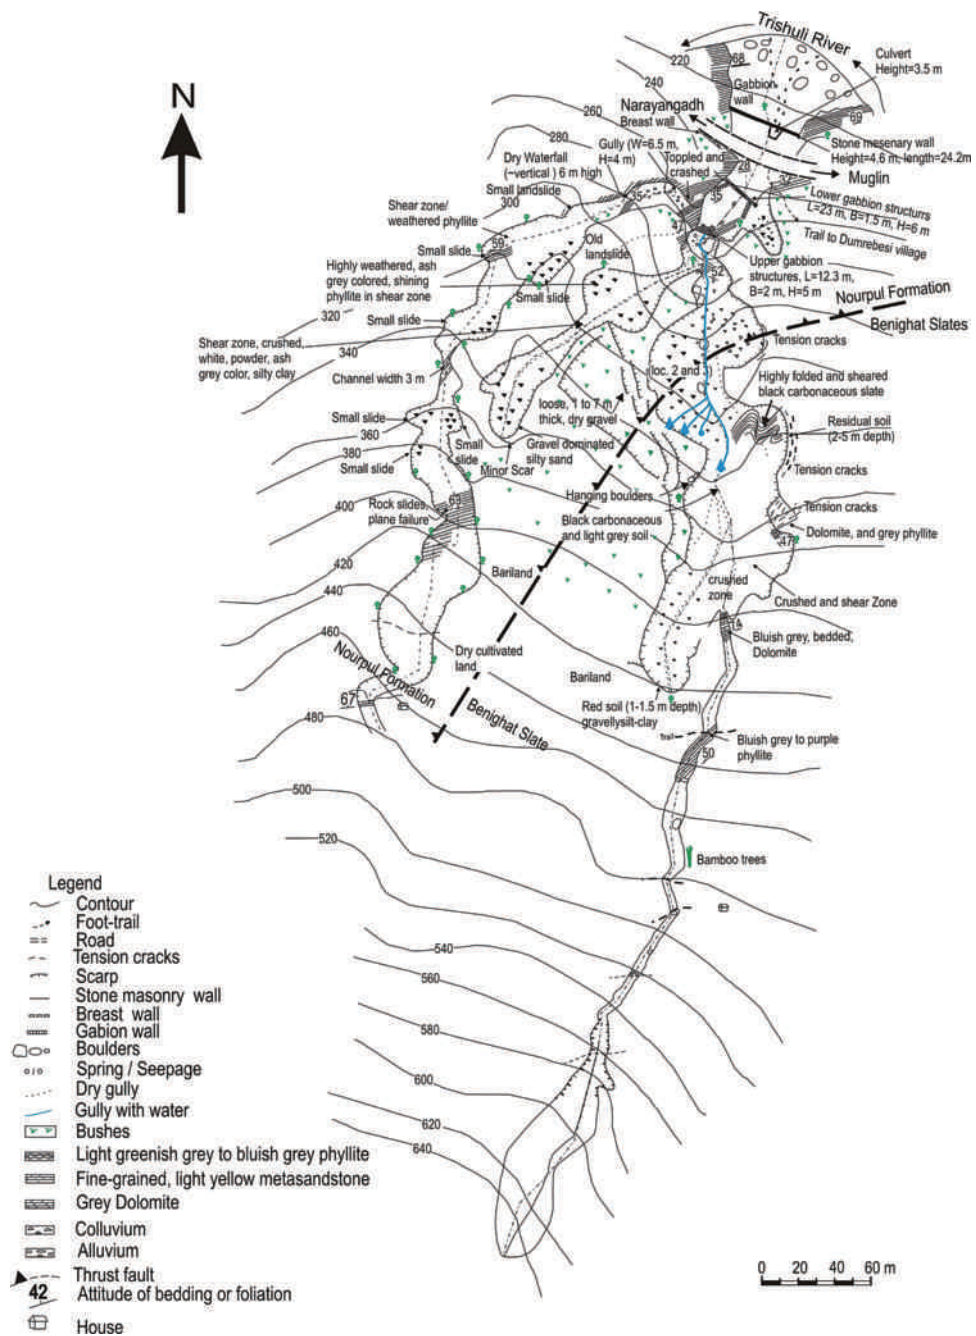
Fig. 3 : Map showing the detailed features of the landslide of Dumre Besi

The Dumre Besi landslide is one of the most active landslips in the Mugling-Narayanghat road section (Fig. 3). It was first recognized during the 2003 monsoon rainfall. At first a small landslide developed below Dumre Besi, near the Simaltal village, and the debris from the failure obstructed the highway. In the same year, many more landslips were initiated in this highway stretch resulting into its blockage for several days. Since then, the road has been experiencing partial closures (from a few hours to several days) in every monsoon season due to the Dumre Besi and other instabilities.

The Dumre Besi landslide has two large scarps developed in each of the tributaries of the Dumre River and they coalesce downstream to form a single complex failure (Fig. 3) involving several types of movement. The top of the slide reaches the Dumre village, situated above the road, while its toe lies at the cut bank of the Trishuli River, below the road. Its upper part is covered by soil with some sparse vegetation, whereas the central zone, from where the thrust passes, contains thick landslide debris with sporadic exposures of severely weathered rock, and the lower portion includes some rock outcrops exhibiting slight weathering.

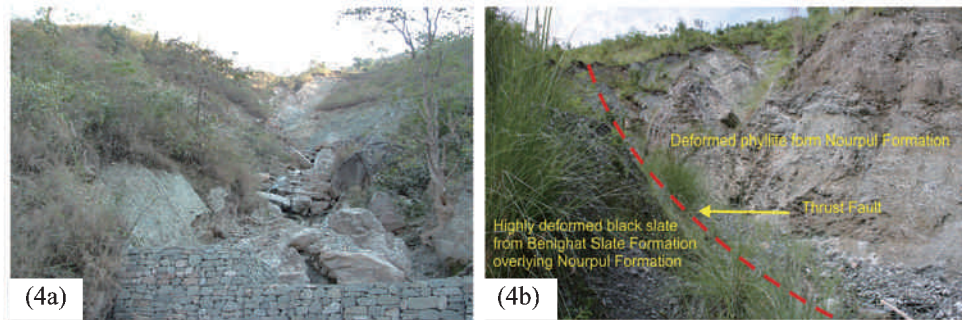
Fig. 4 : (a) Large boulders (up to 7 m in diameter) observed in the debris along the channel draining the landslide (View towards south) (b) Thick crushed zone developed along the thrust, view towards south

About 130 m uphill from the road, on the left bank of the stream, highly sheared light to dark grey phyllites are observed. The sporadic boulders lying in the gully are composed of highly weathered, fine-grained, greenish grey sandstones and folded black carbonaceous shales. The flanks of the landslide are covered by a residual soil with a thickness of 2–5 m. On the right bank of the gully, highly fractured, moderately weathered, light grey to white phyllites crop up whereas the channel is covered by large (up to 7 m across) boulders (Fig. 4a).

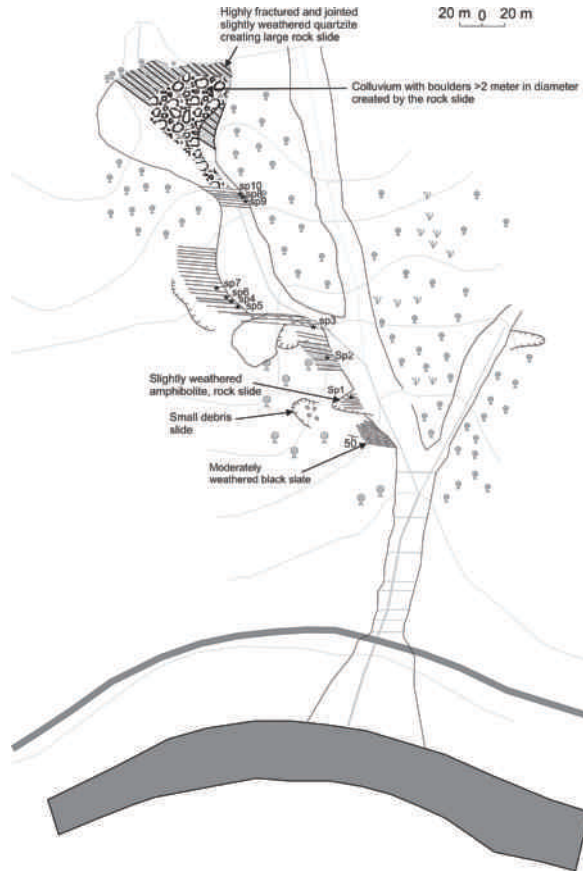
Fig. 5: Map showing the detailed features of Maure Khola landslide

Among several gravitationally deformed zones observed along Mugling–Narayanghat road section, the Maure Khola landslide is the most active one (Fig. 5). The rock debris that was generated by the landslide mobilized into a disastrous debris

The main landslide is located in the upper rich of the slope (Fig. 5). Here mainly rock topple is observed in the amphibolites and slate/phyllite (Fig. 6d) at the western part as well as in the quartzite lying in the in the southeastern part (Fig. 6e). Slate show moderate weathering, while quartzite and amphibolites is not much weathered. 2 m

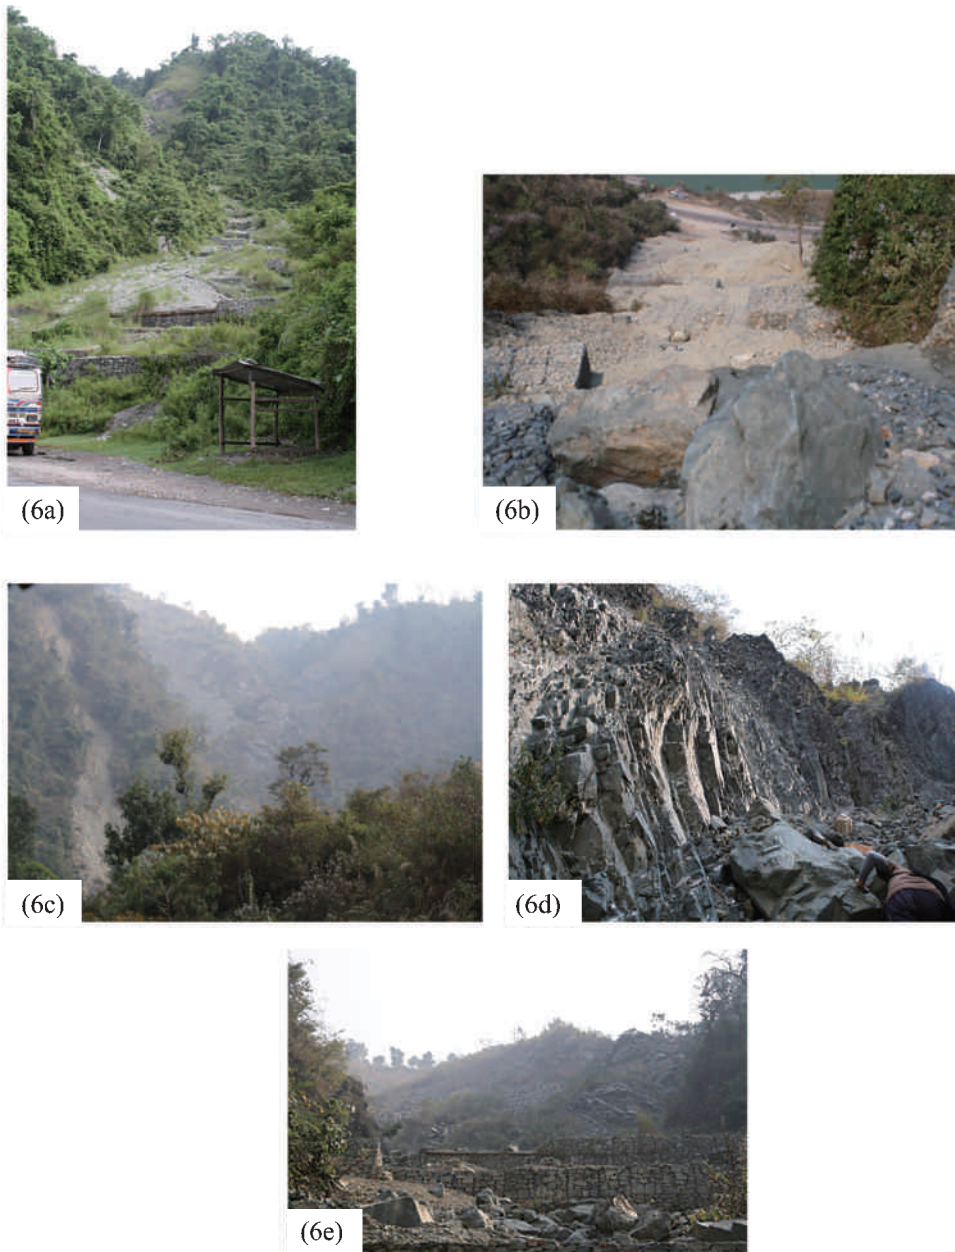
The central part of the landslide mainly consists of debris deposits in the channel while small landslides in the valley walls (Fig. 6c). Here, highly fractured, moderately weathered black slates with some quartz veins are observed. Moderately weathered greenish phyllite is observed above the black slate. The water is observed in the stream here. Moderately weathered, highly fractured pink quartzite with phyllite parting is absorbed about 10 m upstream from the greenish phyllite (Fig. 5). There is a small rotational slide and a wedge type of failure in the valley wall (Fig. 5). The attitude of the foliation plane is 270°/74°N while that of the joints are J1=350°/75°NE, J2=145°/57°SW. The joint spacing is from 20 cm to more than 1 m. These joints are responsible for the rock slide in this part. Massive amphibolite is observed above this. This amphibolite is also highly fractured and jointed. Many big boulders of amphibolite are observed in the channel. The fractured and jointed nature of the amphibolite is the reason for the presence of these boulders. There are several sheared zones in these amphibolites and quartzite, making them susceptible for toppling. These sheared zones are the most unstable zone here and landslides are occurred in such zones. There are many slicken sides in the rocks showing some kind of movement. Many gabion walls have been constructed here to stop the debris flow.

Fig. 6 : (a) The debris fan in the bottom part of the landslide just above the highway, (b) several gabion walls used to control the debris, (c) small landslides observed in the wall of the main landslide, (d) toppled rocks observed in the upper part of the landslide, (e) General view of the top part of the landslide

A landslide characterized by a combination of debris slide/flow, rock slide and rock topple has wrecked the area. It is about 500 m long, 70 m wide and the depth varies from 4–8 m. As the amphibolite is heavily fractured and jointed, the valley walls are prone to rock failure. Pour water pressure in the discontinuities can easily trigger failures. In addition to the occurrence of discontinuities described above, there are several minor faults within the landslide, and the Simaltal Thrust (ST) passes just below it. These thrusts and the fault must have created the incipient weakness and instabilities in the area. The field observations suggest that the area is prone to future landslide and debris flow.

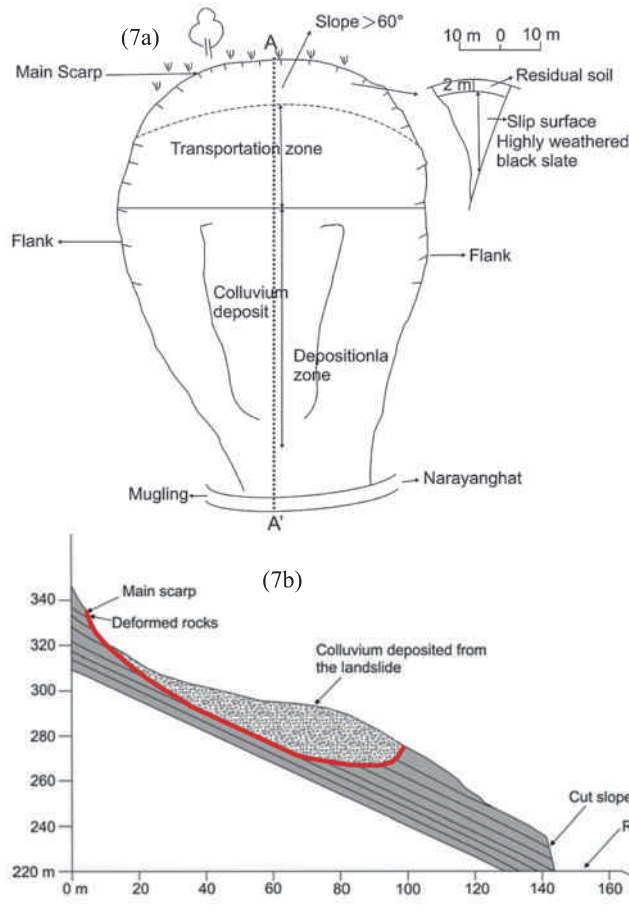
The Gaighat landslide (80 m wide, 100 m long and 5–6 m wide) is a rotational type of rock slide observed along Mugling–Narayanghat road section at Gaighat (Fig. 7a). Geologically, it consists of slate and phyllite of the Nourpul Formation. It was initiated during the monsoon of 2003 and is an active landslide. It is a medium scale landslide along the road section.

This landslide is mainly divided into 3 zones; initiation zone (source area), transportation zone and depositional zone (Fig. 7a). The source area, from where all the debris are derived is located at an altitude of 385 m. The top 2 meter is covered by residual soil. Here, the main scarp of the landslide is observed and it consists of severely to completely weathered, highly crumbled slate and phyllite. Corestone mainly composed of quartz are seen in good condition. The slope of the main scarp is 60°. The slip surface can be seen here. The altitude is variable as the rocks are highly deformed here. However the general trend of foliation plane is EW with north dip direction.

Fig. 7: (a) Detailed view of the landslide, (b) Cross-section along A-A'

The lower portion of the landslide is mostly covered by thick deposit of debris material (Fig. 7a). These debris are derived from the upper slope. This is the zone of deposition. Here, no rocks are exposed. There is no role of any running water in this landslide, as there is no any stream here. The landslide is mainly caused by the rock weathering.

The cross-section of the landslide (Fig. 7b) shows that the upper part, i.e. the main scarp consists of deformed rocks. From the figure, it is clear that the landslide is related to the dip direction of the beds. Thick colluvium is observed in the lower part

of the landslide. Below the landslide, cut-slope is observed from where the Mugling-Narayanghat road section passes. Also, it is seen that the slope is very unstable as the dip of the beds are parallel to the slope and the road cut has worsened the situation.

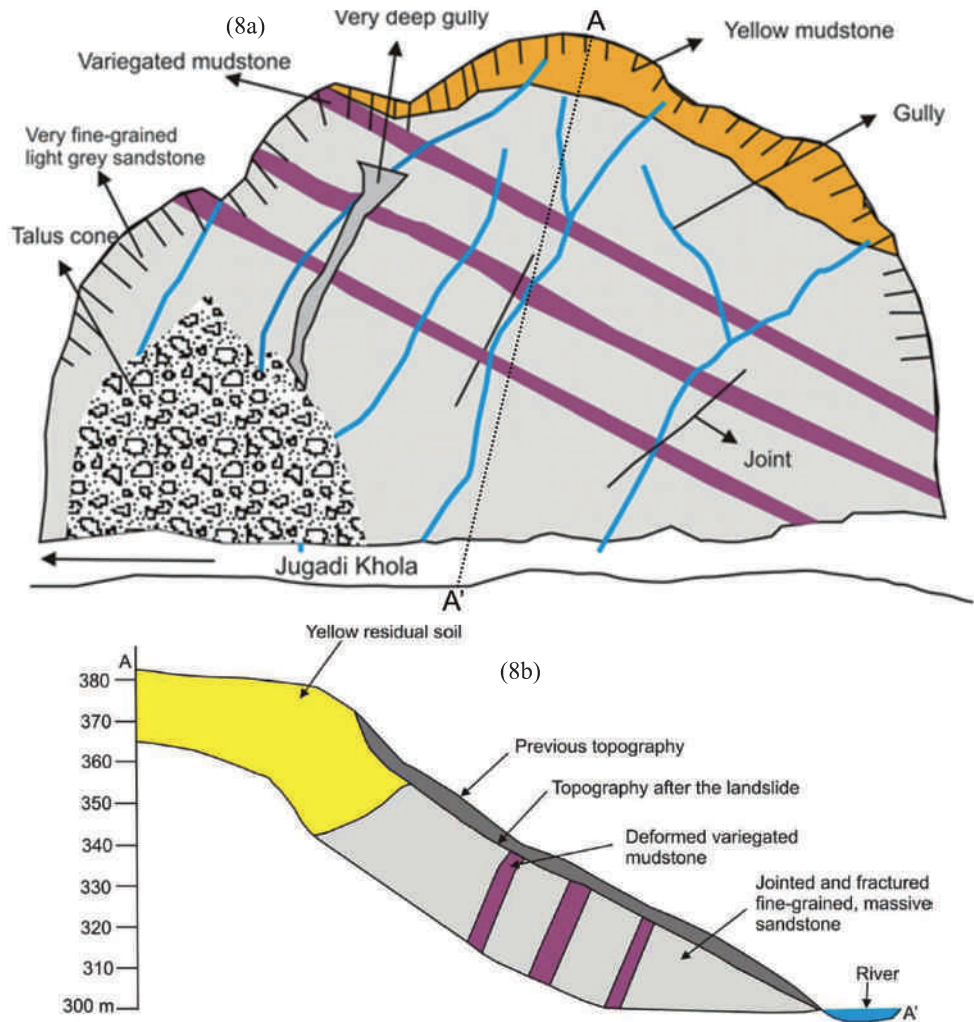
It lies in the rocks belonging to the Lower Siwaliks. The main rock types are interbedding of fine-grained, light gray sandstone and variegated red to purple mudstone (Fig. 8a). The upper part of the landslide consists of yellow mudstone. The sandstone is thickly bedded. The beds are up to 4 m in thickness, but are highly jointed, making them susceptible to failure. The attitude of foliation plane and the joints are, $F=250^{\circ}/40^{\circ}N$, $J1=110^{\circ}/76^{\circ}NE$, $J2=219^{\circ}/69^{\circ}NW$. The landslide is dissected by several gullies (Fig. 8a). These gullies are eroding the rocks very rapidly. Talus cone is observed at the lower portion of the landslide mass (Fig. 8a). There are many similar landslides at the upstream part of the channel. All these landslides are delivering huge amount of debris in the channel, which flow downstream during the monsoon season.

The cross-section of the landslide is shown in Fig. 8b. From the cross-section, it is seen that the top part of the landslide consists of residual soil. Sandstone and mudstone are dipping at high angle. Also, it is seen that the beds are crumbled at the top part. Also, it is seen that the sandstone is highly fractured and jointed. The undercutting action of the river is also seen in the cross-section. Thus, the river undercutting followed by high dip amount of the beds, highly jointed and fractured nature of the sandstone and rock weathering all coupled to generate the present landslide.

Fig. 8: (a) Sketch showing the Jugedi Khola landslide, (b) Cross-section of the landslide along A-A'

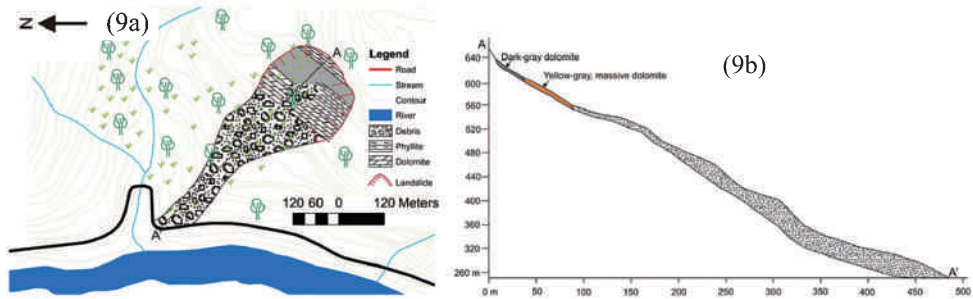
Jalbire landslide is located at the uphill side of the road section near the temple of Jalbire, along Mugling-Narayanghat road corridor (Fig. 9a). Geologically the landslide belongs to the Precambrian Dhading Dolomite and Nourpul Formation. The main scarp consists of dolomites and some phyllite of the Dhading Dolomite Formation, while the lower portion, from where the maximum debris is derived belongs to the

Nourpul Formation. However, the thick debris and residual soil covers the underlying rocks, so no rock exposures are seen here. The attitude of the foliation plane is $245^{\circ}/38^{\circ}\text{N}$, while that of joints are $J1 = 24^{\circ}/84^{\circ}\text{NW}$ and $317^{\circ}/55^{\circ}\text{NE}$. The cross-section shows that the upper part of the landslide consists of dark-gray to light-gray dolomite, where the rock fall occurred. The central and lower part is completely covered by the colluviums and the debris from the above landslide (Fig. 9b).

Fig. 9 : (a) Plan view of the Jalbire landslide. (b) Schematic cross-section of the Jalbire landslide

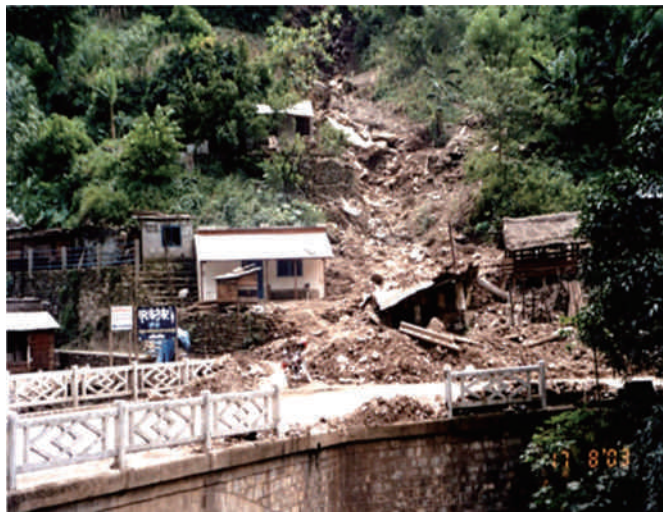
This landslide was triggered by the heavy rainfall of 2003. It is a translational type of rock slide, but develops into debris flow along the lower rich of the mountain, where several houses were destroyed (Fig. 10) and 5 peoples were killed by this landslide. The

Fig. 10 : Photograph showing the damaged houses by the debris flow that occurred in 2003 at Jalbire

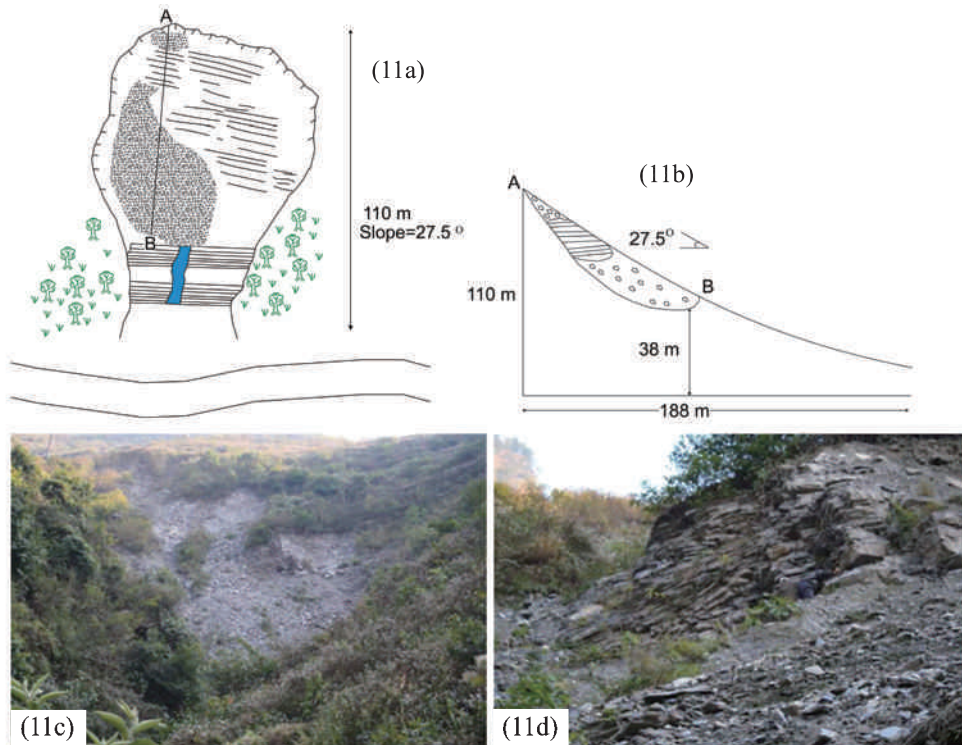
The rock unit around the landslide belongs to the the Nourpulp Formation, which consists of alternate beds of quartzite, phyllites and some carbonate beds with general attitude of $130^{\circ}/30^{\circ}\text{NW}$. It forms the southern limb of the Jalbire Syncline. The Virkuna Thrust is located few meters south of the landslide (Fig. 2). Colluviums are distributed at the upper part of the landslide (Fig. 11a), below which rocks are exposed. The rocks are fresh to highly weathered, and are intensely fractured, jointed and deformed. Two prominent joint sets ($J1=345^{\circ}/30^{\circ}\text{SW}$ and $J2=\text{EW}/45^{\circ}\text{S}$) are developed in the rocks making it very unstable due to the random fracturing of the rocks (Fig.

Fig. 11 : (a) Landslide observed at Ch 28 km, (b) Cross-section along A–B. (c) General view of the landslide at Ch 28 km (d) Rock exposure at the central part of the landslide

11a). The lower slope is mantled by thick ($>5\text{m}$) collapsed deposits consisting of coarse soil with domination of boulders and blocks and younger colluviums on the top (Fig. 11b). The collapsed deposit is believed to have formed during or following the formation of the VF. Fig. 11b shows the cross-section of the landslide. From this, it is seen that the average slope of the landslide is 27.5° . In addition, it is seen that both the top and lower portion of the landslide is covered by debris. Moat part of the landslide is seen to be covered by debris (Fig. 11c), while there exists some rock exposure at the central part consists of the rock exposure (Fig. 11d). The material in the debris ranges from clay to boulder size.

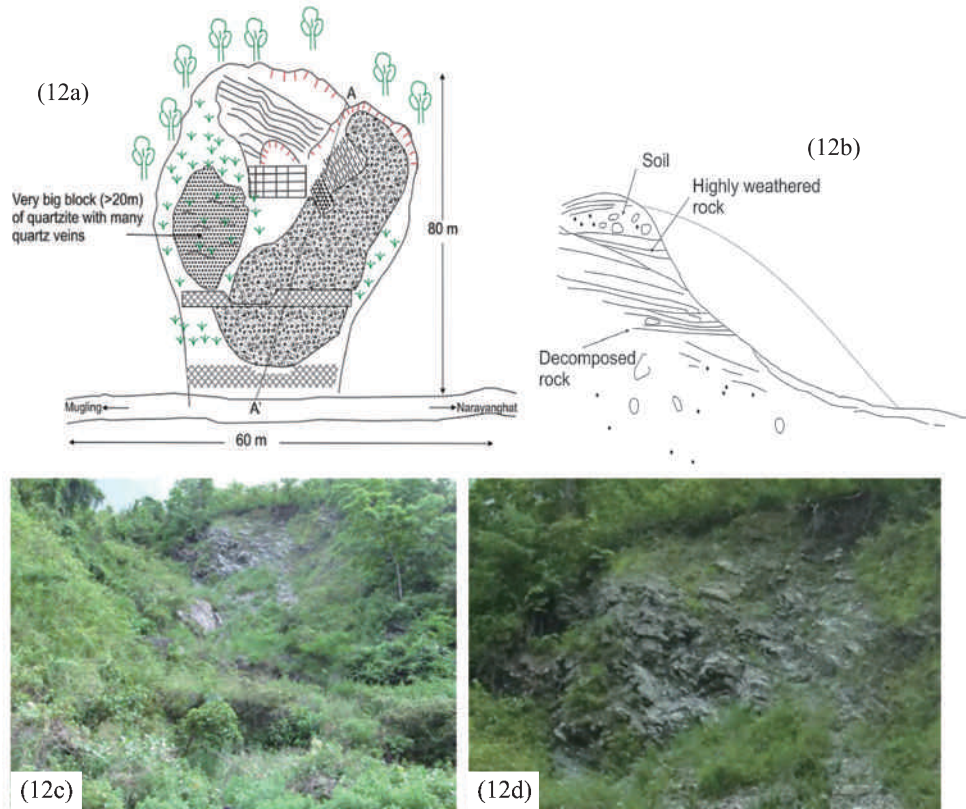
Fig. 12 : (a) Sketch showing the detailed view of the landslide observed at Ch 23.760 km, (b) Cross-section of the landslide, (c) Photographic view of the landslide at Ch 23.760 km (View NW) ; (d) Fractured and decomposed rocks observed in the landslide of Ch 23.760.

it is fresh. In the lower part, soils are sandy gravel with lots of fines and some boulders and blocks, and the thickness varies from <1 m to > 5 m (Fig. 12a). The attitude of the foliation in undisturbed outcrop is dominantly $270^{\circ}/72^{\circ}$ NW and the attitude of the major joint is $220^{\circ}/63^{\circ}$ NW. Some fold structures are also seen on the slate and phyllite.

Here, mainly rock slide is observed at the upper slope of the valley and soil slides both the banks of the river (Fig. 12 c, d). As the dip slope is mantled by thick collapsed deposits consisting of coarse soil with domination of boulders and blocks and younger colluviums on the top, the failed rock along with these debris flow down as a debris flow in every monsoon season. Although some engineering structures are constructed (Fig. 12c), and are protecting the slope from failure to some extent in some parts, the landslide still seems active and highly hazardous both for the village located up slope and road below.

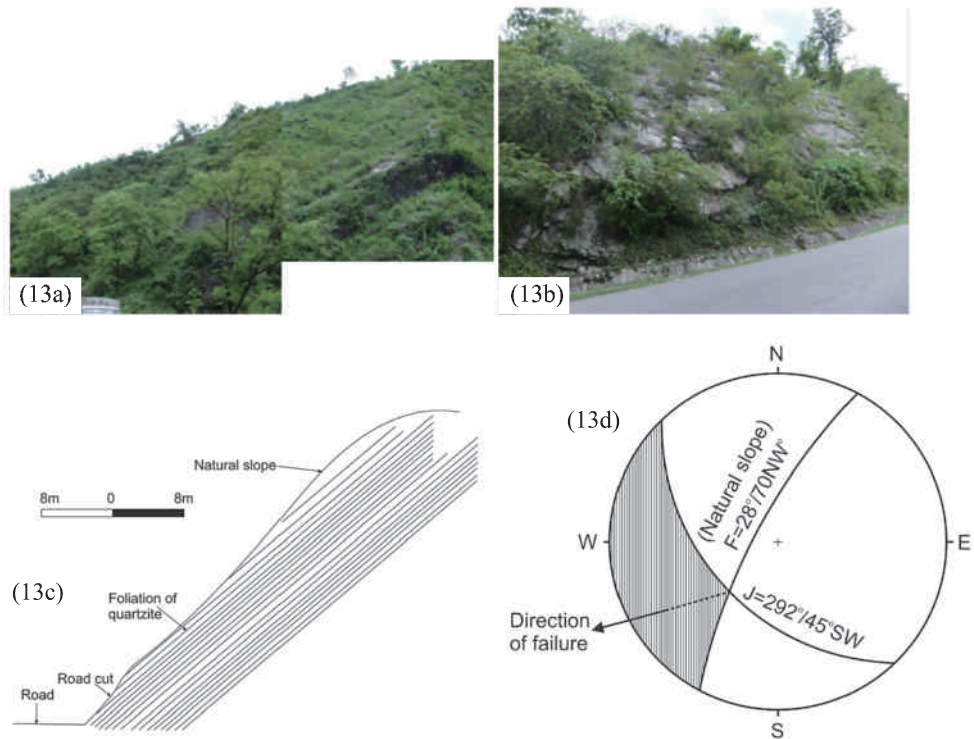
Fig. 13 (a) Photograph of the unstable rock mass at the right bank of Rigdi Khola near the bride site, (b) Photograph of the unstable rock mass at the right bank of Rigdi Khola at the bride site, (c) Sketch of the failure surface, (d) Serigraphic projection of the joint and foliation plane showing the failure surface.

Rigdi Khola is one of the major tributaries of Trishuli River along Mugling-Narayanghat road section. Both banks of the river near the highway are in very unstable stage due to rock plane failure. The road cut along the right bank of Rigdi Khola has created unstable areas around Rigdi Khola (Fig. 13a). Here the rocks are dipping towards the road section with the similar angle as that of the natural slope. In addition the rock mass is suffered from wide opened joints (Fig. 13b). Here one gabion wall has been built to control the rock failure ; however, the foundation of the wall is very unstable (Fig. 13b). Due to the presence of these open cracks, there is a great possibility of failure of rock block including the wall.

As stated earlier, the left bank of the Rigdi Khola near the highway is also in very critical stage due to regular rock plane failure. Fig. 13c shows the rock slope that is very much suffered from rock plane failure. The main rock type is quartzite and potentially daylighted bedding conditions occur on the cut-slope making the area very susceptible for rock failure (Fig. 13c). The attitude of foliation plane is $28/74N$, while

that of joints are ; $J_1=317/35SW$ and $J_2=298/44$. Here, the rocks are rather fresh. Fig. 13d is the cross-section of the rock slide. Here it is seen that the rocks are dipping towards the road, and the road cut has created unstable zone.

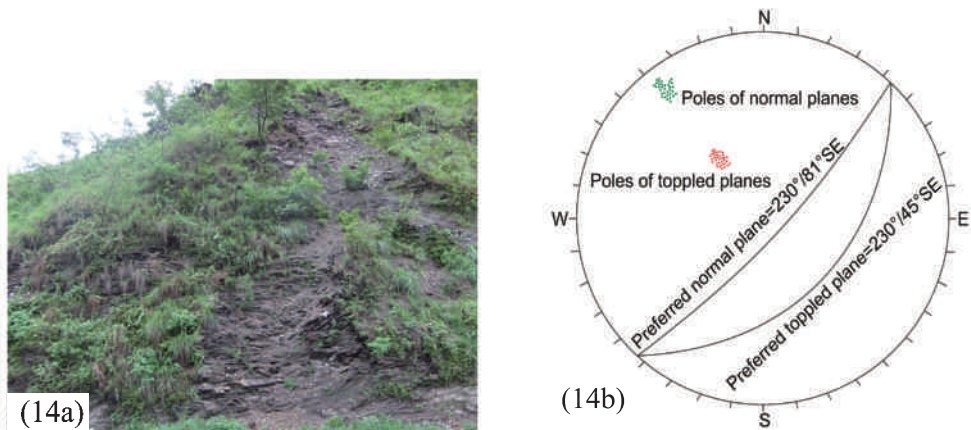
Fig. 14 (a) Photograph showing the landslide (View NW), (b) Serigraphic projection of the poles of the normal beds as well as the toppled beds and the normal and toppled planes

The outcrop is dominated by slightly weathered slate/phylite and few quartzites. The attitude of foliation plane at the lower slope is $233^\circ/78^\circ SE$, while at the upper slope it is $233^\circ/45^\circ SE$ (Fig. 14b). The rocks are well bedded and the thickness of the bed ranges from 55 cm to 20 cm. The rock is light gray and is very hard. The dip amount of the foliation plane decreases as the altitude increases, due to toppling. The opening of cracks between the overlying rocks and the rocks below is more than 20 cm. Also, it is seen that the rocks are dipping away from the slope, but due to the higher amount of dip angle of the rocks, they are toppled in the upper slope. Fig. 14b shows the serigraphic projection of both the normal and toppled rocks.)

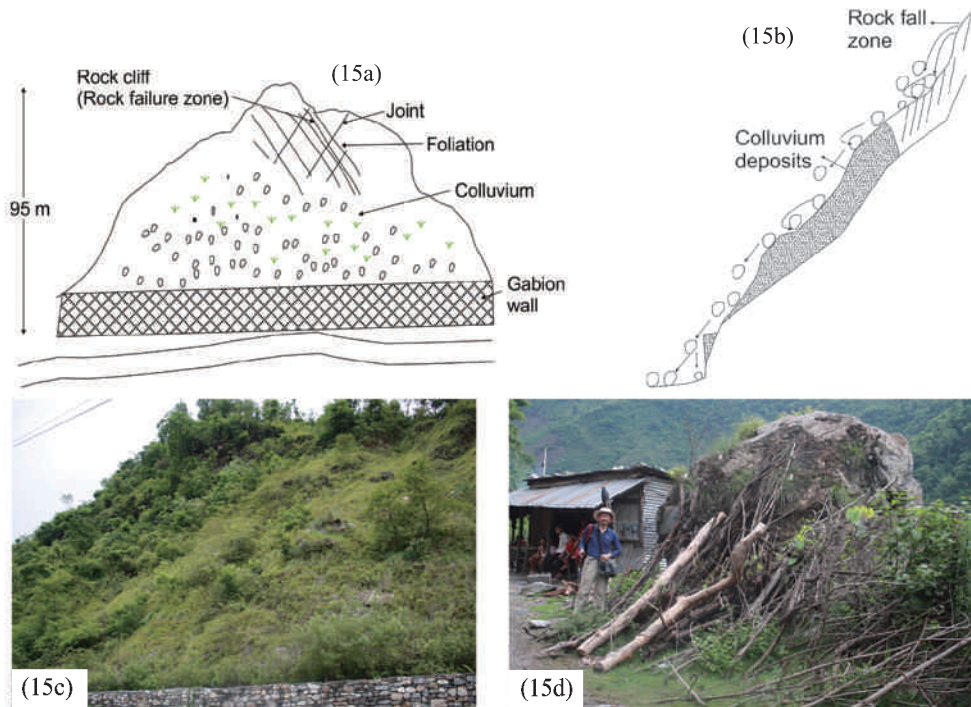
Fig. 15 : (a) Sketch showing the rock fall zone near Ghumaune of 2006, (b) Cross-section of the rock fall area, (c) Road section showing the steep cliff at Ghumaune, where rock failure occurred during the monsoon of 2006, (d) Large boulder of dolomite formed by the rock failure during the monsoon of 2006 lying on the road side.

Mugling-Narayanghat road section. This rock fall ($27^{\circ}49'0''\text{N}$, $84^{\circ}27'30''\text{E}$) crosses Mugling-Narayanghat Highway along the south of Ghumaune.

The outcrop comprising the Ghumaune rock fall are mainly dolomite and dolomitic quartzite with some phyllite partings belonging to Dhading Dolomite Formation of the Nawakot Complex. Nearly vertical cliff persists in the vicinity of the landslides. From the thin section and XRD analysis of the collected rock samples, it is seen that quartz, dolomite, and mica minerals constitute the main mineralogy with some minor amount of feldspar. No clay minerals are found in the rocks sample collected from this landslide. Even though, the phyllite seems to be weathered, no clay minerals could be detected. The high dip amount and highly jointed nature of the dolomite, followed by very steep slope (nearly vertical) are combined together to generate the present rock fall.
